Implementation of a Radiation Protection System at Four Hospitals in Ethiopia

Gebre Mesay Geletu*, Fikru Abiko, and Shamble Sahlu

Department of Physics, Wolkite University, Ethiopia

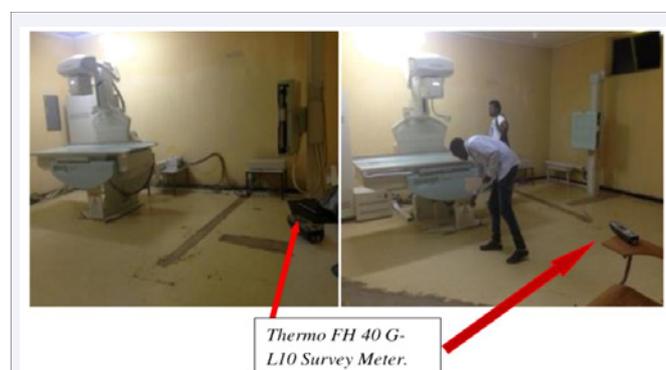
Figure 1 Photograph of X-ray room (XR) dose rate measurement location, along a side of the vertical chest stand (XR1) and along a side to the coach or table (XR2).

µSv/hr maximum Mercy Hospital. At all Hospitals XR1 results are greater than XR2 results. This can reveal the variation of the dose rate level from point to other point in the room.
