Autopsy on an RF-Processed X-band Travelling Wave Structure

F. Le Pimpec, S. Harvey, R.E. Kirby, F. Marcelja
 SLAC, 2575 Sand Hill Road, Menlo Park CA 94025 , USA

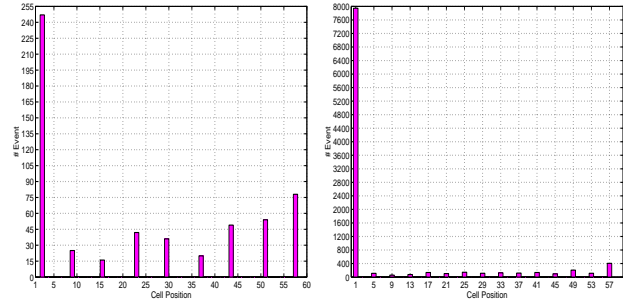
Figure 2: Example of damage localization in T53Vg3R (left) - T53Vg3RA (right) during operation

The breakdown pattern localization Fig.2 reveals that most of the breakdown are occurring in the input coupler (IC) of the TW. In Fig.3 we can see that the input coupler is divided into two parts the waveguide section, left side of the picture and the cell side in the center. The feature separating the waveguide side and the cell side is denominated "horns". The gap between the top and bottom horn is ~ 9 mm.

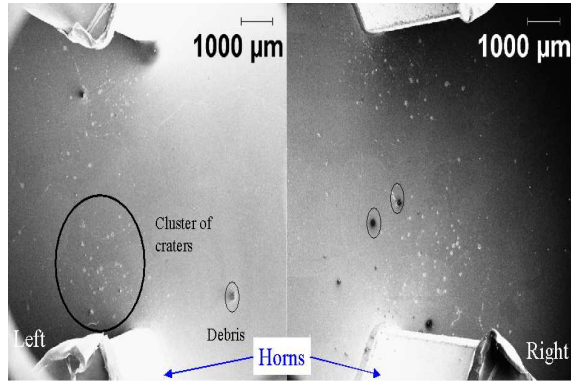
Fig.4, 5 and 6 reveal a very interesting pattern of damage. The craters on the floor of the IC, Fig.4, are mainly located along the imaginary circles connecting the two faces of the horns. Closing up to the horns and focusing on the

Figure 4: Pitting due to RF breakdown on the floor of the Input coupler. The iris is in between the horns.

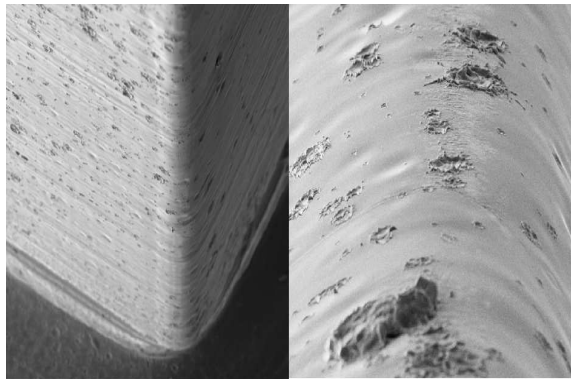
details, one can observe droplets of copper [3]. Craters appears on all the sides of the horns, with a density higher in the face side than the waveguide or cavity side. Looking more closely of the edges of the four horns has revealed that the edge on the waveguide side, Fig.5, shows little damage. In the contrary the edge on the cell side shows a chaos of features, Fig. 6, with sharp and melted objects. The dimension bar in the right picture of Fig.6 is $\sim 10\mu m$.

Figure 5: Typical damage on the waveguide side of a horn of the IC

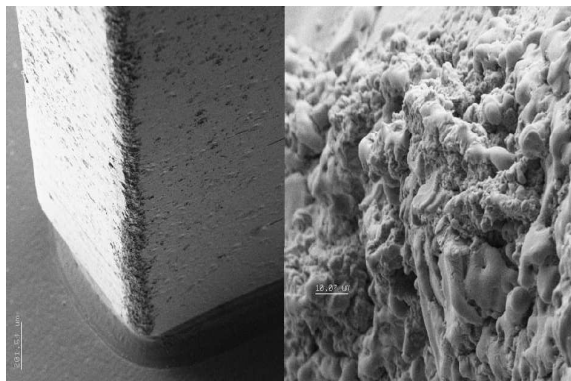
Figure 6: Typical damage on the Cell side of a horn of the IC

be invoked to explain the damages. However, the horns lies in a very low electric field area, and the vacuum is of the order of 3.10^{-9} Torr. It is then not possible to explain how such a low gas density and kinetic energy might start a breakdown leading to the so seen damages. It is also not possible to explain the very localization on the edge of the cavity side of the horns Fig.6. During processing, the RF pulse went from 50 ns to 400 ns carrying up to 100 MW of power. Part of this energy is dumped in the Cu in form of heat or directly or by the induced current due to the high magnetic field 0.7 MA/m at 400 ns pulse length [5]. Along the edge ($76\mu m$ radius) this RF pulse heating leads to an increase of temperature up to $130\text{ }^\circ\text{C}$. It is clear that this temperature do not cause the observed damage. However, it might induce thermal fatigue in the Cu, inducing formations of cracks, as observed in [6], and leading in roughening of the edge. As the surface becomes rougher, the local resistivity of the Cu increases leading to a higher temperature maybe up to the melting point ($1083\text{ }^\circ\text{C}$). At this temperature, the vapor pressure of the Cu is $\sim 3.10^{-4}$ Torr [7]. This gas can now be ionized by the electrons coming form the surface and back bombard the horns. As a result, raising up the temperature and sputtering the surface. We might, in addition, explain the droplet of Cu seen at the surface of the floor. The patterns of craters on the floor, Fig.4, seems to follow the high magnetic field line. As we move toward the center the density of craters diminish and increase again as the electric field start to be consequent Fig 7.

Following our autopsy many studies and simulation led to the decision of rounding the edge to 3mm instead of 76 μm radius in order to avoid the thermal fatigue roughening mechanism. It is believed that the new design of the IC and OC implementing this rounding will cure our breakdown problem in those couplers. Also, machining a 3mm edge radius should leave the surface extremely smooth. We have shown on an identical input coupler of T53Vg3R, Fig.9, that the 4 edges of the cavity side of the horns present a roughness after machining. Following the etching and thermal processing, that sees the structure, do not removed this roughness. In a contrary, the edge on the waveguide side of the horns are well finished.

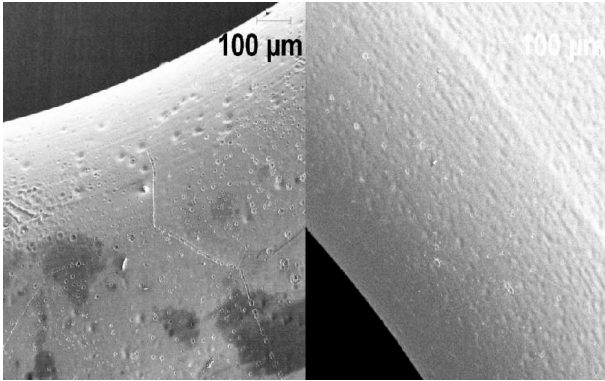
SEM (secondary electron microscopy) Fig. 7 shows the damage on the upstream side and the downstream side of the iris, respectif to the displacement of the NLCTA electron beam. On both sides etch pits can be seen as well as craters. However, the density of craters is much higher in the upstream side. Many craters are also located in the grain boundary. A particle search in and out of the craters shows MnS located in and out of them. Most of this inclusions are located in the grain boundary. The analysis of the contents of the craters shows mainly pure Cu. The black spots on the upstream side is carbon. An Auger analysis of the surface, not including those spots, shows heavy contamination by carbon of this iris [3]. Carbon contamination due to electron bombardement is a well known problem, [8]. There is no such contamination in iris 28 further down the structure [3].

Figure 7: Activity on the 1st iris, Upstream side left picture and downstream side right picture

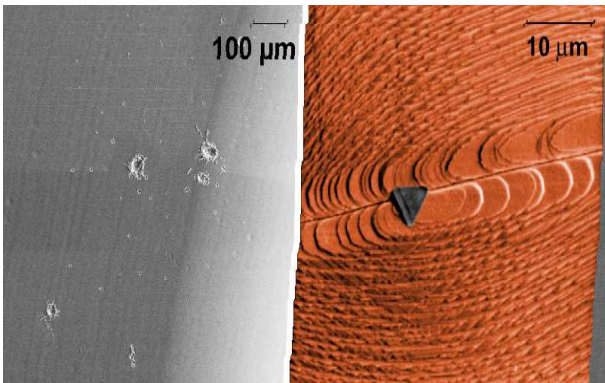
As we move toward the output coupler (OC), the activity on the irises decreases, endoscope (boroscope) monitoring. Fig.8 shows the sparse activity on the 28th iris of the structure. As we looked for particles/inclusions on the surface and at the grain boundary, we did not find MnS. However, some other sulfur compound were found [3], as the atypical one shown in Fig.8.

The cells used to make the structure are bonded and then brazed in a stainless steel (SS) H_2 furnace at $\sim 1020\text{ }^\circ\text{C}$. The Sulfur (S) composition is 0.03 weight % in stainless steel. Other material like Mn, Cr, Ni are also used in the making of SS. The solubility of sulfur in copper is

Figure 8: Activity on the 28th iris, Upstream side. CrS inclusion at a twin boundary, right picture

very high at this temperature and significant at a few hundred °C. Hence, a significant amount of S can get into the copper. After its fabrication, the structure is vacuum baked in a SS pot at 650°C for few days, in order to desorb the H₂. Metals might be present in the atmosphere of the H₂ furnaces and bakeout pot at this given temperature, with vapor pressures of 10⁻⁵ Torr for Mn, 10⁻¹¹ Torr for Cr, 10⁻¹ Torr for Ca and below 10⁻¹¹ Torr for Ni [7]. At 300°C and above the S concentrates at the grain boundaries of the Cu. The S also start migrating to the surface at low temperature 75°C [9]. The Model for sulfur compound formation is that the sulfur getters the metal vapor out of the furnace atmosphere to form crystals/inclusions at/near the grain boundaries. A particle search on the IC reveals that ~80% of the particles are Mn-S. On the very next iris the proportion falls to ~50%. The search in the 28th cell shows no Mn-S but S-compounds are present at ~50%. Finally the search on the last cell in front of the OC shows Mn-S and other S-compounds. Finally in all the cases, other particles are compounds based on C, Al and Si not excluding the presence of Mn or S or other elements. This model might explain the sulfur compound formation, but the understanding of the distribution along the structure of those elements is under investigation.

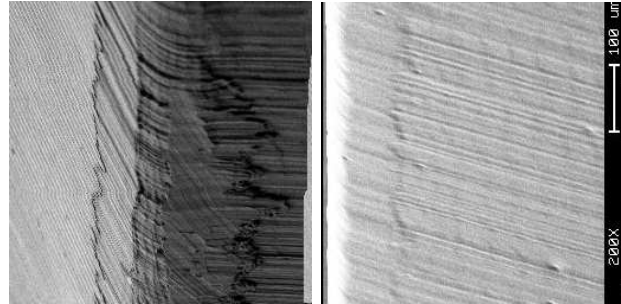
Figure 9: Surface of the edge, cell side, of a horn after machining (left) and after 60'' etch and thermal processing
