# ANALYSIS OF AN IN-SERVICE RUPTURE OF THE INNER FIRST WALL OF TORE SUPRA

R. Mitteau<sup>1</sup>, P. Chappuis<sup>1</sup>, G. Martin<sup>1</sup>, S. Rosanvallon<sup>2</sup>

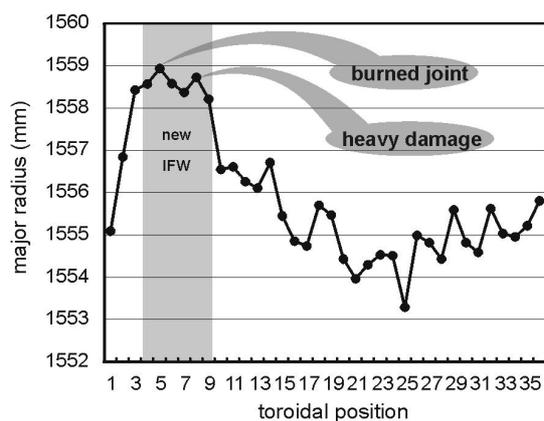
The failure occurred  $10^\circ$  under the equatorial plane. The IFW is not perfectly toroidal, and the new panels were installed a few millimetres forward to be tested more thoroughly. The failure is located on the most advanced panel (see Fig. 1), and the second most advanced is also strongly damaged. It is stunning to see that tiles recessed from only 5 tenth of millimetres are untouched. This give hints of the narrowness of the phenomenon involved. The location of the accident indicates that it is bound to be related to the plasma, the failed tile being the one defining the last closed flux surface. In a poloidal section, the contact should be in the equatorial plane, but slight deformations of the plasma frontier may locate the contact point on the lower row of tiles that was actually touched

fig. 1 : toroidal profile of the Inner First Wall

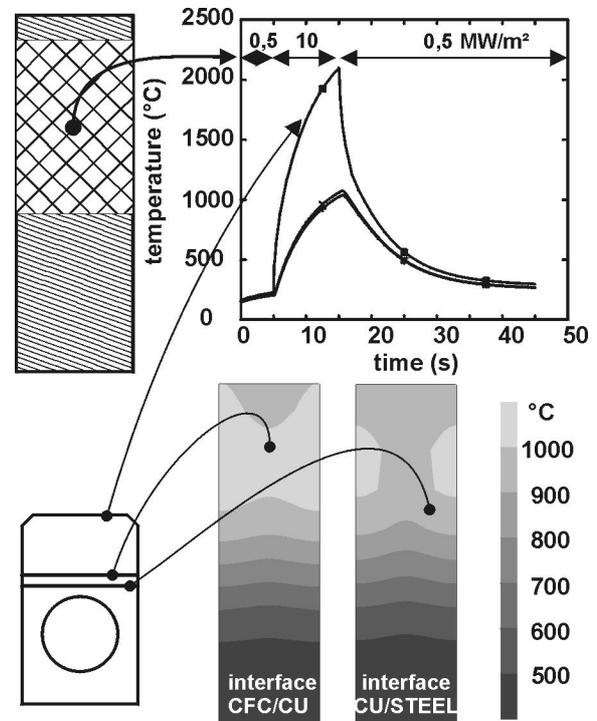
Fig. 2 : time - evolution of the temperature and temperature of brazed bonds at  $t = 15$  s

A thermal transient calculation (Fig. 2) shows that this condition is obtained for a mean incident heat flux of  $10 \text{ MW/m}^2$  over half the surface of the tile. This is ten times more than the nominal value of the structure (which was designed for  $1 \text{ MW/m}^2$ ) and five time more than the toughest test realised on it ( $2 \text{ MW/m}^2$  on the EB200 facility). Under these conditions, the interface between copper and the steel tube reaches the copper melting temperature of  $1083^\circ\text{C}$  in 10 seconds, necessary to explain the ejection of the copper. At the same time, the copper plate under the normal heat flux of  $0.5 \text{ MW/m}^2$  is still under  $500^\circ\text{C}$ . This is the reason why the tile can have stayed well bonded to the heat sink, the interfaces still holding strongly in this area. With this combination of events, the flux incoming on the heavily loaded part of the tile is still passed on to the copper and to the stainless steel, increasing the power load on it and leading ultimately to the

failure of the inner tube before complete detachment of the tile.

Two mechanisms are possible for the rupture of the stainless steel tube : firstly an overheating of the tube, leading to a cracking of the stainless steel, and secondly a critical heat flux in the water of the cooling circuit, which occur at  $6 \text{ MW/m}^2$  incident for the hydraulic conditions of that shot. At that stage, it is not possible to distinguish between the two (see section 5 for further investigations about this.).

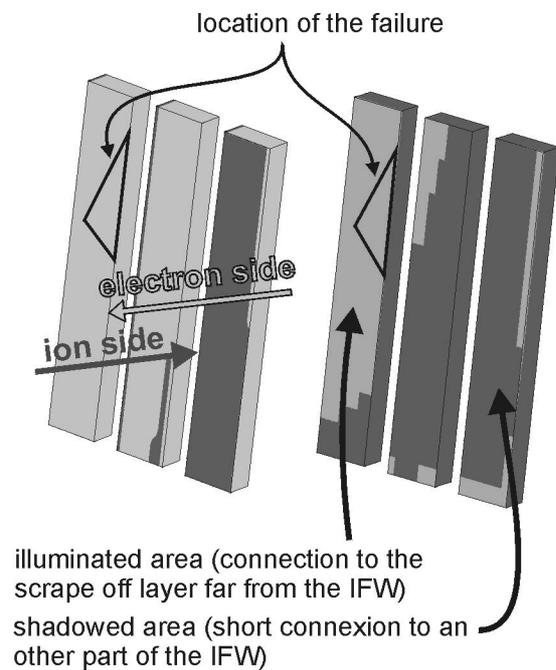
The simulation gives some hints on the heat flux reaching the tile (Fig. 3). The tile is connected to the electron side, thus enabling the hypothesis of supra thermal electrons [5]. The eroded location is actually wetted by the heat flux, not being shadowed by the IFW itself as other tiles (Fig 3.b). A precise value of e-folding length can however hardly be given, because it would be a result of the adjustment of the simulation to the observation of the surface temperature field. As the parameter has an order of magnitude smaller than a millimetre, the correlation would require to know the geometry of the wall and the plasma frontier with an accuracy smaller than that, which is not the case.

3.a : drift sides 3.b : IFW-shadowed areas

Fig. 3 : particle deposition on the IFW

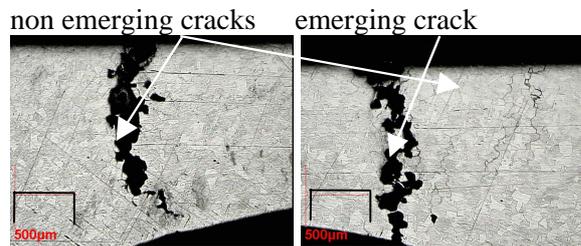
The damaged structure was investigated by metallography. The copper has indeed been blown-up, possibly by water vapour coming with the 2.8 MPa pressure from the inside of the tube. A crater is observed where the copper once stood. The tile and the square tube have retained their external shape and are covered by a thin copper layer. Many cracks are found in the stainless steel tube, where the wall thickness is the smallest. Some of these cracks are emerging, which was the cause for the water leak. Non - emerging cracks show all stages of the formation. The cracks are initiated on the copper side and progress towards the inside, speaking for a rupture caused by excessive heat flux rather than by critical heat flux. The cracks are intergranular, reminiscent of a slow crack progression. This speaks also in favour of a progressive damaging of the structure, well compatible to the flux excess, whereas a critical heat flux is a faster event. Copper is present as dendrites in the cracks. Cracking may have be facilitated

by the presence of liquid copper, which penetrates the grain boundaries of the stainless steel, causing their embrittlement.

Fig. 4 : microstructure of the failed structure

A pattern of corrosion is observed in the tube around the crack, indicating the steel has heated up to around 600°C. There is however no loss of material and the corrosion is more likely to be a consequence of the accident than its cause. No changes in the structure of the carbon fibre reinforced carbon of the tile are observed.
