# Setups for eliminating static charge of the ATLAS18 strip sensors

**ABSTRACT:** Construction of the new all-silicon Inner Tracker (ITk), developed by the ATLAS collaboration to be able to track charged particles produced at the High-Luminosity LHC, started in 2020 and is expected to continue till 2028. The ITk detector will include 18,000 highly segmented and radiation hard n<sup>+</sup>-in-p silicon strip sensors (ATLAS18), which are being manufactured by Hamamatsu Photonics. Mechanical and electrical characteristics of produced sensors are measured upon their delivery at several institutes participating in a complex Quality Control (QC) program. The QC tests performed on each individual sensor check the overall integrity and quality of the sensor. During the QC testing of ATLAS18 strip sensors, an increased number of sensors that failed the electrical tests was observed. In particular, IV measurements indicated an early breakdown, while large areas containing several tens or hundreds of neighbouring strips with low interstrip isolation were identified by the Full strip tests, and leakage current instabilities were measured in a long-term leakage current stability setup. Moreov

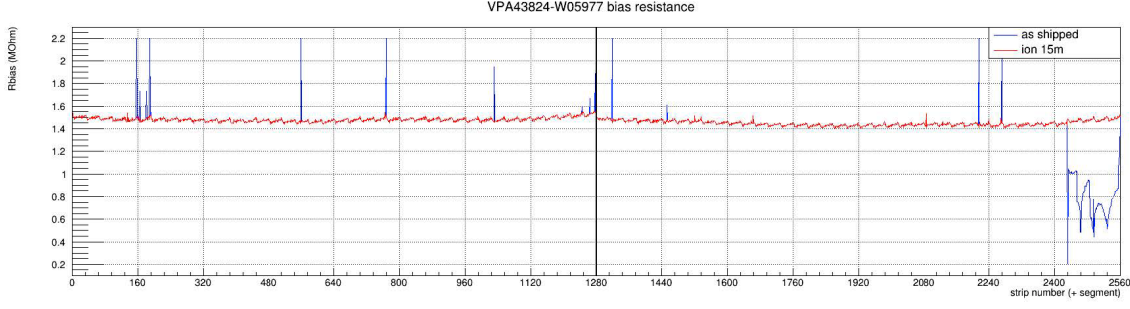
Application of the implemented recovery methods on the sensors affected by the "Local trapped charge" events is typically very effective. In some cases, several iterations are needed to fully recover the electrical characteristics of these sensors. The recovery of the low interstrip isolation by the intensive flow of ionized air is shown in Figure 5, while the application of the UV-A irradiation is illustrated in Figure 6. A significant increase in the breakdown voltage by the UV-A irradiation is represented by Figure 7.

**Figure 5.** The Full strip test performed on the sensor before and after the ion-blower treatment in QMUL. The resistance of the polysilicon bias resistor was measured on all strips of the sensor VPA43824-W05977. The area of 160 neighboring strips (around strip 2500) with low interstrip isolation was recovered by the ion blower treatment.

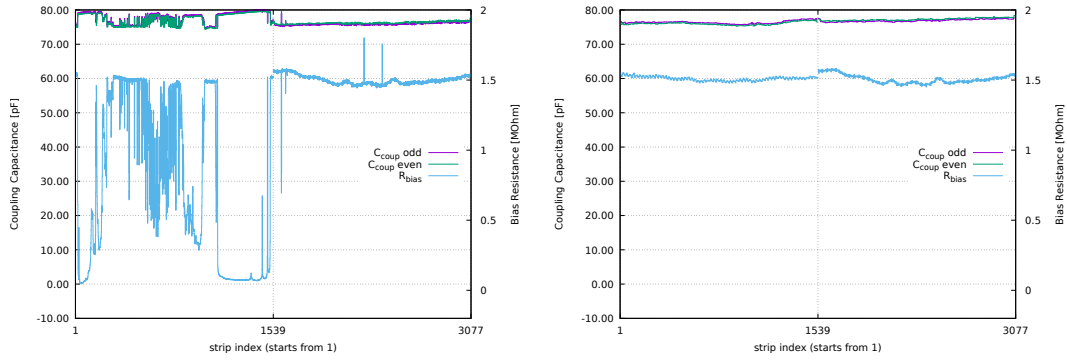
**Figure 6.** The Full strip test performed before (left) and after the UV-A treatment (right) in FZU. The resistance of the polysilicon bias resistor and coupling capacitance was measured on all strips of the sensor VPA38205-W00189. The area of  $\sim 1500$  strips with low interstrip isolation was recovered.

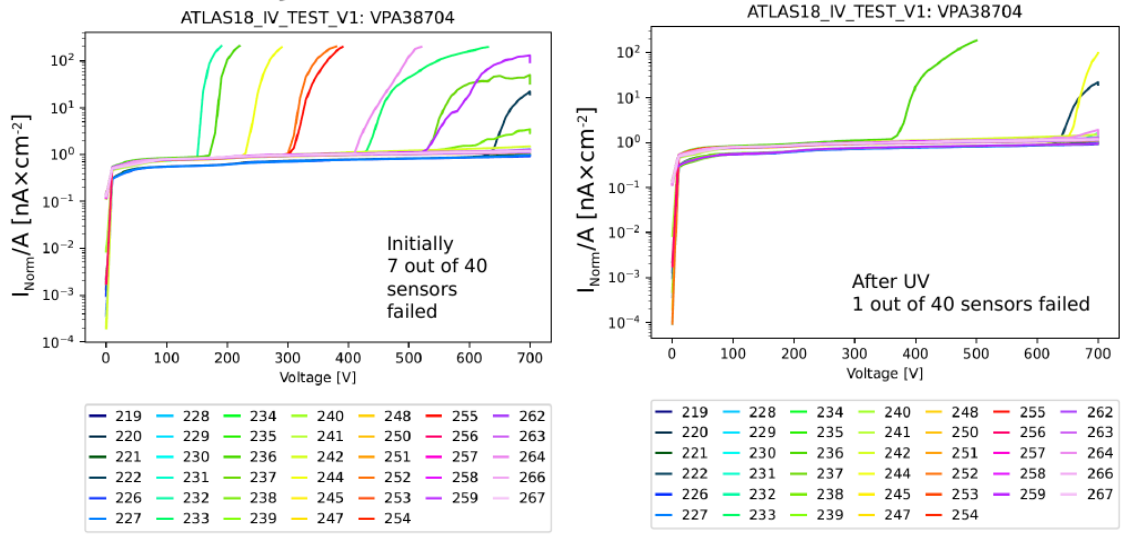
**Figure 7.** The IV measurements for the batch VPA38704 before and after the UV-A treatment in FZU. The current normalized to the surface of a sensor in the dependence of high voltage was measured for all sensors in the aforementioned batch. The majority of sensors with lower breakdown voltage were fully recovered.
