# Defects of Ge quantum dot arrays on the Si(001) surface

## Abstract

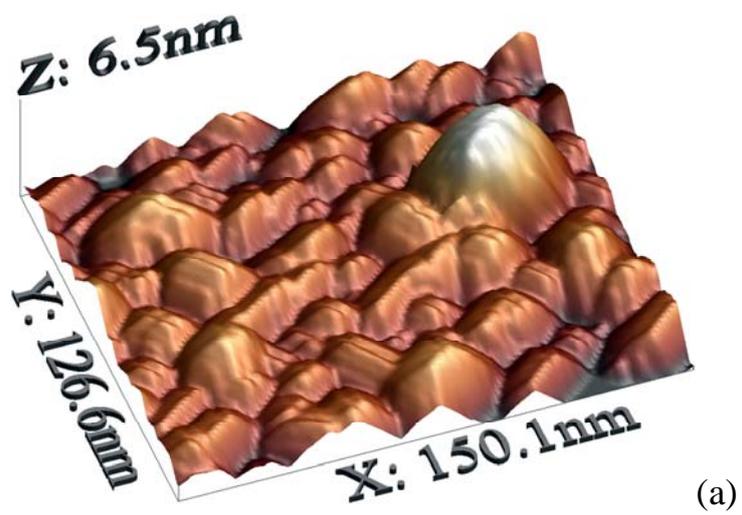
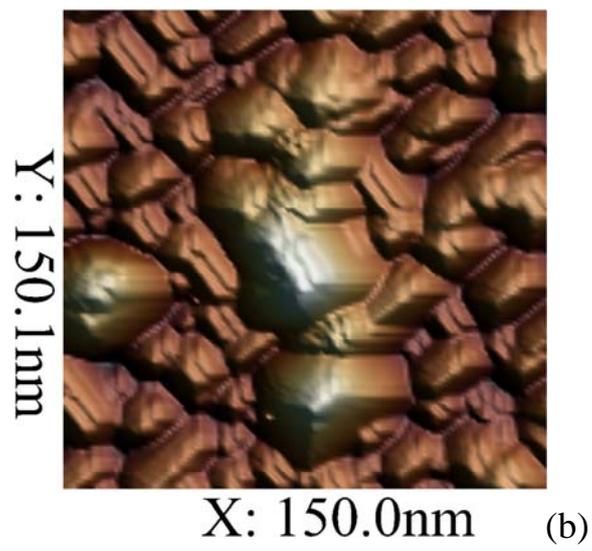
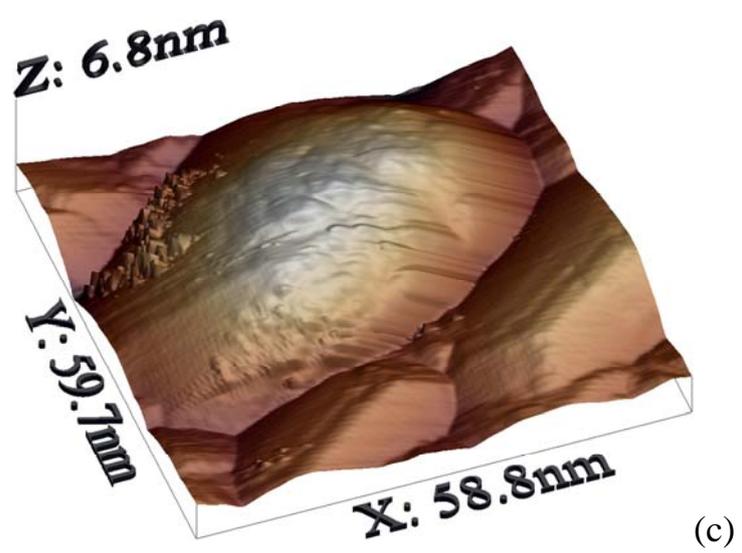
Figure 1.

Fig. 1. STM images of the large defects ( $h_{\text{Ge}} = 14 \text{ \AA}$ ;  $T_{\text{gr}} = 360^\circ\text{C}$ ): single (a) and grouped (b) large defects, a “rounded” large defect (c).

Fig. 1(a) presents a single large defect surrounded by the regular hut clusters. Large defects often gather in groups like those shown in Fig. 1(b). Another large defect looking like some “rounded” cluster is depicted in Fig. 1(c). Such defects being parts of arrays strongly violate their homogeneity. It should be noted also that the large defects never cause depletion areas in the QD arrays formed at  $T_{\text{gr}} = 360^\circ\text{C}$ . In the arrays grown at  $T_{\text{gr}} = 530^\circ\text{C}$ , some depletion was observed around the large defects and their groups.

The STM image of a facet of the large defect shown in Fig. 1(c) is presented in Fig. 3(b); steps and (001) terraces are resolved. The cluster looking like “rounded” have appeared to be faceted. The facet empty state image resembles that of the  $\{105\}$  one rather than some other high indexed facet characteristic for the dome clusters [11].

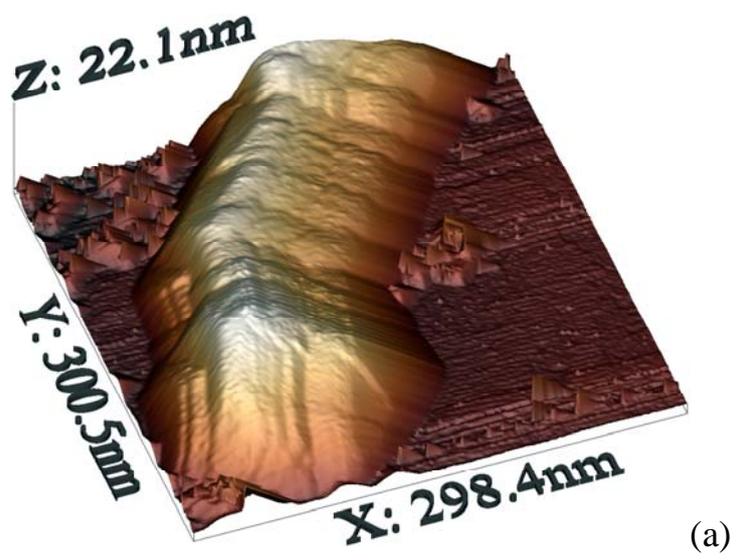
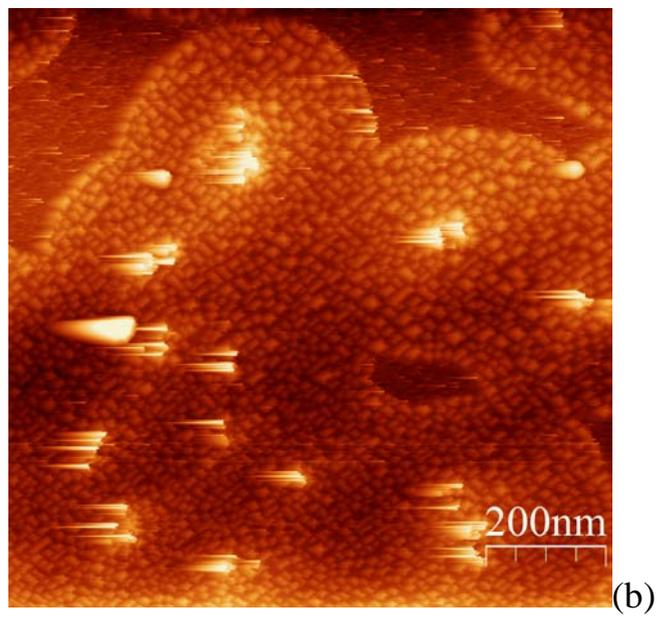
Figure 2.

Fig. 2. STM images of the extended defect (a) ( $h_{\text{Ge}} = 11 \text{ \AA}$ ,  $T_{\text{gr}} = 530^\circ\text{C}$ ) and the depleted regions (b) ( $h_{\text{Ge}} = 8 \text{ \AA}$ ,  $T_{\text{gr}} = 360^\circ\text{C}$ ); the large defects are also seen in the image (b) as tailed light spots.

As a result of the STM study of the samples grown at different values of  $h_{\text{Ge}}$  and  $T_{\text{gr}}$ , a preliminary classification of the defects was carried out. The revealed defects were subdivided into the following groups: (i) large hut or dome clusters [1, 9, 10] with the sizes untypical for the growth temperature referred to as *large defects* (Fig. 1), (ii) extended clusters stretching along the  $\langle 110 \rangle$  direction (*extended defects*), which are shown in Fig. 2(a), and (iii) areas in which QDs did not grow (*depleted regions*) demonstrated in Fig. 2(b).

Fig. 2(a) demonstrates a picturesque view on a huge extended defect. Heights of these defects  $h > 20$  nm, lengths  $l > 300$  nm, width  $w \sim 100\text{--}200$  nm. The hut cluster density is seen to dramatically drop in the vicinity of the extended defect. It is a common rule: the extended defects deplete the adjacent areas consuming all Ge atoms arriving onto the surface near them. Therefore, the extended defects may affect the QD array parameters and at high enough density sufficiently decrease the QD density throughout the array. The extended defects formation probability is increased as  $T_{\text{gr}}$  is enhanced.

In some samples, areas in which the Ge clusters did not grow were revealed. We did not manage to obtain the STM images of the surface in such depleted regions. These defects are likely strongly contaminated areas which are failed to be refined by the standard procedure of the Si surface pre-growth cleaning. Fig. 2(b) demonstrates the STM image of the sample containing the described type of defects.

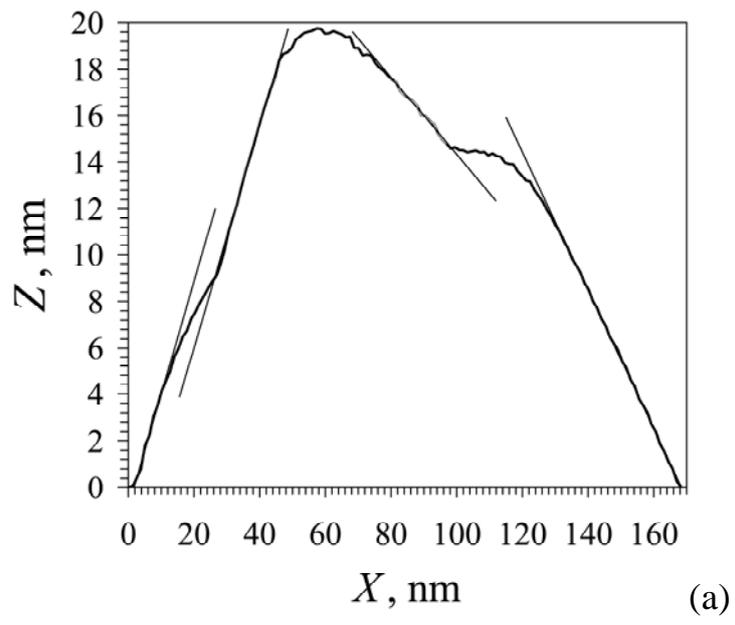
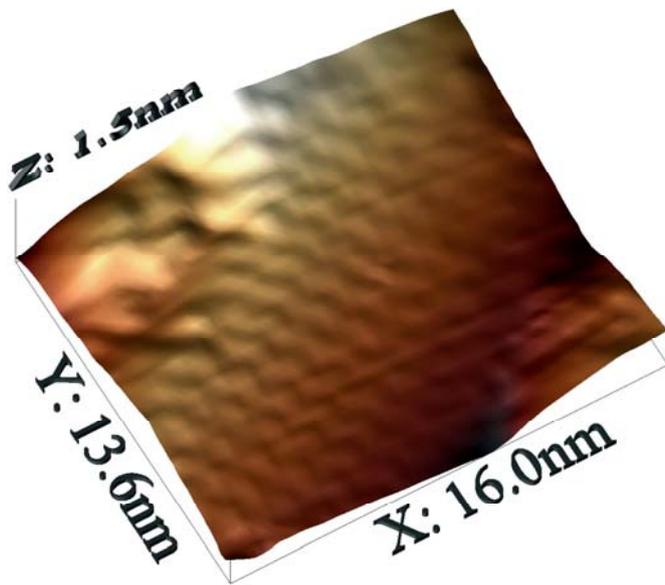
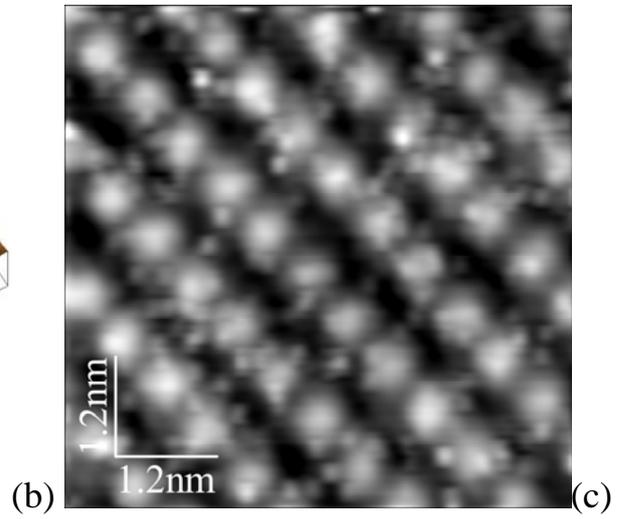
Figure 3.

Fig. 3. Morphology of the large and extended defects: a cross section profile (a) of the extended defect shown in Fig. 2(a), facets are emphasized by solid lines (tilt to the (001) plane is  $\sim 26^\circ$  for the left side and  $\sim 9.5^\circ$  and  $\sim 16.5^\circ$  for the right side); STM image of a facet of the large defect (b) shown in Fig. 1(c), steps and (001) terraces are resolved; a fine structure of the (001) terraces of the extended defect facet (c), the terraces are running from the lower left to the upper right corner of the image, dimer pairs are resolved.

Morphological peculiarities of the large and extended defects have been investigated. Fig. 3(a) depicts a profile of cross section of the extended defect shown in Fig. 2(a). It should be noted that these defects are observed to have very sophisticated shape and faceting. Fig. 3(a) presents only three facets:  $\{102\}$  tilted  $\sim 26^\circ$  to the (001) plane [9],  $\{106\}$  sloped  $\sim 9.5^\circ$  and an exotic  $\{3010\}$  face inclined  $\sim 16.5^\circ$  to (001). Other profiles revealed  $\{105\}$  and  $\{113\}$  facets as well as some additional exotic highly inclined facets. Although faceting of extended defects to some extent resembles faceting of the dome clusters [9, 10] their nature is absolutely different from the nature of ordinary domes.

Facets of the extended defects have been investigated with atomic resolution. The periodical structure of the dimer pairs on the (001) terraces are resolved in the STM image of a facet of the extended defect given in Fig. 3(c). The period was measured to be  $\sim 11$  Å along the terraces and  $\sim 7$  Å in the normal direction (from apex to base).

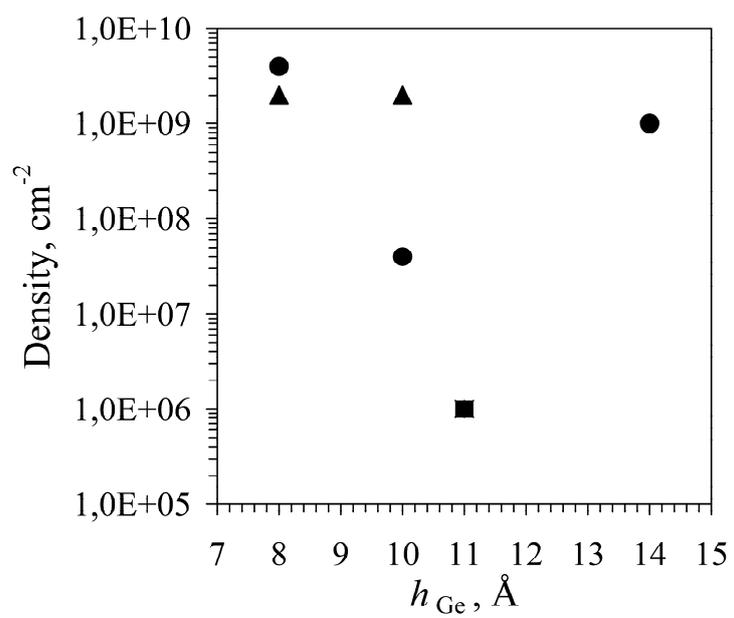
Figure 4.

Fig. 4. Surface density of large ( $\blacktriangle$ ,  $T_{\text{gr}} = 530^\circ\text{C}$ ;  $\bullet$ ,  $T_{\text{gr}} = 360^\circ\text{C}$ ) and extended ( $\blacksquare$ ,  $T_{\text{gr}} = 530^\circ\text{C}$ ) defects estimated from STM images.

Fig. 4 depicts a plot of the defect surface density for different values of  $h_{\text{Ge}}$  and  $T_{\text{gr}}$ . At different  $T_{\text{gr}}$ , the density of the large defects is seen to differently change with  $h_{\text{Ge}}$ . At  $T_{\text{gr}} = 530^\circ\text{C}$  their density is approximately constant ( $\sim 2 \times 10^9 \text{ cm}^{-2}$ ) whereas at  $T_{\text{gr}} = 360^\circ\text{C}$  it is maximum at  $h_{\text{Ge}} = 8$  Å ( $\sim 4 \times 10^9 \text{ cm}^{-2}$ ), drastically drops at  $h_{\text{Ge}} = 10$  Å ( $\sim 4 \times 10^7 \text{ cm}^{-2}$ ) and increases again at  $h_{\text{Ge}} = 14$  Å ( $\sim 10^9 \text{ cm}^{-2}$ ). The density of extended defect was evaluated as  $10^6 \text{ cm}^{-2}$ .
