Reciprocity Failure in HgCdTe Detectors: Measurements and Mitigation

T. Biesiadzinski, W. Lorenzon, R. Newman, M. Schubnell, G. Tarlé, C. Weaverdyck
Department of Physics, University of Michigan, Ann Arbor, MI 48109

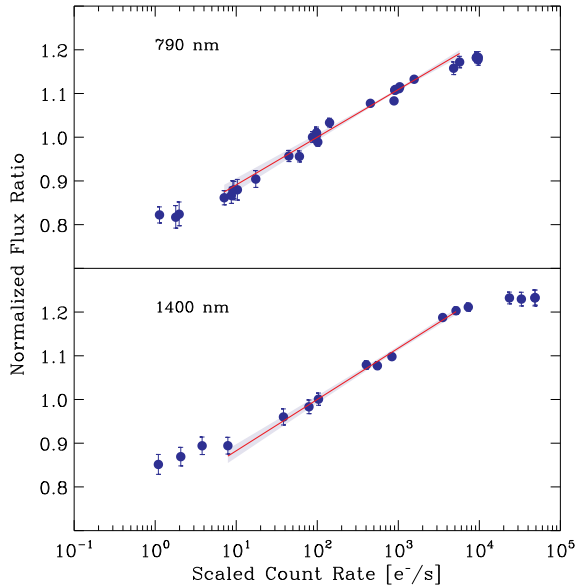
Fig. 2.— Average reciprocity failure measured in device H2RG-236 at 790 nm (top panel) and 1400 nm (bottom panel). Data was taken in the *stripe mode*. The 68% confidence level is indicated by the shaded area.

Devices H2RG-236 and H2RG-238 were produced during the sixth manufacturing run of the SNAP/JDEM R&D program. Like device H2RG-142 they both are mounted on a SiC pedestal but unlike that device, they were hybridized to a newer multiplexer, the HAWAII-2RG-A1 designed in part to reduce capacitive coupling between neighboring pixels (Brown et al. 2006). Both devices have low dark current and read noise and are very good cosmetically. Quantum efficiency of both devices is lower than in earlier detectors but is exceptionally uniform when measured at high flux. The average reciprocity failure measured in *stripe mode* for device H2RG-236, shown in Figure 2, is (10.9 ± 0.5) % decade⁻¹ and (11.7 ± 0.5) % decade⁻¹ at 790 nm and 1400 nm, respectively. The results from the two measurements are very similar, emphasizing the insensitivity of reciprocity failure to the wavelength of the illumination for these detectors. Data taken at 1400 nm and 950 nm (not shown in Figure 2) revealed that a linear fit is only representative for illumination levels between roughly 10 counts s^{-1} and $10,000 \text{ counts s}^{-1}$. Outside this range the detector response appears to become linear, indicating a saturation effect at high illumination levels and possi-

bly a turn-on threshold at low illumination levels. Detector H2RG-236 showed the largest reciprocity failure of the four devices measured.

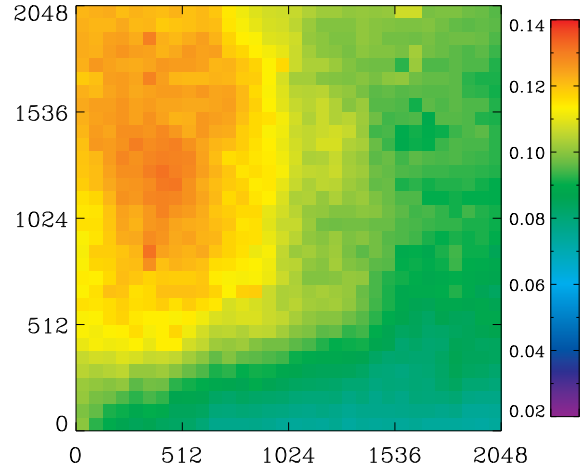
Fig. 3.— Reciprocity failure map for device H2RG-236 at 790 nm. The scale is in $\% \text{ decade}^{-1}$.

Strong spatial variation of reciprocity failure was observed in these two devices, ranging from 7.3% decade⁻¹ to 13.1% decade⁻¹ for device H2RG-236 (Figure 3) and from 2.9% decade⁻¹ to 9.5% decade⁻¹ for device H2RG-238 (Figure 4). It is worth noting that for such a device, simply correcting for the average reciprocity failure without accounting for spatial structure will result in a large residual uncertainty in photometric measurements.

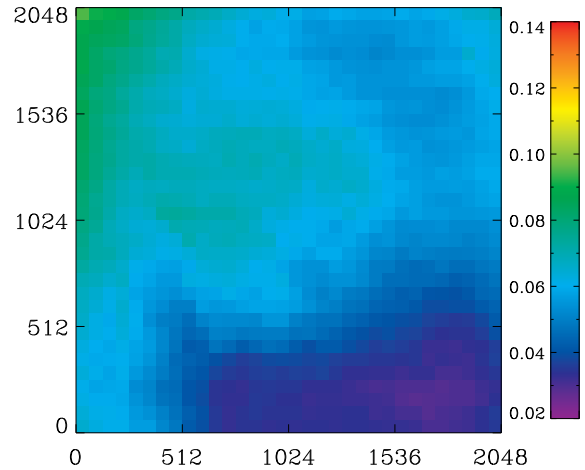
Fig. 4.— Reciprocity failure map for device H2RG-238 at 950 nm. The scale is in $\% \text{ decade}^{-1}$.
