Reciprocity Failure in HgCdTe Detectors: Measurements and Mitigation

T. Biesiadzinski, W. Lorenzon, R. Newman, M. Schubnell, G. Tarlé, C. Weaverdyck
Department of Physics, University of Michigan, Ann Arbor, MI 48109

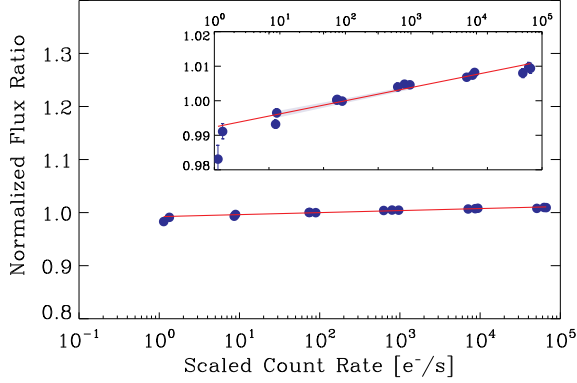
Fig. 1.— Reciprocity failure measured in *stripe mode* for device H2RG-142 at 790 nm. The ordinate scale was set to allow a direct comparison with other detectors. A magnified scale is shown in the insert. The 68% confidence level is indicated by the shaded area.

Device H2RG-142 came from the fifth manufacturing run for SNAP. It was mounted on a SiC pedestal specifically developed for SNAP/JDEM to provide a good thermal match to the multiplexer. Devices from this run were also mated to the HAWAII-2RG-A0 multiplexer. H2RG-142 has high QE and low read noise. It exhibits a somewhat larger number of hot pixels than H2RG-102 but is otherwise cosmetically good. Figure 1 shows reciprocity failure of (0.38 ± 0.03) % decade⁻¹ at 790 nm in *stripe mode*. The average reciprocity failure value measured for this device was very similar to detector H2RG-102 at all wavelengths.

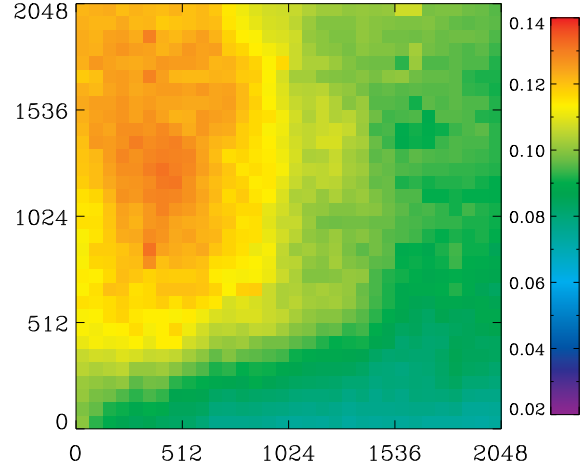
Fig. 3.— Reciprocity failure map for device H2RG-236 at 790 nm. The scale is in $\% \text{ decade}^{-1}$.

Strong spatial variation of reciprocity failure was observed in these two devices, ranging from 7.3 % decade⁻¹ to 13.1 % decade⁻¹ for device H2RG-236 (Figure 3) and from 2.9 % decade⁻¹ to 9.5 % decade⁻¹ for device H2RG-238 (Figure 4). It is worth noting that for such a device, simply correcting for the average reciprocity failure without accounting for spatial structure will result in a large residual uncertainty in photometric measurements.

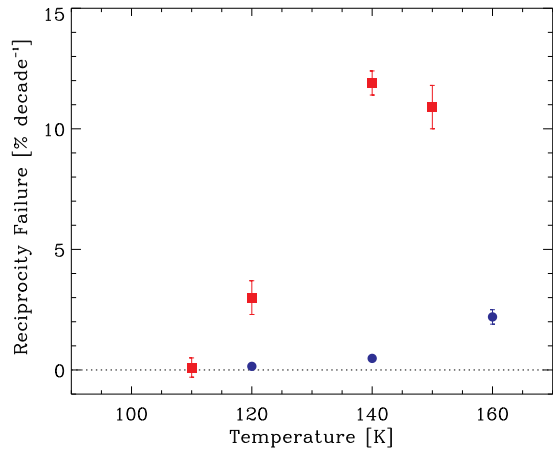
Fig. 5.— Reciprocity failure as a function of detector temperature for devices H2RG-142 (blue circles) and H2RG-236 (red squares).

In an attempt to better understand the physical mechanisms that lead to reciprocity failure, it was investigated how reciprocity failure is affected by device temperature. Detectors H2RG-142 and H2RG-236, low and high reciprocity devices, respectively, were tested at temperatures ranging from 100 K to 160 K. These tests revealed that flux dependent nonlinearity can be “frozen out” at sufficiently low temperatures. The results from the two detectors, shown in Figure 5, suggest that this freeze-out temperature depends on the amount of reciprocity failure in a particular detector and will therefore most likely vary for different detectors. An overview of the temperature test results is presented in Table 2.

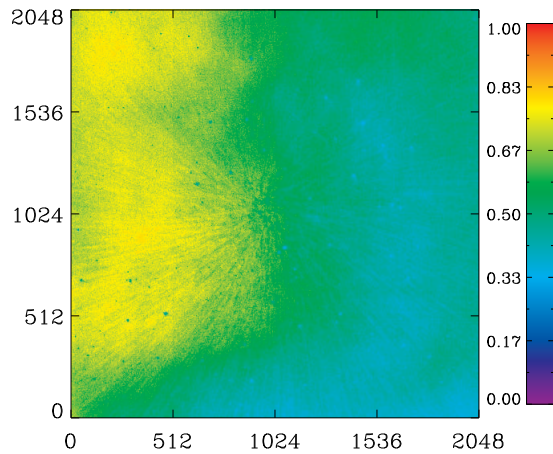
Fig. 6.— Ratio of two H2RG-236 flat field images with a factor of 1000 difference in flux. The observed large scale structure is due to reciprocity failure. The measurement was performed at 140 K.

dard flat field illumination test setup two flat field images were produced, one at a very high illumination intensity and a second at a very low illumination intensity. The ratio of these two images, shown in Figure 6, displays the same spatial variability as the reciprocity failure map for this detector shown in Figure 3. Such a measurement may therefore be used as a simple test that does not require any special equipment beyond a basic illumination system. However, some caveats apply. This test will only reveal spatial structure in reciprocity failure of a device, and will not produce an absolute value for the strength of reciprocity failure, nor will it reveal reciprocity failure in detectors where the effect is spatially uniform.

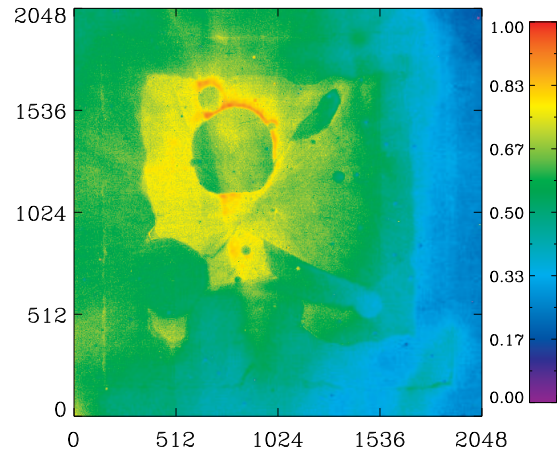
Fig. 7.— Image persistence in H2RG-236.

The observed spatial nonuniformity in reciprocity failure provides an opportunity to investigate a possible correlation with other detector properties such as dark current, QE near cutoff³, and image persistence. Therefore the cross correlation between the spatial structure of reciprocity failure and the other properties was computed for device H2RG-236. This particular detector was selected because of the pronounced spatial nonuniformity in reciprocity failure. The correlation coefficient was normalized to have a value between -1 and 1 for fully anti-correlated structure and identical structure, respectively. A value of zero represents the absence of correlation. Both, the 790 nm and the 1400 nm reciprocity failure data were used for this analysis as shown in Table
