# Assembly and Installation of the Daya Bay Antineutrino Detectors

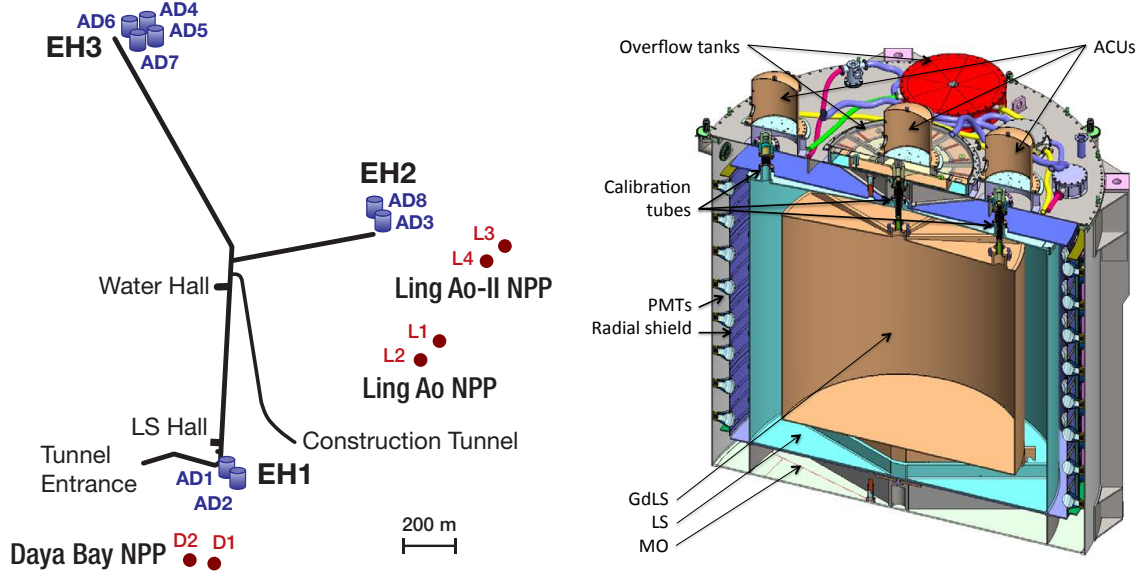
**Figure 1.** (left) Layout of the Daya Bay experiment. The dots represent reactors cores, labeled as D1, D2, L1, L2, L3 and L4. There is one pair of cores at each of the Nuclear Power Plants (NPP). Eight antineutrino detectors (ADs) are installed in three experimental halls. (right) The Daya Bay antineutrino detector contains 3 zones: a gadolinium loaded liquid scintillator inner target (20 tons) inside the inner acrylic vessel (brown), a liquid scintillator gamma catcher (21 tons) contained by the outer acrylic vessel (aqua), and a mineral oil buffer (37 tons) inside the stainless steel outer vessel (grey).

As shown in Fig. 1 the Daya Bay experiment consists of three underground experimental halls located 360-2000 m from three pairs of reactor cores. The experimental halls are excavated under the side of an adjacent mountain to reduce cosmic ray backgrounds and are connected by large aperture tunnels. Each of the two near experimental halls contains two antineutrino detectors (ADs) in an instrumented water pool. The far experimental hall contains four ADs in a larger water pool. The ADs are constructed in an above ground assembly building before being transported underground to the liquid scintillator (LS) filling hall. The filled ADs are then moved on a custom transport to the appropriate experimental hall and lifted by an overhead crane into the water pool.

Each AD consists of a Stainless Steel Vessel (SSV) containing 3 detector zones filled with different liquids as shown in Fig. 1. Two nested acrylic cylinders separate the 3 zones. The innermost target zone contains 20 tons of gadolinium-doped liquid scintillator (GdLS) inside an Inner Acrylic Vessel (IAV). This zone is surrounded by 21 tons of liquid scintillator (LS) gamma catcher contained by an Outer Acrylic Vessel (OAV). The scintillation light from IBD interactions is observed by 192 photomultipliers (PMTs) arranged in a cylindrical shell. An outer zone of liquid contains 37 tons of mineral oil (MO) that shield the inner zones from radioactivity originating in the PMT glass or other background sources. Overflow tanks above the SSV lid allow for the expansion of the liquids with changes of temperature or external pressure. Reflectors above and below the LS volume improve the light collection efficiency, increase the uniformity of the light collection, and reduce variations in the energy response of the detector along its vertical axis. Three automated cal-

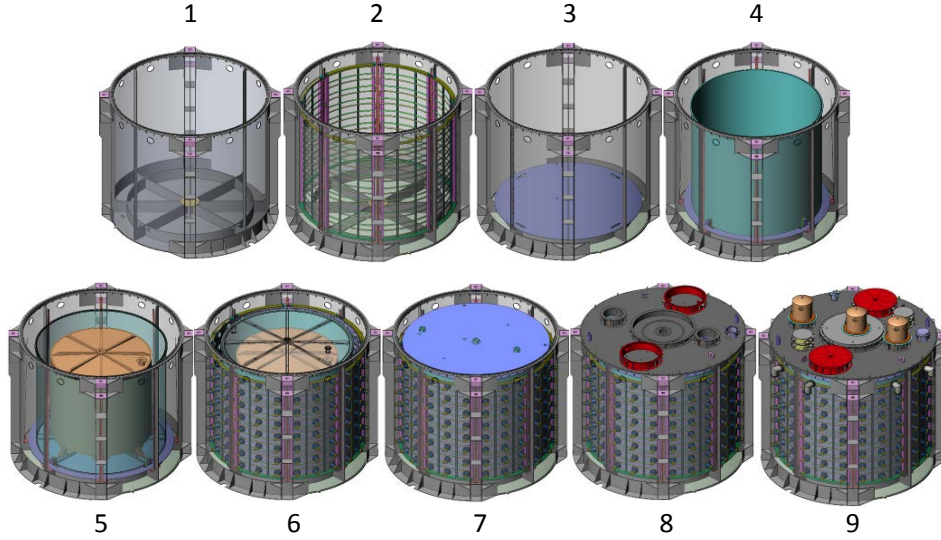
**Figure 2.** AD assembly sequence. (1) After cleaning, the SSV is placed in the assembly pit. (2) Bare PMT ladders are test mounted and surveyed. (3) The bottom reflector is inserted. (4) The OAV is placed on the reflector. (5) The IAV is brought in and mounted inside the OAV. (6) the OAV lid is mounted and the PMT ladders are installed. (7) The upper reflector and lower parts of the OAV calibration tubes are installed. (8) The SSV lid is installed. (9) The overflow tanks, upper calibration tubes, covers and ACUs are installed.

Assembly of an AD followed a well defined sequence of steps, previously shown in Fig. 2 and

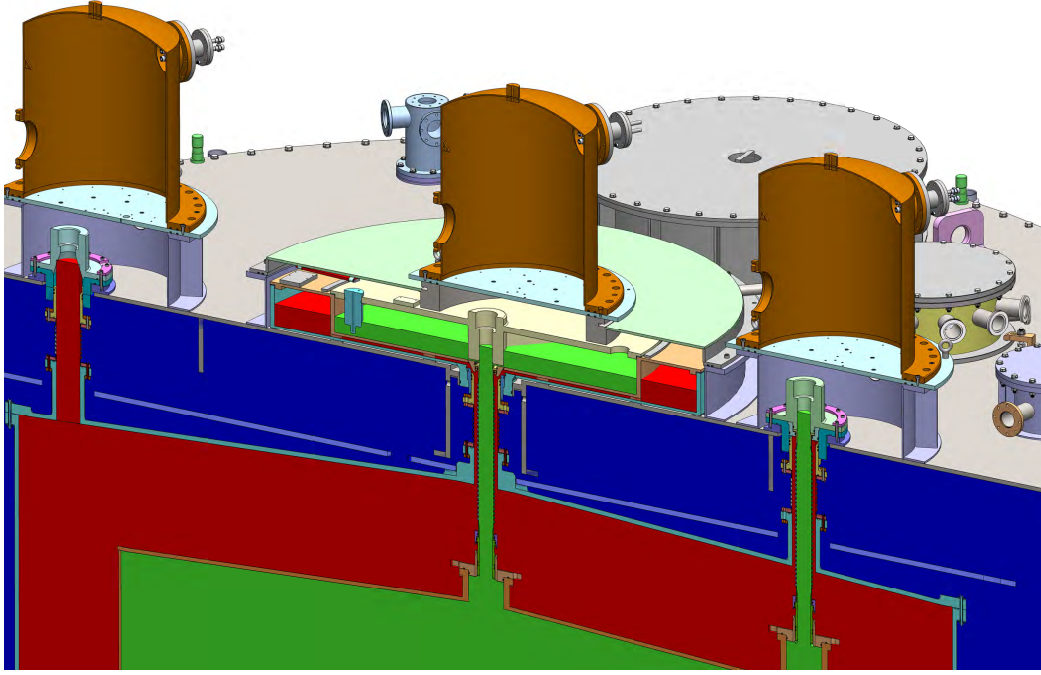
**Figure 3.** Liquid volumes inside the Daya Bay vessels, calibration tubes, and overflow tanks: GdLS - green, LS-red, MO-blue. The outside of one of the MO overflow tanks is seen behind the central ACU. The IAV and OAV are connected by convoluted teflon tubes to the SSV lid or to the central overflow tanks. All surfaces contacting the GdLS or LS (red or green) are constructed from acrylic or teflon components.

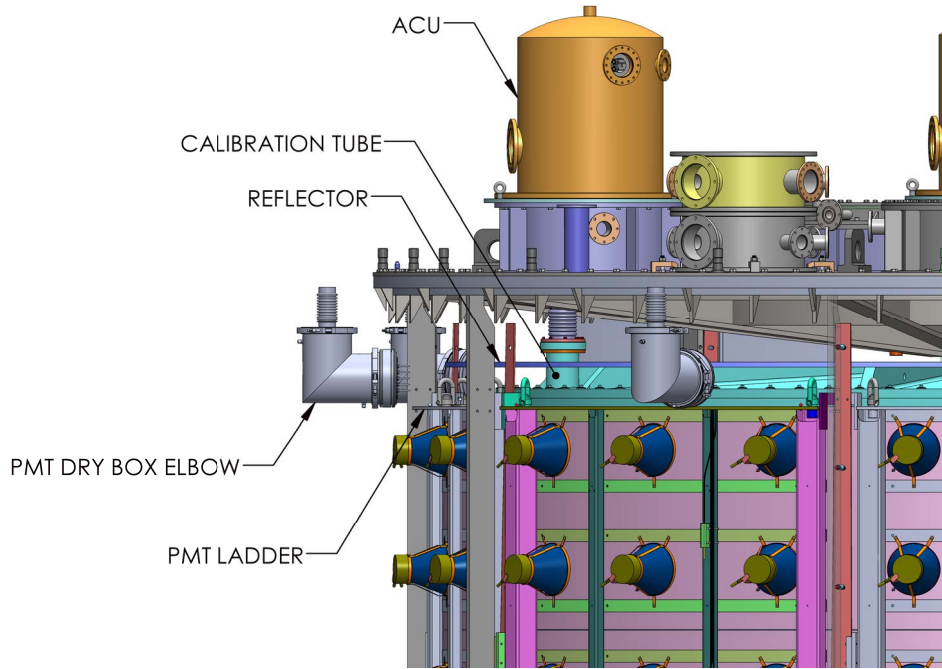
**Figure 4.** AD section with the SSV wall removed to show details of the PMT mounting method, the dry box connections, upper reflector support and one of the OAV calibration tubes. Above the SSV lid are ACUs, electrical interface boxes and overflow tanks. The complicated geometry of the SSV ribs and tube connections are hidden from the PMT field of view by the reflector.

Daya Bay ADs have reflectors below and above the GdLS target volume to reduce the number of PMTs required and to simplify construction (see Fig. 4). Monte Carlo simulations [6] predict an acceptable light collection uniformity. The reflector also has the advantage of hiding complex lid or SSV base geometry from the PMT's field of view.

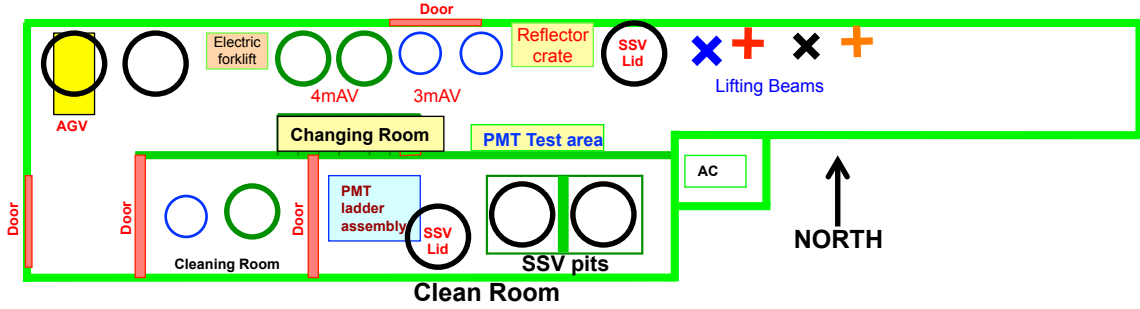
**Figure 5.** Surface Assembly Building during the height of activity. Two partially assembled stainless steel vessels (SSVs -black circles) are in the clean room. A recently cleaned 4 meter outer acrylic vessel (OAV - green circle) waits in the cleaning area. A 3 meter inner acrylic vessel (IAV - blue circle) is also being prepared for cleaning. Other components are stored in the neighboring bay.

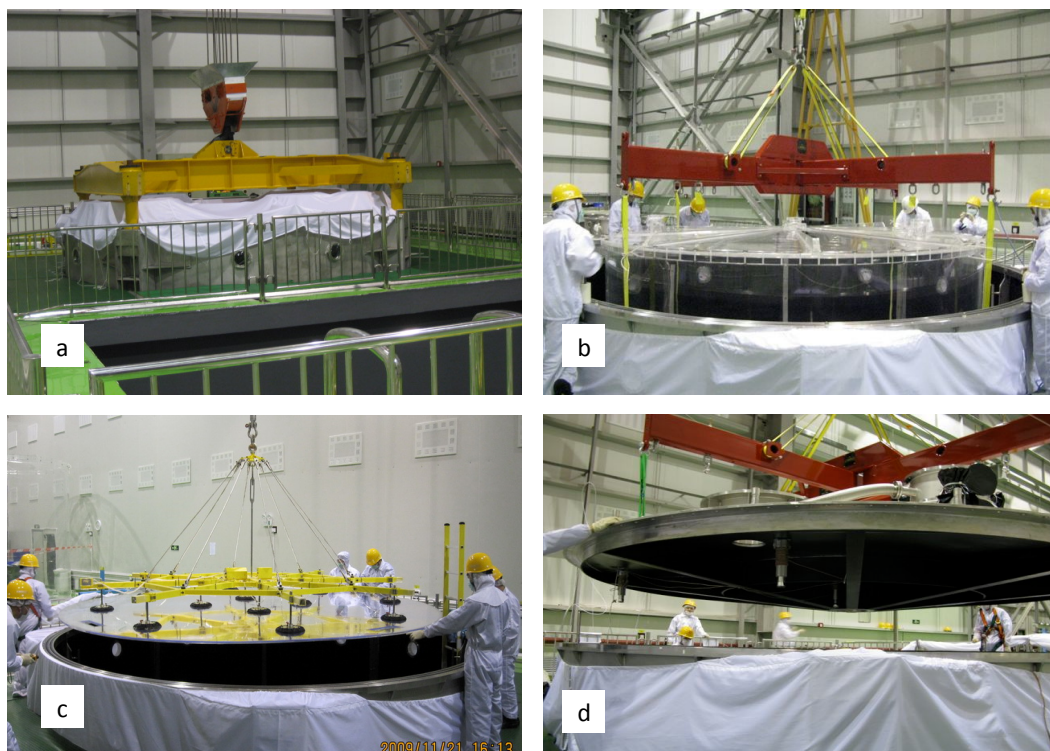
**Figure 6.** Custom lifting fixtures for AD assembly. (a) SSV lifting fixture (yellow) connected to a SSV. (b) multipurpose fixture (red) used to lower an OAV into the SSV. (c) vacuum pad fixture (yellow) used to install the reflector. (d) the multipurpose fixture lowering the SSV lid into place.

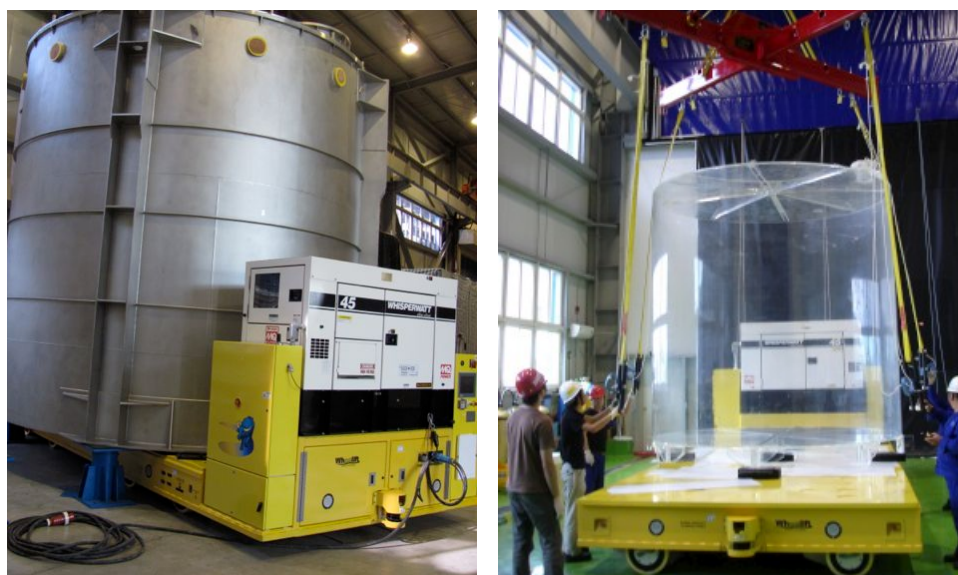
**Figure 7.** (left) The SSV is being lifted by the AGV from storage stands prior to transport to the cleaning room. (right) An IAV has been lifted onto the AGV after cleaning.

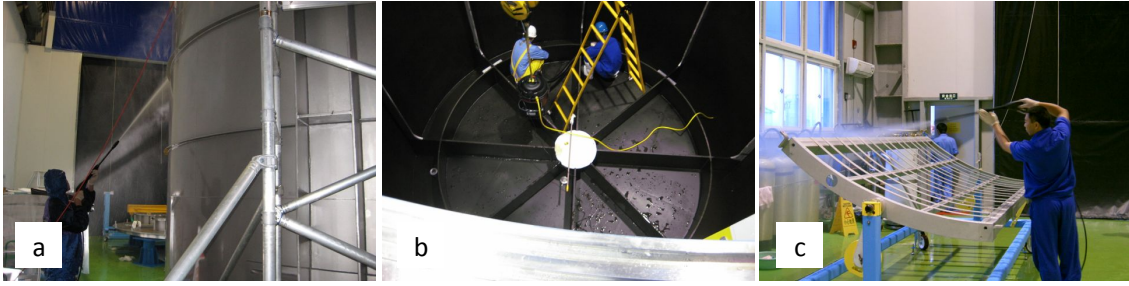
**Figure 8.** (a) Pressure cleaning of the outside of the SSV. (b) Cleaning the interior of the SSV. (c) Pressure cleaning of a PMT ladder..

A summary of the SSV cleaning procedure follows. The SSV was delivered into the cleaning area and set on temporary stands. The SSV lid was removed and stored for a separate cleaning. The top flange and grooves were cleaned with a microfiber cloth and a 1% Alconox solution. The flange area was then pressure rinsed with high resistivity water. Cleaning the outside of the SSV followed the same procedure as seen in Fig. 8a. Extra spot scrubbing was done with  $Al_2O_3$  powder and microfiber cloth. The rinse water was collected and measured with a conductivity meter. When the rinse water conductivity matched that of the water from the pressure washer,  $\approx 6\mu S$ , rinsing was considered complete. The cleaning of the interior of the SSV, shown in Fig. 8b, followed

The PMT ladders displayed some corrosion after shipment to Daya Bay from the United States. An additional acid cleaning step at a local factory was added to the cleaning regimen with an extra vigorous pressure wash as seen in Fig. 8c.

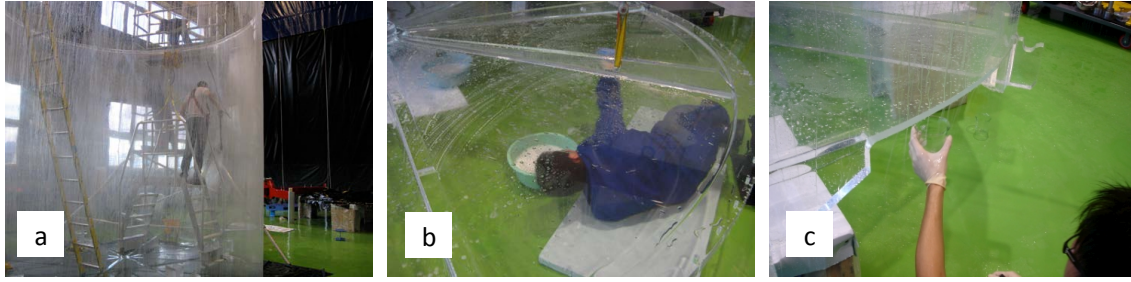
**Figure 9.** (a) Pressure cleaning of the inner OAV. (b) Scrubbing the bottom of an OAV with an Alconox solution. (c) Collecting the rinse water from an IAV.

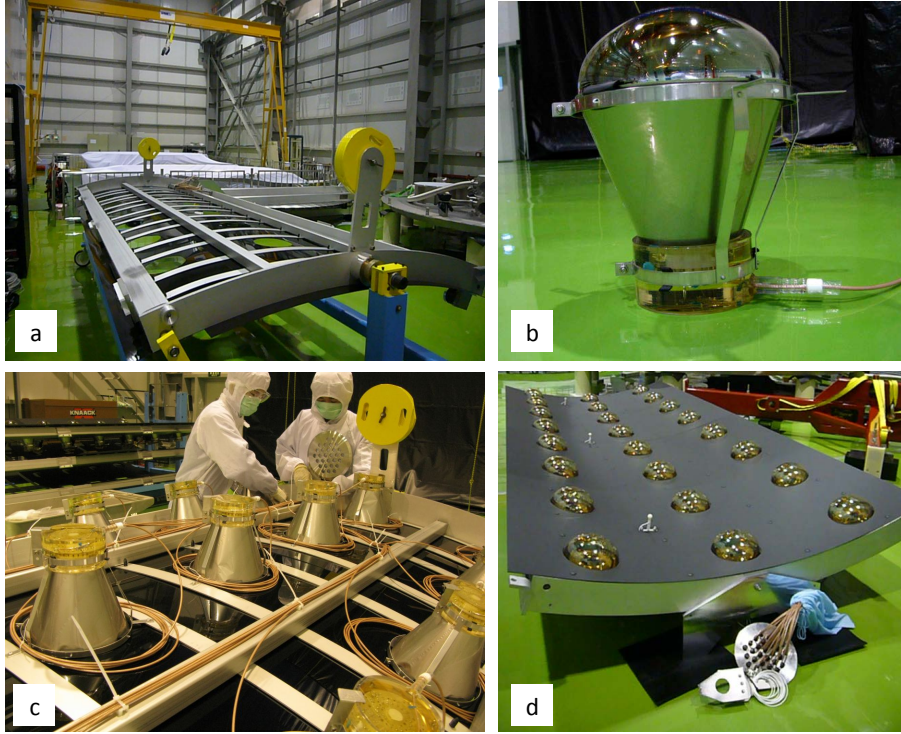
**Figure 10.** (a) Empty ladder mounted on assembly frame. (b) PMT with magnetic shield ready to mount. (c) Routing signal cables after PMTs were mounted. (d) Completed PMT ladder with calibration LEDs installed.

the mount where it touched the PMT glass or base. A completed PMT assembly is shown in Fig. 10b. Each 7-m-long RG303 cable carrying both signal and HV was tagged with the PMT serial number and location on the ladder. The PMT assemblies were then bolted to pre-drilled holes in the ladder frame.

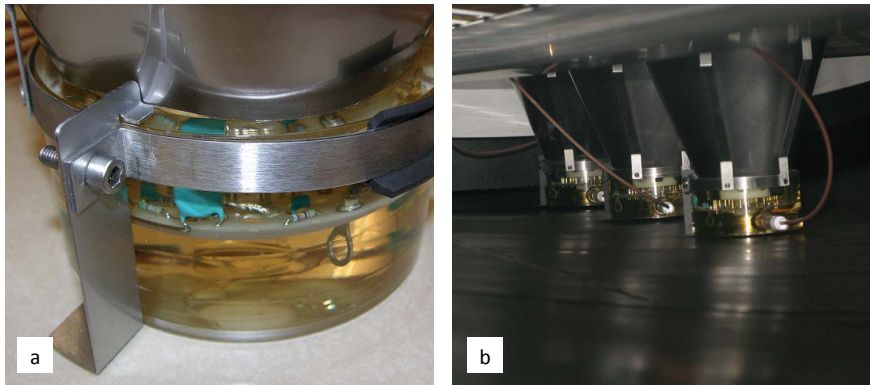
**Figure 11.** (a) Details of the PMT mount showing the retaining clamp which can be adjusted to move the PMT radially in or out as needed. (b) View of an installed PMT ladder showing typical clearances.

One minor modification of the original design was required. Both the PMT frames and SSV cylinder deviated from true cylinders by up to 35 mm. In some cases the back end of the PMTs touched the SSV inner wall. A retaining clamp was added to the design which could be adjusted to move the PMTs radially inward. PMTs were moved inward up to 20 mm from their design position when necessary. A closeup of the clamp and PMT base is seen in Fig. 11a. Fig. 11b shows the clearances of a typical installation.

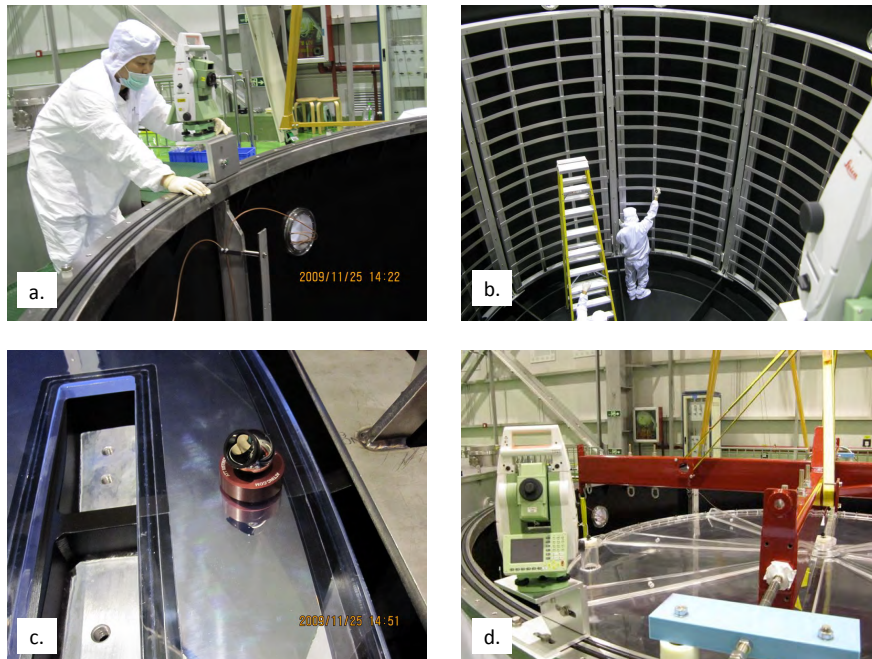
**Figure 12.** (a) Setting up Total Survey Station on SSV flange. (b) Measuring radius of PMT ladders. (c) Survey of height of lower reflector. (d) Adjusting the position of the OAV to align the central port with the SSV.

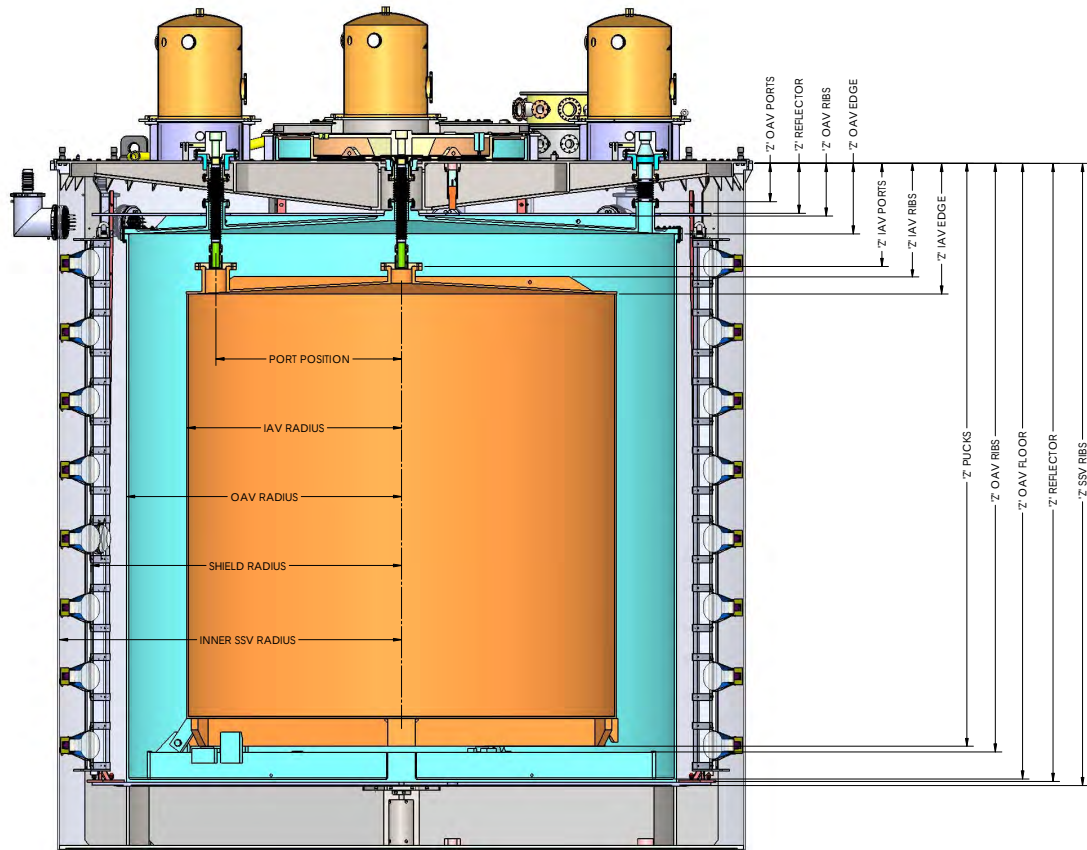
**Figure 13.** Some of the survey data points available for each AD. Measurements at multiple locations sampled variations in the shape of the reflector, SSV, IAV and OAV.

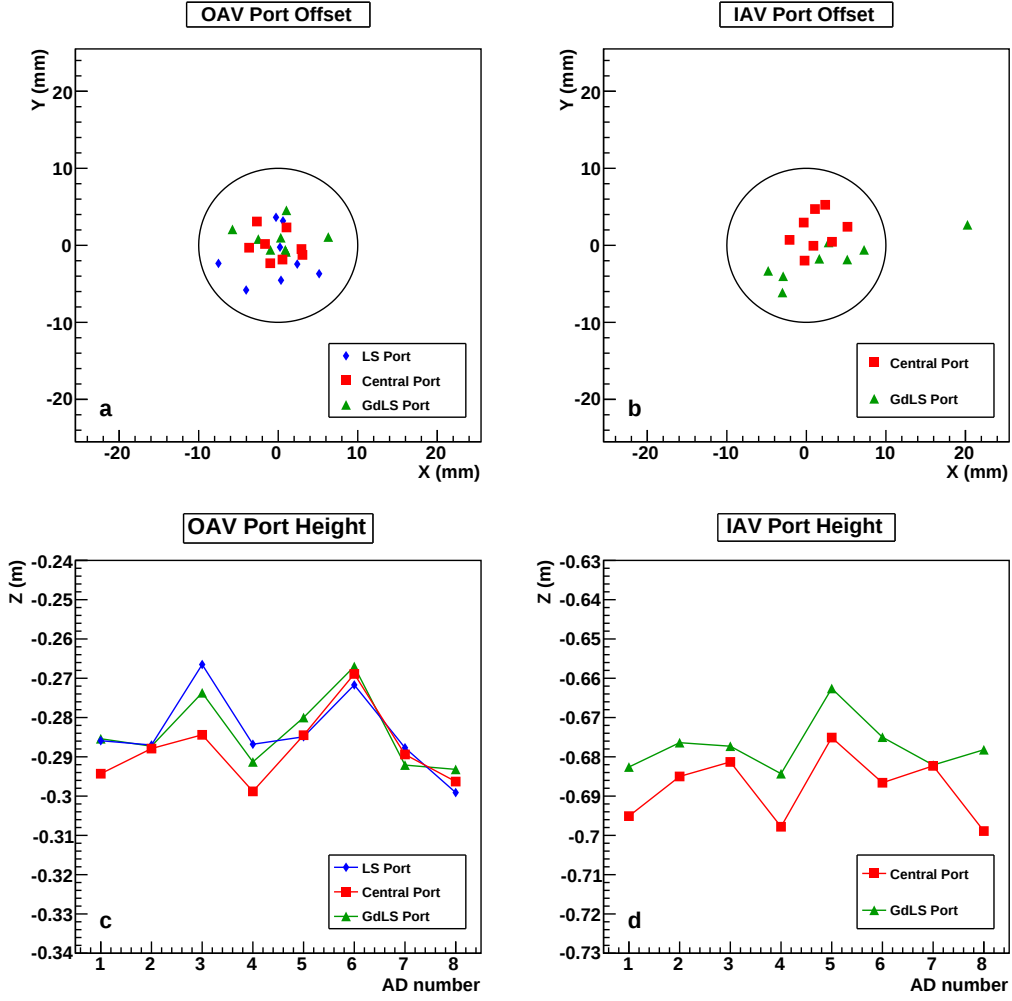
**Figure 14.** Measured XY locations of the OAV and IAV calibration ports relative to the SSV port are shown in a and b. A 1 cm radius circle is shown for scale. The z positions relative to the SSV lid are shown in c and d have a larger spread.

During AD assembly particular care was taken to align the IAV and OAV calibration ports with the openings in the SSV lid to minimize interference with the calibration sources which are lowered through these ports. The measured XY offsets are shown in Fig. 14a and b. All but one of the ports are well within 1 cm of the nominal location. A construction error in the first AD caused the 2 cm offset in the IAV off-axis port. The z locations of the AD ports are shown in Fig. 14c and d. In many cases the central port is lower than the off-axis ports indicating that the central lid has sagged in the center without the presence of the final liquids.

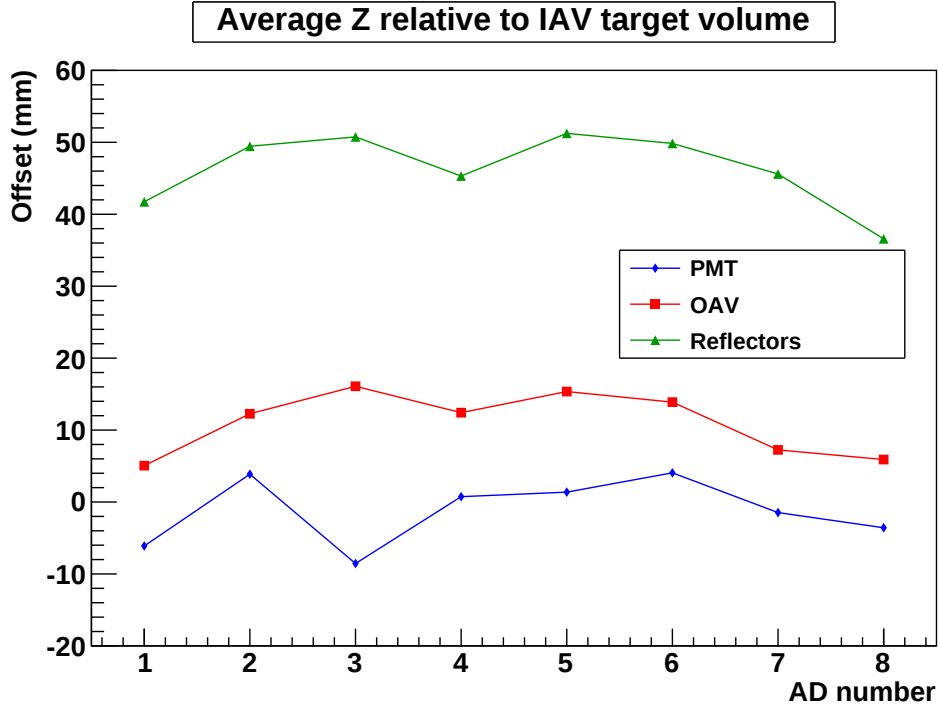
**Figure 15.** Average z position of detector elements relative to the center of the GdLS target mass.

The survey data can also be used to characterize parameters which may alter the light collection efficiency between differing ADs. Fig. 15 compares how well various detector elements are centered vertically on the center of the visible GdLS target mass volume contained in the IAV. The

average GdLS z is calculated from a combination of survey and construction data with a correction for the volume in the cone shaped IAV lid. Although the PMTs are centered on the GdLS volume within a cm, the center of the OAV is systematically displaced from the IAV center by  $\approx 1$  cm. By design, the difference between the OAV top and bottom rib heights and the conical lid cause the reflectors to be placed asymmetrically causing the observed 4.5 cm offset between the center of the reflectors and the center of the IAV. The RMS spread observed about these central values is 0.5 cm.

Other dimensions that could impact the light collection efficiency are the average radii of the PMTs and the space between the upper and lower reflectors. The position of the PMT photocathodes are measured from the highest point of the glass bulb to the surface of the radial shield. Although the spread in the measured PMT ladder radii can be over 3 cm within a single AD, the average AD radii are consistent with a standard deviation of 0.2 cm. Seven of the eight ADs have similarly consistent distances between the two reflectors ( $\sigma = 0.2$  cm), however in the last AD this

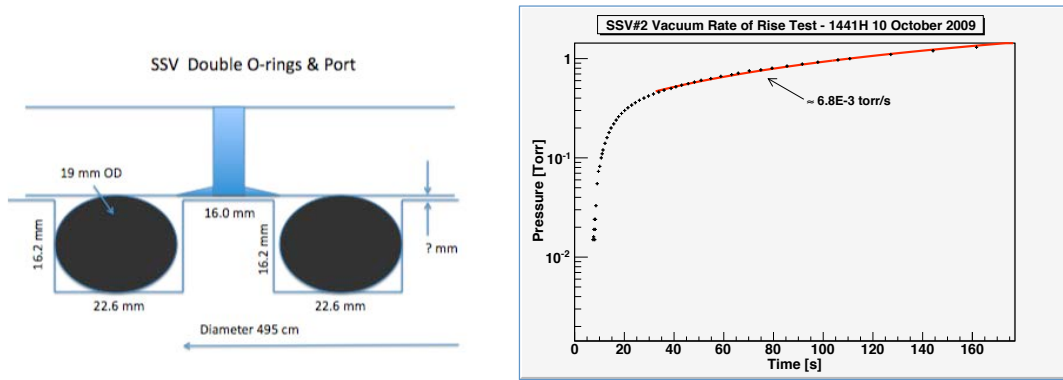
**Figure 16.** (left) Drawing of the double O-ring design for the SSV lid. (right) Typical vacuum rate of rise measurement.

Several methods of differing sensitivity were used for leak checking. Where possible, a vacuum pump-down followed by a vacuum rate of rise measurement was used since this had the best sensitivity and tested the entire surface area or volume. All bellows used on the lid of the AD or used to connect the AD to the outside of the water pool were pre-tested by this method. Vacuum tests were also made on the double O-rings used in most of the overflow tank covers, ACUs, and port covers. For example the pump-out port between the O-rings on the SSV lid, shown in Fig. 16, was used to evacuate the air between the O-rings until the pressure fell to  $\approx 1$  mTorr. The vacuum pump was then valved off and the vacuum rate of rise was measured and plotted in Fig. 16. Using the known volume under vacuum, the leak rate could be calculated. Leak rate goals of  $\approx 1.5 \cdot 10^{-3}$  cc/sec were achievable despite significant out-gassing of the O-rings.

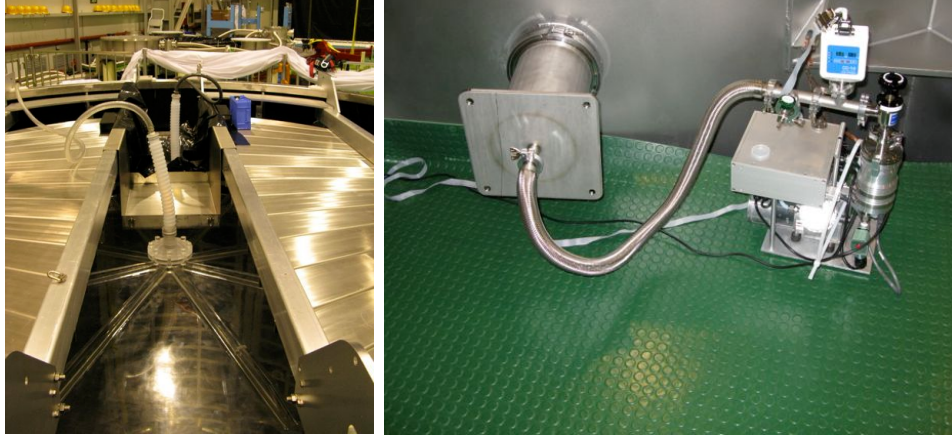
**Figure 17.** (left) The IAV was filled with more than 75% argon at 12cm of water equivalent pressure for a leak test. (right) Leak test of the PMT cable flange with the Top hat.

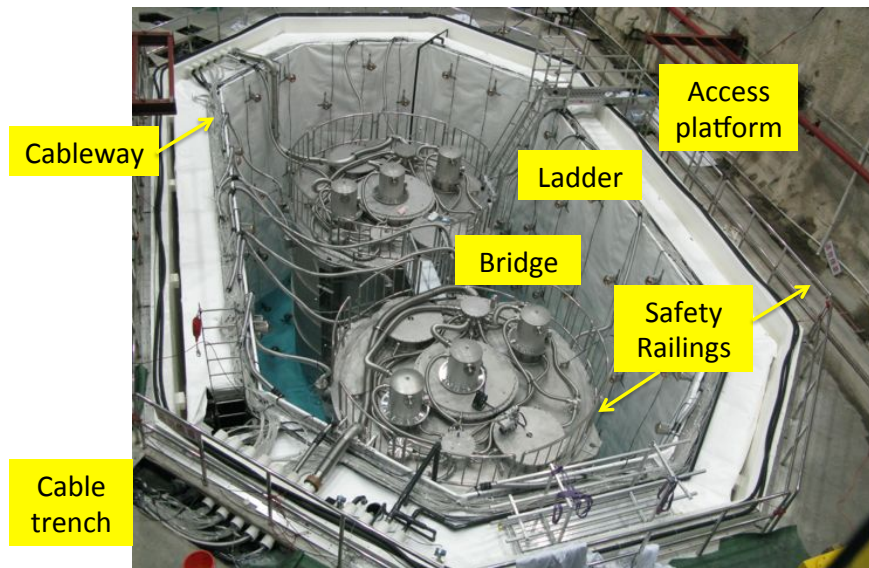
**Figure 18.** A near hall nearing completion. The access platform and ladder provided access to the top of the detector where final gas and electrical connections were made. Railings around the AD and pool protect workers from the 7-10m drop to the pool floor. The cableway running around the pool and the cable trenches outside the pool are also shown.

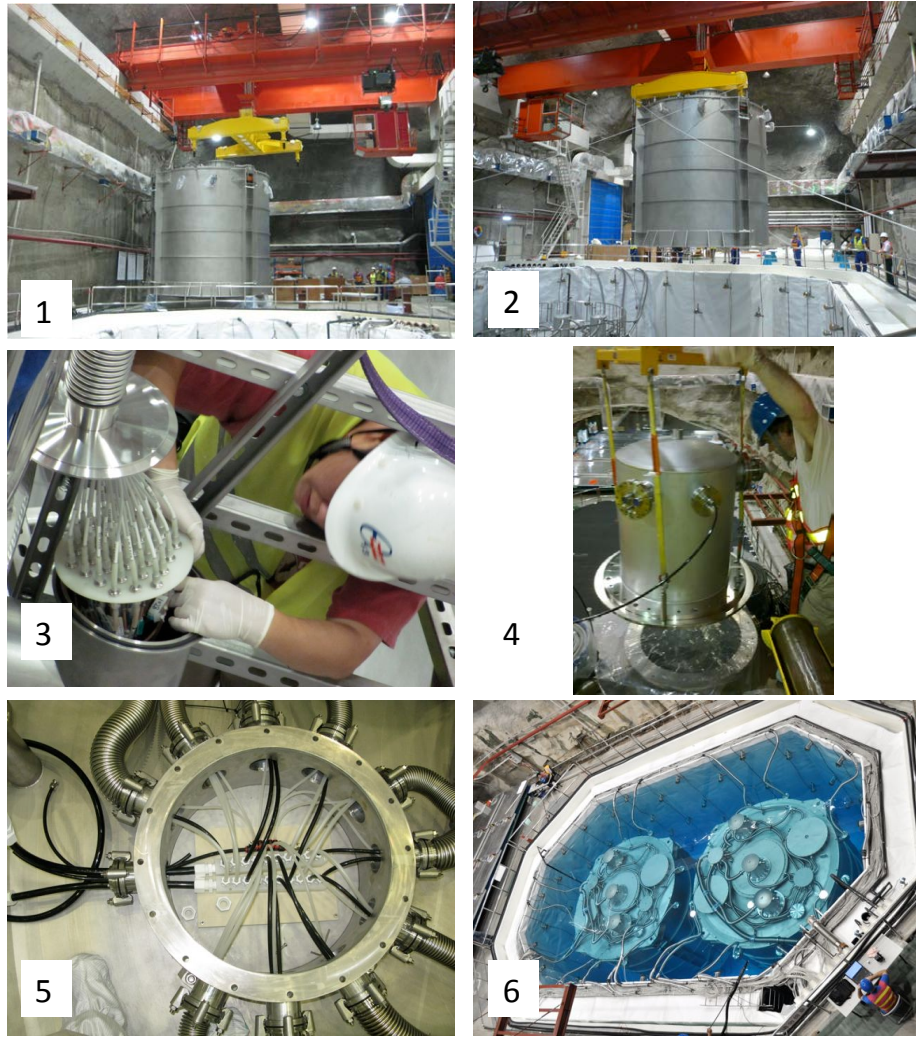
**Figure 19.** Installation sequence. 1) AD is prepared for lift into pool. 2) Lift into pool. 3) PMT cables connected 4) ACUs installed. 5) Gas lines installed. 6) Water pool filled.

The typical installation sequence is shown as a series of photographs in Fig. 19.

1. An AD is delivered from the LS hall on the automated guided vehicle (AGV) and placed on temporary stands next to the water pool. The move dislodges gas bubbles under the OAV and SSV lids lowering the liquid levels in the overflow tanks. The level change is measured by the AD levels monitors. The fluid levels are then manually topped up to the desired levels. Drybox elbows were mounted over the PMT feedthrough ports. Muon pool calibration LEDs were mounted on the side of the AD. Finally the heavy lifting fixture and positioning cameras were mounted in preparation for the lift into the pool.

5. Gas connections to the ACUs are finalized and leak checked. The PMT, electrical and gas line bellows are independent gas volumes distinct from the gas in the overflow tanks and

6. The lid is wiped clean and the water pool is filled. The AD is monitored for any signs of leaks. After filling the pool cover is installed and AD commissioning starts.
