# Radiation Hardness Test of Eljen EJ-500 Optical Cement

## Abstract

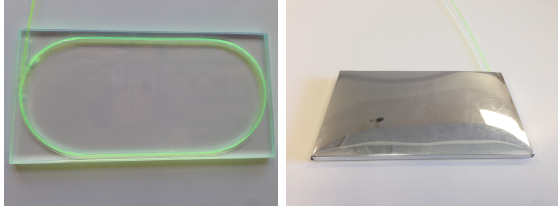
Figure 1:  $12\text{ cm} \times 5.5\text{ cm} \times 0.5\text{ cm}$  EJ-200 scintillator with a triple layer of Kuraray Y-11 WLS fibers glued with EJ-500 optical cement. This was one of the tiles used in the radiation hardness experiment. The right picture shows the same tile wrapped in aluminum mylar.

*Scintillator Tiles.* The design of the test tiles was directly taken from that of a midrange tile in the EPD. The tiles were machined from EJ-200 plastic scintillator sheets into  $12\text{ cm} \times 5.5\text{ cm} \times 0.5\text{ cm}$  trapezoids. Sigma-shaped grooves  $0.16\text{ cm}$  wide were machined into the tile to a depth of  $0.36\text{ cm}$  in order to hold three layers of a single WLS fiber for each tile (See below section on Optical Fibers for more information). An assembled test tile is shown in Figure 1.

Once the edges were sufficiently polished, each tile was cleaned and the optical fibers were glued into the sigma grooves (see below section on Epoxy Preparation). After the epoxy hardened the tiles were cleaned again before being wrapped in aluminum mylar to contain the signal photons inside the scintillator. We found that simply hand-wrapping a piece of mylar around the tiles was insufficient because the result was not tight enough. Instead, we drew a template cut for the mylar that would minimize the total surface area of the mylar while completely covering all faces of the tile. The mylar was then laid over the template and cut out with a box cutter for each tile. Any piece of the mylar that would be a fold on the tile was also perforated somewhat so as to ensure sharp edges all around. A wrapped test tile is shown in Figure 1 (right). This mylar wrapping was used during the pre- and post-radiation measurements but was not

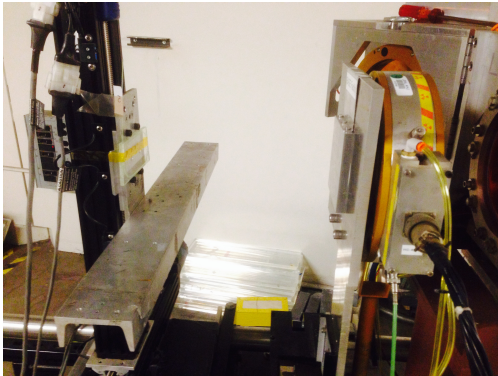
Figure 2: Test tile attached to a vertical support post (left) in the direct path of the beamline, positioned about 25 cm away from the beam window (right).

The radiation experiment was conducted at Lawrence Berkeley National Lab’s 88-Inch Cyclotron with a 50 MeV proton beam. The tiles were positioned in a way that about 90% of the surface was uniformly irradiated. A camera was set up inside the experiment vault so that we could monitor the tiles by live video feed as they were being irradiated. No bubbling or melting of any component was seen throughout the entire experiment. The tiles were attached one at a time to a vertical bar

directly in the path of the beam. This setup is pictured in Figure 2. Once the experiment finished all tiles were left in the experiment vault for two to four days to allow time for the activation levels in the tiles to decrease so that they could be safely handled and tested.

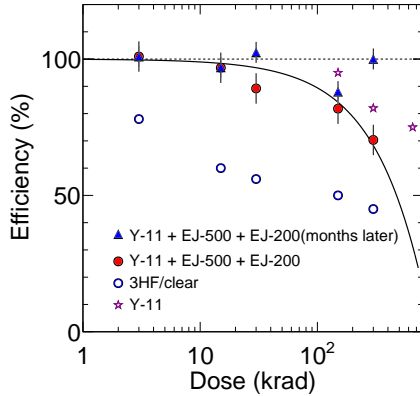
Figure 3: Measurement of the efficiency rate per dose of the assembled detector tiles compared with the reported efficiency rates of the Kuraray Y-11 WLS and 3HF clear optical fibers. EJ-500 is the optical cement while EJ-200 represents the plastic scintillator.

With the exception of Tile #5 which showed no change in efficiency, each of the other four test tiles showed a decrease in efficiency with increasing levels of radiation, with the sharpest decrease manifested in Tile #1. Table 1 shows the radiation levels for each test tile along with their calculated efficiency after radiation. We found that the efficiency of the tile falls to 70% when irradiated with  $1.0 \times 10^{12}$  ions/cm<sup>2</sup>. As mentioned before, this level of radiation, corresponding to Tile #1, is about 3 times the maximum amount of radiation expected during BES-II. We performed another event-by-event measurement and analysis on all tiles four months after the experiment to see if the efficiency would recover over time. We found that all tiles almost completely recovered from the radiation damage four months after irradiation.

during the experiment is calculated to be  $19 \text{ MeV} \cdot \text{cm}^2/\text{g}$ . This equates to a maximum dosage of 300 kRad in our WLS fibers, a factor of two less than the aforementioned study. A second study measured the attenuation length of Kuraray 3HF clear optical fibers to decrease by about 50% after an irradiation dosage of 300 kRad [4]. The results of both studies are compared to our experiment results in Figure 3. Both studies report that while a small percentage of the radiation damage to the fibers is permanent, the fibers are able to partially recover from the damage after a rest time on the order of one to two months. From the comparison of our 30% loss in efficiency with the aforementioned studies we conclude that our result is in agreement with the reduction in efficiency of WLS fibers that have been exposed to high dosages of radiation. This indicates that the WLS fibers account for the majority of the radiation damage to the tiles. With the efficiency back to normal after about four months we consider the whole detector setup to be safe for BESII.
