# Detector Damage at X-Ray Free-Electron Laser Sources

**Abstract**—Free-electron lasers (FELs) opened a new window on imaging the motion of atoms and molecules. At SLAC, FEL experiments are performed at LCLS using 120 Hz pulses with  $10^{12}$  to  $10^{13}$  photons in 10 fs (billions of times brighter than at the most powerful synchrotrons). Concurrently, users and staff operate under high pressure due to flexible and often rapidly changing setups and low tolerance for system malfunction. This extreme detection environment raises unique challenges, from obvious to surprising, and leads to treating detectors as consumables. We discuss in detail the detector damage mechanisms observed in 7 years of operation at LCLS, together with the corresponding damage mitigation strategies and their effectiveness. Main types of damage mechanisms already identified include: (1) x-ray radiation damage (from "catastrophic" to "classical"), (2) direct and indirect damage caused by optical lasers, (3) sample induced damage, (4) vacuum related damage, (5) high-pressure environment. In total, 19 damage mechanisms have been identified. We also present general strategies for reducing damage risk or mi

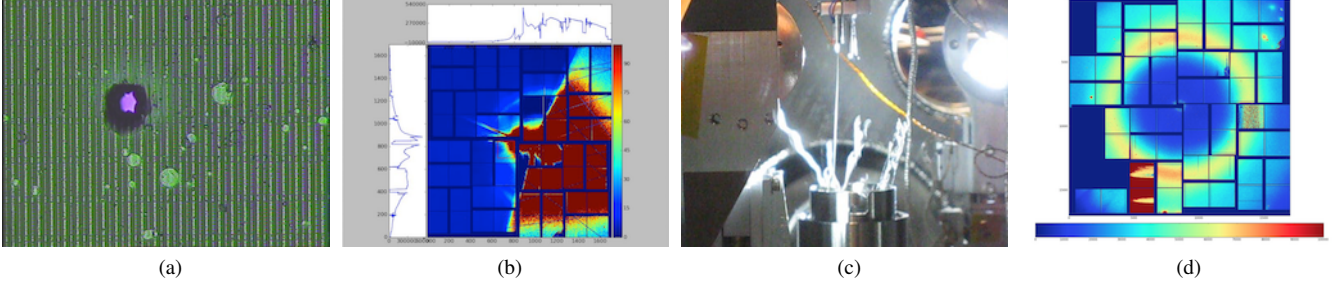
Fig. 1. Catastrophic FEL x-ray beam damage: (a) pnCCD plane hit by the focused direct beam in the CAMP chamber (reproduced with permission from [11]); (b) CSPAD 2.3 Mpixel camera hit by scattered radiation caused by the beam accidentally hitting a setup part [12]; (c) spontaneous formation of water crystals. Top: sample injector; bottom: catcher with crystals. Jet and crystals visible. Multiple crystals can be produced every second; (d) water crystals in the direct beam produced intense diffraction spots which, in this instance, quasi-instantly damaged at least 3 ASICs of a CSPAD 2.3 Mpixel camera [12].

Fig. 1d shows the aftermath of such an incident on a CSPAD 2.3 Mpixel camera. After this incident, at least 3 ASICs were permanently damaged [12]. Currently the operators are aware of this risk, monitoring and adjusting jet parameters to avoid icicle formation. This is one of the leading causes of spot damage (clusters of several pixels).

Radiation damage of entire ASICs was greatly reduced by using high-Z shields over the exposed ASIC balcony [12]. However, local damage can't be prevented in high intensity x-ray imaging. If damage occurs, annealing only slightly improves the damaged areas [12].

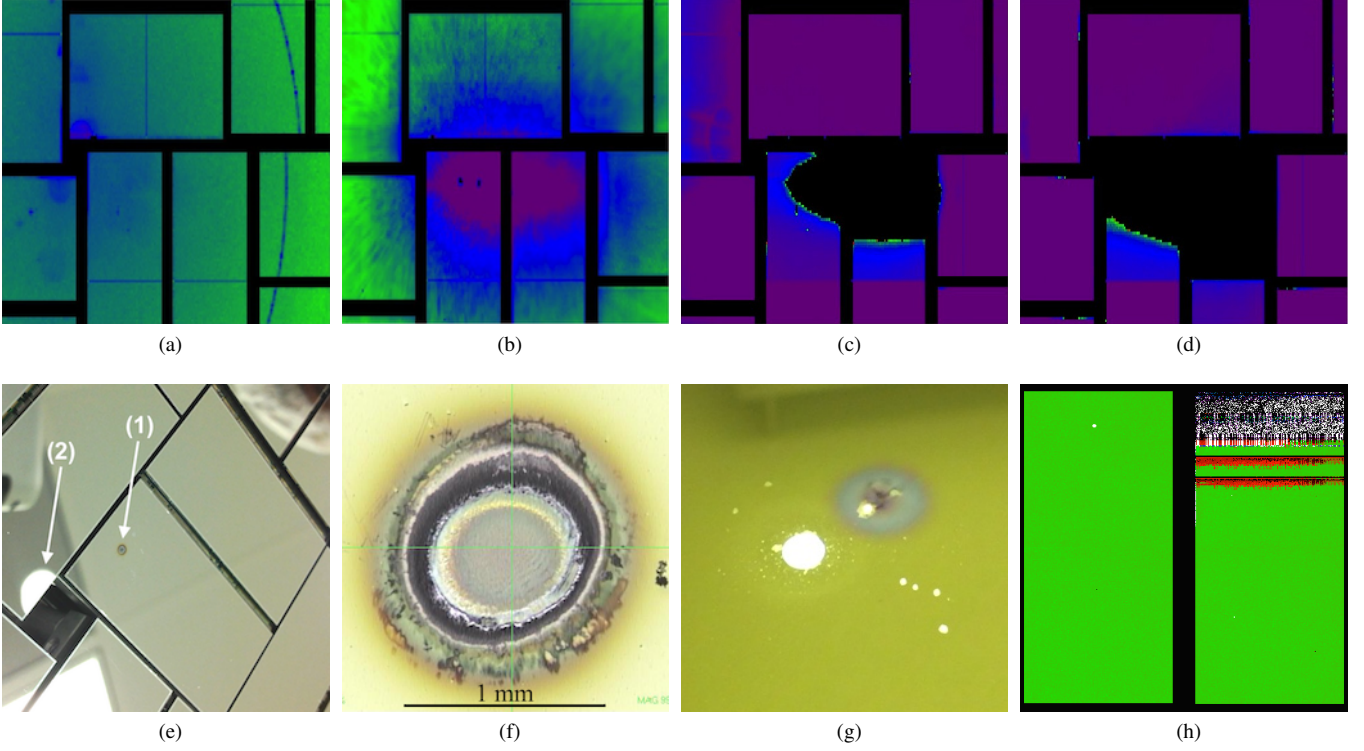
Fig. 2. Optical laser damage incident involving a CSPAD 2.3 Mpixel camera: (a) last successful shot, showing diffraction pattern (geometric correction not applied); (b) first optical laser shot into detector, high intensity pattern visible, all ASICs read out normally; (c), (d) second and third optical laser shots into detector, one ASIC already damaged; (e) resulting sensor damage by laser ablation (small dark spot), indicated by arrow (1); also semicircular surface contamination is visible (white), indicated by arrow (2); (f) microscope close-up of damaged spot on the sensor (1 mm diameter, 10  $\mu$ m depth); (g) damaged front shield (aluminum coated polyimide). Visible: central aperture (large bright spot), laser damage (small bright spots), diffuse laser reflection damage (discolored area); (h) dark frame of the affected CSPAD module: focused beam damage (bright spot, top left) and diffuse scattering damage (ASIC, top right).

This occurred in an experiment where the optical pump laser had to be directed towards the detector (a CSPAD 2.3 Mpixel camera). A beam stop was placed. After reconfiguration during the experiment, the laser beam missed the beam stop and impacted the detector instead (Fig. 2).

High power optical lasers should ideally be pointed away from detectors, focused outside the detector plane, and shielded with beam stops. We found that only one of these precautions is not sufficient, as the chamber layout is often optimized during experiments. Unfortunately, existing experimental chamber constraints and changing setups do not always allow implementing all these precautions.

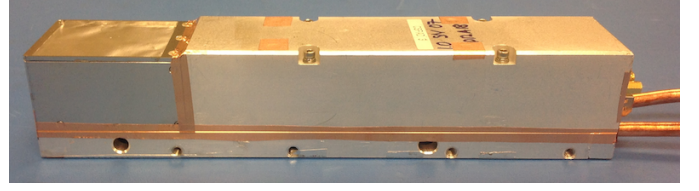
Fig. 3. Careful EMP shielding (copper tape) and electrically conducting front shield (aluminized black polyimide, top left) made it possible to operate cameras within centimeters to the interaction point in HED experiments; CSPAD 140 kpixel camera shown.

The EMP shielding and grounding were gradually improved for the relevant CSPAD 560 kpixel and 140 kpixel cameras and cables (e.g., Fig. 3) by carefully shielding the cameras and cables with vacuum compatible copper tape and aluminum foils, respectively. Improved shielding eliminated detector damage, however, some frames were still corrupted. Further shielding refinement eliminated data acquisition errors and led to reliable operation currently.

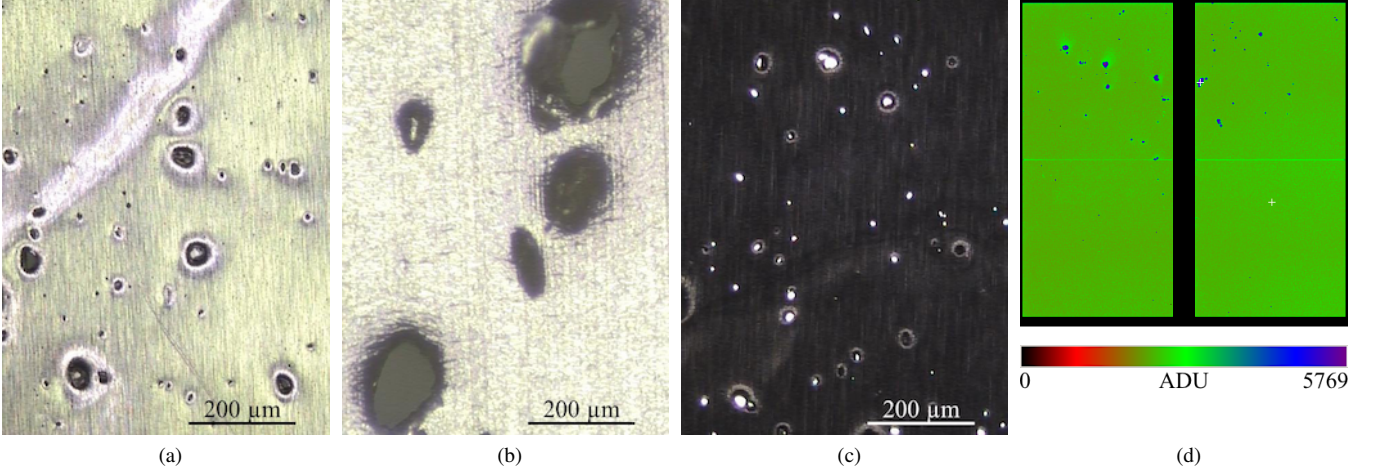
Fig. 4. Shrapnel damage with different shields in high energy density experiments: (a) aluminum shield; (b) aluminized polyimide shield; (c) aluminized black polyimide shield; (d) Damaged sensor in CSPAD 140 kpixel camera, dark frame.

High energy deposition in small areas can cause (parts of) the sample to explode, expelling high velocity pieces of shrapnel that can impact the detector [28]. This is especially true in HED type experiments, where the detectors can be within centimeters to the sample.

Fig. 4a–4c shows examples of shrapnel damage on different shields and Fig. 4d shows an example of sensor damage caused by nano- and micro-shrapnel.

In HED experiments, the x-ray pattern intensity is often high enough to allow using thick polyethylene shields ( $125\mu\text{m}$ ) stacked on top of the shields. These greatly reduce the shrapnel damage, with a limited impact on quantum efficiency (e.g., 95 % at 10 keV and 60 % at 5 keV).

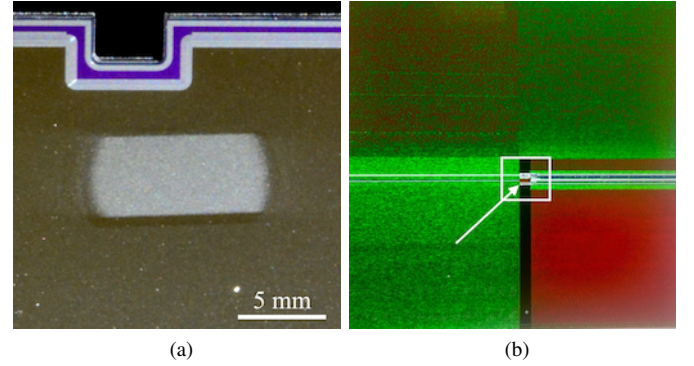
High velocity sample clusters impacting sensor surfaces can etch them, as it was accidentally observed in a pnCCD experiment with xenon clusters. It was deemed necessary from a scientific point of view to operate without a detector shield. The xenon clusters formed were sufficiently energetic to etch the pnCCD sensor surface, damaging the thin aluminum coating and the silicon crystal structure (Fig. 5a) and leading to a dramatic increase in the noise level in the affected area and corresponding rows and columns (Fig. 5b).

Fig. 5. Accidental xenon sputter etching of a pnCCD sensor: (a) shows a close-up of the affected rectangular area of a half-plane, surrounded by the intact sensor surface. The inner edge and central beam hole are visible at the top; (b) shows the leakage and noise of a full plane. The white box indicates the edges of close-up in Fig. 5a. The xenon etching resulted in a significant increase in leakage and noise, disabling the damaged area and corresponding rows and columns. The arrow shows the location of damage.

x-ray transparency for used photon energies), various front shields have been produced. These are manufactured from different materials with a range of thicknesses: black polyimide, aluminum-coated polyimide, aluminum-coated black polyimide, polyethylene, aluminum and beryllium, often with a central beam pipe for the large cameras.

These shields greatly reduce detector surface contamination, however, they do not eliminate it completely. They also protect the detectors from spurious signals induced by stray light. However, they are not very effective against shrapnel and need to be replaced regularly.

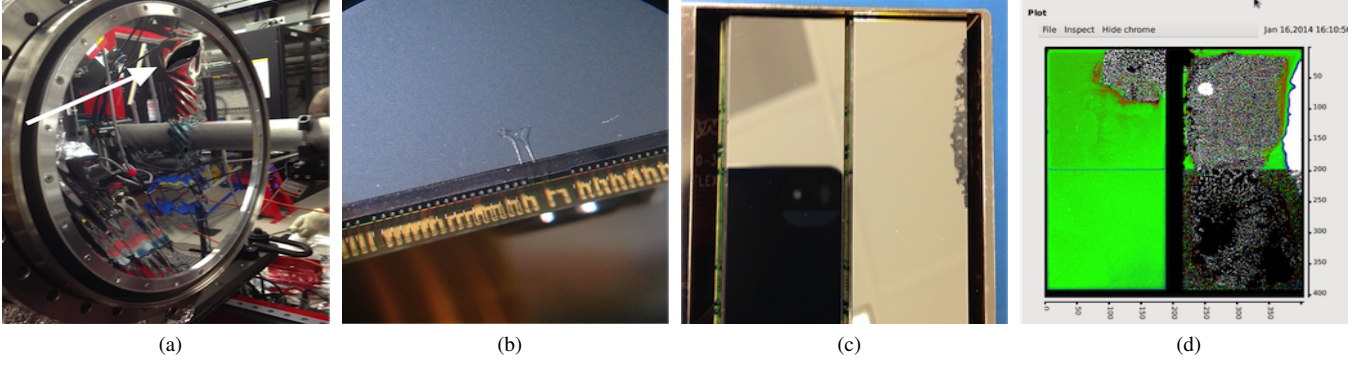
Experimental chambers are complex, with tight limits and flexible layouts that need to be changed from experiment to experiment or even during experiments. The high degree of flexibility required by the experiments limit the implementation of engineering controls. Consequently, accidental collisions and damaged front shields have been observed  $\sim$  twice a year, e.g., Fig. 6a.

Sometimes, exchanging detector shields or redeploying cameras resulted in wire-bond damage, e.g., Fig. 6b. This risk was greatly reduced by having only detector experts perform particularly delicate handling, including shield replacements.

The CSPAD water cooling uses brazed copper pipes with Swagelok VCR or Swagelok Quick-Connect fittings; these pipes and fittings are delicate, requiring careful handling. During an experiment, a CSPAD 140 kpixel camera was converted from VCR to Quick-Connect to match the existing chiller fittings. The resulting connection was faulty, causing water leakage on the powered detector and resulting in detector damage (Fig. 6c, 6d).

Fig. 6. Handling damage: (a) detector collision resulting in damaged shield on CSPAD 2.3 Mpixel camera, with damaged area indicated by the arrow; (b) damaged wire-bonds; (c) water damage on CSPAD 140 kpixel; (d) corresponding dark frame.

For the short term, we maintain a supply of spare shields and replace them as necessary. For the long term, there is a tendency to move towards sets of pre-defined configurations for each instrument, which will simplify and standardize the support for experiments, facilitating implementation of engineering controls.

Another significant reduction of damage incidence was achieved by modifying the relevant camera mechanical assemblies to allow the operators to easily stack and exchange filters onto the relevant detector shields.
