Crack initiation of printed lines predicted with digital image correlation

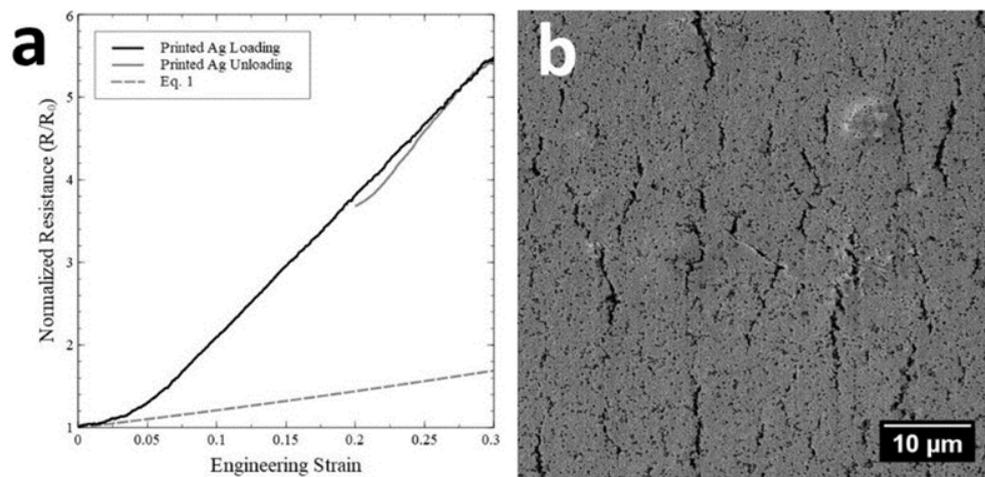
Figure 1: (a) Relative resistance during applied tensile load and unloading. At small tensile strains during loading, the system performed close to the predictive model until about 3% engineering strain when cracks initiated in the printed line. (b) Post-mortem SEM micrograph of the flexographically printed line after stretching to 30%. Numerous cracks that appear in black are clearly visible. The straining direction is horizontal.

A typical result of the relationship between normalized resistance and engineering strain for the printed Ag lines is shown in Figure 1a. During tensile loading of the Ag lines, the normalized resistance initially aligns with the theoretical prediction (Eqn. 1) before deviating to a higher normalized resistance at approximately 3% engineering strain. This deviation to a higher normalized resistance correlates to the printed line reaching a critical cracking strain for brittle materials. The normalized resistance then continued to increase during continued loading, and then, upon unloading, the normalized resistance began to recover. This recovery is due to a combination of elastic recovery and crack re-bridging, when opposing edges of cracks reconnect to some degree [15]. The cracking of the printed Ag films after 30% engineering strain can be seen in as SEM of the surface (Figure 1b). These cracks formed during loading of the films and were not observed in the as-deposited films. The propagation of the cracks is assisted by the pores and pre-existing print defects in the film.

What cannot be observed in Figure 1b is the role that the flexographic printed wavy surface and the initial defects have on the crack initiation and evolution. The printed surface has waves, which range in height (amplitude) between 400 and 800 nm, as measured from CLSM height images (Figure 2a,b). At this magnification it is difficult to evaluate the crack density using the height images, but cracks are visible in the laser intensity image (Figure 2c). A proof-of-concept of the applicability of DIC strain measurement on the flexographic printed lines is shown in Figure 2d. The CLSM laser images (Figure 2c) provide better and more varied contrast for correlating the images than optical or SEM micrographs. From the DIC (Figure 2d), it can be observed that the wavy surface leads to a two different crack densities (qualitatively shown) due to the large thickness variation between the wave crests and troughs. After only 12% engineering strain, the difference can be better viewed the DIC calculated strain image (Figure 2d), which is the same area shown in Figure 2a,c. Comparing the height image and profiles, which are rotated 90 degrees in Figure 2b from Figure 2a, it can be clearly seen that there is a higher density of regions of high strain or cracks (red streaks) in the DIC image that correspond to the wave crests compared the troughs. Thicker films fracture before similar thinner films and thicker films have

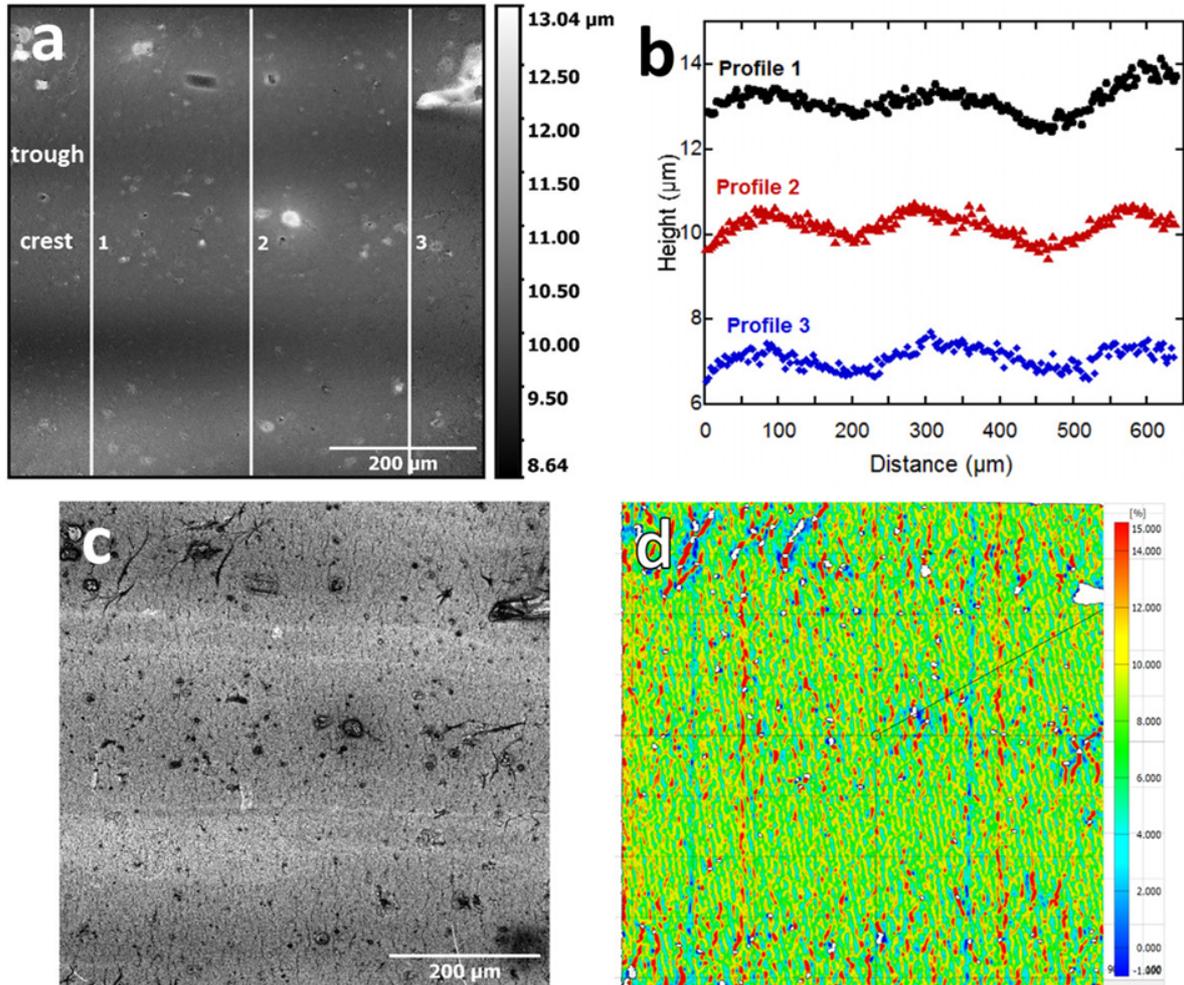
Figure 2: (a) CLSM height image at 12% applied strain with three marked profiles (white lines). (b) Extracted height profiles from (a) illustrating the wavy surface of the flexographic printing process. (c) CLSM laser intensity image at 12% of the same area as (a) and (d) the DIC calculated strain image of the printed Ag line at 12% strain demonstrating that in the wave crests there are more red streaks (cracks) than in the troughs.

lower average crack densities (larger average crack spacing) [16–20]. A similar result was observed in the wavy lines by the different crack densities. It should be noted that the larger print defects were found on the wave crests compared to the troughs (Figure 2a) and also influenced crack initiation in the printed lines.

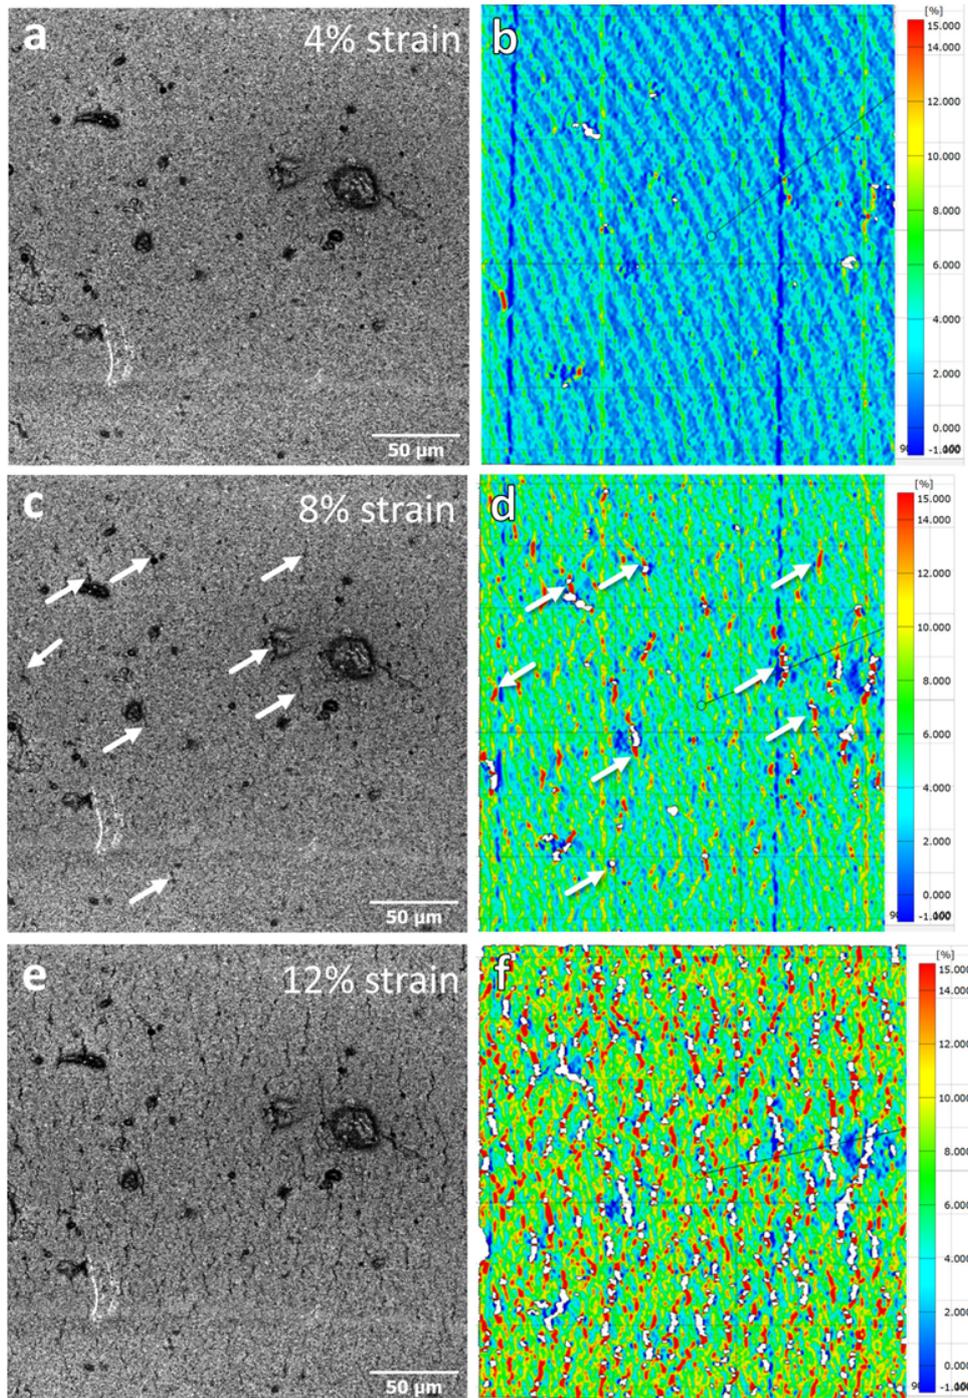
Figure 3: (a) In the CLSM laser image at 4% strain, it is difficult to observe cracks without DIC (b), which finds cracks near large defects. (c) At 8% strain cracks are observed in the CLSM laser image (arrows) and correspond well to the DIC (d). At the maximum strain of 12% cracks are more visible in the CLSM laser image (e) but the DIC evaluation (f) finds more red streaks and larger cracks (white areas).

Closer inspection of the CLSM images taken at a higher magnification of a wave crest provide more details about crack initiation and propagation in flexographic printed films. At an engineering strain of 4%, it is difficult to observe cracks in the CLSM laser image (Figure 3a) even though the in-situ resistance measurements indicate fracture of the film (Figure 1). Recall that the resistance measurements are a global measurement while the in-situ CLSM images are a local measurement, concentrated only on a small portion of the entire sample. Application of the DIC local strain measurements provides evidence of crack initiation. In Figure 3b, red streaks, which have an increased local strain, indicate crack initiation near the large defects. The diagonal stripes in Figure 3b are due to the movement of laser during imaging and are artifacts from the DIC analysis that arise only at low applied strains and do not influence the interpreted results. At a higher level of strain (Figure 3c,d) cracks are now more visible in the CLSM laser image (arrows) and correlate well with what is calculated with DIC. Again, more cracks (areas of high strain) are found near the pre-existing defects of the crest. Finally at the maximum applied strain (Figure 3e,f) the crack density has increased and more cracks are observed in both CLSM image and the DIC local strain measurement. However, not only are areas of high strain are found (red streaks) but also more white areas, which correspond to larger cracks on the surface in the CLSM image. The white areas are a result of an extreme contrast difference from the initial image and directly correspond to visible cracks at high strains in the CLSM laser images.

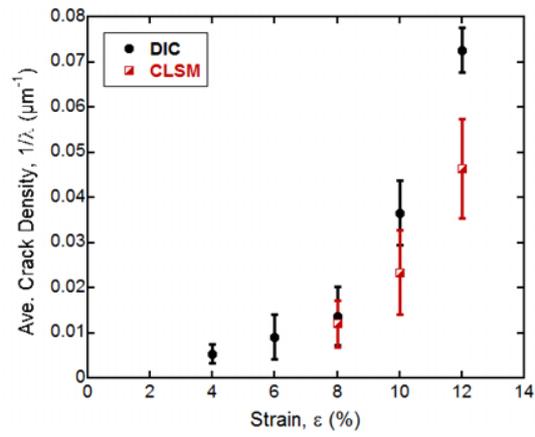
Figure 4: Measured average crack density as a function of applied strain. Crack densities were evaluated from the CLSM laser images and DIC assuming areas of large tensile strain (red streaks and white areas) were cracks.

Initially, only DIC can be used to evaluate the crack density (4-6% engineering strain) to directly observe cracks of the rough surface. However, the roughness does make DIC analysis possible to examine the early stages of crack growth in printed films (Figure 4). At about 8% engineering strain, both CLSM and DIC images can be used to determine the crack density and are comparable to one another. The measured crack densities deviate at larger strains, most likely due to the fact that two methods have two different resolutions. Cracks viewed in CLSM images can only be evaluated by eye (what can be seen in the image), while the DIC measurements look at the very local strains on the microscale (pixel resolution). It is interesting that the saturation in the crack density has not been reached at 12% strain and that the shape of the trend is a gradual

increase, rather than immediate increase in density commonly observed in sputtered or evaporated films [18,21]. The two different crack density measurements, therefore, give a maximum (DIC) and minimum (CLSM) threshold for crack density until, most likely, saturation is reached at much higher strains. For the current in-situ straining set-up with CLSM, crack saturation could not be achieved since it most likely occurs at engineering strains around or even higher than 30% (Figure 1).
