# Railway Anomaly detection model using synthetic defect images generated by CycleGAN

**Abstract**—Although training data is essential for machine learning, railway companies are facing difficulties in gathering adequate images of defective equipment due to their proactive replacement of would be defective equipment. Nevertheless, proactive replacement is indispensable for safe and undisturbed operation of public transport. In this research, we have developed a model using CycleGAN to generate artificial images of defective equipment instead of real images. By adopting these generated images as training data, we verified that these images are indistinguishable from real images and they play a vital role in enhancing the accuracy of the defect detection models.

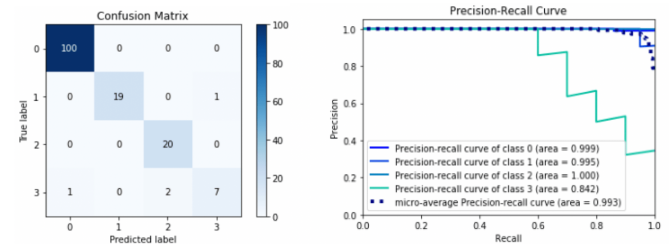
The defect detection model was unable to identify 1 incident of a superficial shelling defect. The accuracy of the defect detection model is shown in Fig.3 while the image of the shelling that was not detected is shown in Fig.4.

Fig. 3: Accuracy of defect detection model (0: normal, 1:scratch, 2: inside-scratch, 3: shelling defects)

The image conversion using CycleGAN model is shown in Fig.7. The images converted by CycleGAN were difficult for human eyes to distinguish from actual images on rails. From the 1000 images generated by CycleGAN model, 70 of them which were similar to the undetected shelling defect, were chosen and added to the defect detection model as training data. The accuracy of detecting shelling defects was successfully improved and the test data showed that the average area under the curve was 1, higher compared with 0.993 of Fig.3. The test results are shown in Fig.8.

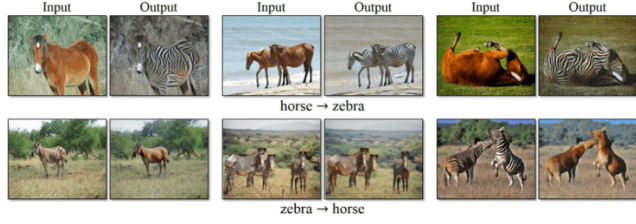
Due to the lack of adequate training data in order to generate images of railway defects, we have chosen an algorithm known as CycleGAN. CycleGAN is a type of style transfer method where an image is generated based on original input with its characteristics altered. The examples of images generated by CycleGAN and the algorithm used are shown in Fig.5 and the configuration of the Generator and Discriminator used in this research is shown in Fig.6.

Fig. 5: Examples of images generated by CycleGAN [3]

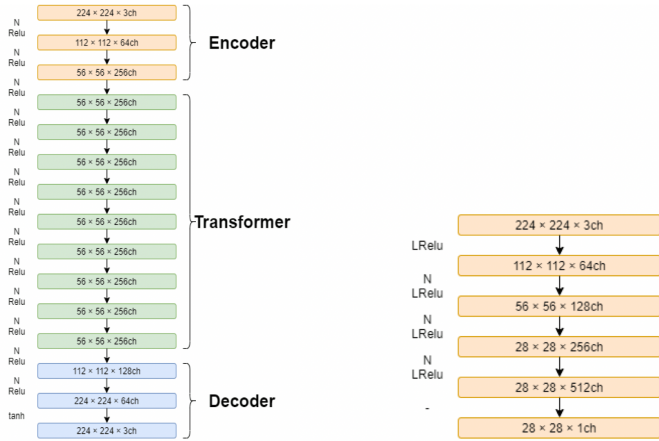
Fig. 6: Configuration of Generator and Discriminator

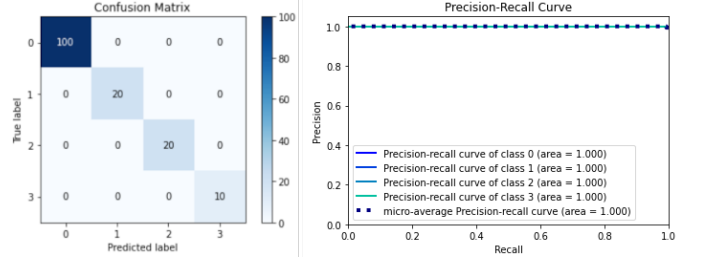
Fig. 8: Accuracy of defect detection model after addition of CycleGAN generated images.

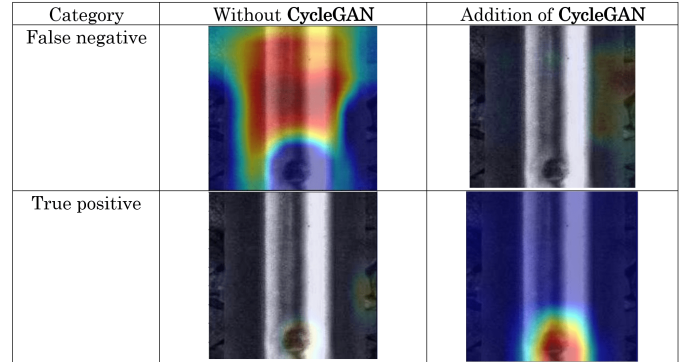
focused on when classifying the images. The parts that were used to classify the images are shown in red while the parts that were not are shown in blue. The results are shown in Fig.9.

Fig. 9: Heat map changes before and after addition of images generated by CycleGAN

As shown in Fig.9, the defect detection model before the input of images generated by CycleGAN reacted strongly towards the linear parts other than the defects on the rails. It can be thought that small shelling defects were not detected as such due to the lack of data on images of defective equipment. It is evident that adding the generated images of shelling defects as training data enables the neural network to focus on the shelling defects and identify them as such. t-SNE was used to perform classification analysis (clustering) on the data of 2048-dimensions immediately before the generation of final results by the defect detection model. The results are shown in Fig.10.

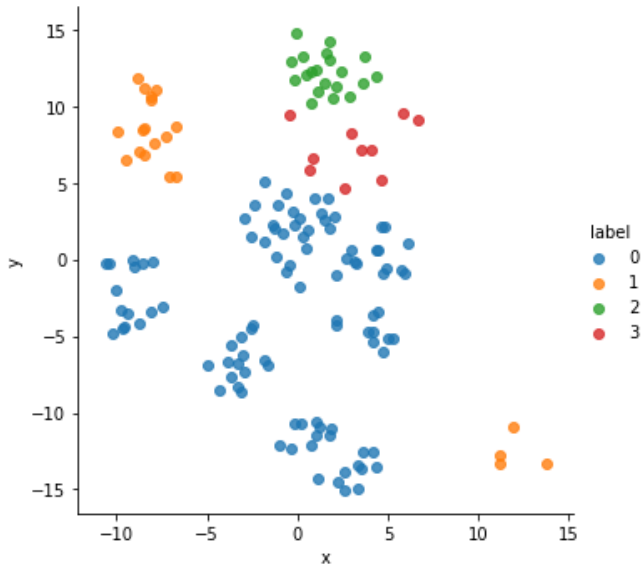
After the addition of images of shelling defect as training data, the aforementioned image was categorized in the same group as other images of shelling defect, showing that the

Fig. 10: t-SNE graph input of images generated by CycleGAN (0: normal, 1: scratch, 2: inside-scratch, 3: shelling defects)

defect detection model identified the image as similar to other images of shelling defect.
