Optical Links for ATLAS Liquid Argon Calorimeter Front-end Electronics Readout

ABSTRACT: We present the optical data links for the ATLAS liquid argon calorimeter. The current status of the vertical cavity surface emitting laser failures, the up-to-date results in searching for the failure cause, experiences gained in the searching process, possible backup plans for the optical transmitters and the lessons learned are also discussed.

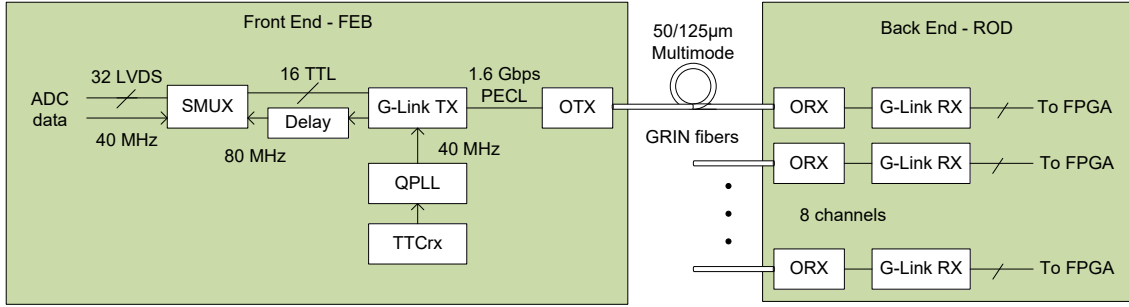
Figure 1 is the block diagram of optical links for the ATLAS LAr calorimeter. The G-link transmitter (TX) and receiver (RX) are a serializer/deserializer chip set specially ordered from Agilent Technologies, Inc. SMUX, an application specific integrated circuit (ASIC) fabricated in DMILL process, is the interface between the G-Link TX and the data coming from analog-to-digital-converters (ADCs). The optical transmitter (OTX) and receiver (ORX) are custom assembled optical interface modules. All components inside an OTX and an ORX are commercial-off-the-shelf (COTS) devices. The laser diode used in the OTX is an oxide confined VCSEL mounted in a TO-can package. The front-end electronics, which operates in a radiation environment, must tolerate up to total ionizing dose (TID) of 3.41 kGy(SiO₂), non-ionizing energy loss (NIEL) of 1.09×10^{14} 1-MeV equivalent neutrons/cm², and total fluence of 1.53×10^{13} (energy greater than 20 MeV) hadrons/cm² in 10-year life time, including safety factors [4].

Figure 1. Block diagram of optical links for the ATLAS LAr Calorimeter

The front-end electronics, including 1524 front-end boards (FEBs) hosted in 58 front-end crates (FECs), of the ATLAS liquid argon calorimeter is mounted on the detector. Each FEB contains 128 channels [2]. The back-end electronics is located in the counting room 150 meters away [3]. Between the front-end and the back-end electronics are 1524 optical links. Each optical link runs at 1.6 gigabit per second (Gbps) and transmit the data of 128 channels on one FEB.

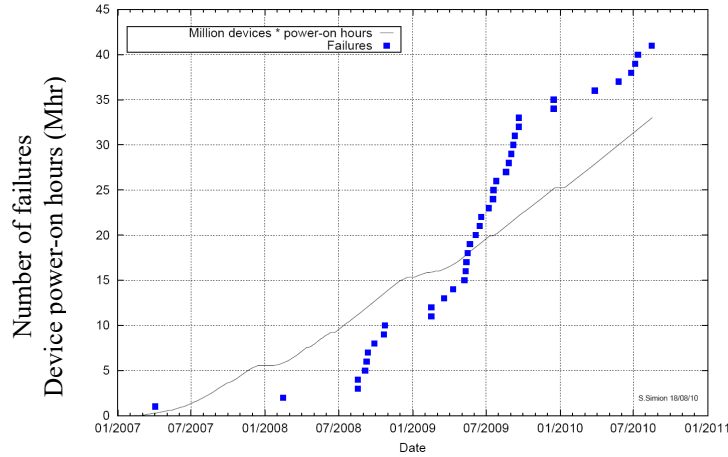
As mentioned in the previous section, in each optical link for the ATLAS LAr Calorimeter the data of 128 channels are transmitted. In other words, the failure of one optical link means the data loss of 128 channels. After the ATLAS LAr readout system started running at the beginning of 2007, few failures appeared until the first short run of the ATLAS detector in 2008. Since then, we have experienced optical link failures from the initial rate of one failure per week to the rate of one failure per month this year. The number of link failures and device power-on hours as functions of date are shown in Figure 2. The OTXs of the dead links were replaced in the 2008–2009 shut down and all failures were traced back to the VCSELs. Since May of 2009, we have had no access to the detector. By now there are twenty-four dead links. No dead link has light output, consistent with the symptoms of VCSEL failures. Therefore, we suspect that all optical link failures are due to VCSELs.

Figure 2. Link failures and device power-on hours as functions of date

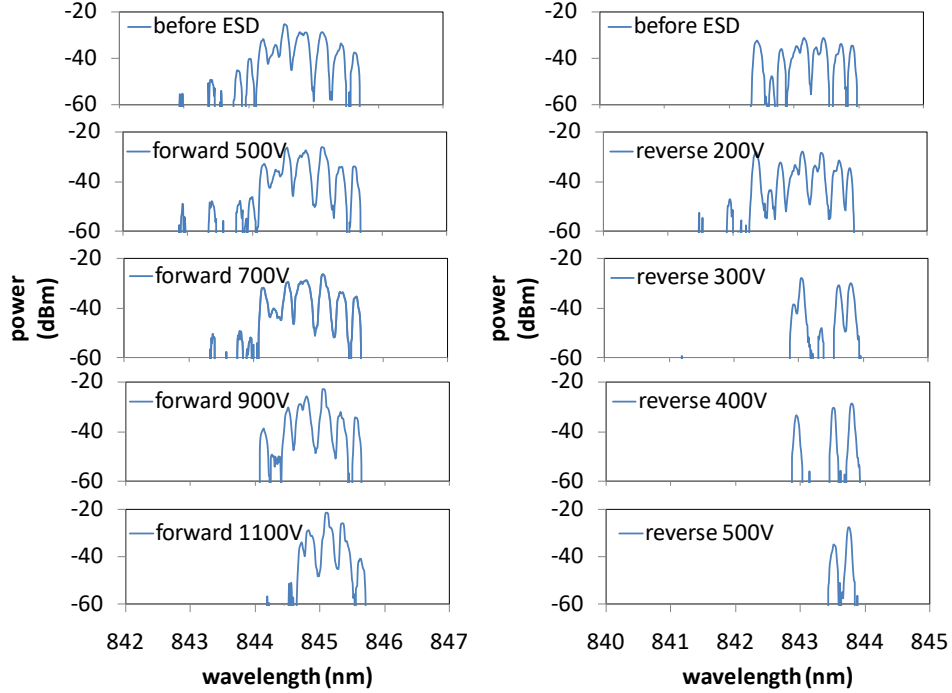
electronics during the ATLAS run, optical spectrum of the VCSEL in each optical link can still be measured in the counting room. Optical spectrum of a VCSEL becomes narrow after it is exposed to electrostatic discharge [7]. We verified that the same phenomenon occurs on the VCSELs used in the ATLAS LAr calorimeter. We chose randomly several spare OTXs and took the VCSELs out. Then we applied either forward or reverse ESD voltage pulses to each VCSEL. The optical spectrum of each VCSEL was measured before and after the ESD pulse application. Optical spectra of two VCSELs are shown in Figure 3. Above a certain threshold, the higher ESD voltage pulse is applied to a VCSEL, its optical spectrum becomes narrower. A VCSEL is more sensitive to reverse ESD than to forward ESD damage.

Figure 3. Optical spectra before and after an ESD damage

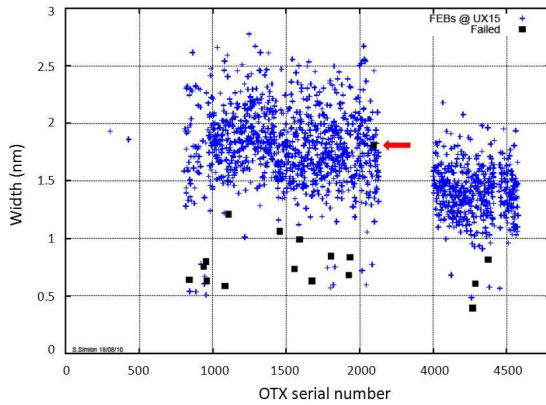
So far narrow optical spectrum method is effective at predicting which VCSEL is more likely to fail. A plot of spectral width versus OTX serial number is shown in Figure 4. The spectral width is defined as the narrowest window which contains 90% of the total power. All the points below -50 dBm or dBm/nm are ignored in the width calculation. Note that there is a serial number gap from 2200 to 4000. All failures are located in the narrow spectrum region except the one which is pointed to with a red arrow. We suspect this failure is not due to the VCSEL, but we cannot know for sure until we get the FEB out.

Figure 4. The OTX spectral width and serial number

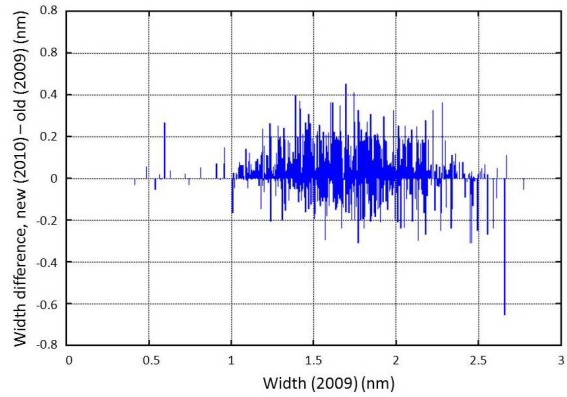
Optical spectra of VCSELs in the optical links are stable. We measured optical spectra four times. The spectral width differences between two measurements (February 2010 and July 2009) versus the spectral width in July 2009 are shown in Figure 5. Only one spectral width difference is larger than 0.5 nm because a peak at the far short wavelength end is included in the spectral width in one measurement and excluded in the other time.

Figure 5. The OTX spectral stability

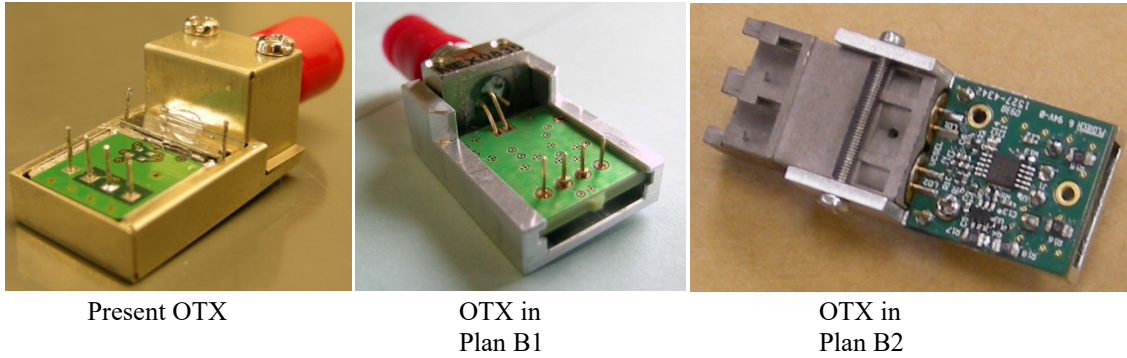
While we look for the failure cause, we are developing two backup plans. The pictures of OTXs used at present and under development in the backup plans are shown in Figure 6. In both backup plans, the VCSELs used in the present OTXs will be replaced. The first backup plan (Plan B1) focuses on the compatibility. While the same laser driver chip is kept, a conventional biasing/coupling circuit is used to replace that used in the present OTX. No extra work needs to

Figure 6. The pictures of present OTX, Plan B1 and Plan B2

be done when we replace the present OTX with the new OTX in Plan B1. Plan B1 is still on the testing and qualification phase.

The second backup plan (Plan B2) concentrates on redundancy. Each new OTX in Plan B2 contains two laser driver chips (only one driver chip can be seen in Figure 6), two VCSELs, and has two optical outputs. The laser drivers and the biasing/coupling circuits are the same as those in the present OTXs. The high speed input signals of each OTX drive both the laser drivers, but the signals are terminated at the far end only once. In order to keep the same module size, we use two smaller LC connectors in the new OTX to replace the single larger ST connector in the present OTX. In case one VCSEL dies, we only need to swap the two fibers in the control room. The replacement of new OTXs in Plan B2, compared to that in Plan B1, require extra work like modification on the front-panels of each FEB and the installation of extra fibers. However, the even bigger workloads in the replacement of new OTXs with either option is to get all FEBs out of the pit, dismount the cooling plates, and solder each OTX off an FEB.

In Plan B2 many tests including the radiation qualification have been done and the reliability test is still ongoing. 122 new OTXs have been assembled. Eye diagrams, average optical power, extinction ratio, rise/fall time, jitter, bit error rate (BER), and optical spectra of all channels have been measured except three modules with various problems. All measured parameters fall into quality control specifications of the present OTXs. Radiation qualification of new OTXs in Plan B2 has been done. Four new OTXs have been tested in 200 MeV proton beam. All OTXs continued to function throughout the test. For two modules, the power supply
