A Thought of Wrapping Space Shuttle External Tank with Ceramic Fiber Fishnet Stockings

Sun Hong Rhie

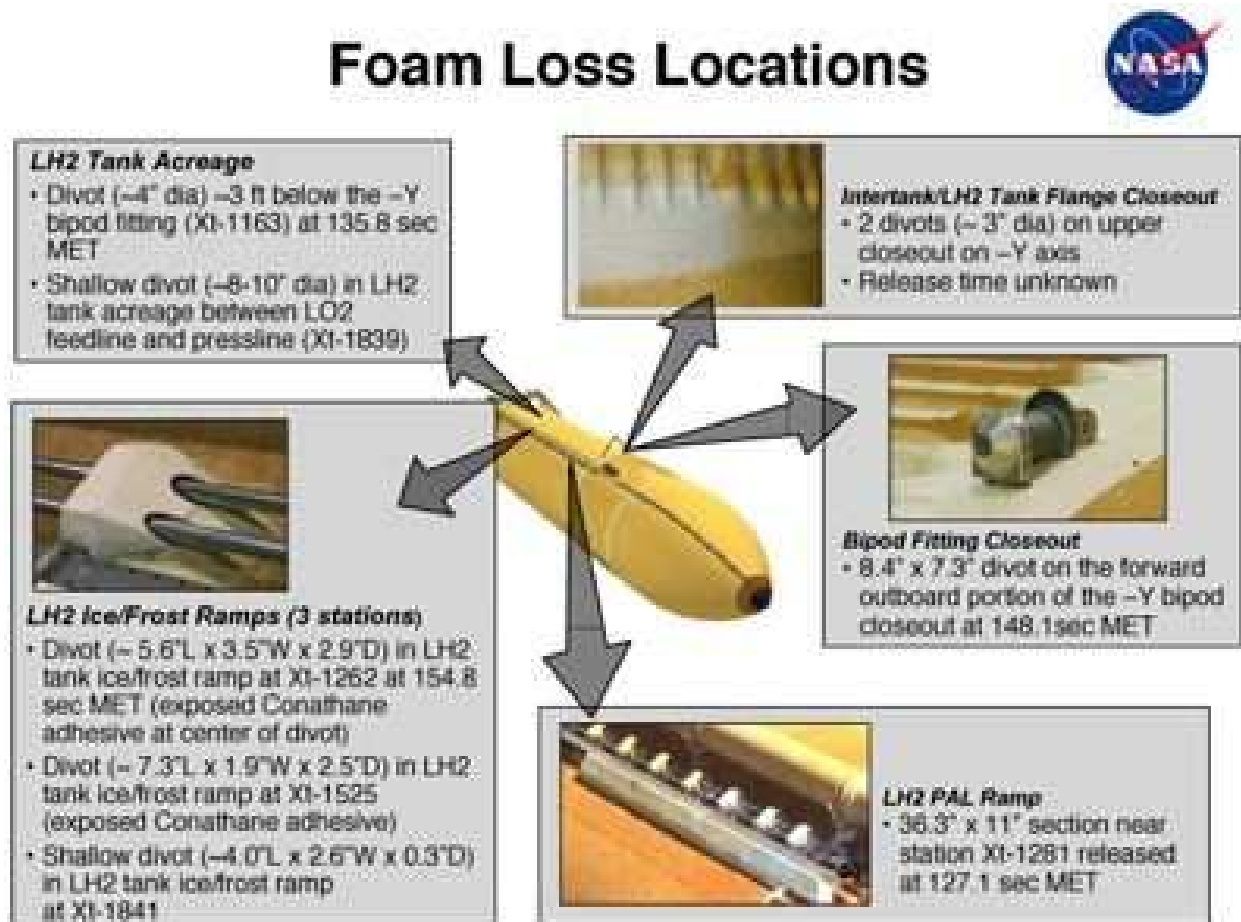
Fig. 1. | Foam loss locations on STS-114 external fuel tank publicly released by NASA : <http://www.nasa.gov> or <http://www.space-ignition.com> .

While HST customers were crossing their fingers, the STS-114 camera system exhibited a spectacular scene of a top-hat shape 0.9lbs insulation foam flying off the external tank. The public release of the foam loss locations by NASA shown in Fig.1 read as follows.

1. LH2 PAL ramp: 36:30⁰⁰ - 11⁰⁰ section near station Xt-1281 released at 127.1 sec MET;
2. 8:40⁰⁰ - 7:30⁰⁰ divot on the forward outboard portion of the -Y bipod closeout at 148.1 sec MET;

3. Divot (5:6⁰⁰L 3:5⁰⁰W 2:9⁰⁰D) in LH 2 tank ice/frost ramp at Xt-1262 at 154.8 sec MET (exposed Conathane adhesive at center of divot);
4. Divot (7:3⁰⁰L 1:9⁰⁰W 2:5⁰⁰D) in LH 2 tank ice/frost ramp at Xt-1525 (exposed Conathane adhesive);
5. Shallow divot (4:0⁰⁰L 2:6⁰⁰W 0:3⁰⁰D) in LH 2 tank ice/frost ramp at Xt-1841;
6. Divot (4⁰⁰ dia) 3ft below the -Y bipod fitting (Xt-1163) at 135.8 sec MET;
7. Shallow divot (8⁰⁰ 10⁰⁰ dia) in LH 2 tank acreage between LO 2 feedline and pressline (Xt-1839);
8. 2 divots (3⁰⁰ dia) on upper intertank/LH 2 tank range closeout on -Y axis (release time unknown).

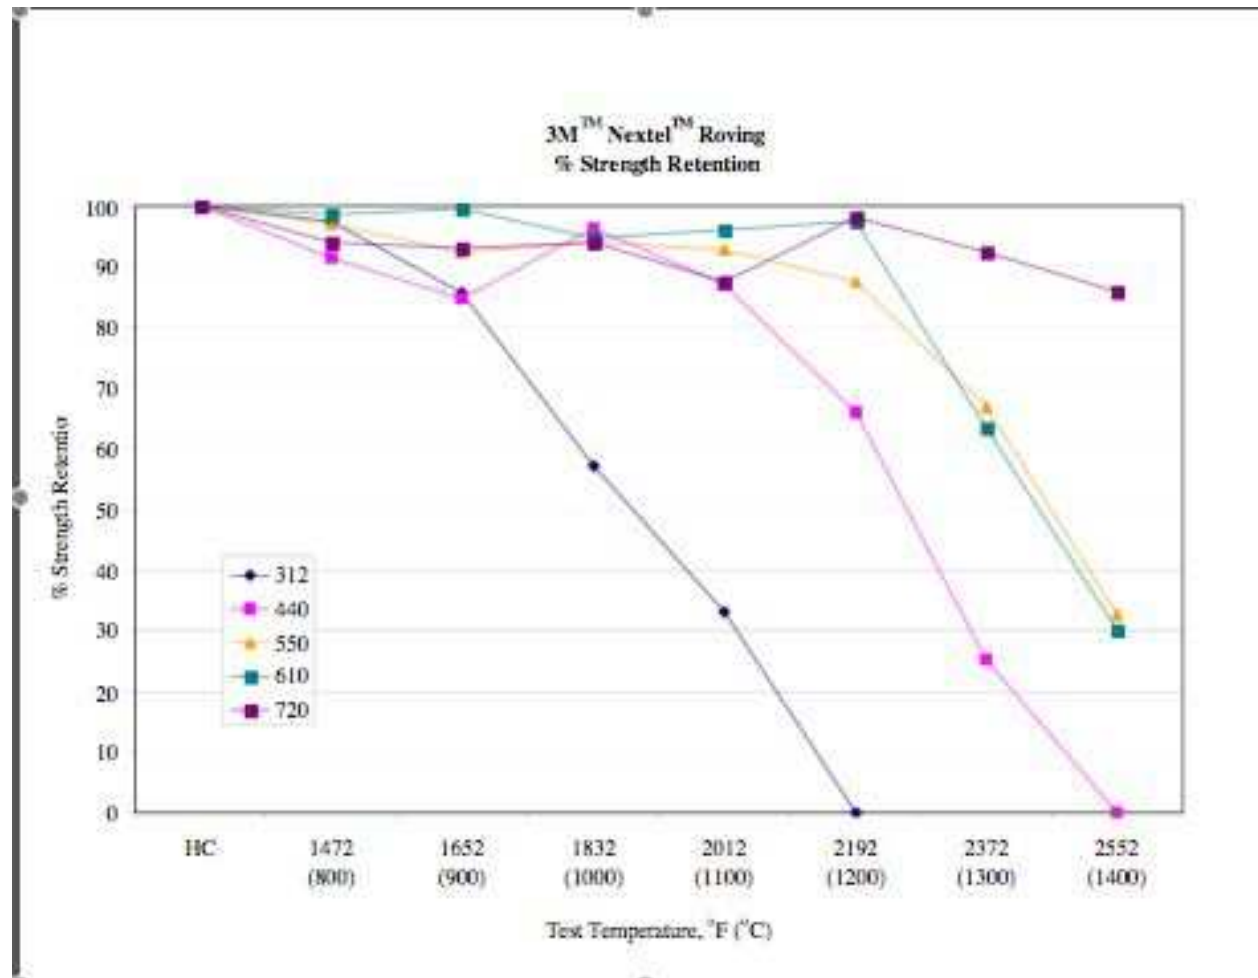
Fig. 2. | 3M Nextel 720 tow shows relatively high stability in high temperatures. Fiber 610 shows sudden drop in strength at 1200 C . (The figure is from 3M TTN .)

Figure 2 shows the stable strength of fiber 720 tow in high temperatures. (3M Nextel oxide fiber tows come in fiber counts of 400 or 750.) Figures 3 and 4 show the single fiber tensile strengths of the fibers 610 and 720 in room temperature and high temperatures where the high temperature heatings lasted about 90 seconds. (Note that the maximum aerodynamic friction and heating occurs around 80 seconds after the launch.) The fiber 610 is stronger at room temperature, but fiber 720 is preferred because of the stability of the strength in high temperatures. Comparison of figures 2 and 4 shows that the fiber 720 tow performs better than single fiber at higher temperatures (> 1150°C) consistently with the report by DY.

The concern of foam shedding is on the area where the aerodynamic stress is high, and the design requirement⁸ of the temperature tolerance due to aerodynamic heating is 1200°C. Within the temperature range, fiber 720 shows excellent strength behavior and also very slight difference in the strengths between a tow and an average single fiber. The temperature tolerance requirements for the areas with heating from solid rocket booster and from main engine are very high with 1650°C and 3300°C. Foam shedding or ablation from those areas (aft dome and lower part of the acreage) is not a concern in regard to the potential damage to the thermal protection systems (TPS), and reinforcement fibers should not be used to avoid generating unnecessary potential hazard of loose fiber fragments or melts.

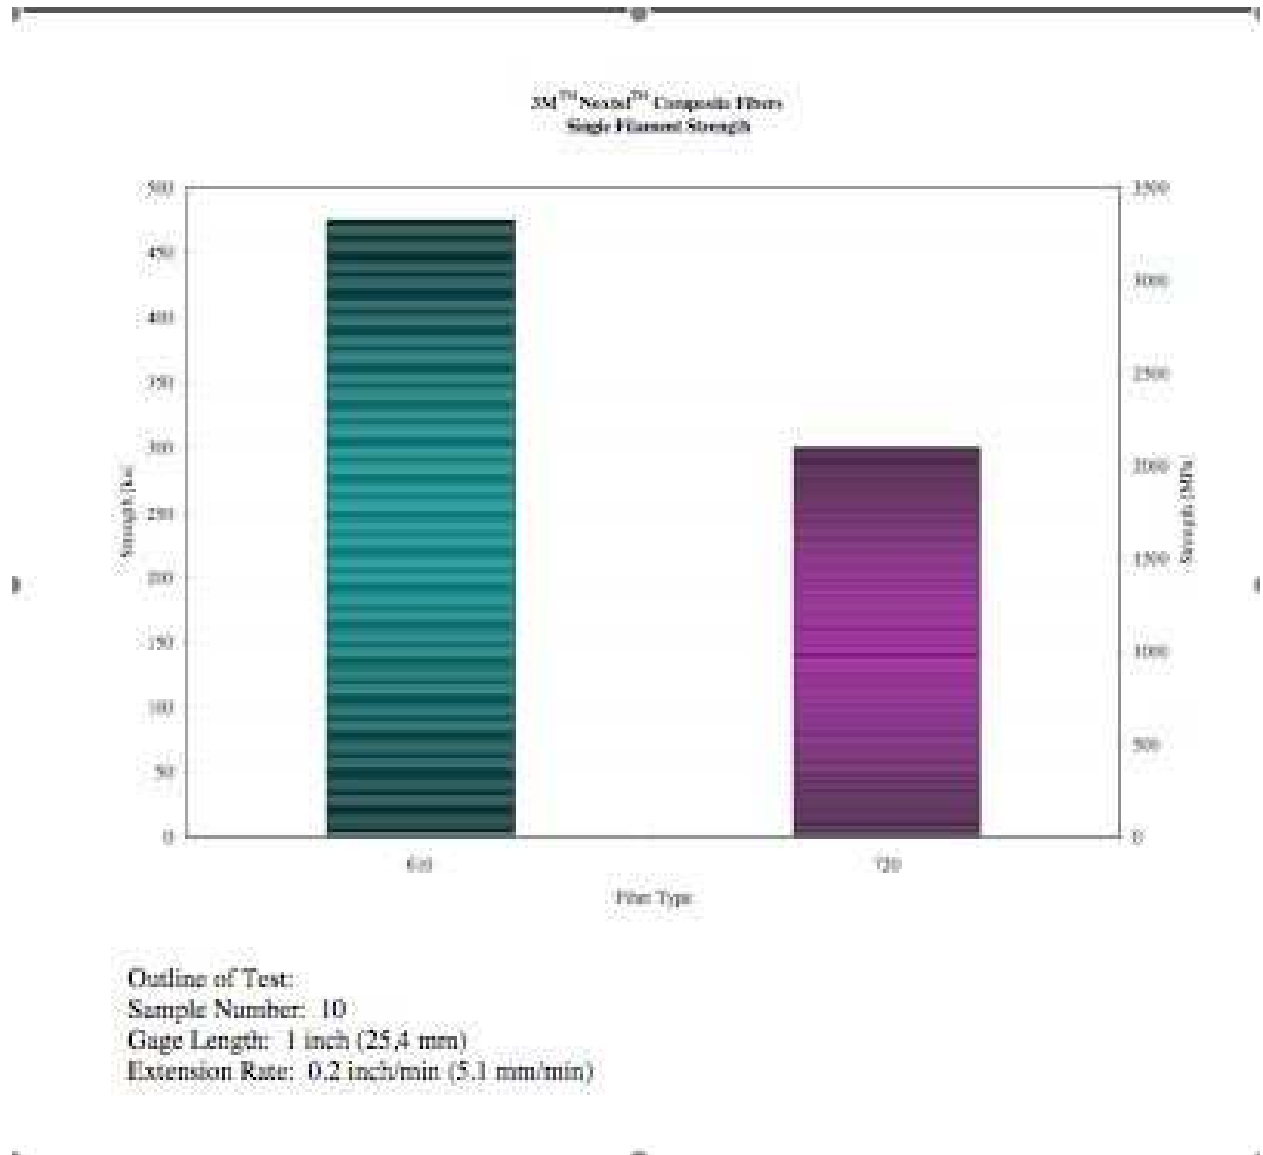
Fig. 3. | Room temperature single fiber tensile strengths of fiber 610 and fiber 720. (The figure is from 3M TTN.)

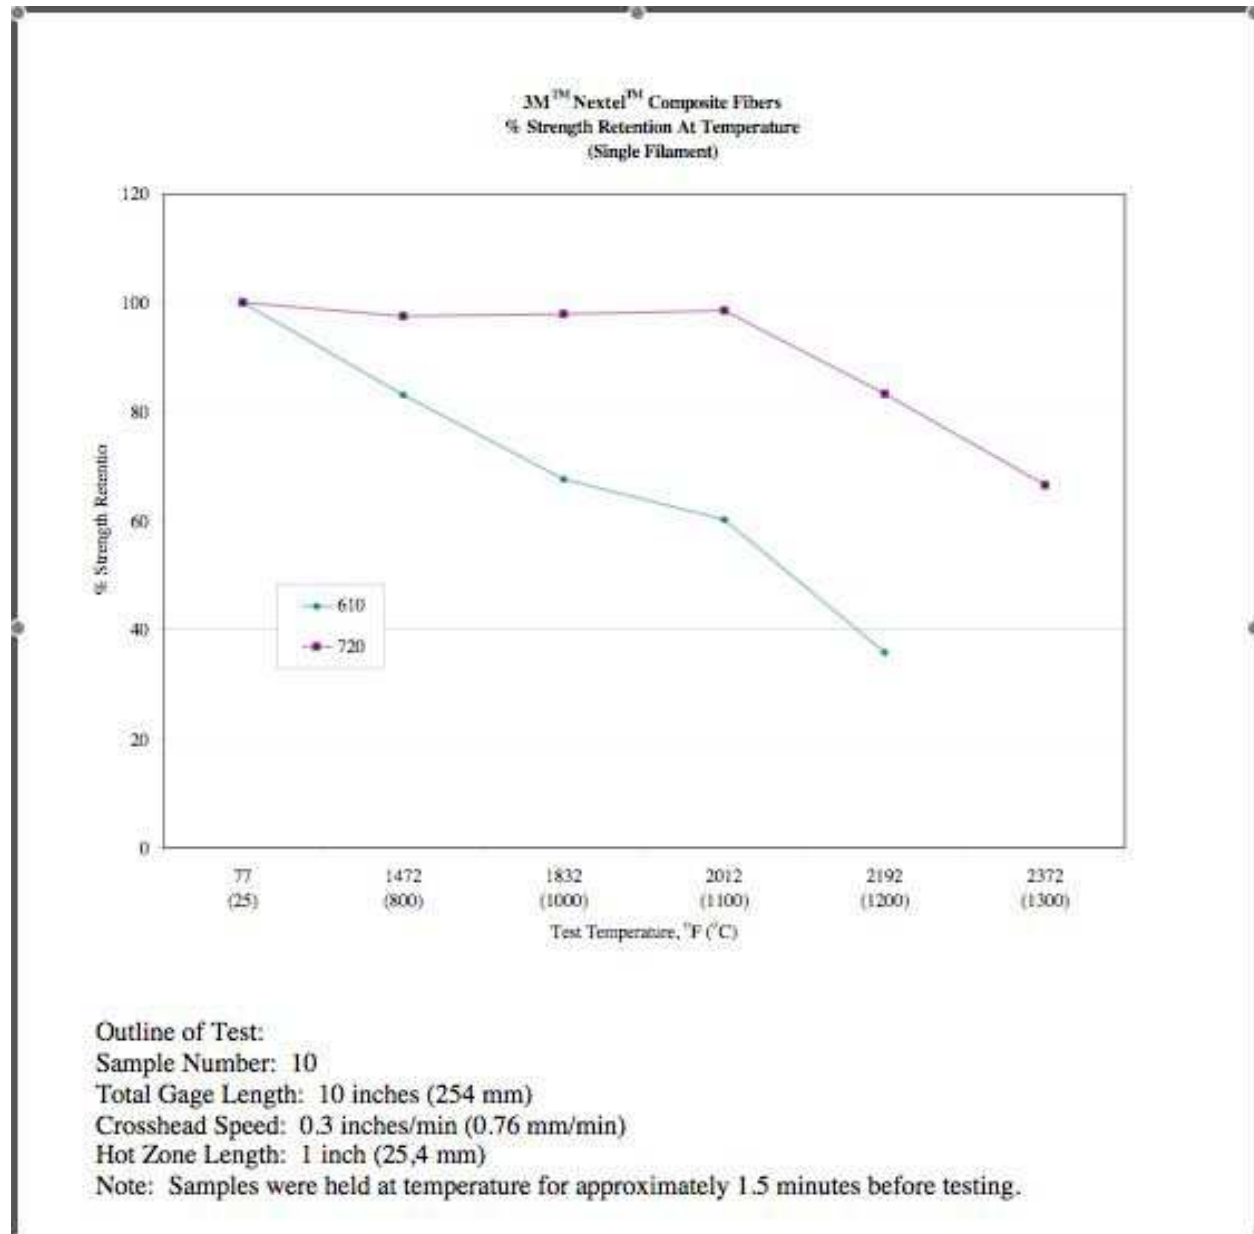
Fig. 4. Fiber 720 shows a relatively stable strength at high temperature heating for 90sec. The maximum aerodynamic heating of the external tank occurs at 80sec after the launch. (The figure is from 3M TTN.)
