Field Emission Dark Current of Technical Metallic Electrodes

F. Lepiniec, R. Ganter, R. Betemps
Paul Scherrer Institut
5232 Villigen
Switzerland

12 October 2006

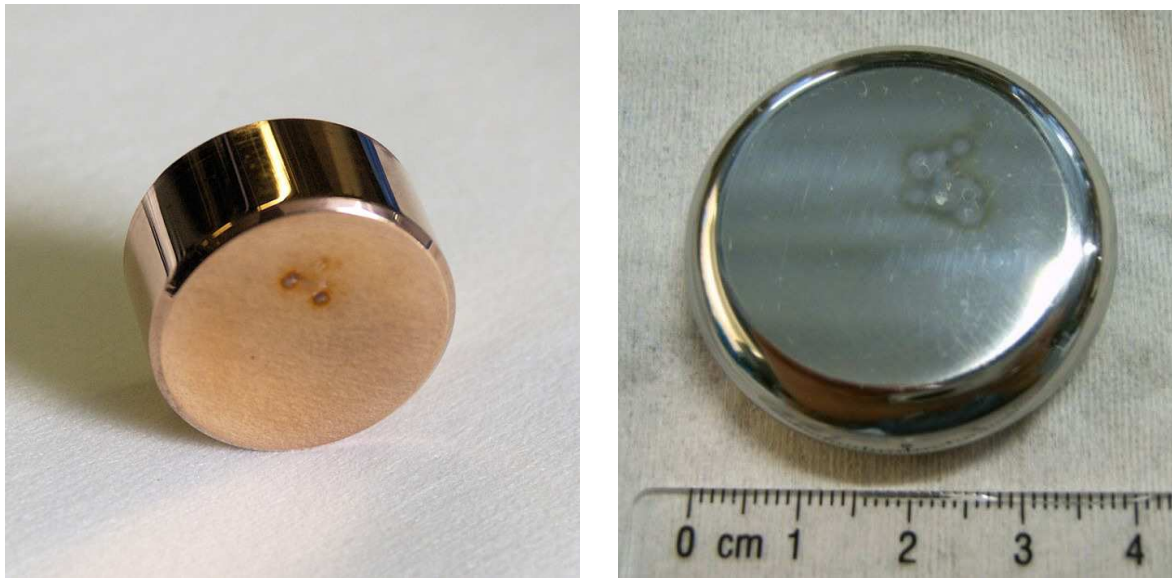
Figure 3: Cleaned Cu cathode after high voltage testing, left. Damaged Mo cathode, right picture. Damage can be clearly seen.

All our electrodes tested have the same shape, see Fig. 3 & 4 for the cathode and anode, respectively. The mean roughness was, by design, defined to be less than $R_a = 0.2 \text{ } \mu\text{m}$. In Fig. 4, the copper anode, has a hole in the middle. This hole was made to mimic the behaviour of the extracting anode of the 500 kV pulser. None of the other electrodes have this hole. The R_a of the electrodes was checked after high gradient testing.

In comparison to Al electrodes, craters in the Cu were neither as deep, nor as extended : see the 2 spots in Fig. 3, compared to damages in Fig. 7. All breakdown damage on the Cu anode remained localized around the hole of the mushroom. That suggests two possibilities without excluding a combination of the two. The energy in the arc was not sufficient to vaporize the Cu materials, by melting and sputtering the melted Cu, despite the fact that Cu has a higher sputtering rate than Al. Or the field was not strong enough to pull out droplets of Cu which could have then been vaporized [29].

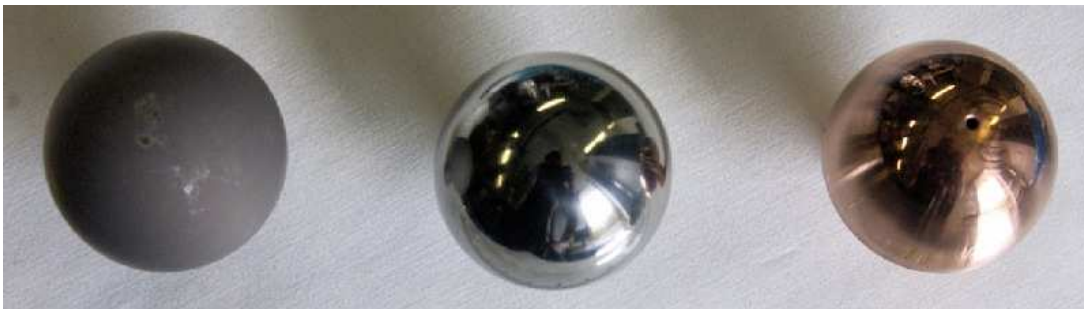
Figure 4: Three anodes used for HV testing, Titanium the left (grey black colour, after vacuum ring), Mo in the center and Cu on the right. Pictures taken after HV testing. Damage can be seen on the Ti electrodes

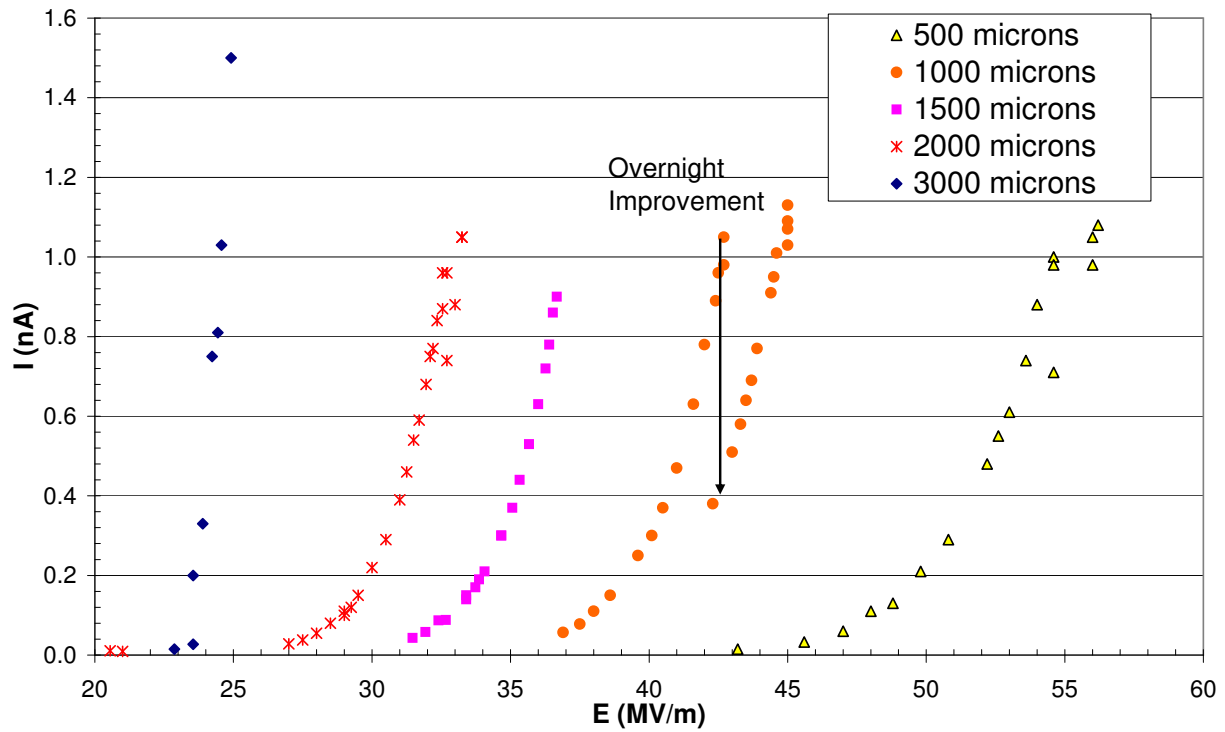
Figure 6: Dark current of Al electrodes after an ArG low D ischarge, following the previous He processing and high field conditioning.

In the next test an He-Ar plasma was used to clean the same electrodes. The behaviour, after pumping out the noble gases, was that no FE was observed until breakdown. The Al electrodes held stably (12 hours) a field of 42 MV/m without dark current at 1.5 mm gap. Whilst the field was at 45 MV/m an arc occurred and an emission current of 350 nA could be measured. Nevertheless, damage due to this and further breakdowns during the voltage processing, were not severe; the current at 1 mm, for a field of 41.5 MV/m was still only 1 nA. Finally, the best result obtained by He-ArGD, was a field of 52 MV/m at 1 mm without dark current. However, at some point an arc more violent than the previous ones, damaged the cathode so that no more GD was able to restore the holding of the high electric field. A summary of the performance obtained with Al electrodes is shown in Table.4.

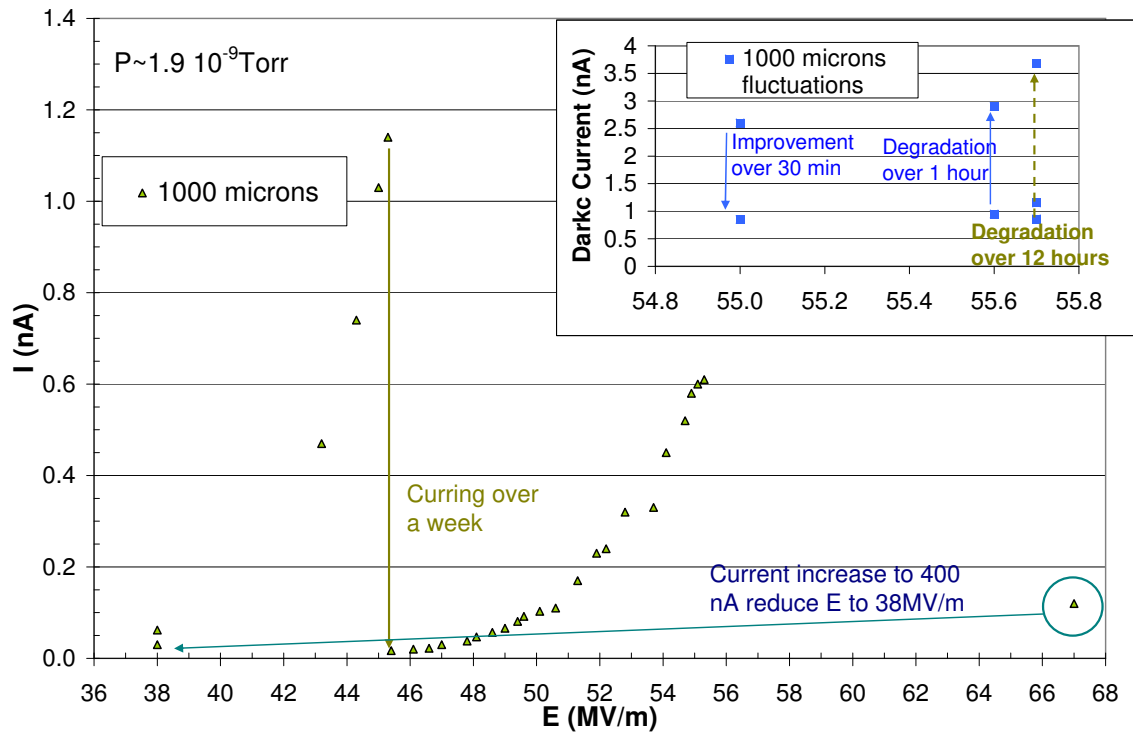
Figure 9: Dark current evolution of Ti electrodes after a 3rd Ar Glow discharge.

eld obtained for 1 nA at 1 mm gap is 55 MV/m, see insert in Fig.9. Above this level of eld, the dark current does not diminish but it increases with time, Fig.9.
