# Studies of VCSEL Failures in the Optical Readout Systems of the ATLAS Silicon Trackers and Liquid Argon Calorimeters

Mark S. Cooke  
Lawrence Berkeley National Laboratory, Berkeley, CA, USA

The readout systems for the ATLAS silicon trackers and liquid argon calorimeters utilize vertical-cavity surface-emitting laser diodes to communicate between on and off detector readout components. A number of these VCSEL devices have failed well before their expected lifetime. We summarize the failure history and present what has been learned thus far about failure mechanisms and the dependence of the lifetime on environmental conditions.

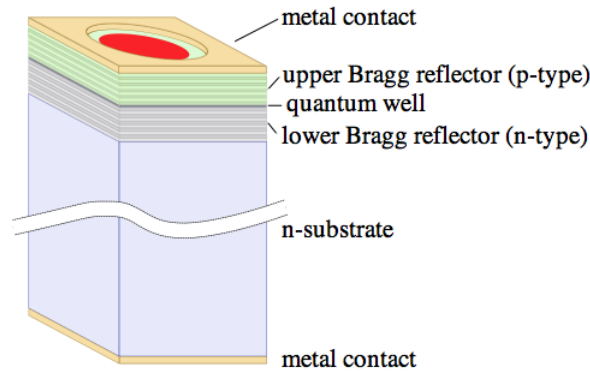
Figure 1: A schematic depiction a typical VCSEL device.

Figure 1 shows a schematic depiction of a typical VCSEL structure. The laser resonator consists of two doped reflector regions about an active region. The reflector regions alternate layers of high and low index of refraction (e.g. GaAs/AlGaAs). Quantum wells in the active region provide optical gain, and enhanced transverse current confinement is typically achieved with an oxidized layer or a layer containing ion implants (not depicted in the figure). VCSELs may be fabricated as single channel devices or in arrays. Single channel VCSELs are often hermetically packaged, as the devices are known to be sensitive to damage from external sources [3], such as humidity [4] and electrostatic discharge (ESD) [5]. Hermetic sealing of arrays is generally not an economic option, and some ATLAS VCSEL arrays have been coated with epoxy instead.

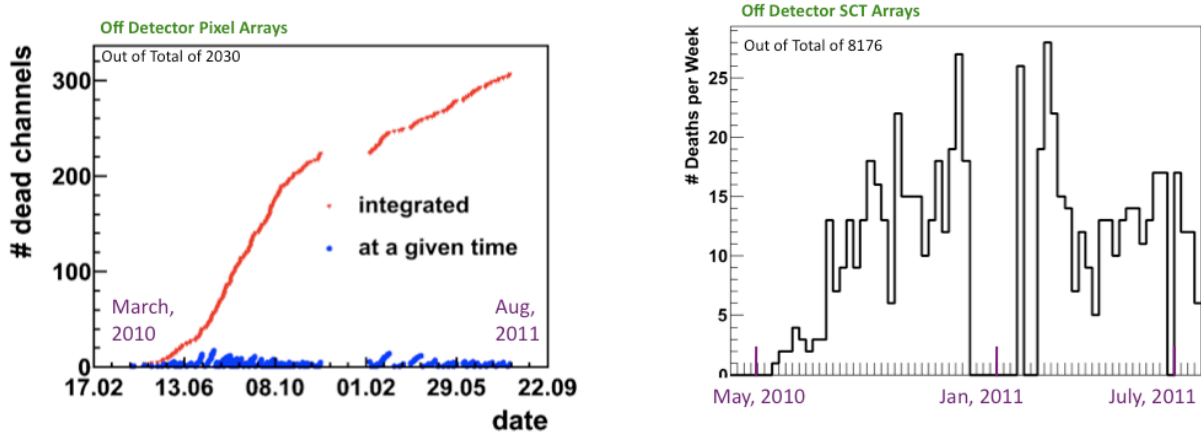
Figure 2: (Left) The integrated number of failed pixel TX-plugin channels versus time. (Right) The number of SCT TX-plugin deaths per week versus time.

The pixel and SCT detectors have experienced VCSEL deaths in the off-detector optical readout electronics. Early failures in the epoxy covered VCSEL arrays of the TX-plugins were observed in 2009, and a full replacement was performed with batches produced using a higher degree of quality assurance, particularly for ESD. Nonetheless, failures continue to persist. Figure 2 (left) shows the integrated number of failed pixel TX-plugin channels versus time between March 2010 and August 2011. Figure 2 (right) shows the total number of SCT TX-plugin deaths per week versus time between May 2010 and July 2011. In both cases, order 10 deaths occur per week. As these failures occur in the off-detector electronics, they are continuously replaced during sufficiently long periods between LHC fills.

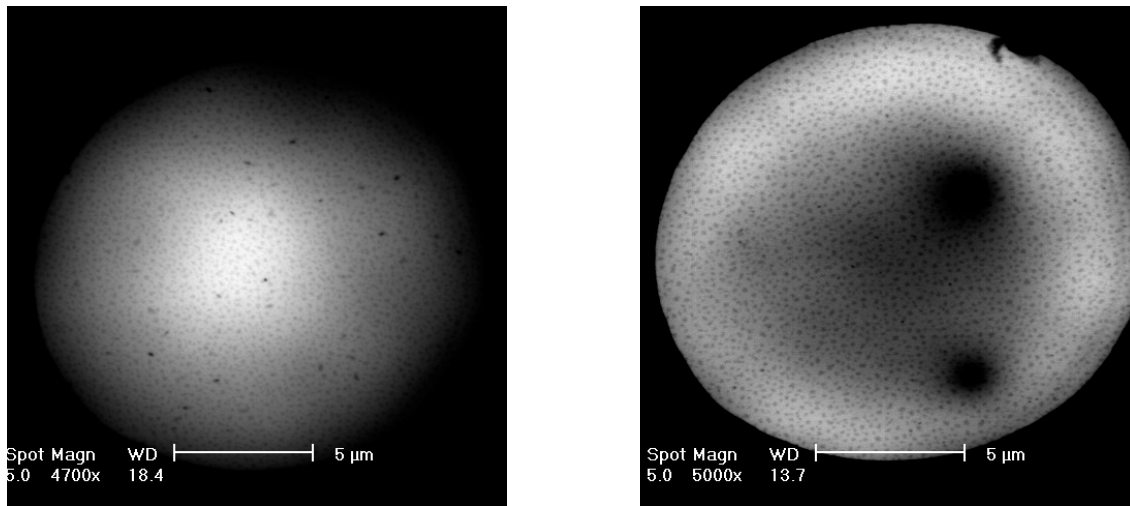
Figure 3: (Left) An EBIC image of a working VCSEL channel in a used pixel TX-plugin. The small dark speckles reflect small variations in surface topography. (Right) An EBIC image of a failed VCSEL channel in the same array as the channel shown on the left. The image reveals two large defect regions.

Electron beam induced current (EBIC) analysis utilizes the scanning electron microscope beam to reveal defects in biased semiconductor devices, as the induced current will vary when the electron beam is scanned over such regions. Figure 3 (left) shows an EBIC image of a working VCSEL channel in a used pixel TX-plugin device. The small dark speckles reflect small variations in surface topography. Figure 3 (right) shows an EBIC image of a failed VCSEL channel in the same array. Two localized dark regions are evident.

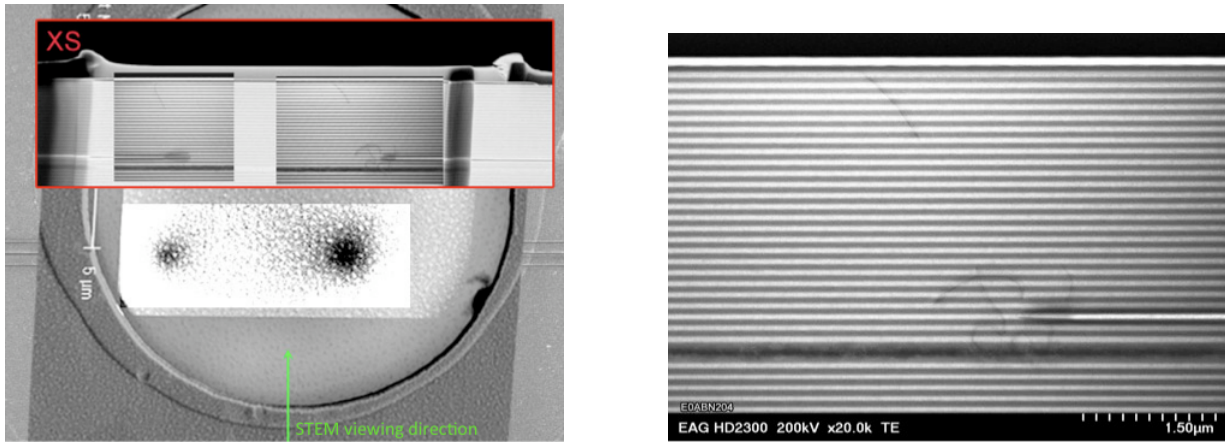
Figure 4: (Left) A second EBIC plan view of the failed channel in Figure 3 (right) indicating the region prepared for STEM analysis. The boxed inlay labeled XS shows an STEM image of a cross-section slice through the defect regions. (Right) A zoomed-in STEM image of the right oxide layer aperture and neighboring quantum well region.

The EBIC image of the failed VCSEL channel informed the preparation of a cross-sectional slice using a focused ion beam for analysis with a scanning transmission electron microscope (STEM). Figure 4 (left) presents a second EBIC image of the failed VCSEL channel, and indicates the region prepared for STEM analysis. The boxed inlay shows the STEM image of the cross section slice. Dislocations are observed to emanate from the oxide layer, recognized as the white band protruding into the reflector region from the left and right of the inlay. Figure 4 (right) provides a zoomed view of the right oxide layer tip and the neighboring quantum well region. In addition to the dislocation growth emanating from the oxide layer, defects are seen within the quantum well region, observed as the wide dark band layer.

The pixel array under investigation also contained an unbonded and hence unused VCSEL channel. Figure 5 (right) shows an STEM cross section image of this channel. An absence of defects is clear when compared with the similar image of the failed device in Figure 4 (right).

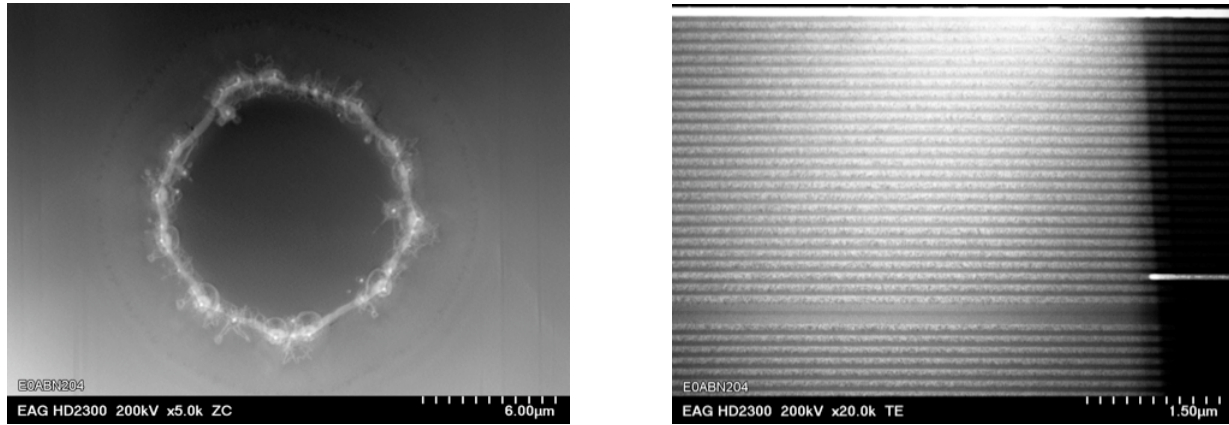
Figure 5: (Left) Plan view STEM image of a vertical slice of the working VCSEL channel containing the oxide and quantum well layers. (Right) Cross section STEM image of an unused VCSEL channel.

Figure 5 (left) shows a plan view STEM image of a vertical slice containing the oxide and quantum well layers of the working channel whose EBIC image is shown in Figure 3 (left). A ring of dislocations about the oxide layer aperture is observed. No such defects were seen on this channel in the EBIC analysis, as the defects were evidently too far below the surface. The absence of dislocations within the ring suggests they had not yet grown into the active region and the channel therefore remained functional.

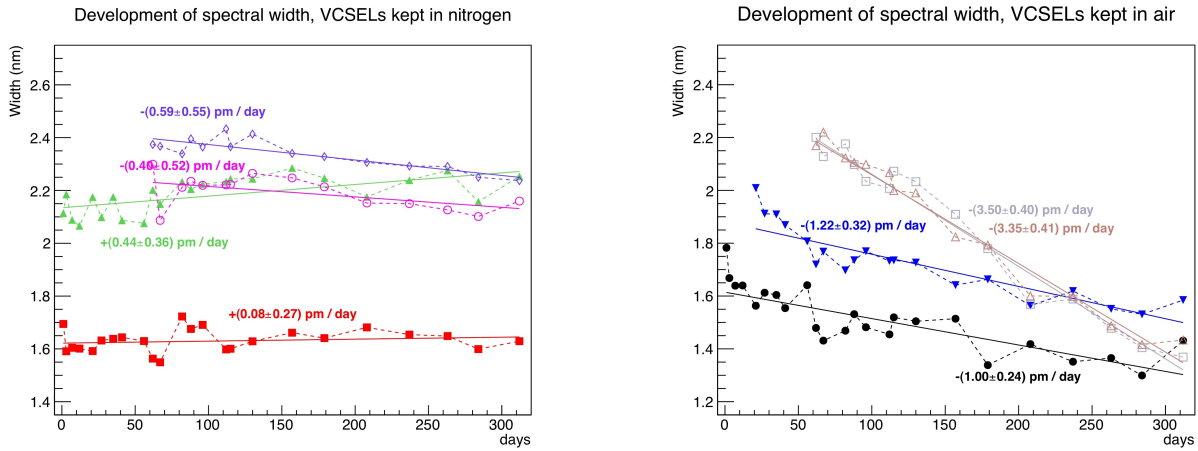
Figure 6: (Left) Development of the spectral width over time of four TX-plugin arrays kept in nitrogen gas (1% relative humidity) at 20°C. (Right) Development of the spectral width over time of four TX-plugin arrays kept in air (50% relative humidity) at 20°C.

A similar test has also been performed by the SCT collaboration using spare TX-plugin arrays. Figure 6 (left) shows the average spectral width versus time of four spare TX-plugin arrays operated in a low humidity nitrogen gas environment at 20°C. The widths have remained stable for  $\sim 250$  days. In contrast, Figure 6 (right) shows the development of the width of four arrays operated in an air environment at 20°C and 50% relative humidity. Each array shows significant spectral narrowing in time when exposed to humid air.

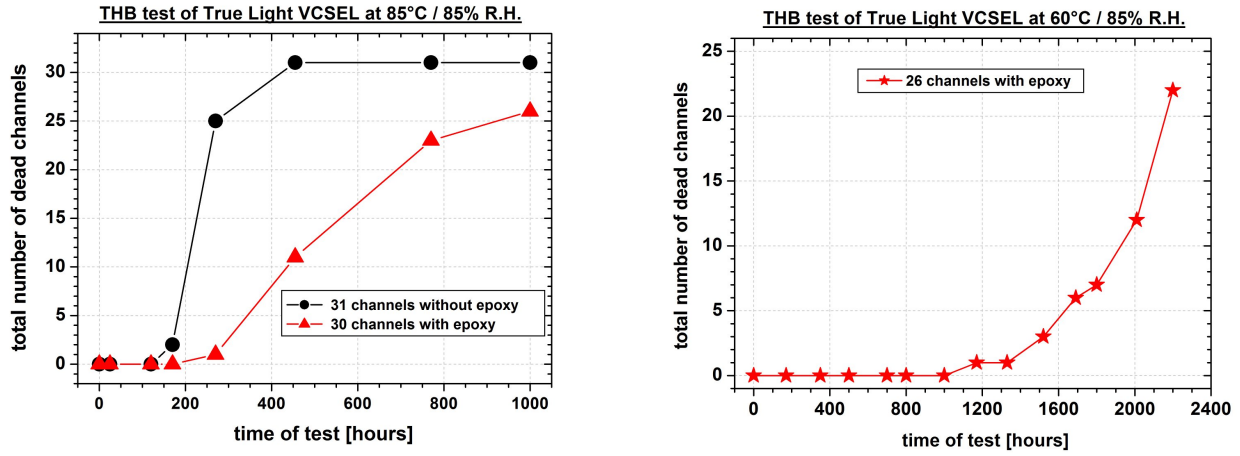
Figure 7: (Left) The integrated number of failed VCSEL channels versus time in Test 1 at 85°C and 85% relative humidity. Arrays with and without epoxy coated were studied in this test. (Right) The integrated number of failed VCSEL channels versus time in Test 2 at 60°C and 85% relative humidity. This test was performed on epoxy coated arrays.

Test 1 was carried out at a temperature of 85°C and 85% relative humidity, and examined arrays with and without epoxy coating. The number of failed channels during the test is shown as a function of time in Figure 7 (left). A device surviving operation in such conditions for 1000 hours is generally thought to be able to survive approximately 10 years in typical use conditions [4]. The channels on arrays without epoxy began to fail after only a couple hundred hours, and those on arrays with epoxy fared only marginally better.

Test 2 was performed with a lower temperature, 60°C, and the same 85% relative humidity as Test 1. Only epoxy covered arrays were studied in this test. Figure 7 (right) displays the results. The first failures occurred shortly after 1000 hours, and nearly all had failed by 2200 hours.
