A study on the mechanical property and corrosion sensitivity of an AA5086 friction stir welded joint

Zhitong Chen*, Shengxi Li, Kaimiao Liu, Lloyd H. Hihara*

Hawaii Corrosion Laboratory, Department of Mechanical Engineering, University of Hawaii at Manoa, Honolulu, HI 96822, USA

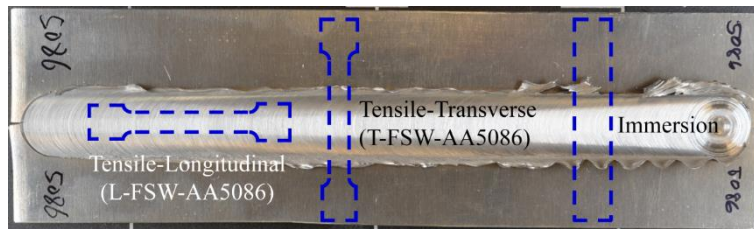
Fig. 1. Schematic diagram showing the locations from where the tensile test (L-FSW-AA5086 and T-FSW-AA5086) and immersion specimens were obtained.

Vickers microhardness testing (Wilson Rockwell, R5000) was performed on the top surface across the FSW weld at a distance of 2 mm using a 50 g load. The tensile tests were performed at a crosshead speed of 3 mm/min using an Instron-5500R testing machine. Tensile specimens were machined from the weld in two directions: longitudinal and transverse (Fig. 1). An axial extensometer with 25 mm gage length was attached to the specimens at the gauge section. The strain analysis of each specimen was made by an ASAME automatic strain measuring system. The tensile properties of the joints were evaluated using three tensile specimens cut from the same joint.

The tensile stress-strain curves of the BM and two types of FSW specimens (Fig. 1) are shown in Fig. 4. The elongation, yield strength, and tensile strength of the BM-AA5086 were approximately 16.7%, 237 MPa, and 300 MPa, respectively. As compared to the BM, all FSW tensile specimens had lower tensile and yield strength values, which can be attributed to the weld zone having lower hardness than the BM. However, the ductility of the two FSW specimens increased as compared to that of the BM. Notice that the longitudinal tensile specimen (L-FSW-AA5086) had a significant increase in ductility with an elongation value more than 2 times of that of the BM. Because the longitudinal tensile specimens contained only fine equiaxed grains from the NZ (Fig. 1), they had better ductility than the BM with relatively large grains. The transverse tensile specimens contained all four zones (i.e., BM, HAZ, TMAZ, and NZ) which have different resistances to deformation due to the differences in grain size and precipitate distribution. Therefore, the observed ductility was measured as an average strain over the gage length. When a tensile load was applied to the joint, failure occurred in the weaker regions of the joint [19], which is the HAZ for the specimen T-FSW-AA5086. As a comparison, the BM-AA5086 and L-FSW-AA5086 fractured in the center of the specimen.

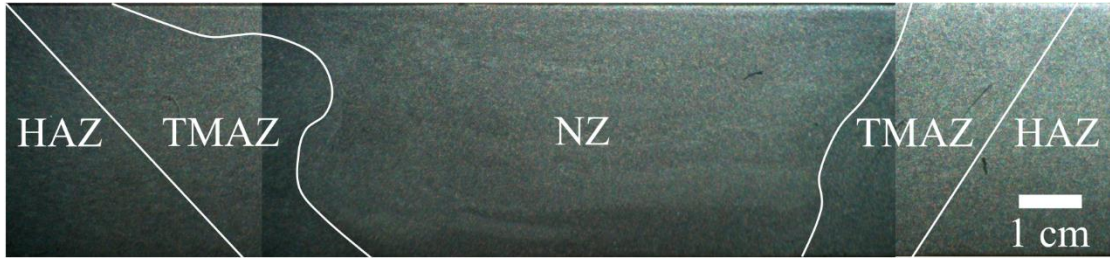
Fig. 2. Cross-sectional view of FSW AA5086 showing typical weld zones (NZ, HAZ, and TMAZ).

Fig. 2 shows the metallographic cross-section of a FSW-AA5086 sample after slight corrosion in acid solution (2.5 vol.% HNO_3). The central NZ has microstructure commonly denoted as onion rings. The NZ is wider on the crown region of the weld because the upper surface was in contact with the tool shoulder.

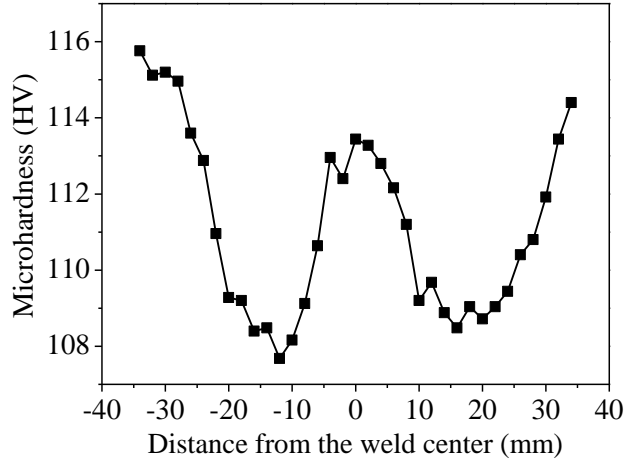
Fig. 3 shows the microhardness distribution across the top surface of the FSW-AA5086. The hardness curve demonstrates a “W”-shaped hardness distribution, which is asymmetrical with respect to the weld centerline. The minimum hardness was observed in the TMAZ/HAZ regions, while the maximum value occurred in the BM. According to the Hall-Petch relationship, the hardness value in the NZ was higher than that of the TMAZ/HAZ because of the fine equiaxed grain structure in the NZ [18]. In addition, because AA5086 is strengthened by strain hardening and not by the presence of precipitates, it is possible that the thermal cycle of FSW causes the annihilation of dislocations and destroys the strain hardening mechanism.

Fig. 3. Microhardness distribution across the top surface of FSW-AA5086 measured with a 2-mm step.

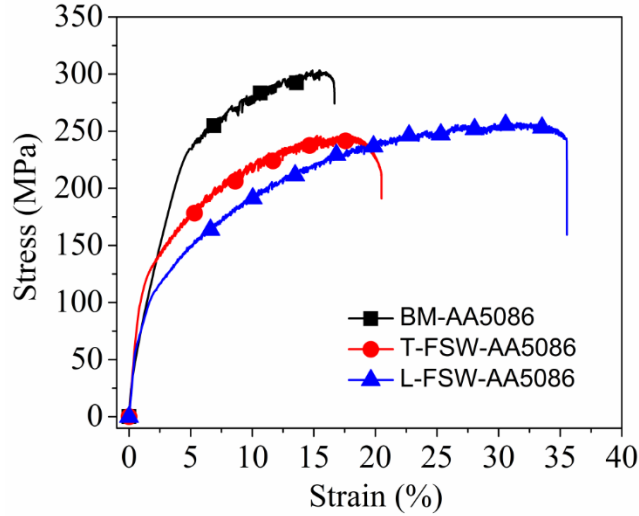
Fig. 4. Tensile stress-strain curves of the two types of FSW specimens as compared to that of the BM.

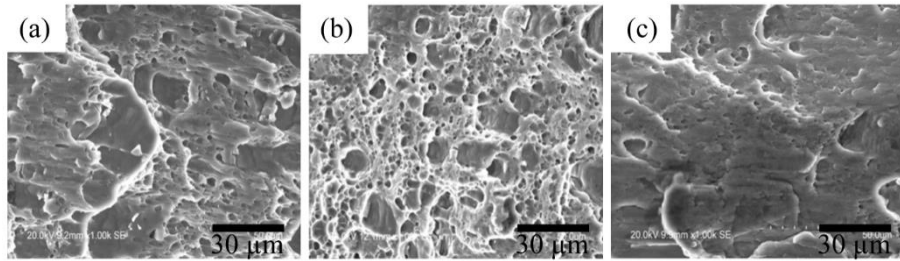
Fig. 5. SEM fractographs of the (a) BM-AA5086, (b) T-FSW-AA5086, and (c) L-FSW-AA5086.

The fractured FSW tensile specimens showed obvious necking/plastic deformation but not the specimen BM-AA5086. The fractographs of the BM and the two FSW specimens (Fig. 5) reveal dimple fracture patterns with teared edges full of micropores. The dimples were of various sizes and shapes. Compared to the specimen BM-AA5086, the dimples in the specimen T-FSW-AA5086 (failure occurred in HAZ) were deeper and the teared edges were thinner. Therefore, the specimen T-FSW-AA5086 exhibited worse mechanical properties than the specimen BM-AA5086. In addition, the specimen T-FSW-AA5086 had much deeper dimples and thinner teared edges than the specimen L-FSW-AA5086 and thus worse mechanical properties.

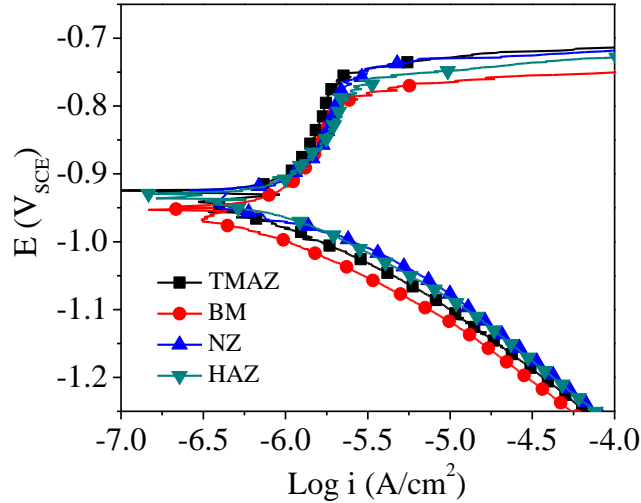
Fig. 6. Polarization curves of different zones in FSW-AA5086 in deaerated 3.15 wt.% NaCl solutions.

Fig. 6 shows typical polarization curves of different zones in FSW-AA5086 in deaerated 3.15 wt.% NaCl solutions. All zones in FSW-AA5086 showed a critical passive region below E_{pit} . The current density increased abruptly at potentials greater than E_{pit} due to the breakdown of the passive film. Table 1 summarizes the E_{corr} , I_{corr} , and E_{pit} values obtained from Fig. 6. Compared to HAZ, TMAZ, and NZ, BM exhibited the lowest E_{corr} and E_{pit} values and the highest I_{corr} value. Therefore, the FSW process improved the corrosion resistance of AA5086 in the weld zones. Notice that HAZ had the lowest I_{corr} value among the four different zones, indicating its highest corrosion resistance. The coarsening of precipitates in the HAZ region seem to be the responsible factors for the improved corrosion resistance [20, 21]. Finally, it is worth to mention

that a higher E_{pit} value (e.g., NZ and TMAZ) did not necessarily correspond to a lower corrosion rate, while I_{corr} gave the direct measure of corrosion rate [22].

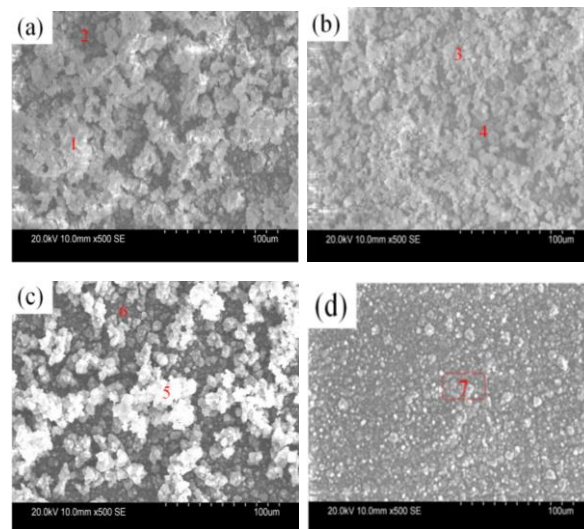
Fig. 7. SEM images of different zones in FSW-AA5086 after 90 days immersion in 3.15 wt.% NaCl: (a) TMAZ, (b) BM, (c) Nugget, and (d) HAZ.

The SEM images of FSW-AA5086 samples that were immersed in the three different solutions for 90 days are shown in Figs. 7-9. Generally, the SEM images showed that the amounts of corrosion products on FSW-AA5086 samples immersed in the three solutions decreased from 3.15 wt.% NaCl to ASTM seawater and finally to the 0.5 M Na₂SO₄ solution. This trend indicates that among the three solutions, 3.15 wt.% NaCl solutions is the most corrosive environment for AA5086 samples while 0.5 M Na₂SO₄ is the least corrosive environment. In addition, the SEM images showed that, in all three environments, HAZ had much less corrosion products than the other three zones (i.e., NZ, TMAZ, and BM). However, it is difficult to differentiate the other three zones in terms of the amounts of corrosion products on them. The conclusion that HAZ is the most corrosion-resistant zone in FSW-AA5086 is in good agreement with the polarization results as discussed in Section 3.3.

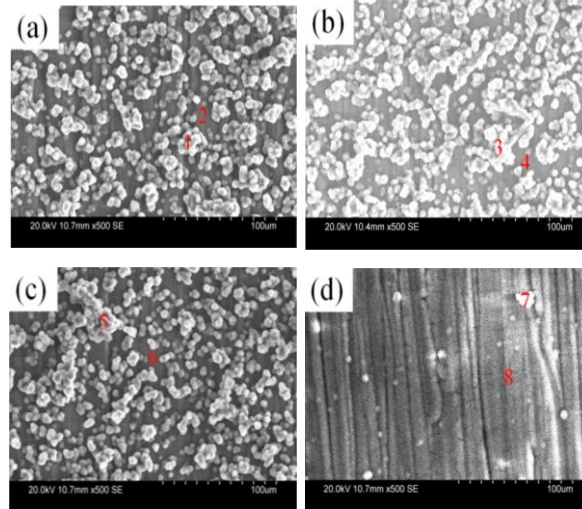
Fig. 8. SEM images of different zones in FSW-AA5086 after 90 days immersion in ASTM seawater: (a) TMAZ, (b) BM, (c) Nugget, and (d) HAZ.

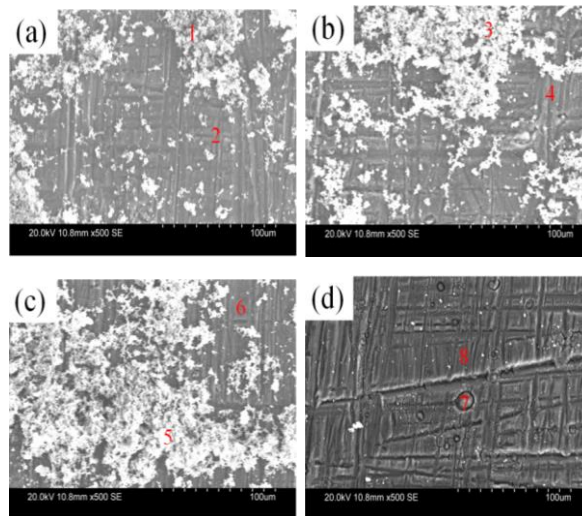
Fig. 9. SEM images of different zones in FSW-AA5086 after 90 days immersion in 0.5 M Na_2SO_4 : (a) TMAZ, (b) BM, (c) Nugget, and (d) HAZ.

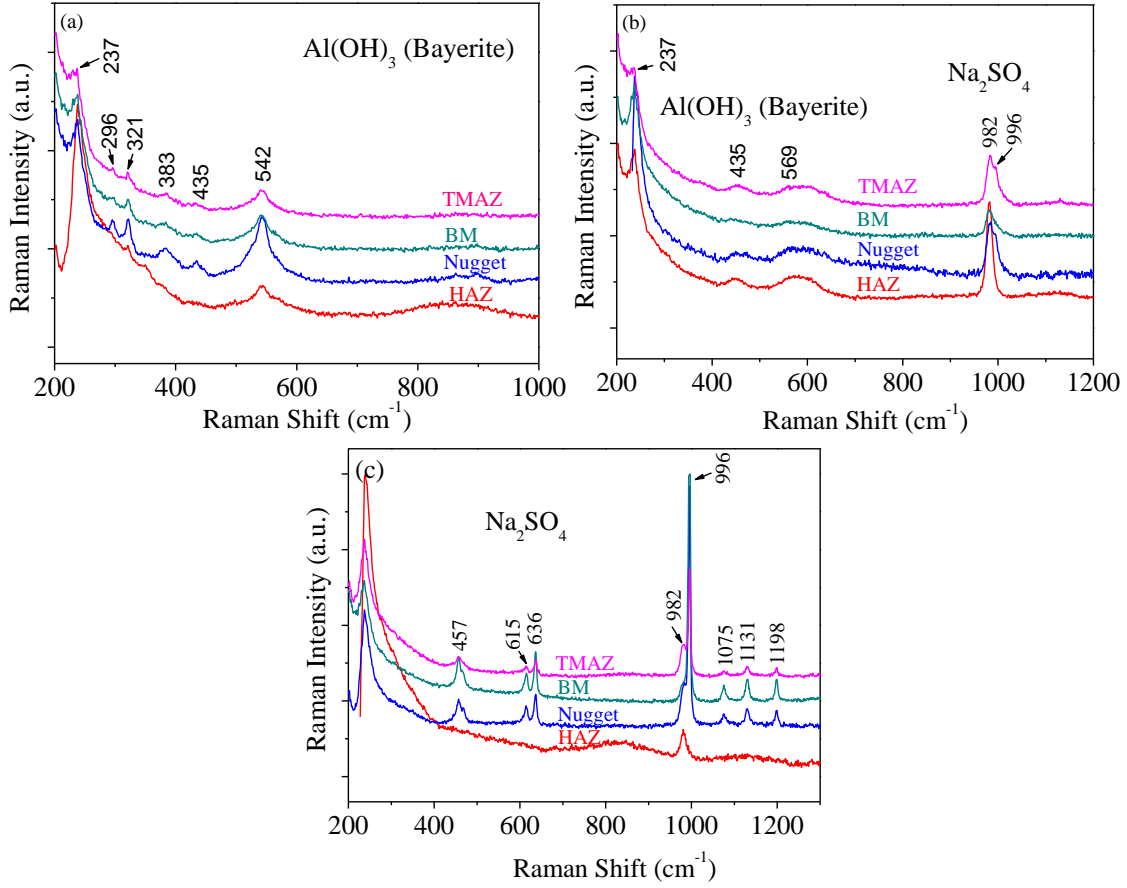
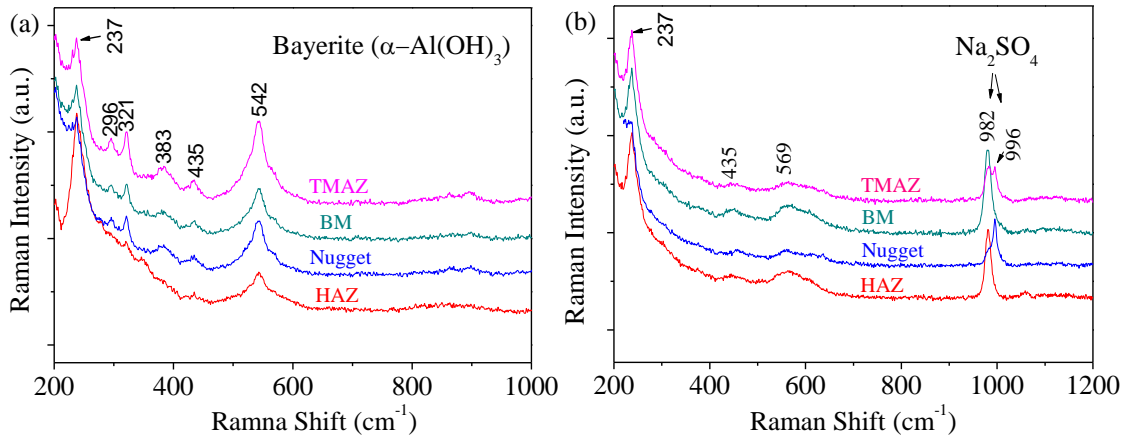
Fig. 10. Raman spectra obtained from the corrosion products on different zones in FSW-AA5086 after 90 days immersion in (a) 3.15 wt.% NaCl, (b) ASTM seawater, and (c) 0.5 M Na₂SO₄ solution.

Fig. 10 shows Raman spectra obtained from the corrosion products formed on different zones in FSW-AA5086 after 90 days immersion in 3.15 wt.% NaCl, ASTM seawater, and 0.5 M Na₂SO₄ solutions. Bayerite (α -Al(OH)₃) with characteristic Raman bands at 237, 296, 321, 383, 435, and 542 cm⁻¹ were detected from all zones in FSW-AA5086 immersed in 3.15 wt.% NaCl solution (Fig. 10a) [23]. Notice that the strong Raman band at 237 cm⁻¹ might be partially from system noise [24-26]. On the sample immersed in ASTM seawater (Fig. 10b), only weak Raman signal of α -Al(OH)₃ at 435 and 569 cm⁻¹ was detected. The sharp bands at 982 and 996 cm⁻¹ are from Na₂SO₄ (ruff.info) in the ASTM sea salt. On the sample immersed in Na₂SO₄ solution (Fig. 10c), only Raman signal of Na₂SO₄ (457, 615, 636, 996, 1075, and 1131 cm⁻¹) was observed and that from Al(OH)₃ was not detected.

prominent Raman bands of $\text{Al}(\text{OH})_3$ on samples immersed in ASTM seawater and 0.5 M Na_2SO_4 solutions is likely an indication of less corrosion products on these samples as compared to that on the sample immersed in NaCl solution. The Raman spectroscopic analysis agreed well with the SEM results and showed that more corrosion products (i.e., $\text{Al}(\text{OH})_3$) formed on FSW-AA5086 samples immersed in 3.15 wt.% NaCl solution than the other two solutions. Another agreement between the Raman analysis and SEM observation is that they all differentiate the HAZ from the other three zones on FSW-AA5086 immersed in 3.15 wt.% NaCl, in terms of the amount of corrosion products. This is evidenced by the two Raman bands at 296 and 321 cm^{-1} for Bayerite having the lowest intensities in the Raman spectra (Fig. 10a and Fig. 11a) from HAZ as compared to the other three zones.

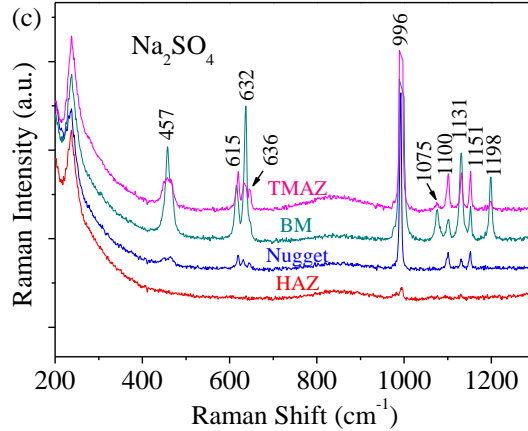
Fig. 11. Raman spectra obtained from the corrosion products on different zones in FSW-AA5086 after 120 days immersion in (a) 3.15 wt.% NaCl, (b) ASTM seawater, and (c) 0.5 M Na₂SO₄ solution.

Fig. 11 shows the Raman spectra obtained from different zones in FSW-AA5086 after 120 days immersion in 3.15 wt.% NaCl, ASTM seawater, and 0.5 M Na₂SO₄ solutions. Generally, the Raman spectra in Fig. 11 are similar to those shown in Fig. 10. One apparent difference is that the Raman bands in Fig. 11a are relatively stronger than those in Fig. 10a, indicating that more corrosion products (α -Al(OH)₃) formed on AA5086 after longer exposure. The absence of

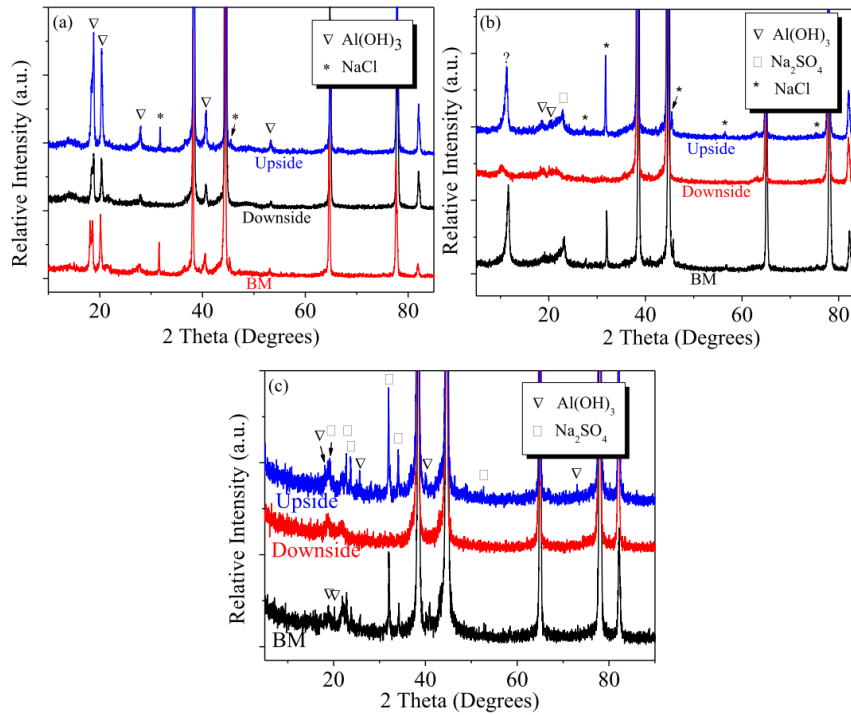
Fig. 12 shows the XRD patterns obtained from FSW-AA5086 samples immersed in the three solutions for 90 days. Notice that XRD patterns were collected from both the upside and downside of the FSW weld zone and the base metal with an area of approximately $1 \times 1 \text{ in}^2$. Fig. 12a shows strong peaks of $\alpha\text{-Al}(\text{OH})_3$ which indicates that a considerable amount of $\alpha\text{-Al}(\text{OH})_3$ formed on the samples immersed in NaCl solution. On the contrary, only extremely weak peaks of $\alpha\text{-Al}(\text{OH})_3$ were observed in Fig. 12b and c, implying the formation of small amounts of corrosion products. The XRD analysis generally agrees well with SEM and Raman results.

Fig. 12. XRD patterns obtained from FSW-AA5086 samples after 90 days immersion in (a) 3.15 wt.% NaCl, (b) ASTM seawater, and (c) 0.5 M Na₂SO₄ solution.

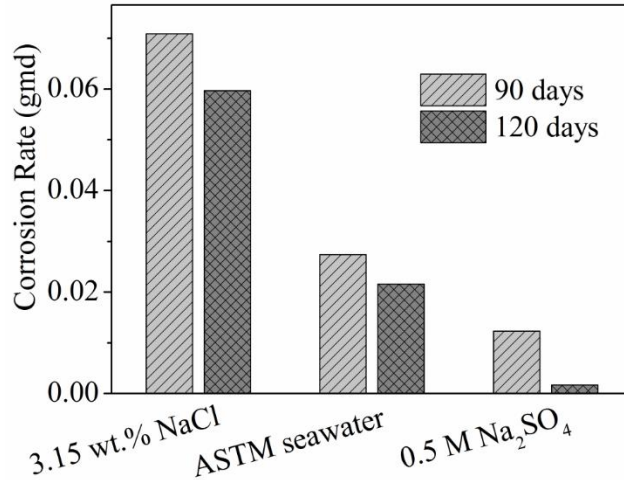
The corrosion rates of FSW-AA5086 immersed in the three different solutions for 90 and 120 days are shown in Fig. 13. The corrosion rates of FSW-AA5086 decreased from 90 days to 120 days in three solutions, which might be due to the main corrosion product Al(OH)₃ being protective to the substrate. The corrosion rates of FSW-AA5086 from the highest to the lowest for three solutions was as follows: 3.15 wt.% NaCl > ASTM seawater > 0.5 M Na₂SO₄, which agrees with SEM, Raman, and XRD results.

Fig. 13. Corrosion rates of FSW-AA5086 specimens after 90 and 120 days immersion in 3.15 wt.% NaCl, ASTM seawater, and 0.5 M Na₂SO₄ solution.
