Microstructure, mechanical properties and corrosion of friction stir welded 6061 Aluminum Alloy

Zhitong Chen*, Shengxi Li, Lloyd H. Hihara*

Hawaii Corrosion Laboratory, Department of Mechanical Engineering, University of Hawaii at Manoa, Honolulu, HI 96822, USA

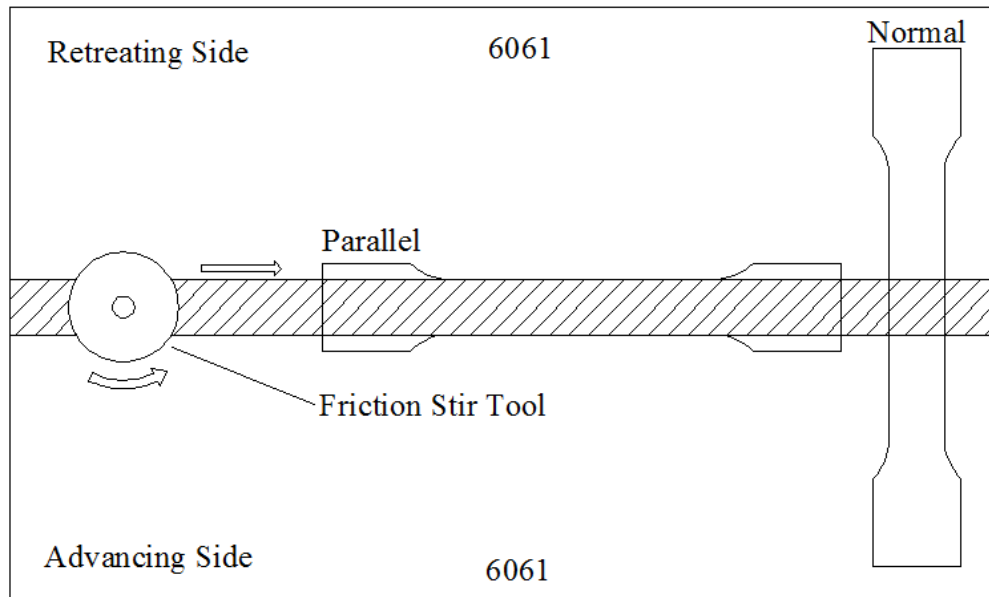
Fig.1 Schematic of the locations from where tensile test specimens were cut from (P-AA6061 (Longitudinal) and N-AA6061 (Transverse))

Instron-5500R testing machine. Tensile specimens were machined from the NZ in two directions from the weld: parallel (longitudinal) and normal (transverse). The configuration of the tensile specimens is shown in Fig. 1. An axial extensometer with 25 mm gage length was attached to the specimens at the gauge section. The strain analysis of each specimen was made by an ASAME automatic strain measuring system. The tensile properties of the joints were evaluated using three tensile specimens cut from the same joint.

As shown in Fig. 4, the elongation, yield strength, and tensile strength of the BM AA6061 were 12.1%, 242 MPa, and 276 MPa, respectively. By comparison, the two FSW specimens showed a significant decrease in both tensile and yield strength. Fig. 4 also show that the the ductility for tensile specimen P AA6061 significantly increased compared to that of the BM while that of specimen N-AA6061 decreased. As indicated in Fig.1, the tensile specimen P-AA6061 contained

only recrystallized grains from the NZ. From the hardness results, we know that the hardness values of the NZ were lower than that of the BM, possibly explaining why the longitudinal tensile specimen P-AA6061 exhibited both tensile and yield strength values. The transverse tensile specimens contained all four zones (i.e., BM, HAZ, TMAZ and NZ). The observed ductility was measured as average strain over the gage length, including the various zones that have different resistances to deformation due to differences in grain size and precipitate distribution. When a tensile load was applied to the joint, failure occurred in the weakest regions of the joint [31], which is the HAZ in this work.

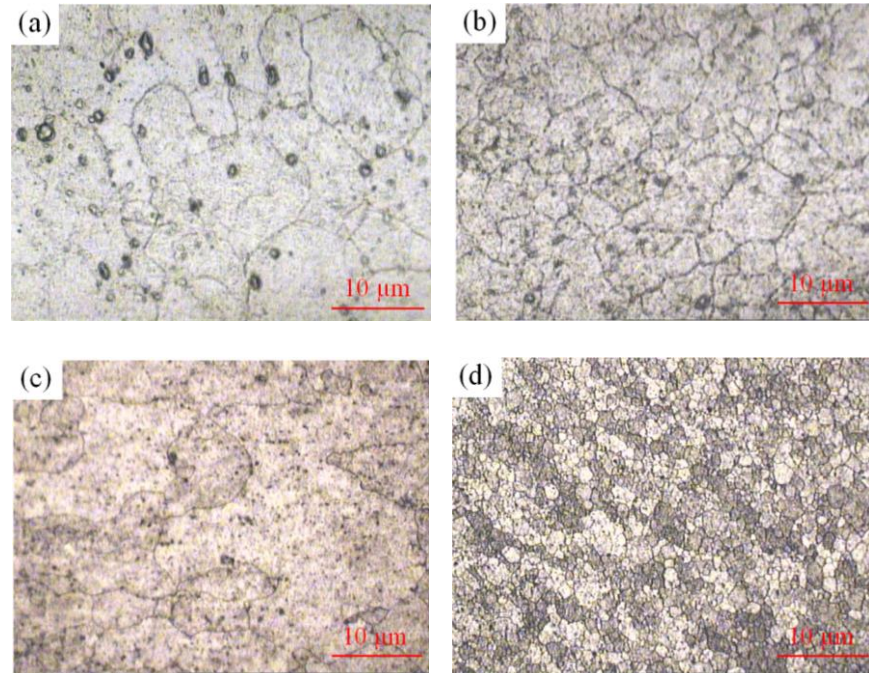
Fig. 2 Typical microstructures at different regions of FSW AA6061-AA6061 after etching with Keller's reagent: (a) HAZ, (b) TMAZ, (c) BM, and (d) NZ

Fig. 2 shows typical grain structures of different regions in FSW 6061-6061. The NZ consists of fine equiaxed grains due to dynamic recrystallization [25, 26]. The grains in NZ are much smaller than those in other regions. The average grain size in the four zones in follows the order of $BM > HAZ > TMAZ > NZ$. In the TMAZ which is adjacent to the NZ, the strain and the temperature were lower than in the NZ and the effect of welding on the microstructure was correspondingly smaller. Unlike NZ, the microstructure was recognizably that of the parent material, although significantly deformed and rotated. The grain size of the HAZ was similar to that of the BM. The HAZ was common to all welding processes subjected to a thermal cycle, but it was not deformed during welding.

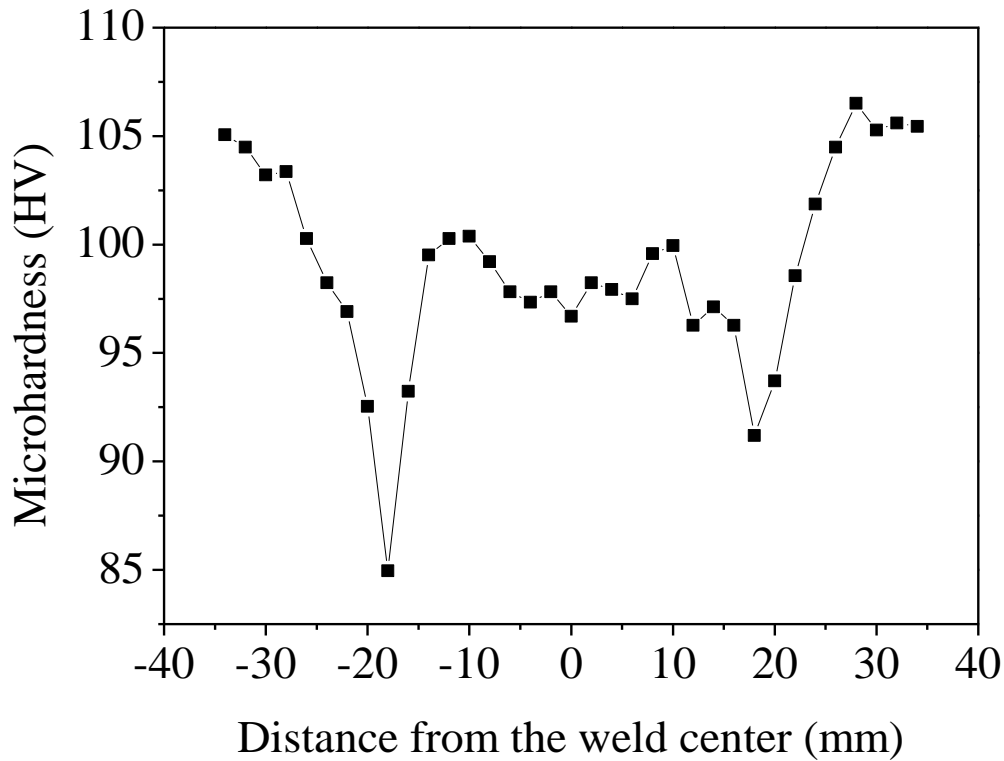
Fig. 3 Microhardness distribution across the top surface of FSW AA6061-AA6061 measured with a 2 mm step

Fig. 3 shows the typical microhardness distribution across the top surface of FSW AA6061-AA6061. The hardness curve is asymmetrical with respect to the weld centerline because the plastic flow field in the two sides of the weld center is not uniform [27, 28]. The larger distorted grains and distortion energy causes the strain-hardness to increase, resulting in the asymmetrical microhardness distribution. The minimum hardness of 85.0 HV was obtained in the HAZ region, suggesting that the tensile specimens are prone to fracture in this zone. The maximum value was present in the BM. The hardness of the TMAZ was higher than that of the NZ. However, according to the Hall-Petch relationship [29], the hardness value in the NZ should be higher than

other zones because of its fine equiaxed grain structure. . The reason for the NZ having lower hardness values than those in TMAZ is possibly due to the thermal history of the FSW AA6061-AA6061 which creates a softened region around the weld center. The possible reasons for softening are that the thermal cycle of FSW causes strengthening precipitates to coarsen or dissolve. To analyze the hardness, the Orowan mechanism, which is based on the impediment of dislocation movement around small precipitates inside grains, may over shadow the Hall-Petch mechanism, which is based on grain size [29, 30].

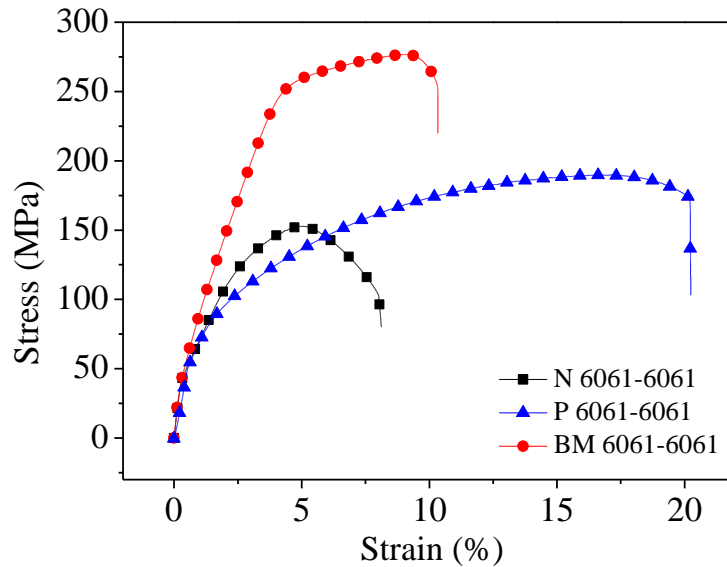
Fig. 4 Tensile properties of BM and two FSW specimens cut from different orientations (P: parallel, N: normal, see Fig. 1).

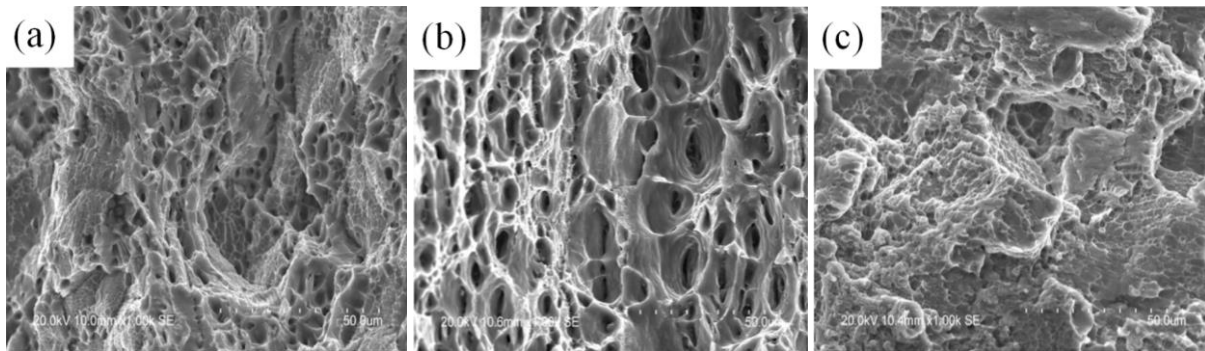
Fig. 5 SEM fractographs of BM and two directions (Transverse and Longitudinal) FSW specimens: (a) BM AA6061-AA6061, (b) T AA6061-AA6061 (Failure occurred in HAZ), and (c) L AA6061-AA6061 (Failure occurred in Weld Zone)

Fig. 5 shows the fracture surfaces of tensile specimens characterized by SEM. The tensile fractures of L AA6061-AA6061 presented a 45° angle shear fractures along the tensile axis, while BM AA6061-AA6061 and T AA6061-AA6061 (failure occurred in HAZ) presented a 90°. The fracture surfaces of T AA6061-AA6061 and L AA6061-AA6061 showed obvious necking/plastic deformation except the BM AA6061. The fractographs reveal dimple fracture patterns with teared edges full of micropores. The dimples were of various sizes and shapes. . Compared to L AA6061-AA6061, T AA6061-AA6061 had deeper dimples and thinner teared

edges. Therefore, the L AA6061-AA6061 exhibited much better mechanical properties than did the BM AA6061. Thus, the longitudinal direction FSW specimens have much better mechanical properties than do the transverse direction specimens.

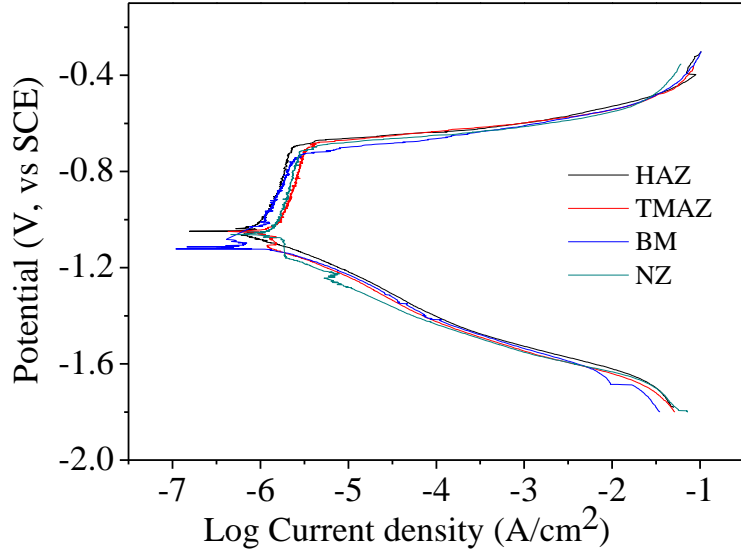
Fig. 6 Polarization curves of different weld zones of FSW AA6061-AA6061 in deaerated 3.15 wt% NaCl solutions

Fig. 6 shows polarization curves of different weld zones of FSW AA6061-AA6061 in deaerated 3.15 wt% NaCl solutions. All four samples showed passive region with current density in the

range of 10^{-6} and $10^{-5.5}$ A/cm². Compared to the BM, the three samples from weld zones had higher E_{corr} and E_{pit} values and lower I_{corr} values (Table 1), indicating that the corrosion resistance was improved by FSW. The order of corrosion potential for samples from different zones was as follows: HAZ (-1048 mV_{SCE}) > TMAZ (-1049 mV_{SCE}) > NZ (-1063 mV_{SCE}) > BM (-1114 mV_{SCE}). For the E_{pit} , the order was as follows: TMAZ (-685 mV_{SCE}) > HAZ (-692 mV_{SCE}) > NZ (-719 mV_{SCE}) > BM (-724 mV_{SCE}). For I_{corr} , the values from highest to lowest were as follows: BM (2.44 μA/cm²) > NZ (2.29 μA/cm²) > TMAZ (1.54 μA/cm²) > HAZ (0.76 μA/cm²). The dissolution of finer precipitates occurred both in the NZ and the downside. The coarsening of precipitates in the TMAZ and HAZ could be the reason for the improved corrosion resistance [32].

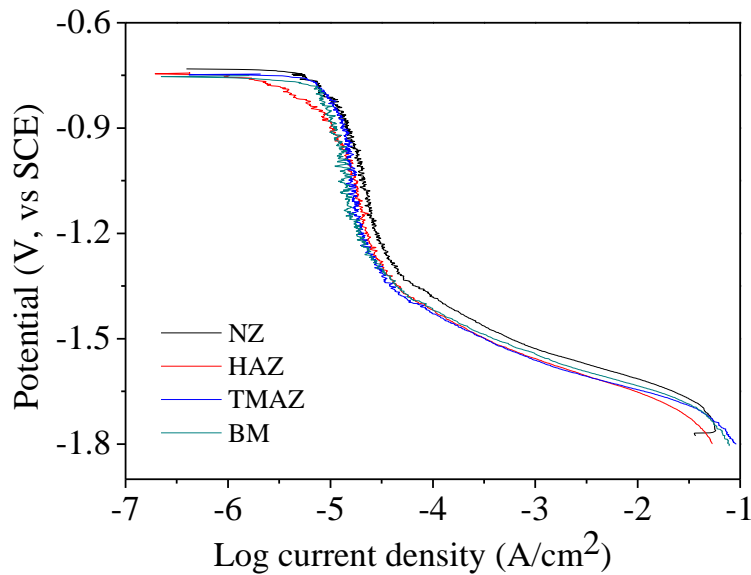
Fig. 7 Cathodic polarization curves of different weld zones of FSW AA6061-AA6061 in aerated 3.15 wt% NaCl solutions

Fig. 7 shows cathodic polarization diagram of various weld zones of FSW AA6061-AA6061 in aerated 3.15 wt% NaCl solutions. In aerated 3.15 wt% NaCl, different weld zones of FSW AA6061-AA6061 showed diffusion-limited oxygen reduction, which was different from FSW AA5086-AA5086 (references?). The E_{corr} and I_{corr} values of the various weld zones of FSW AA6061-AA6061 in aerated 3.15 wt% NaCl solutions are shown in Table 2. The E_{corr} values of HAZ (-742 mV_{SCE}), TMAZ (-746 mV_{SCE}), and NZ (-731 mV_{SCE}) shifted to more positive values from that of the BM (-750 mV_{SCE}). The E_{corr} values were also different from those for FSW AA5086-AA5086 (references?). The I_{corr} values decreased from that of the BM (8.57 $\mu\text{A}/\text{cm}^2$). These results show that FSW improved the corrosion resistance of welded AA6061-AA6061.

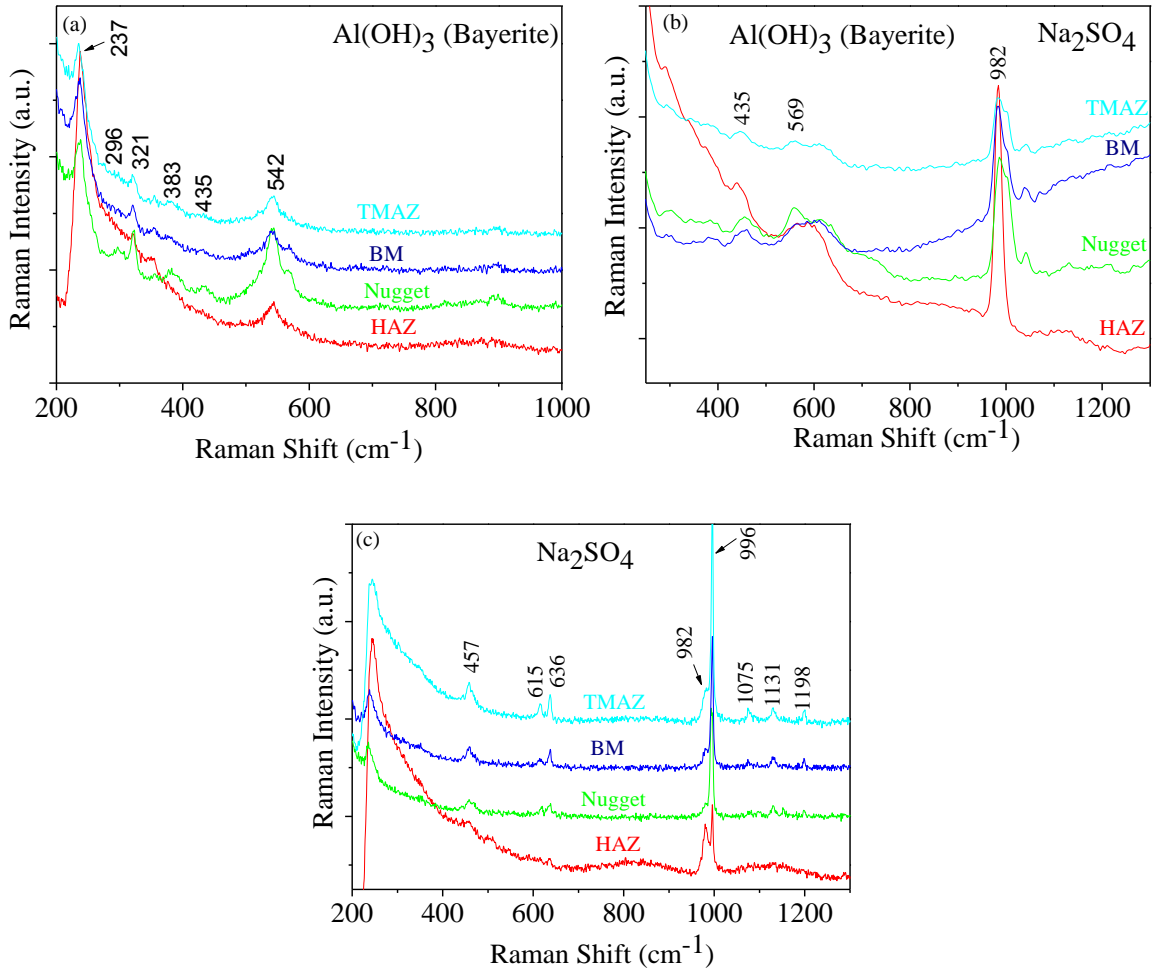
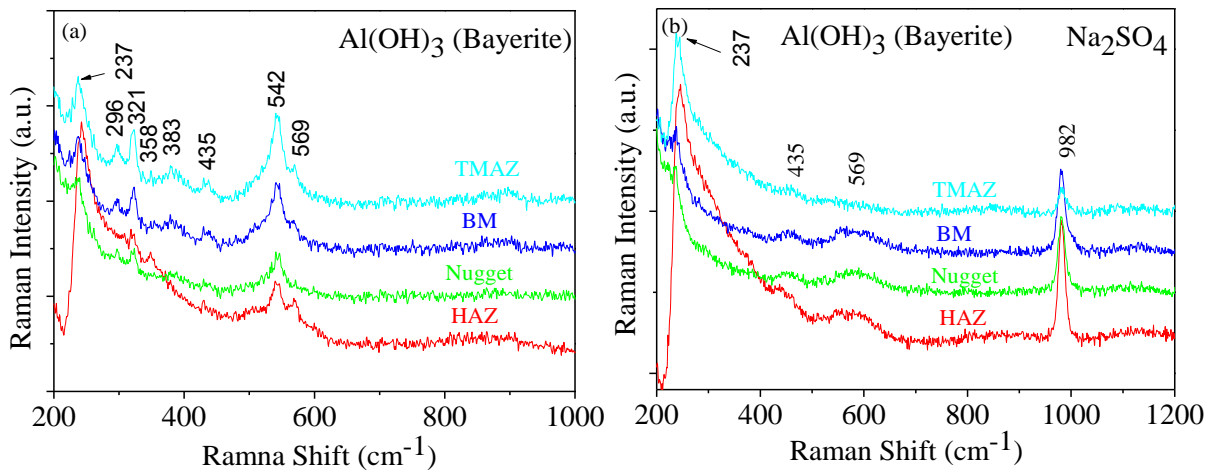
Fig. 8 Raman spectra of the corrosion products formed in distinct zones of FSW AA6061-AA6061 after 90 days immersion in: (a) 3.15 wt% NaCl, (b) ASTM seawater, and (c) 0.5 M Na₂SO₄ solution.

Figs. 8 and 9 show Raman spectra of the corrosion products formed in distinct zones of FSW AA6061-AA6061 after 90 and 120 days immersion in 3.15 wt% NaCl, ASTM seawater, and 0.5 M Na₂SO₄ solution, respectively. Al(OH)₃ was identified as the corrosion products formed on samples (from all FSW regions) that were immersed in 3.15 wt% NaCl for both 90 and 120 days (Fig. 8a and Fig. 9a). The Raman intensities of characteristic bands increased as the immersion time increased from 90 to 120 days. Raman spectra from samples immersed in ASTM seawater (Fig. 8b and Fig. 9b) show strong bands of Na₂SO₄ (982 cm⁻¹) and relatively weak bands of Al(OH)₃ (435 and 459 cm⁻¹). A characteristic band (237 cm⁻¹) of was found only in Fig. 9b. In Fig. 8(c), the characteristic bands of Na₂SO₄ (457, 615, 636, 982, 996, 1075, 1131, and 1151 cm⁻¹) were observed on the TMAZ, BM, and NZ, while only characteristic bands of Na₂SO₄ (982 and 996 cm⁻¹) were observed in the HAZ. As shown in Fig. 8 (c), the bands that were not marked were ghost band [33-35]. Raman bands of Al(OH)₃ for FSW AA6061-AA6061 after immersion 90 days in 0.5 M Na₂SO₄ solution were missing because the amount of corrosion products may have been insufficient to generate Raman peaks. As shown in Fig. 9(c), characteristic bands of

The SEM images of five regions of FSW 6061-6061 after 90 days immersion in 0.5 M Na₂SO₄ solution are shown in Fig. 10. The EDXA analysis depicted in Table 3 revealed that the corrosion products had high contents of oxygen and aluminum. According to the Raman spectra in Fig. 8c, the white particles on the surface of the TMAZ, BM, and NZ were Na₂SO₄. Cracks were also observed in the HAZ (Fig. 10c) and formed as a result of cathodic reduction [4]. Cathodic reduction on the constituent particles can increase the alkalinity in the surrounding solution, leading to the dissolution of the aluminum matrix. SEM/EDXA results agree well with those from the Raman analysis (Fig. 8c).

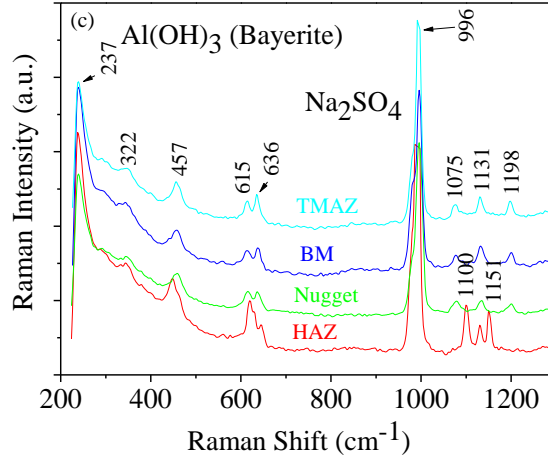
Fig. 9 Raman spectra of the corrosion products formed in distinct zones of FSW AA6061-AA6061 after 120 days immersion in: (a) 3.15 wt% NaCl, (b) ASTM seawater, and (c) 0.5 M Na₂SO₄ solution

$\text{Al}(\text{OH})_3$ (237 , 322 , and 457 cm^{-1}) and Na_2SO_4 (615 , 636 , 996 , 1100 , 1131 , and 1151 cm^{-1}) were observed in four regions, a finding that tells us that the amount of $\text{Al}(\text{OH})_3$ increased for FSW 6061-6061 coupons immersed in $0.5\text{ M Na}_2\text{SO}_4$ solution from 90 to 120 days. There were also characteristic bands (1075 and 1198 cm^{-1}) that cannot be identified.

Fig. 11 shows the SEM images of four regions (NZ, TMAZ, HAZ, and BM) of FSW 6061-6061 after 90 days of immersion in 3.15 wt% NaCl. EDXA quantification results shown in Table 4 reveal high concentrations of oxygen and aluminum, which agrees well with the Raman results (Fig. 9 c). The main corrosion product on the four regions was $\text{Al}(\text{OH})_3$. As shown in Fig. 11, there was more corrosion product in the TMAZ, BM, and NZ than in the HAZ, which means that the corrosion resistance of the HAZ was better than the TMAZ, BM, and NZ. The low corrosion on the NZ could be caused by the microstructure or the specimen orientation.

Fig. 12 showed SEM of NZ of FSW AA6061-AA6061 after 120 days immersion in 3.15 wt% NaCl, ASTM seawater, and 0.5 M Na₂SO₄ solution. According to Raman analysis (Fig. 9), the corrosion products on the surface of the coupon immersed in 3.15 wt% NaCl and ASTM seawater was Al(OH)₃. A denser layer of corrosion products appeared to cover the coupon exposed in the NaCl solution (Fig. 12a) as compared to the coupon exposed in ASTM seawater (Fig. 12b). The oxygen concentration of the two locations shown in Fig. 12a (NaCl solution) was also higher than that in Fig. 12b (ASTM seawater). As shown in Fig. 12c, cracking on the surface of the specimen exposed to the 0.5 M Na₂SO₄ solution was also found. The cracks are likely to be in the aluminum oxide corrosion layer.

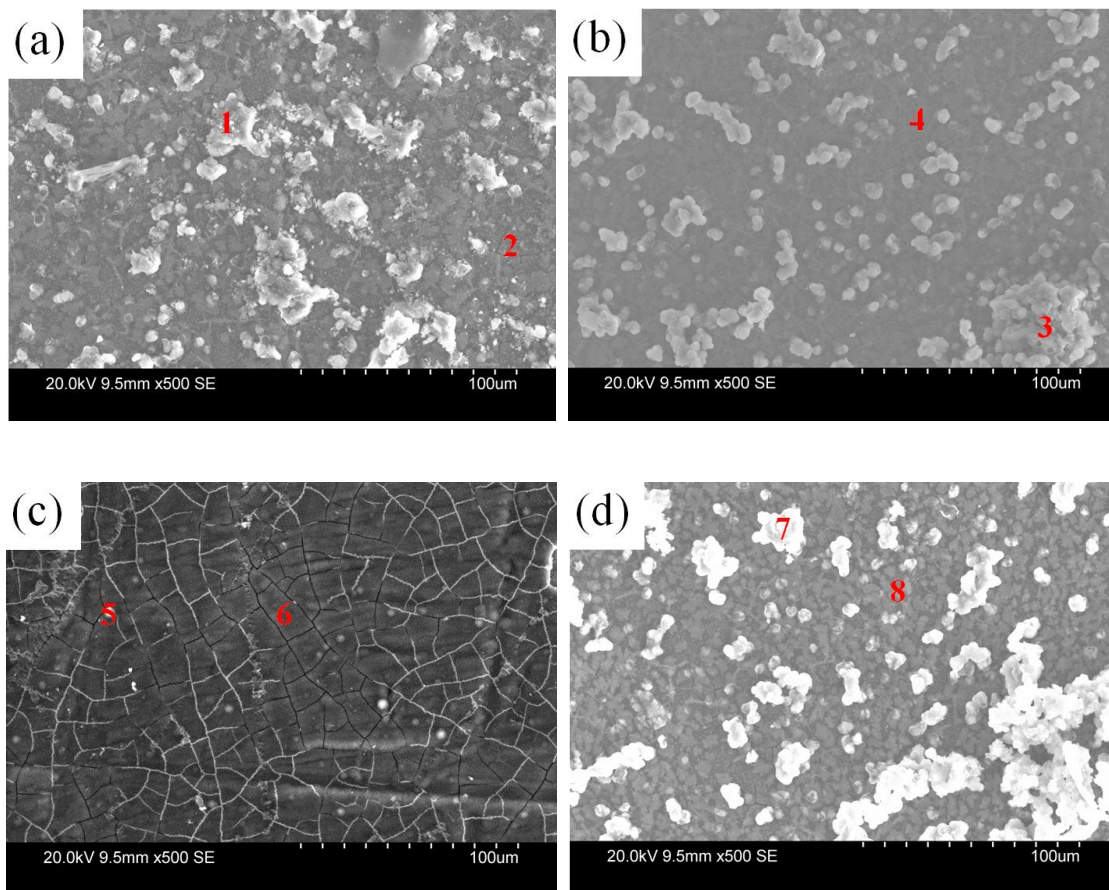
Fig. 10 SEM images of FSW AA6061-AA6061 after 90 days of immersion in $0.5\text{ M Na}_2\text{SO}_4$: (a) NZ, (b) TMAZ, (c) HAZ, and (d) BM

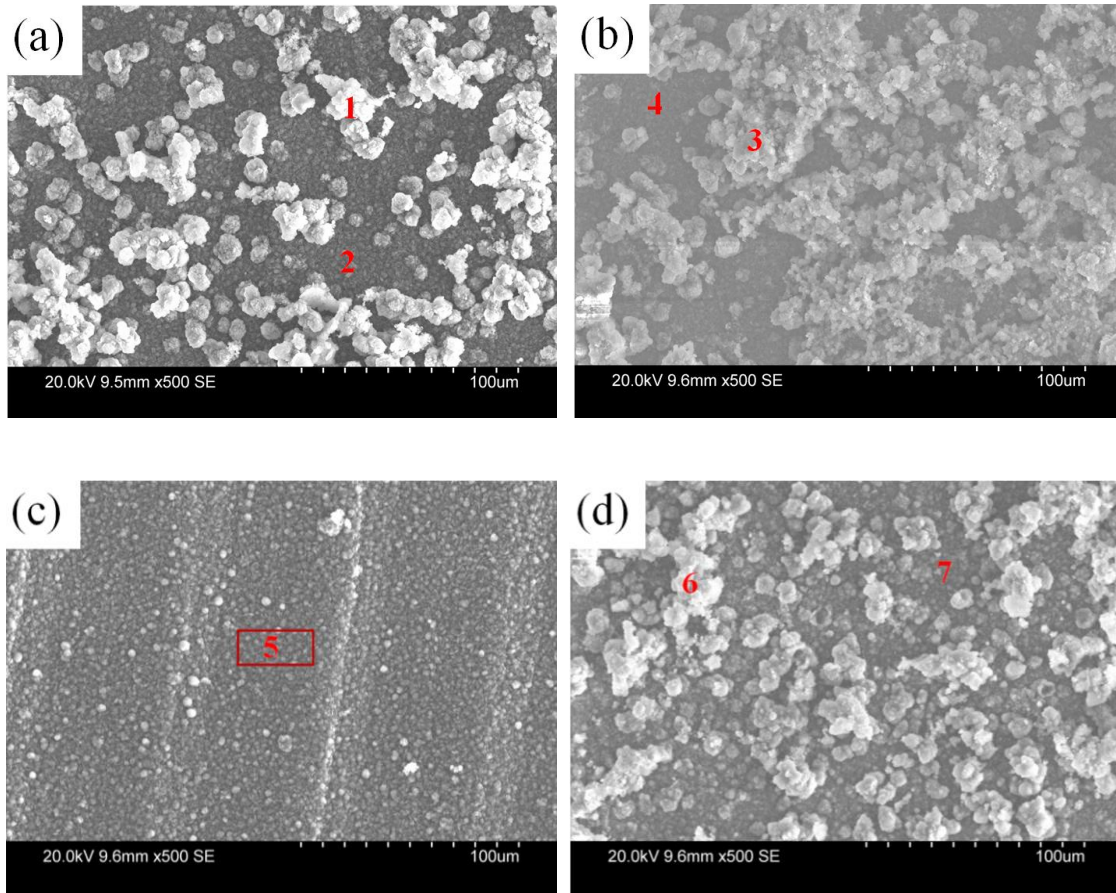
Fig. 11 SEM images of FSW AA6061-AA6061 after 90 days of immersion in 3.15 wt% NaCl: (a) NZ, (b) TMAZ, (c) HAZ, and (d) BM

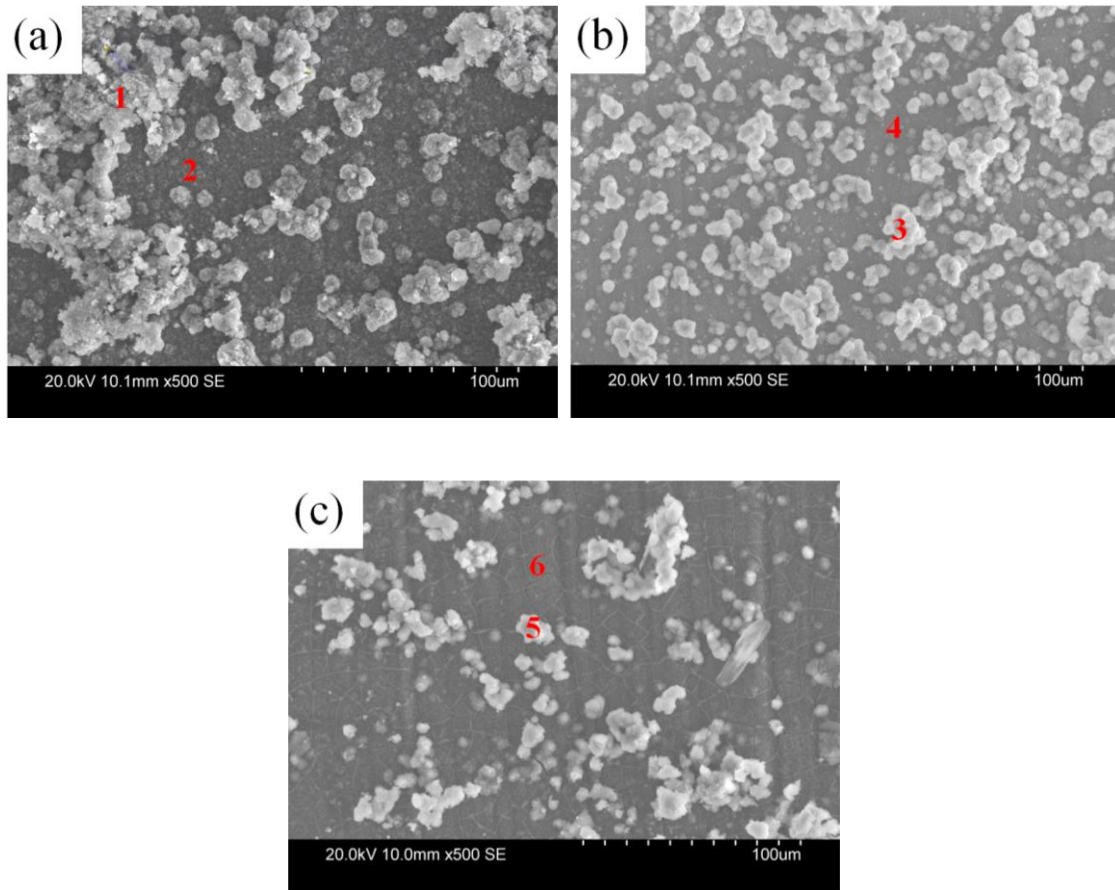
Fig. 12 SEM images of NZ of FSW AA6061-AA6061 after 120 days immersion in (a) 3.15 wt% NaCl, (b) ASTM seawater, and (c) 0.5 M Na_2SO_4 solution

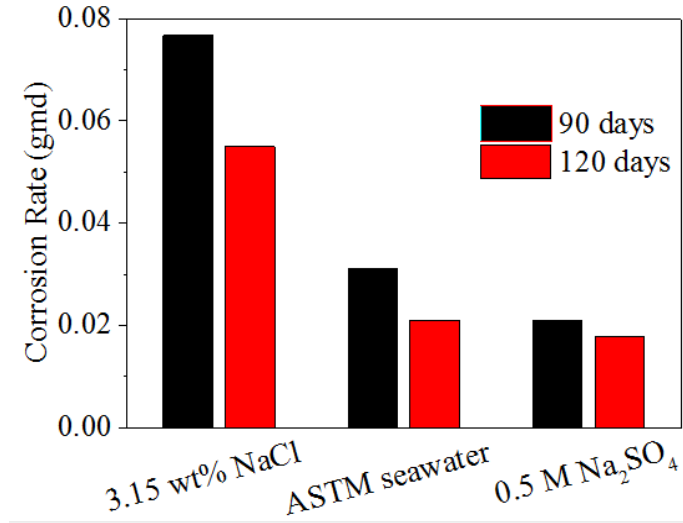
Fig. 13 Corrosion Rate of specimens after 90 and 120 days immersion in 3.15 wt% NaCl, ASTM seawater, and 0.5 M Na₂SO₄ solution for FSW AA6061-AA6061

The results of corrosion rate FSW AA6061-AA6061 by weight measurement were shown in Fig. 13. The corrosion rate of FSW AA6061-AA6061 decreased from 90 days to 120 days in three solutions. The corrosion rate from highest to lowest for three solutions was as follows: 3.15 wt% NaCl > ASTM seawater > 0.5 M Na₂SO₄. The maximum value of corrosion rate was obtained in 3.15 wt% NaCl solution after 90 days immersion.
