Performance-defining properties of Nb₃Sn coating in SRF cavities

Abstract. Nb₃Sn has great potential to become the material of choice for fabrication of SRF cavities. The higher critical temperature of Nb₃Sn potentially allows for an increased operational temperature in SRF cavities, which could

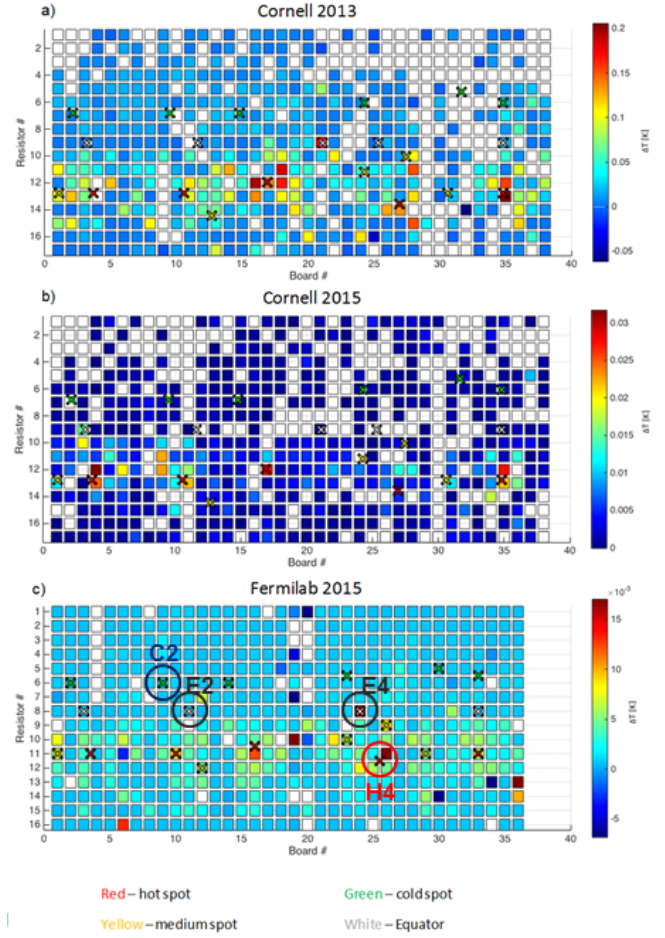
Figure 1. Temperature maps showing excessive heating in one half cell (regions below resistor 9 on the Cornell T-map and below resistor 8 on the Fermilab T-map). First measurements were taken at Cornell in 2013 (a) then new studies were performed in 2015 at Cornell (b) and FNAL (c).

1.3 GHz single cell Nb cavity coated with Nb_3Sn (ERL1-5) at Cornell University [8] had been RF characterized at Cornell in 2013 and at Fermilab in 2015 (Fig.1). The first cavity coated under Cornell's program [9], ERL1-5 demonstrated significantly degraded performance compared to the cavities which had been Nb_3Sn -coated afterwards. Temperature map shows

Temperature maps indicate that the half-cell with the unusually shiny appearance has large regions with far a higher surface resistance than is observed in the other half cell. The intention of repeated RF characterization at Fermilab was to map out well the surface resistance of the cavity, so that the “hot” and “cold” regions could be identified with a high degree of confidence. T-map was measured at 9 MV/m at 4.2 K at Fermilab. Coupons located at these hot and cold spots were subsequently cut out from the cavity. Cutouts were in a 1cm diameter, circular shape. Two cutouts were depicted for the analysis. Spot marked as “H4” on the temperature map, was taken from the shiny half-cell as representative of strongly dissipating region (referred as hot spot). “C2” on the temperature map indicates the location of non-dissipating cold spot taken from the matte half-cell (Fig.1c). Fig.2a and b shows optical images of cold cutout (C4) and hot cutout (H1), respectively.

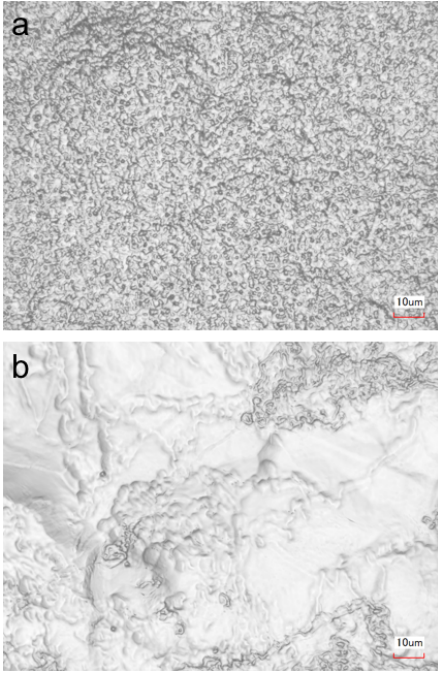
Figure 2. Images of (a) cold and (b) hot cutouts from optical microscope.

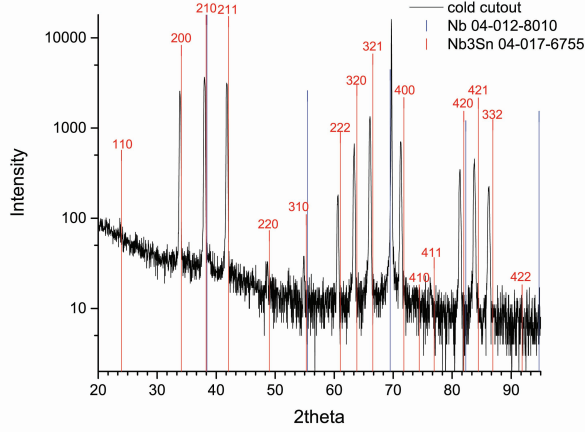
Figure 3. XRD of cold cutout taken with Pananalytical/Philips X'pert². Red and blue markers indicated positions of the reference peaks for Nb_3Sn and Nb, respectively.

Structural characterization of ERL1-5 cavity cutouts was initiated in order to confirm A15 Nb_3Sn structure of the coating and the absence of non-stoichiometric phases, such as Nb_6Sn_5 . XRD taken with medium resolution X’pert² diffractometer showed A15 Nb_3Sn structure (PDF 04-017-6755) in both, cold and hot cutouts. Fig.3 demonstrates data for cold cutout as an

example. Due to the relatively large probing depth of XRD, Nb substrate signal is also present (PDF 04-012-8010). XRD confirmed the absence of non-A15 phases in the coating. Lattice constant of Nb_3Sn in cold cutout was estimated to be 5.2889 Å. Lattice constant of Nb_3Sn in hot cutout is 5.2901 Å. According to the previous measurements [10], lattice constants for both cutouts translate into Sn content in the desired range of 24-25 at.%. Wavelength-dispersive spectroscopy (WDS) (not shown here) on cold cutout supports this assumption, demonstrating Sn content of 25 at.%.

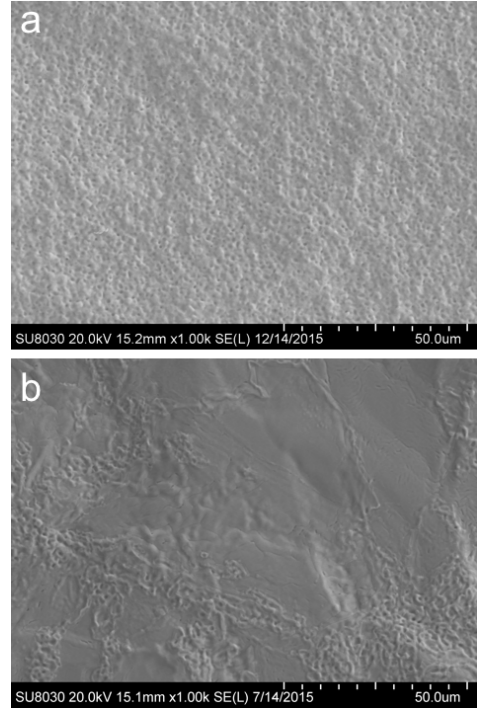
Figure 4. SEM images of (a) cold and (b) hot cutouts.

SEM images in Fig.4a and b demonstrate the surface of the coating in cold and hot cutouts, respectively. Cold cutout is uniformly covered with micron-sized Nb_3Sn grains. Hot cutout, on the other hand, shows “patchy” regions surrounded by the areas of uniform coating with an appearance similar to the cold cutout surface. EDS maps of cold cutout taken at the incident accelerating electron voltage of 20 kV are highly uniform and completely featureless (not shown here), demonstrating lateral and in-depth uniformity for Sn and Nb. Sn content from EDS maps was estimated to 24-25 at.%. Since Sn content estimation from EDS agrees well with WDS measurements at the same accelerating voltage, as well as with XRD, we can conclude at an accelerating voltage of 20kV most of EDS signal is coming from within the coating.

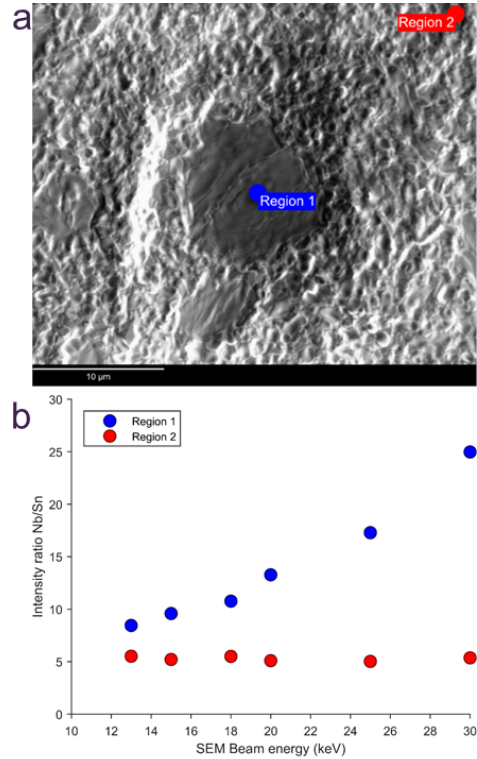
Figure 5. (a) SEM image of Nb_3Sn coating taken at Cornell University; (b) Niobium to tin intensity in two regions of the surface vs. SEM incident beam energy.

Fig.5a shows SEM picture of the typical patchy region taken at Cornell University. Fig.5b summarizes the incident voltage varying experiment. Niobium to tin ratio in the patchy region (Region 1) increases with an incident beam energy, since contribution of niobium from the substrate increases. Niobium to tin ratio outside the patchy region (Region 2) remains constant with an increase in beam energy, since EDS interaction volume is concentrated within the thickness

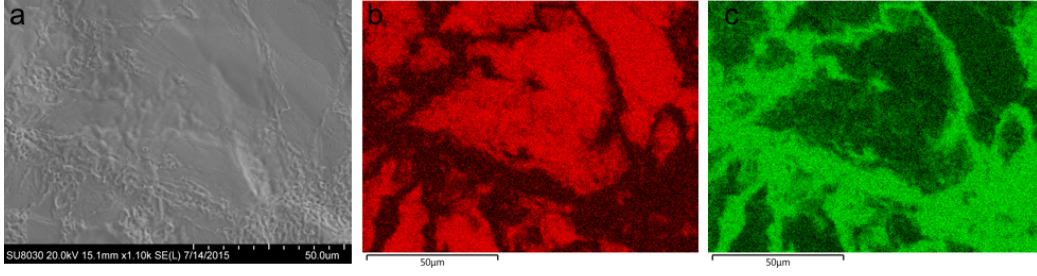
Figure 6. (a) SEM image of hot cutout with corresponding (b) Nb and (c) Sn maps at 20 kV.

The appearance of the Nb_3Sn coating surface in the hot cutout is very different, compared to the cold one. Fig.6 shows SEM image and corresponding Sn and Nb EDS maps of hot cutout taken at accelerating voltage of 20kV. Patchy regions show significantly

reduced Sn content (darker contrast in Sn map) and elevated Nb concentration (brighter contrast in Nb map). Reduced Sn signal in EDS map can indicate either significantly reduced Sn concentration in the coating which no longer supports A15 structure or variation in thickness of the coating itself.

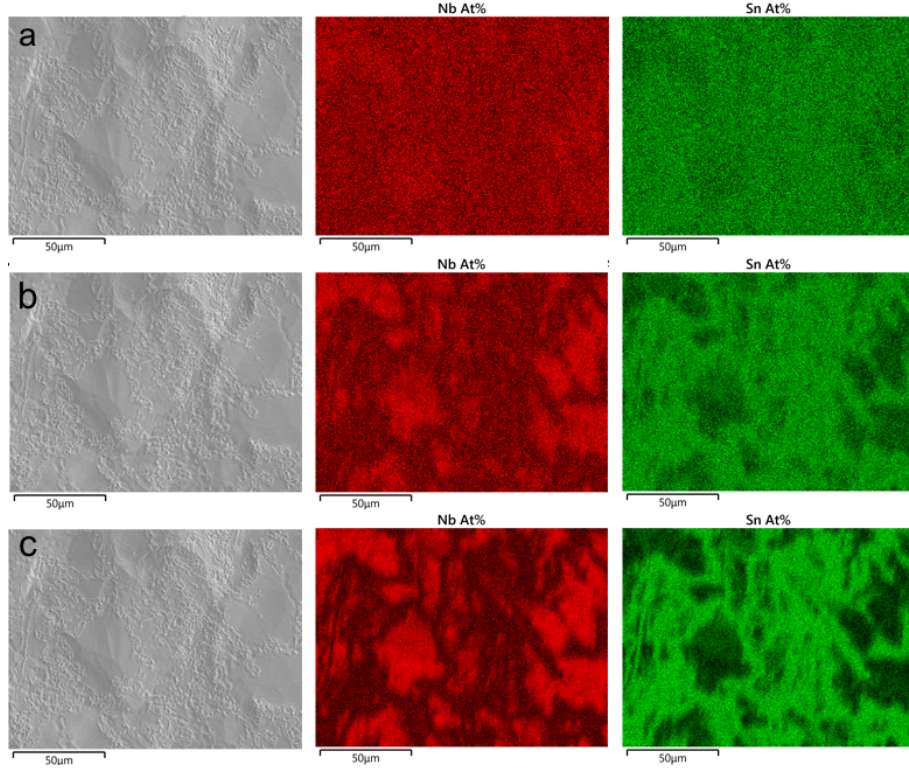
Figure 7. SEM images and EDS maps of Sn and Nb taken from the same spot on hot cutout at (a) 10KV, (b) 15 kV, and (c) 20 kV.

By varying the incident electrons accelerating voltage in SEM, one can change probing depth for EDS signal. Fig.7 demonstrates the result of changing the accelerating voltage. As we increase incident electron voltage, EDS probes a thicker surface layer. Most of the EDS signal comes from within hot cutout's coating at the lowest voltage of 10 kV, as can be seen from Fig.7a. Sn concentration taken from the map which was acquired at 10 kV, is close to 24 at.%. Much lower Sn and higher Nb content in maps taken at 15

kV and 20 kV (Fig.7b and c, respectively) indicates that the EDS signal comes not only from the coating but also from Nb underneath. Comparing Fig.7a with Fig.7b and c, we can conclude that Nb_3Sn coating in the patchy regions in hot cutout is much thinner than in cold one. The hot cutout shows significant variation in Nb_3Sn coating thickness across the whole area.

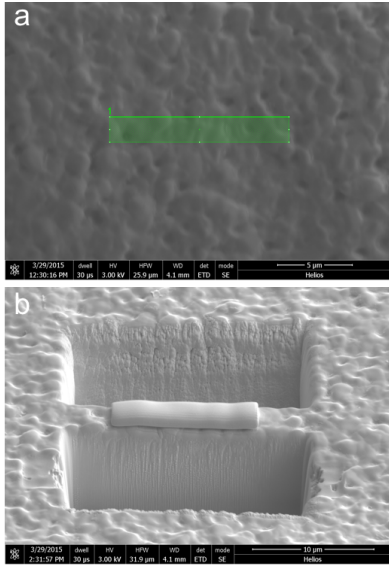
Figure 8. SEM image of Nb_3Sn coating in cold cutout (a) prior to FIB sample preparation, (b) with trenches around the cross-sectional cut.

Cross-sectional TEM samples had been prepared from cold and hot cutouts to evaluate Nb_3Sn coating thickness directly (Fig.8). Fig.9a and b demonstrates TEM bright field (BF) images of cold and hot cutouts, respectively. Hot cutout FIB sample was taken from the patchy region of the surface which has thinner coating according to SEM studies. Difference in Nb_3Sn coating thickness in cold and hot cutout is obvious when looking at TEM cross-sectional images. Nb_3Sn coating is about $2\mu\text{m}$ thick in cold cutout and in the order of only $0.1\mu\text{m}$ in the thinnest regions of hot cutout. More than 10 times difference in Nb_3Sn thickness can be noticed comparing cold and hot cutouts.

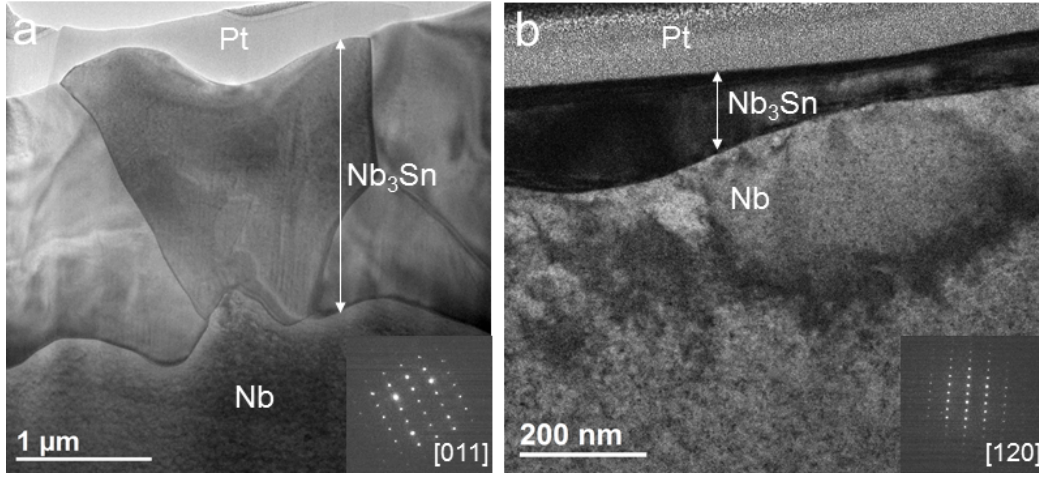
Figure 9. Bright Field image of FIB sample prepared from (a) cold and (b) hot cutouts with corresponding NED patterns.

The strong Q-slope observed in ERL1-5 cavity could be explained by the presence of thin Nb_3Sn coating regions in the highly dissipating half-cell. Coating thickness less than magnetic field penetration depth (about 100nm for Nb_3Sn) leads to superconducting current passing through Nb substrate and Nb_3Sn -Nb interface. Large surface of one half-cell affected by unacceptably thin coating causes significant dissipation which most probably resulted in Q-slope.

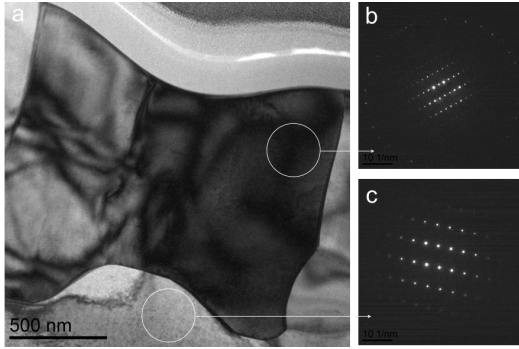
Figure 10. (a) BF image of Nb_3Sn coated sample's near-surface; (b) NED taken from within Nb_3Sn grain, $[120]$ Nb_3Sn zone axis; (c) NED taken below the coating, Nb $[113]$ zone axis.

It is worth mentioning that microstructure of Nb_3Sn coating in cold cutout is similar to the coating produced in the flat sample (Fig.10) which was coated in the same experimental setup at Cornell University.

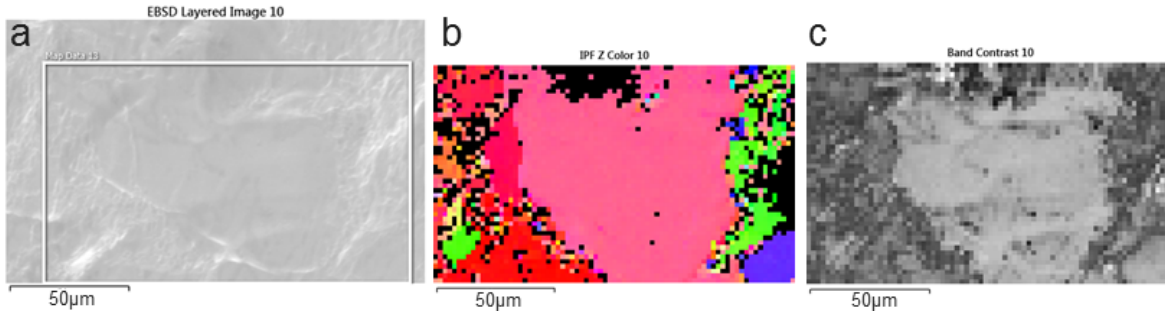
Figure 11. (a) SEM image of the patchy region on hot cutout surface; (b) Inversed Pole Figures (IPF) colors; (c) Band contrast.

from EBSD taken from one of the patchy regions in the surface of hot cutout (Fig.11), the entire thin (patchy) region is a single Nb_3Sn grain of about $100\mu\text{m}$ in diameter. Our conclusions are supported by the analysis of 5 additional TEM samples prepared from cold cutout and 2 additional TEM samples from hot cutout. Fig.9a shows contrast variation in the center of the largest grain which looks like a presence of some domain. Appearance of intragrain domains in cold cutout will be explored in the sections below.

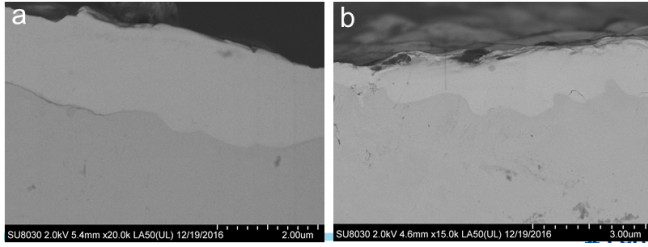
Figure 12. Backscattered images of cross-sectional SEM samples prepared from (a) cold cutout, (b) hot cutout.

In order to directly compare thickness of the coating over the area much larger than TEM sample dimensions, cross-sectional samples were prepared from cold and hot cutouts Fig.12. Hot sample demonstrates rapidly changing, wavy Nb_3Sn /Nb interface which was definitely not induced by Nb substrate. Cause of such peculiar interface line will be investigated in future studies.

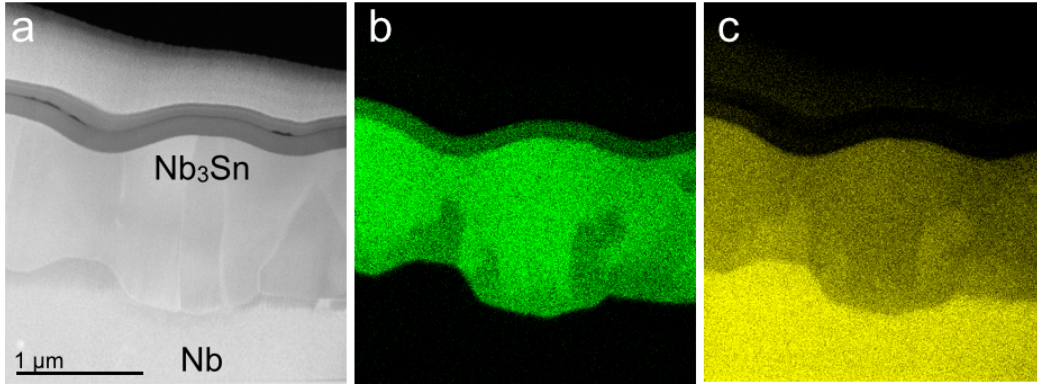
Figure 14. (a) Z-contrast image of the near-surface of the Nb_3Sn coated Nb sample; (b) EDS map for Sn; (c) EDS map for Nb.

Local composition of Nb_3Sn coating in both cutouts and flat sample was explored with STEM/EDS mapping. Fig.14a shows a Z-contrast image of the flat sample's near-surface. EDS maps of Sn and Nb distribution in the near-surface are represented in Fig.14b and c, correspondingly. Sn map of the near-surface shows several areas with decreased signal intensity in the Nb_3Sn coating. Decreased Sn intensity areas are few hundred nm in size and are located close to the interface between Nb_3Sn and Nb. Decrease in Sn signal intensity in the EDS map can be observed due to either a thinner region of the sample or deficiency of Sn in this particular area. If the thickness variation would be the case, the Nb map would show the same areas of decreased Nb signal intensity. However the Nb map shows brighter regions in Nb_3Sn coating which

indicates higher Nb content. Also no obvious thickness variation can be observed in corresponding STEM image of the area. Estimations of the Sn concentration difference between normal and Sn-deficient areas show the difference of 7 to 8 at. %, regardless of the model used for EDS quantitative evaluation. Sn-deficiency do not mimic individual Nb_3Sn grains.

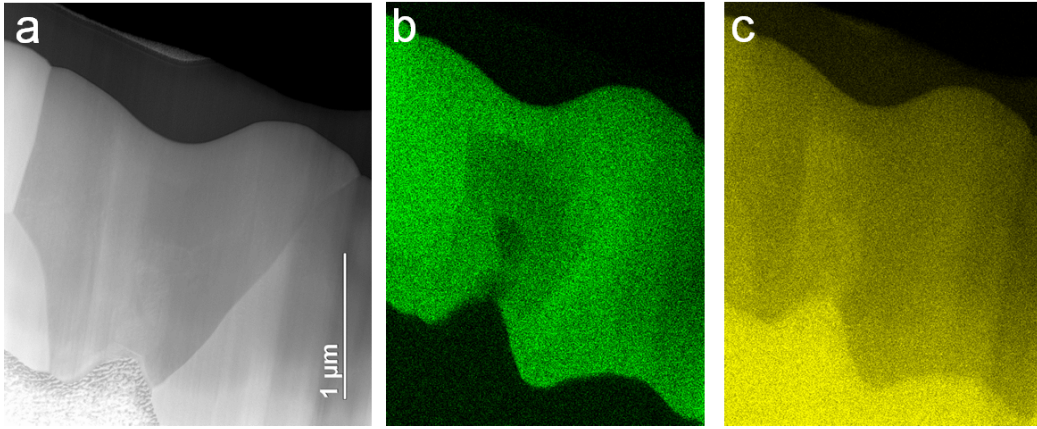
Figure 15. (a) Z-contrast image of the near-surface of cold cutout; (b) EDS map for Sn; (c) EDS map for Nb.

Sub-micrometer-sized regions of Sn-deficiency, similar to the ones observed in the flat sample's coating, were found in Nb_3Sn coating in cold cutout (Fig.15). Three samples prepared from the cold cutout and one sample prepared from the flat sample were STEM/EDS measured. Sn-deficiency regions were found in all of them. Sn-deficiency regions with likely reduced T_c were found in Nb_3Sn -coated cavity for the first time. The presence of Sn-deficiency regions in the flat sample implies that their formation is inherent to the deposition process rather than the substrate geometry. Appearance of Sn-deficiency region approximately in the center of the largest grain in cold cutout (Fig.15) might be explained by deficiency of Sn during grain growth. Sn from the surface is expected to diffuse along the grain boundaries during the deposition process [11, 17]. The region in the center of the largest grain is the furthest from the grain boundaries which provide Sn source during the film growth.

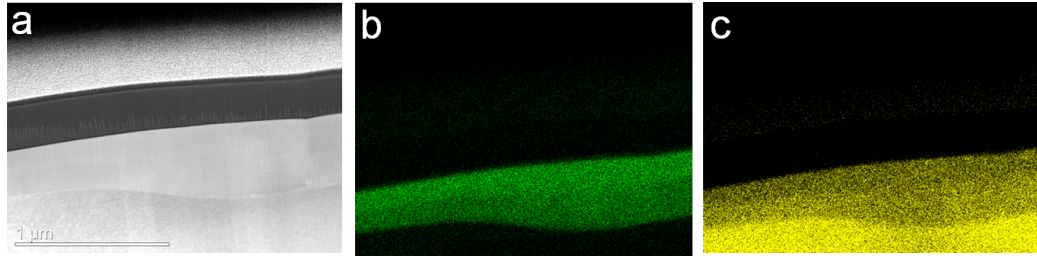
Figure 16. (a) Z-contrast image of the near-surface of hot cutout; (b) EDS map for Sn; (c) EDS map for Nb.

STEM/EDS characterization of hot cutout is demonstrated in Fig.16. Two TEM samples prepared from a hot cutout were studied with the STEM/EDS. It was observed in both TEM samples that the Nb_3Sn coating in hot cutout shows reduced Sn signal and brighter Nb signal at the bottom part of the coating. Observation of lower Sn concentration at the bottom of the coating can be explained by insufficient Sn supply from the grain boundaries during the growth. Being thin, 100 μm -sized single grain, the patchy region most likely demonstrates Sn-deficiency due to lack of close grain boundaries which transport Sn below the surface.

However signal intensity variations in Sn and Nb maps in hot cutout samples are rather weak.

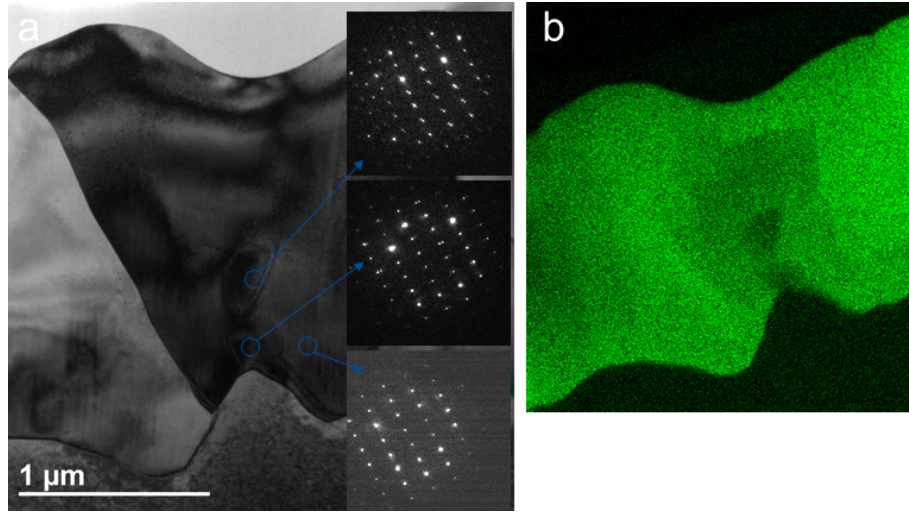
Figure 17. (a)BF TEM image of intragrain domain in cold cutout sample with NED patterns, (b)EDS Sn-map of the same area.

Sn-deficiency regions produce contrast variation in the TEM images in some samples (Fig.17). Sn-deficiency regions look like domains in the largest Nb_3Sn grains in TEM and TEM BF images. NED with parallel beam of approximately 100 nm in diameter was used to explore the structure of Sn-deficient domains. Fig.17a, b shows BF TEM image of intragrain domain in

cold cutout sample and EDS Sn-map of the same area, respectively. Corresponding NED show Nb_3Sn patterns from intragrain Sn-deficient domain and surrounding area from the same grain. No change in crystal structure within the grain containing deficiency region was noticed. However weak additional reflections accompany major diffraction spots inside of Sn-deficiency domain. Similar additional reflections observed in intragrain domains in all cold cutout TEM samples.

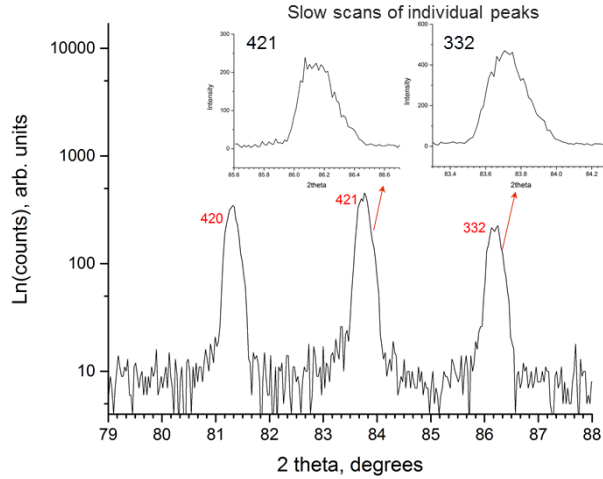
Figure 18. High resolution slow XRD scan of cold cutout.

Effect of compositional variation in Sn-deficiency regions on global properties of the film was explored with high resolution XRD performed with X'pert¹ diffractometer. One would expect reduction of the lattice constant with lower Sn concentration. Since A15 Nb_3Sn structure was already confirmed in cold cutout, shape of diffraction peaks was investigated with higher resolution. Fig.18 shows several diffraction peaks which were slowly scanned with the best possible resolution and count rate. Every Nb_3Sn diffraction peak in cold cutout shows some asymmetry in the peak shape. Asymmetry extends toward higher

diffraction angles. According to Bragg's law diffraction peaks at higher angles indicate smaller d-spacings in diffracting material which, for cubic structures, translates into the smaller lattice constant. Previous experiments [10] show decrease in T_c of Nb_3Sn with reduced lattice constant which was induced by lower Sn concentration. Consistent asymmetry of diffraction peaks shape indicates a spread in d-spacings in diffracting material which can be interpreted as presence of A15 Nb_3Sn with a few slightly different lattice constants. Smaller lattice constants are most certainly originating from Sn-deficiency regions observed by STEM/EDS. Presence of a spread in lattice constants was previously reported in Nb_3Sn coating prepared by the same method [21].
