Structural study of the Notre-Dame ancient *charpente*

P. Vannucci

The timber roofing structure (*charpente* or *combles*, in French) of the cathedral Notre-Dame, destroyed by the fire of April 15th, 2019, is studied. The aim is twofold: on the one hand, it is interesting to evaluate the structural behavior of the original wooden structure in view of the reconstruction of the cathedral's roof. On the other hand, its structural analysis, never done before, can help to shed a light on the design process used by the masterbuilders of the XIIIth century, and to reconstruct, at least in part, the structural thought and knowledge of the ancient builders.

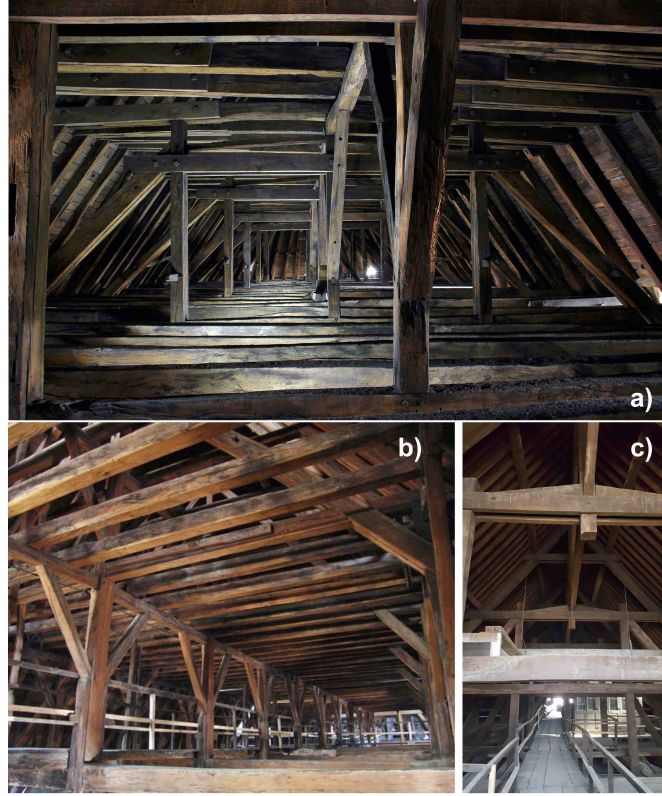
Figure 1: Views of the *combles*: a) in the choir (from Fromont and Trentesaux [2016], b) in the nave (from Épaud [2019a], c) in the transept (by the author).

The *charpente* was a very large structure: about 115.6 m long, 13 m wide, 9.75 m high for the nave and the choir. Though in Dubu [1854] it is said that the *charpente* was made with chestnut wood, it is certain that it was realized with the wood of oak trees. Scholars disagree about the quantity of trees employed for the structure: according to F. Épaud, who has deeply studied the timber structures of the Middle Ages, it was composed by the wood of about 1000 oaks, almost all of them with a diameter of $\sim 25 \div 30$ cm and 12 m high, a small part with a diameter of ~ 50 cm and 15 m high, corresponding to about 3 hectares of forest. In an interview, Corvol [2019], A. Corvol, an expert in forests, evaluates at 3000 to 5000 m³ the volume of the *charpente*'s wood, corresponding to about 2000 oaks; other estimations give the value of 1300 oaks for 21 hectares of forest. The quantity of wood was, anyway, very important, so that the *charpente* was called *la forêt*, the forest: the visitor was immersed in an amazing very intricate set of wooden beams and struts, like in a sort of artificial forest crystallized during several centuries, Fig. 1.

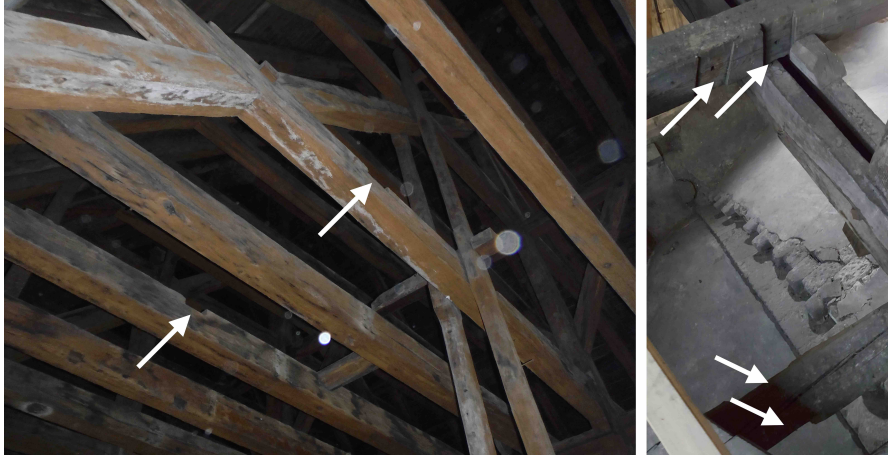
Figure 2: Notches indicating the reuse of ancient wooden beams (by the author).

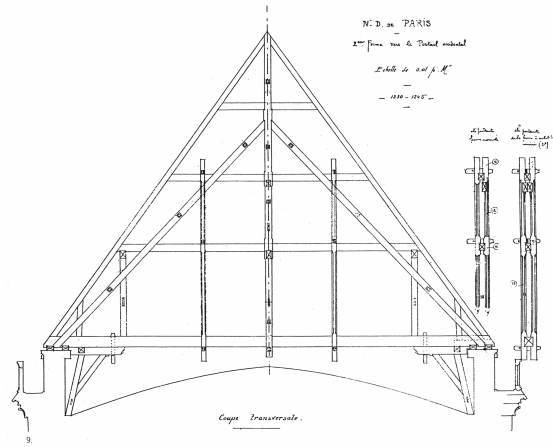
Figure 3: The survey of the second *ferme*, FN2, of the nave, according to Deneux [1927]; the *suspente* on the right side was not present, in reality.

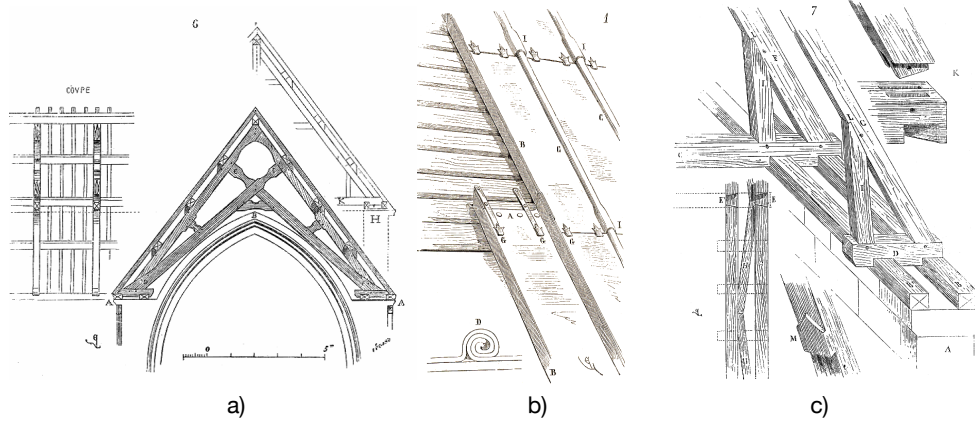
Figure 4: Structural schemes from [Viollet-le-Duc \[1854\]](#): a) scheme of a *ferme* without *entrait*; the *charpente* of ~ 1170 was probably similar to this one; b) the system of lead tiles observed by Viollet-le-Duc on the roof of the cathedral of Chartres, before the fire of 1836 that destroyed entirely the *combles*; it is this system that he used to cover the roof of Notre-Dame of Paris after the restoration of the mid of the XIXth century; c) the system for the support of the *fermettes* (G), composed by *blochets* (D) and *sablières* (B), in a *charpente* with *chevrons formant ferme*.

The crucial architectural transformation of the cathedral operated after 1220 that with no doubts is directly linked to the change of the structural type of the *charpente* was the raise of the guttering wall, already mentioned above. This allowed the carpenters to use frames (*fermes* in French) with an *entrait*, i.e. a long tie-beam relying the bases of the frame's rafters (the *chevrons*, in French), which is the ideal device to absorb the horizontal component of the force in the rafters. In the previous roofing structure of ~1170, the vault exceeded in height the top of the guttering wall, so it was not possible to use *fermes* with *entrait*. We do not know how this older *charpente* was made, we can just imagine that it was something like that in Fig. 4 a). This type of solution

severely deform the *fermette*. The way invented by the Gothic carpenters is that of the *sablières* and *blochets*, see Fig. 4 c). Each *chevron* of a *fermette* has at its base a *blochet*, hosting the *chevron* and a *jambette*. The *blochet* is not directly placed on the top of the guttering wall, but it is linked to and supported by two longitudinal rods, the *sablières*. These two wooden beams are restrained by the *entrails* of two successive *chevrons maîtres*. In this way, the horizontal thrust at the base of each *fermette* is absorbed by the system of the *sablières*. These ones are hence solicited in bending and shear in the horizontal plane and transfer in this way the resultant of the horizontal thrust of the *fermettes* between two *chevrons maîtres* to the *entrails* of these last. The whole system hence does not apply any horizontal thrust on the top of the guttering wall. This is a fundamental fact of the *charpentes* with *chevrons formant ferme*: all the system was designed to transmit only vertical forces to the top of the guttering wall, while the horizontal forces engendered by the vertical loads, i.e. by the own weight of the structure, were self-equilibrated by the system composed by the *chevrons*, *blochets*, *sablières* and *entrails* of the main frames. Because the *charpente* is simply posed onto the guttering wall, the only mechanism able to absorb horizontal forces should be the friction between the wood of the *charpente* and the stone of the wall. We will see in Sect. 4.7 that actually this is not possible: not only friction cannot absorb the horizontal thrust of the Notre-Dame's *charpente*, but more importantly, such a situation could bring the guttering wall to a failure. In fact, the horizontal thrust applied to a high guttering wall could produce a rotation of the wall at its base, i.e. where it meets the vault, causing its collapse. It is likely that the builders of Notre-Dame were conscient of this danger, consequence of the elevation of the guttering wall, and adopted intentionally the system described above in order to create a structure not pushing horizontally on the wall's top.

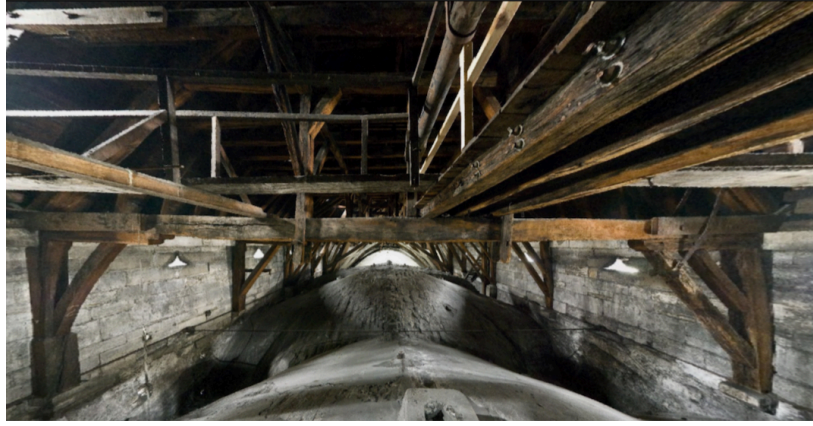
Figure 5: The *charpente* of the choir; the top of the guttering wall was, before ~ 1220 , at the level of the corbels supporting the wall pieces and braces beneath the *fermes* (extracted from [Tallon \[2019\]](#)).

We have already mentioned that during the modifications started around 1220, the guttering wall was raised of ~ 2.70 m above the keystone of the high vault, see Fig. 5, where it is apparent that the *entrants* of the *fermes* can now well pass above the vault, while this was impossible for the *charpente* of ~ 1170 , as the top of the guttering wall was at that time at the level of the stone corbels well visible in the picture and serving as support for the lower part of the *fermes*.

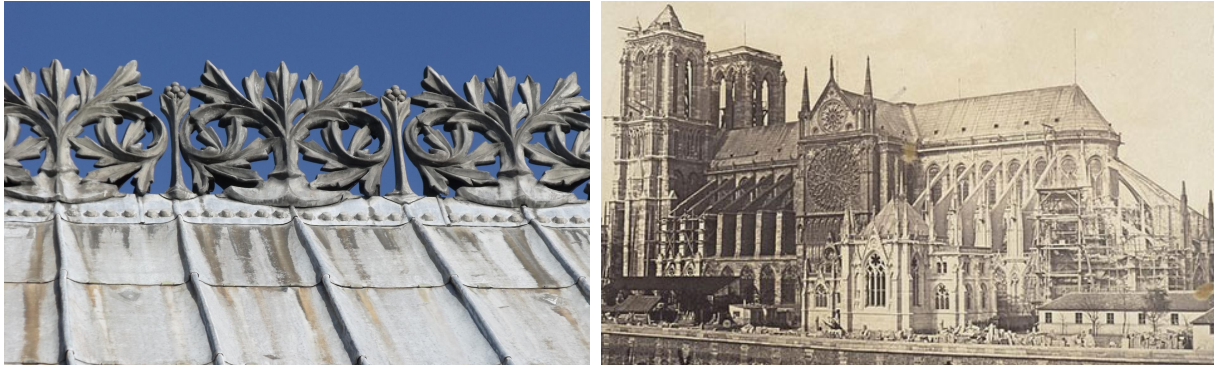
Figure 6: The lead frieze at the roof top and Notre-Dame before the restoration of Lassus and Viollet-le-Duc, without the frieze.

Originally, according to [Dubu \[1854\]](#), who wrote a history of Notre-Dame during the restoration works of Lassus and Viollet-le-Duc, the covering of the roof was made by 1236 lead plates, each one of the dimensions 0.975×3.248 m and 5 mm thick, for a mass of 120 kg each, which gives a total mass of the lead covering of ~ 2060 tons. This calculation is manifestly false: if the dimensions of a tile are correct, its mass should be of ~ 180 kg, and the total mass of the covering of 221.15 tons, not far from the value normally given of 210 tons. However, this was not the lead covering melt by the fire of April 15th, 2019. In fact, in [Lassus and Viollet-le-Duc \[1843\]](#) it is specified that the Cardinal of Noailles proceeded to the restoration of the roof in 1726 and that the new mass of the lead covering was of 220240 pounds, i.e. about 99.9 tons. Evidently, the new lead tiles had a less thickness, presumably of ~ 2.25 mm. Successively, during the restoration of Lassus and Viollet-le-Duc, the covering was made again, still with lead tiles, but now with a thickness of 2.82 mm, [Laboulaye \[1873\]](#); the tiles were welded together and fixed to the *charpente* with staples, Fig. 4 b). This was the lead covering melt by the fire of 2019. Its total mass can be estimated to ~ 135 tons. Also, a lead frieze was put on the top of the roof, that did not exist before, Fig. 6.

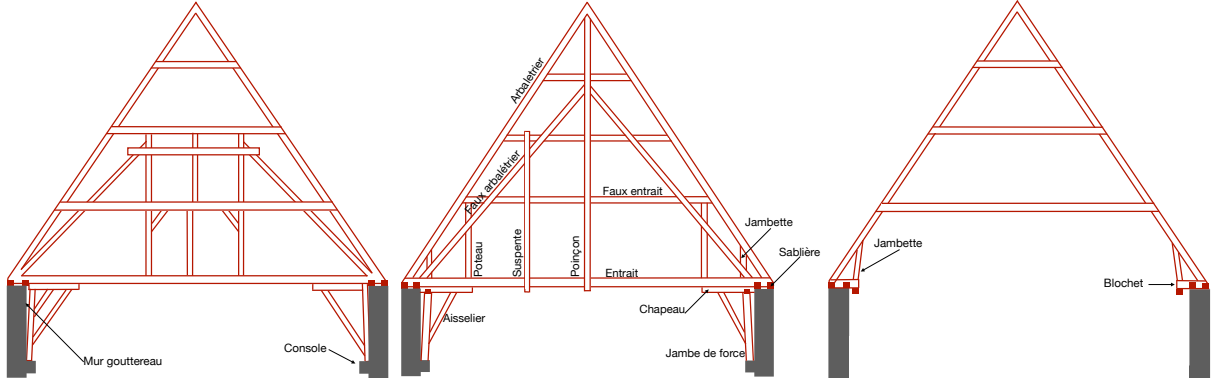
Figure 7: From left to right, scheme of a *chevron maître* of the choir, of the nave and of a *fermette*.

The *chevrons maîtres* of the choir and nave of Notre-Dame, as well as the model of a *fermette*, are shown in Fig. 7. In the same figure, the French names for the different pieces of the structure are also indicated, they will be used in the remainder of this paper. These schemes have been reconstructed using mainly Chevrier [1995] and Fromont and Trentesaux [2016]. These

Another point of debate is the presence of the *suspentes* on the North side of the nave's *charpente*. As apparent from Figs. 7 and 12 c), this was a clear element of dissymmetry for the frame. In Fromont and Trentesaux [2016] a plausible hypothesis for this dissymmetric solution is given: the *suspente* was used to support the *entrait* where a catwalk, running all along the *combles*, was placed, between the *poinçon* and the *suspente*, Fig. 9. This hypothesis, that seems to be confirmed by dendrochronological analyses, is the only reasonable one, from the structural point of view. Anyway, in correspondence of FN3 at least, the link between the *suspente* and the *entrait* was broken. Still in correspondence of FN3, on the North side, there was not contact between the *blochets* and the longitudinal tie running between the *jambes* of the *chevrons maîtres*, see Fig. 10 a). However, this was not the rule: in other parts, perhaps everywhere else, this contact was ensured, see Fig. 10 b). The reason for this lack of contact, that is undoubtedly a defect from the structural point of view, is argued in Fromont and Trentesaux [2016] as the probable use of the longitudinal tie only for the constructive phase. This is not likely: all the *blochets* of the nave's *charpente*, unlike those of the choir, jut outside the thickness of the guttering wall, and were charged by the *jambettes* exactly above the longitudinal tie, Fig. 10 b). There cannot be any doubt that the longitudinal tie was put in place to relieve the bending of the *blochets* and better support the *jambettes*, which is confirmed by the contact that actually existed between the *blochets* and the tie in other parts of the *charpente*, contact at least in some parts ensured through a thick piece, like in Fig. 10 b). This is a clear sign that the builders wanted to use the longitudinal tie not particularly (but how?) in the constructive phases, but principally for the structural functioning of the whole *charpente*. The lack of contact discussed here can be imputed, very probably, to the absence of a thick piece between the *blochets* and the longitudinal tie. It is likely that this thick piece existed at the beginning and that, afterwards, it disappeared for some reason, e.g. it was fallen for the inescapable and physiological movements of the timber structure and never put back in its place for a lack of maintenance during the ages. The discrepancies between the structure close to FN3 and the rest of the nave's *charpente* cause some differences in the structural response of the *combles* that have been considered in the numerical simulations on the structural model of the nave's *charpente* as special cases, see Sect. 4.

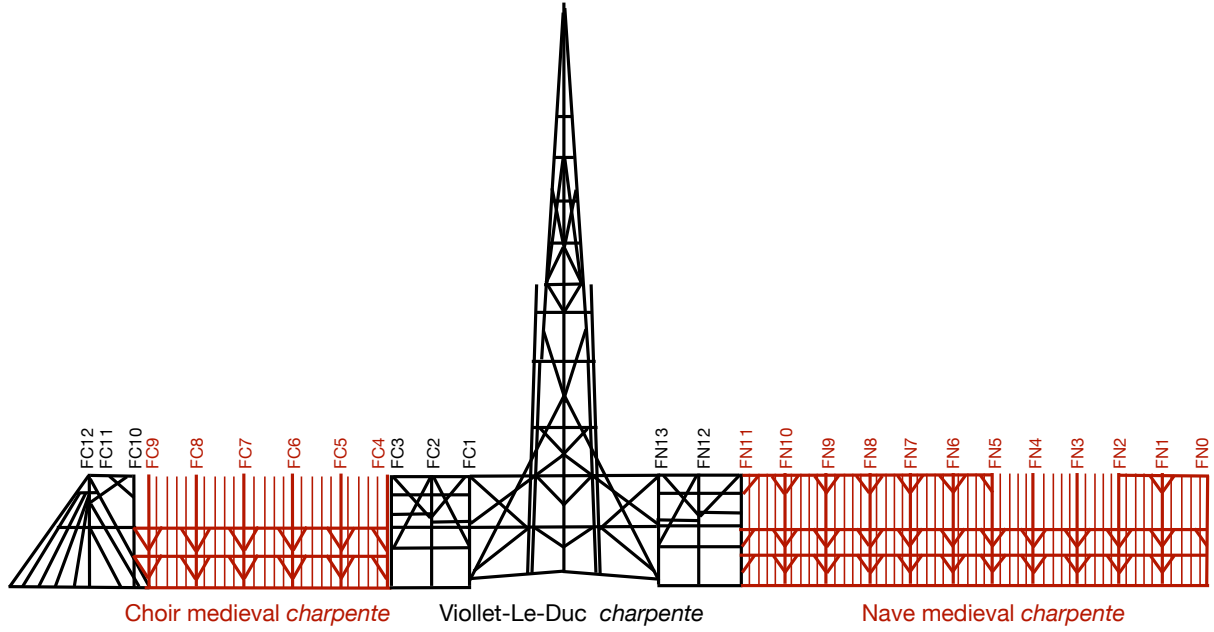
Figure 8: Longitudinal scheme of the *charpente*; the parts of the structure studied in this paper are in red; thick lines indicate the main frame and the longitudinal bracing system, while thin lines represent the secondary frames (scheme reconstructed from the survey in Fromont and Trentesaux [2016]).

The longitudinal scheme of the entire *combles* is presented in Fig. 8. The three parts of the *charpente* are clearly indicated as well as the notation of the *fermes principales*, as usually adopted. The longitudinal structure relying together the *fermes principales* and the *fermettes*, formed by *liernes* and *aisseliers* is schematically presented too. In this paper, only the parts of the *charpente* between *fermes* FC4 and FC9, for the choir, and between FN1 and FN11, for the nave, are studied. They correspond to the regular part of the medieval *charpente*, the rest being the part of the structure constituting the apse of the choir or that reconstructed by Lassus and Viollet-le-Duc during the XIXth century, and based upon a different structural scheme, that of *fermes, pannes et chevrons*, Bechmann [1981], Bernardi [2011]. Above the *chevrons* of the main or secondary *fermes*, there is a wooden decking, the *voligeage*, this last supporting the lead tiles, nailed on it, see Fig. 4 a).

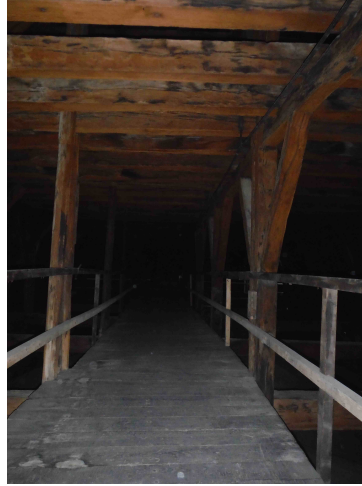
Figure 9: The catwalk; the *suspente* is the vertical tie on the left, while the *poinçon* the one on the right, with its *aisseliers* (by the author).

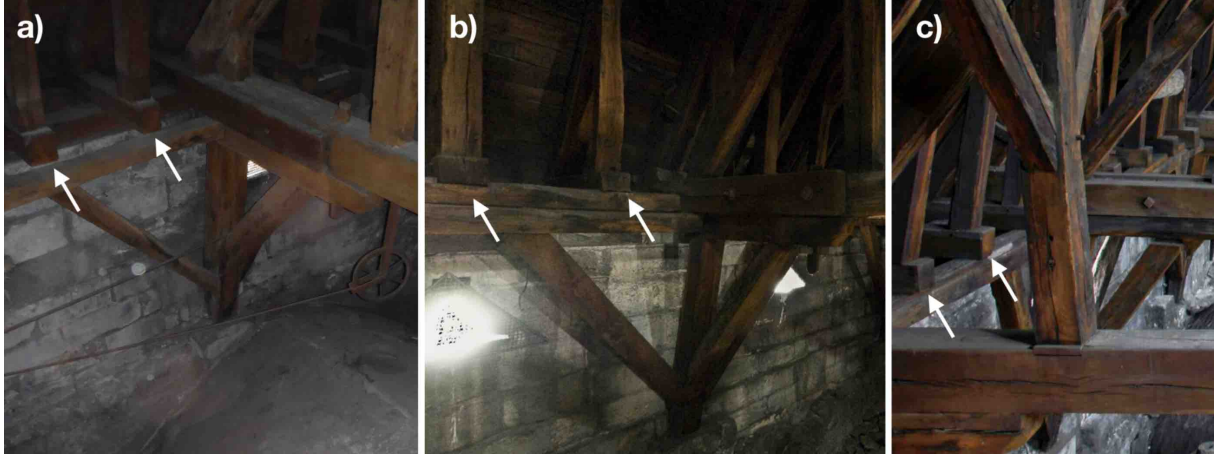
Figure 10: The detail of the contact between the *blochets* and the longitudinal tie, in the nave's *charpente*: a) the lack of contact for the part close to FN3, North side (by the author); b) the contact ensured by a thick piece in other parts of the *charpente* (extracted from Tallon [2019]); c) the direct contact close to FN6, South side (from Fromont and Trentesaux [2016]).

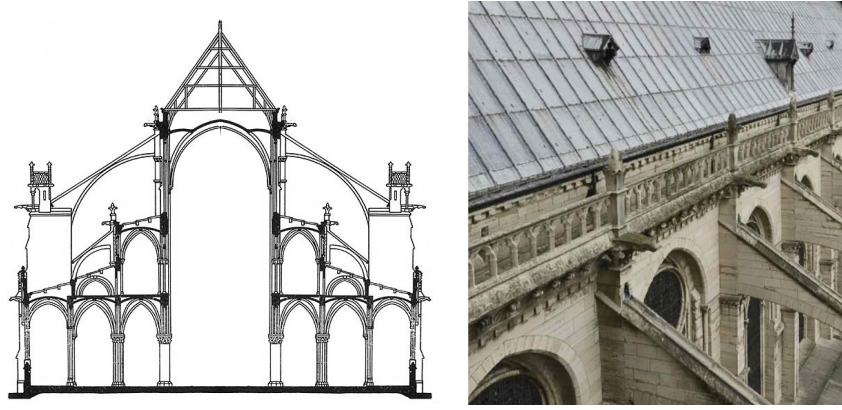
Figure 11: The vertical gap between the top of the flying-buttresses and that of the guttering wall.

The *charpente* of a Gothic cathedral was, normally, built before the construction of the high vault, see e.g. [Bechmann \[1981\]](#). During this phase, the *charpente* had also another role: to counterbalance the flying-buttresses thrust, ensuring the connection between the two sides of the clerestory before the construction of the vault. The device constituted by the *consoles* well assumed this structural role: the *entraits*, equipped with the two *consoles*, were able to balance and resist the inward thrust applied to the two opposite clerestory walls by the flying-buttresses on the North and South side of the cathedral. In particular, in Notre-Dame, after the raise of the guttering wall, the top of the flying-buttresses was too far below the *charpente* to assume such a kind of thrust balance without a device, the *consoles*, acting down below the *charpente*. The vertical gap between the *charpente* and the top of the flying-buttresses can be appreciated

in Fig. 11.

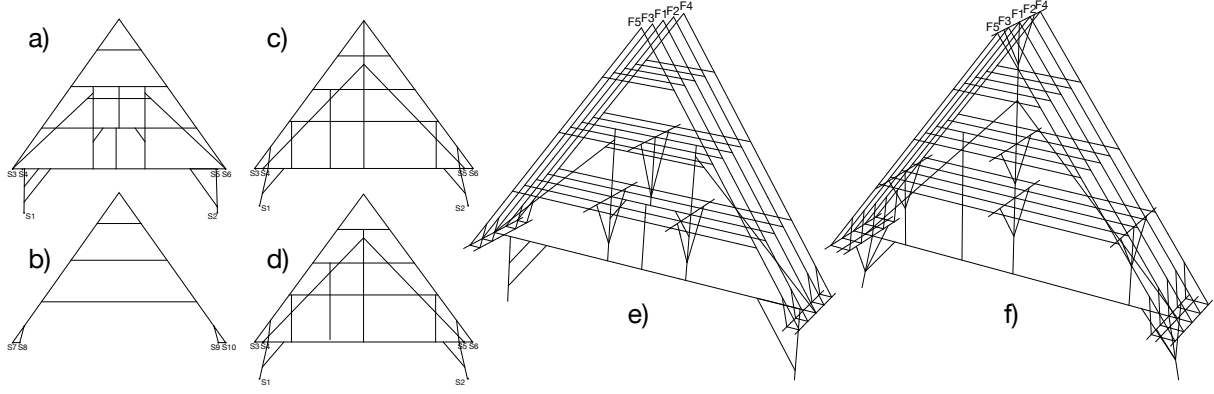
Figure 12: Schemes of the *combles*'s structure: a) *ferme principale* of the choir; b) a *fermette*; c) *fermes principales* FN1-FN2 and FN5-FN11 of the nave; d) *fermes principales* FN3-FN4 of the nave; e) the structural unit of the choir's *charpente*; f) the structural unit of the nave's *charpente*.

In the case of the nave, two different calculations are performed: one for the structural unit in Fig. 12 f), valid for FN1 to FN2 and for FN5 to FN11. The other one, for the structural units of FN3 and FN4, for which the model is slightly modified to account for some peculiarities, described above: the *suspente* is not linked to the *entrait*, the *poinçon* is interrupted at the level of the third *faux entrail* and the tie connecting together the *consoles* is not linked to the *jambettes*, Fig. 12 d).

The distribution of the reaction forces for each support point, S1 to S6 for the main frame F1, S7 to S10 for the secondary frames F2, F3 and F4, F5, cf. Fig. 12, is detailed in Tab. 5 for all the *charpentes* and loading conditions (R_x : horizontal reaction; R_y : vertical reaction). The distribution of the reactions is almost symmetric between the South and North sides, though not exactly, due to the small asymmetries in the main frames structure. It is interesting to notice that not all the supports are active for the vertical load (condition OW): for the choir, the supports S7 and S10 of the *fermettes* are inactive, as well as S9 for F2 and F3 of the nave's *charpente* exception made for the part between FN3 to FN4. We can also observe that the vertical reactions in S1 and S2, i.e. at the level of the corbels supporting the *jambes*, is far less than that absorbed by nodes S3 to S6, on the guttering wall's top, for the choir's *charpente*, while it is higher in the nave, due to the different arrangement of the structure. This confirms that the system of wooden *consoles* is not determining in supporting the vertical loads, as already commented. For the loading condition OW+W, the situation is different: the presence of the *jambes* strongly affects the distribution of the reactions. The set of supporting nodes changes: in the choir, nodes S3 on the North side (the wind is simulated to blow from the South, where the cathedral is more exposed to the wind) are heavily charged, while nodes S4, S5, S8 and S10 are inactive. Nodes S6, S7 and S9 are also active, but with a reaction force far below that of S3. The node S1 is charged only horizontally, to entirely absorb the wind thrust, while S2 is charged in the vertical direction, as an effect of the roof's slope, see below. In the nave, due to the different

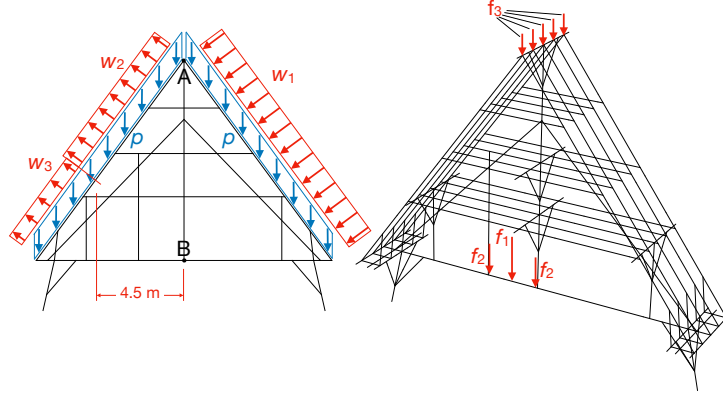
Figure 13: Scheme of the actions on the *charpente*; p : lead tiles and *voligeage* load; w_1, w_2, w_3 : wind load; f_1, f_2 : load of the catwalk; f_3 : load of the frieze.

Two loading conditions have been considered: own weight and own weight plus the wind. For what concerns the own weight, two different cases have been analyzed: the original state (OS), i.e. the one before the changes occurred in 1726, and the final state (FS), that before the fire of April 15th, 2019. The differences between these two cases are due to the lead covering: tiles with a thickness of 5 mm for the OS, of 2.82 mm for the FS and the presence of the frieze, Fig. 6. The OS is analyzed to evaluate the structural situation of the original *charpente* as designed by the Gothic carpenters, while the FS is considered to have an assessment of the state of the *charpente* before its destruction. For what concerns the wind loads, the objective is just to evaluate what were the consequences on the *charpente* of an horizontal load. This analysis is a rather classical one: the wind action is modeled as a static load, orthogonal to the impinging surface, and distributed on the windward (overpressure) and leeward (suction) sides of the roof. The value of the wind load is calculated and distributed according to the European norm EUROCODE 1, CEN [2005]. The objective, however, is not to evaluate whether or not the *charpente* was safe according to such a standard, a meaningless objective for an ancient and now destroyed structure, but just to have a value of the wind action that is commonly accepted in the analysis of civil structures. The actions applied to the *charpente* are sketched in Fig. 13 and the values of the loads shown in Tab. 3.

To remark that the slope of the roof, $\sim 55^\circ$, ensures a stabilizing moment of the wind force distribution w_1 on the windward side, Fig. 13, which explains the positive reaction in nodes S2, S6 and S9 of the choir and the high reaction at node S5 of the nave's *charpente*. Of course, we cannot affirm with certitude that the Gothics were conscious of this fact (the moment of w_1 becomes an overturning one at a slope of 60°), though the concept of moment of a force and its role in the equilibrium of a mechanical system was already roughly grasped in the Middle Ages, see Benvenuto [1981]. Nevertheless, the slope of the *combles* has at the same time a stabilizing effect for the wind actions and allows to decrease the bending of the *chevrons*, two real structural advantages. In Tab. 5 the resultant of the reactions is also indicated. This gives also an estimation of the global loads and weights; they are summarized in Tab. 6.

points A and B indicated in Fig. 13 are shown. The entity of the displacements is very small in all the cases.

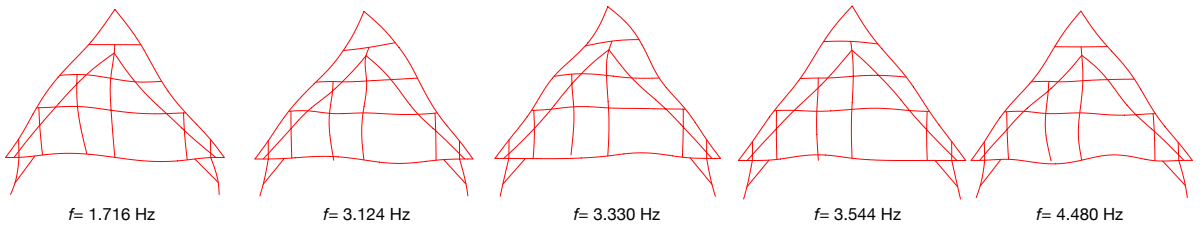
Figure 14: From left to right: the first five modal forms of FN3, CAST3M simulation.

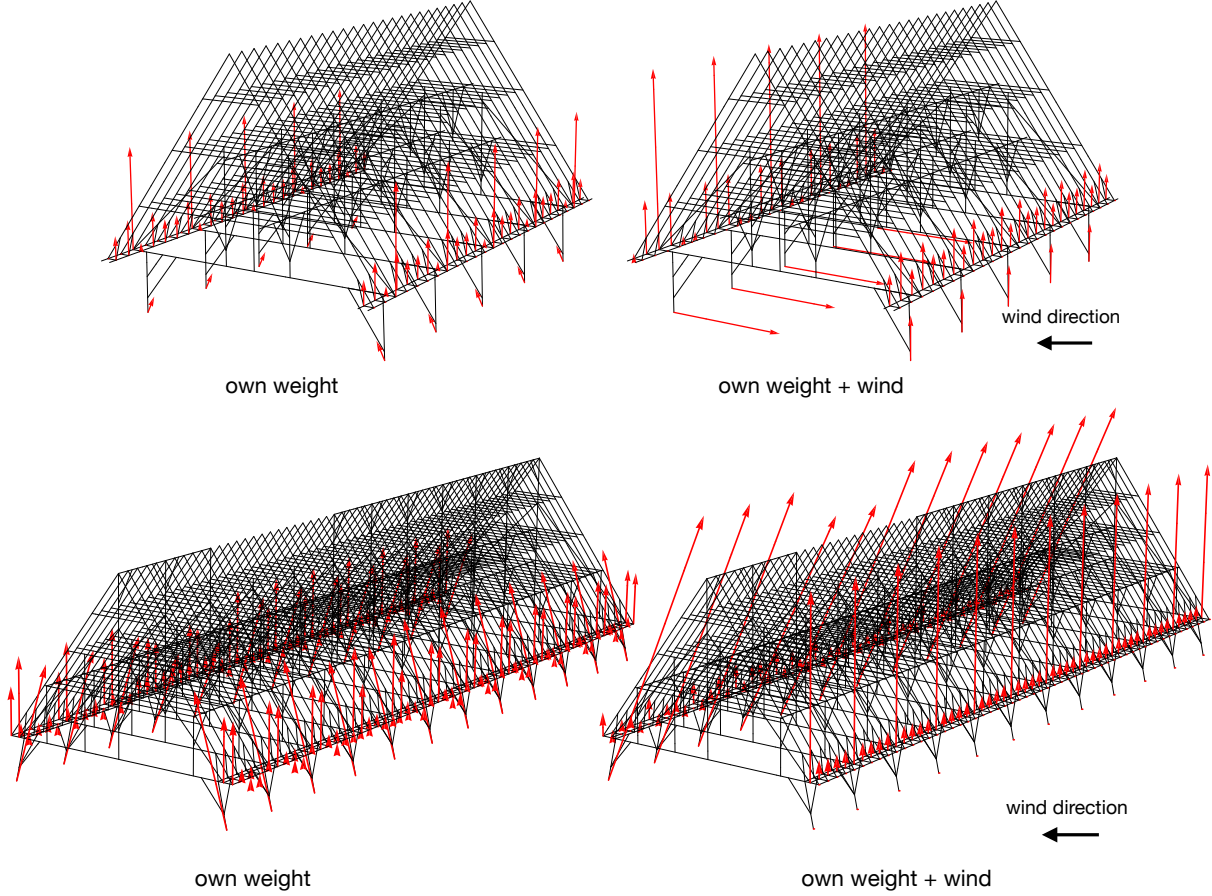
Figure 15: Distribution of the reaction forces in the original state; top, the choir's *charpente*, bottom the nave's one.

scheme, S2, S4, S6, S8 and S10 are inactive, while S1, S3, S5, S7 and S9 active. It is interesting to notice the high reaction at node S5, consequence of the structural scheme. The distribution of the reaction forces is depicted in Fig. 15, for the original state. Better than the data in Tab. 5, this two figures let see how the distribution of the reactions on the top of the guttering walls was far from being uniform. The main part of the load is transmitted by the *chevrons maîtres*, that play a fundamental role in the structural functioning of the *combles*.

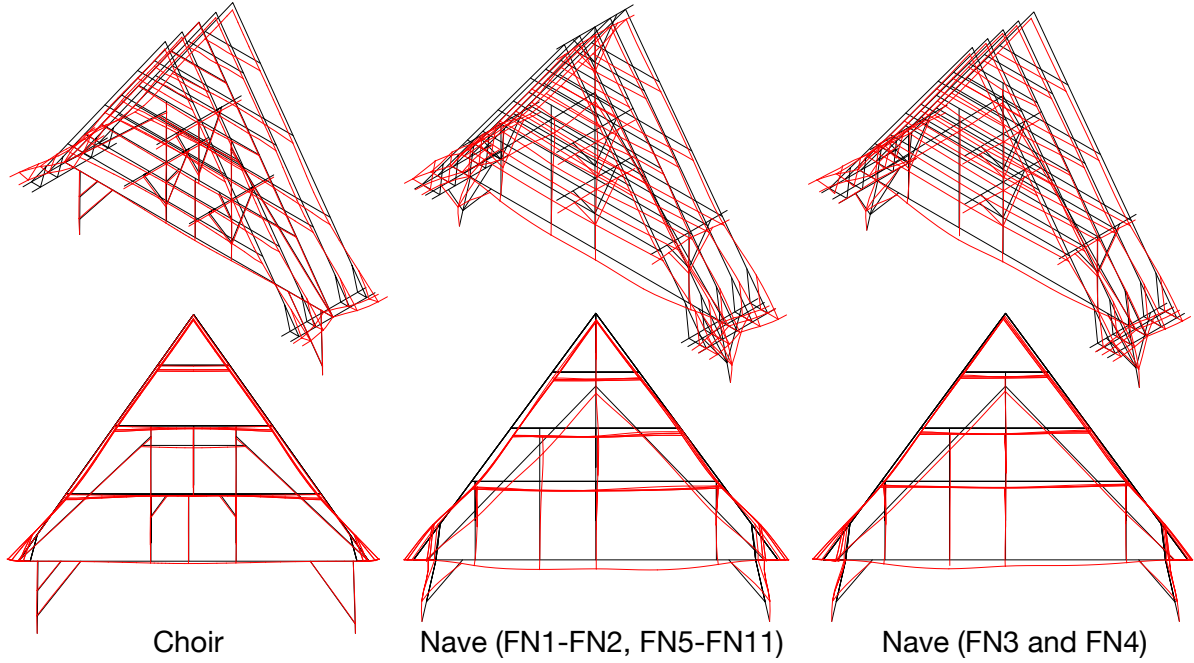
Figure 16: Deformation of the structural units of the *charpente*, in the original state, for the own weight (displacements magnified).

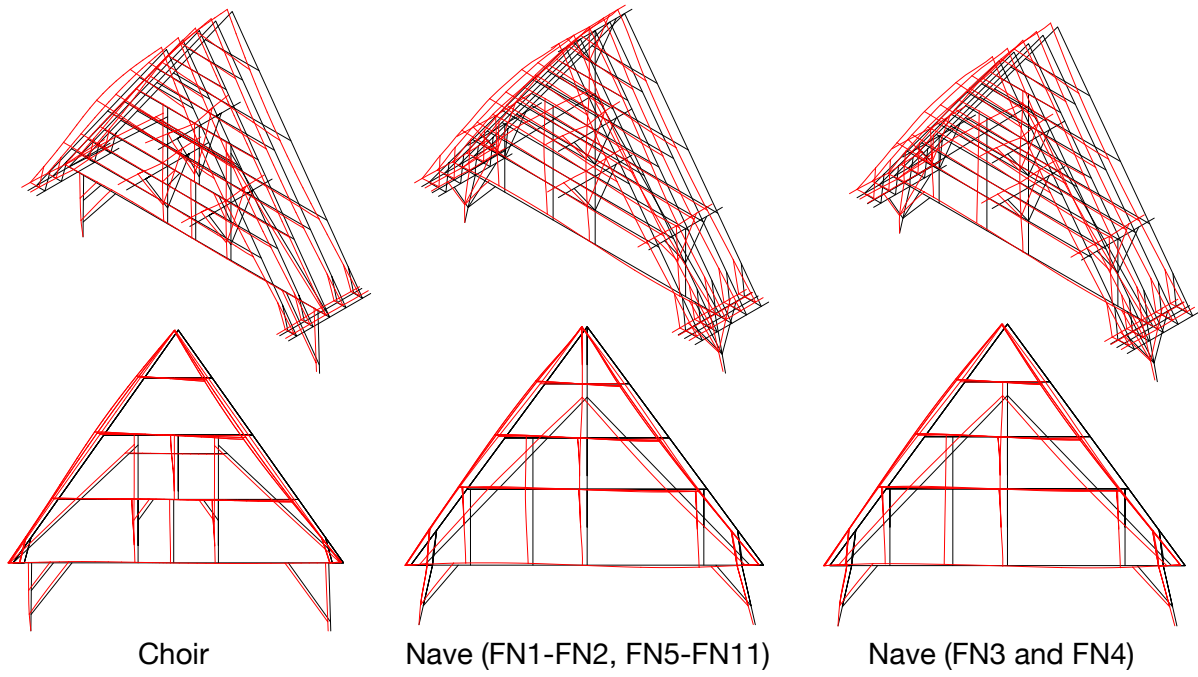
Figure 17: Deformation of the structural units of the *charpente*, in the original state, for the own weight and wind (displacements magnified).

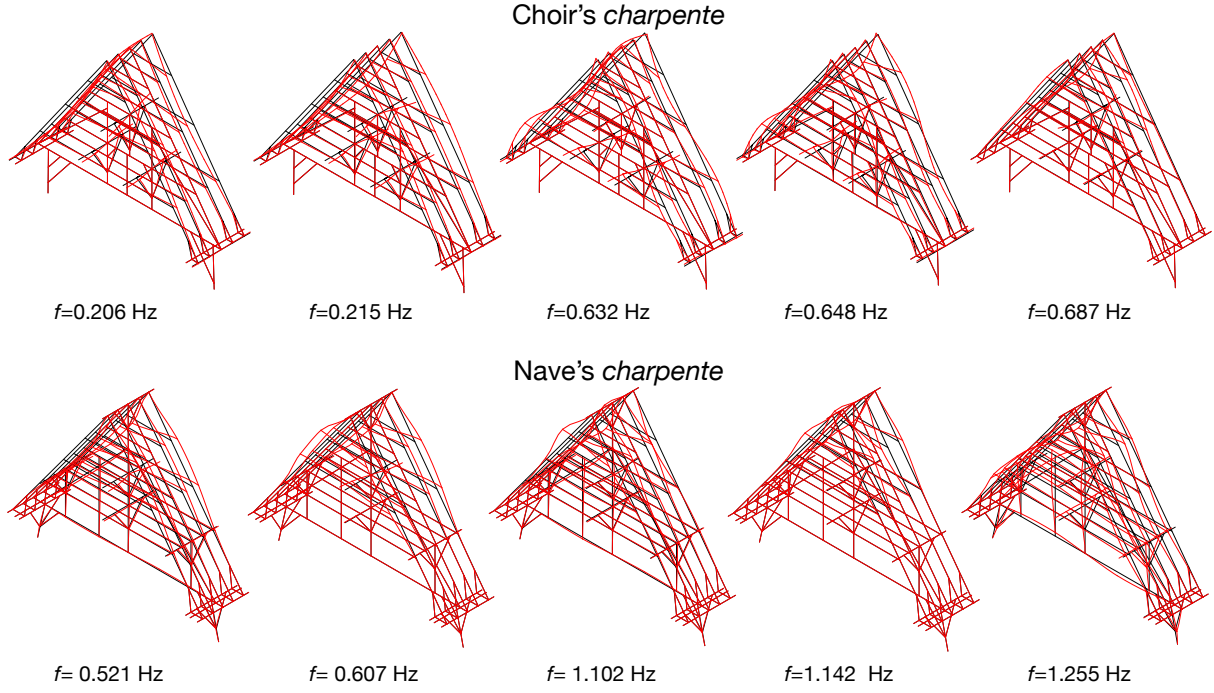
Figure 18: First five normal modes and corresponding vibration frequencies, original state.

Undoubtedly the solution of a *charpente* with *chevrons formant fermes* allowed the use of trunks of moderate diameter, easier to be found in the France of the Middle Ages, so realizing relatively light structures, though this seems more properly dictated by economical reasons than by statics. In fact, the dimensions used for the timber beams are largely sufficient to withstand the loads and a heavy load on the top of the clerestory walls could help in stabilizing the whole construction, knowing that the stress level in the stone of a Gothic cathedral is normally far from being critical, Heyman [1995]. Anyway, the change of the static scheme from the choir's *charpente* to the nave's one was certainly not dictated by economical reasons, because the mass of wood for unit length of longitudinal axis is greater for the nave. What clearly appears from a study of the two *charpentes* is that the nave's one is better designed and that this results in an increased stiffness of the wall structure. This is confirmed by a comparative modal analysis of the two *charpentes*: the structural unit of the nave has a fundamental frequency which is much higher than that of the choir, for about the same mass.
