A statistical analysis of pores and micro-cracks in nuclear graphite

Qing Huang, Hui Tang

Shanghai Institute of Applied Physics, Chinese Academy of Sciences, Shanghai 201800, China

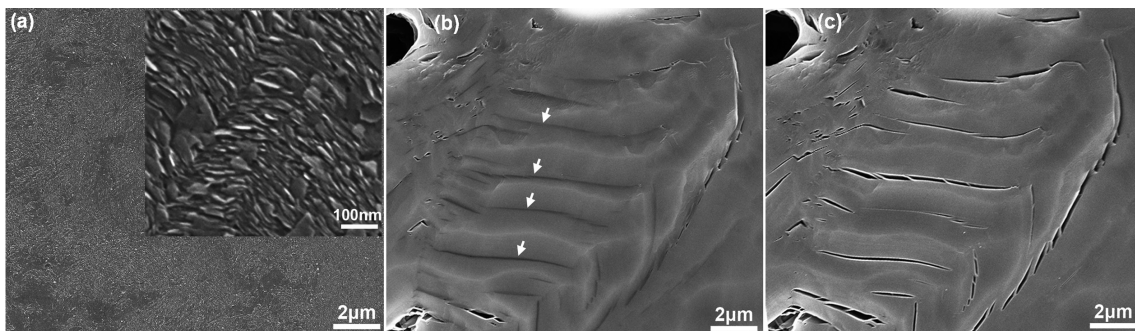
Fig. 1 (a) A SEM image of mechanically-polished surface of IG-110. One typical area is magnified in the inset image. (b) A SEM image of ion-milled surface of IG-110. The micro-cracks are indicated by white arrows (c) A SEM image of polished surface after rapid oxidation for 3 minutes.

Fig. 1(a) shows a SEM image of mechanically-polished surface of IG-110 graphite. The widespread micro-cracks cannot be seen, and the fillers cannot be readily distinguished from the binder regions on the surface. One typical area is magnified in the inset image and shows small broken graphite pieces induced by friction between graphite surface and diamond particles during mechanical polishing.

Fig. 1(b) shows a SEM image of ion-milled IG-110 graphite. The broken graphite pieces have been completely removed. More importantly, micro-cracks (indicated by the white arrows in Fig. 1(b)) are observed on the ion-milled surface. However, it is observed that the very thin cracks are not empty after ion beam milling.

to oxidation. Therefore a rapid oxidation process was adopted to remove this artificial carbon material. Fig. 1(c) shows a SEM image of IG-110 graphite after oxidation at 680 °C for 3 minutes. The artificial carbon material induced by argon ion milling is completely removed by rapid oxidation, and the micro-cracks can be clearly seen on the sample's surface.

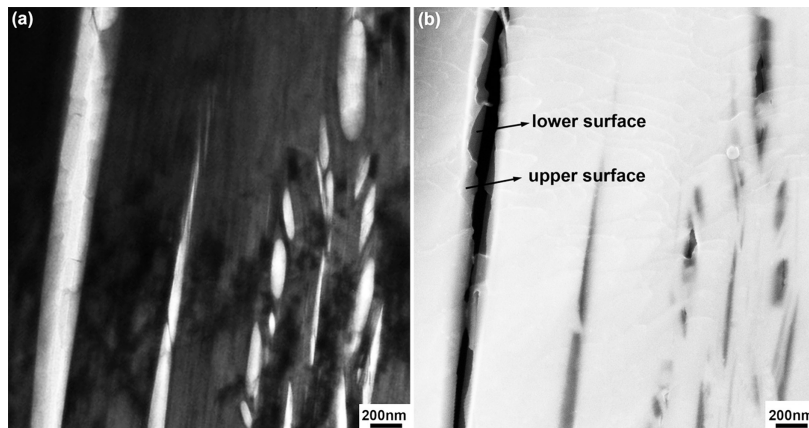
Fig. 2 (a) A TEM image of one filler with micro-cracks in IG-110 graphite and (b) a SEM image of the same filler.

In order to understand the origin of non-empty cracks, a thin disk specimen with a hole in the middle was prepared by low energy argon ion milling. Fig. 2(a) shows a TEM image of one filler in IG-110 graphite. The low-density carbon material which has been reported in previous studies [9-12] also appears in cracks shown in Fig. 2(a). If this carbon material is inherent in as-manufactured graphite, it should be found inside the cracks. The TEM image do show that the carbon material seems to reside inside the cracks. However, the cracks look different when observing them via SEM. The SEM image (Fig. 2(b)) shows that the cracks are highly likely to be covered by a thin layer of carbon material. The narrow cracks are fully covered and the wide cracks are partly covered. Especially the wide crack on the left is observed to be empty and partly covered by two thin layers of carbon material on the upper surface and the lower surface (indicated by arrows) respectively. Both sides of the thin specimen were processed by argon ion milling. Except for sputtering, another important effect is irradiation during argon ion milling. It is well known that irradiation induces swelling of graphite along the *c* axis. The irradiation-induced *c*-axis swelling could be as high as 200% at room temperature [15]. Therefore, this carbon material should be caused by irradiation-induced *c*-axis swelling of graphite crystallites. The argon ion irradiation process was simulated by using “The Stopping and Range of Ions in Matter” program. The irradiation damage induced by 3-keV argon ions at a glancing angle of 6° is deposited in a 2-nm-thick surface layer. Thus the cracks shown in Fig. 2 should be covered by a 2-nm-thick layer of carbon material.

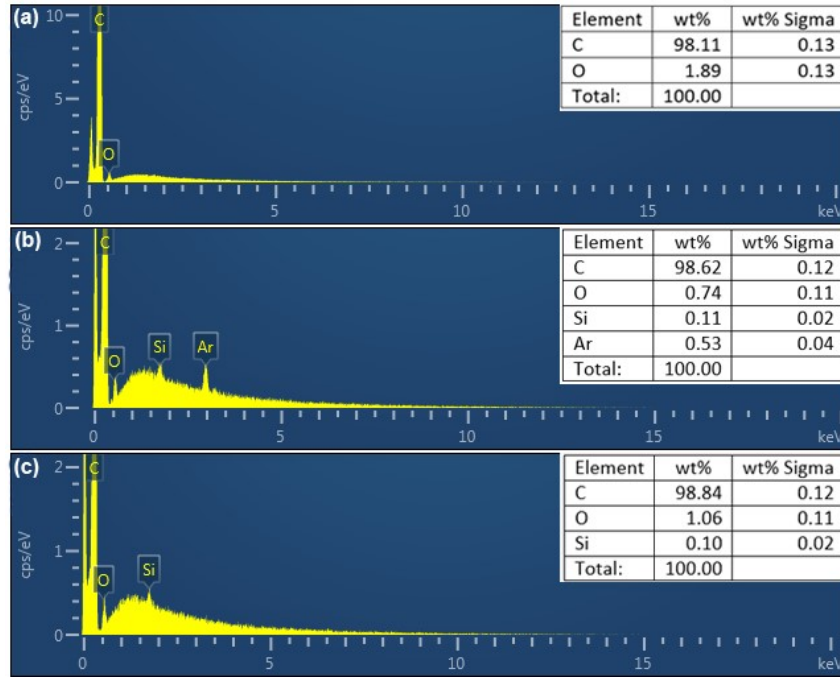
Fig. 3 The EDX spectra of (a) as-machined graphite surface and surface after (b) ion milling and (c) rapid oxidation.

Fig. 3(a) - 3(c) shows the EDX spectra of as-machined graphite surface and graphite surface after ion milling and rapid oxidation respectively. Oxygen, either chemically absorbed ($C-O$ or $C=O$) or physically absorbed ($C(O_2)$), always can be detected on graphite surface even after ion milling. The reason is that ion milling only sputters the graphite surface and the graphite pores' inner surfaces were left untouched. After ion milling, a strong signal of argon can be seen in Fig. 3(b), indicating that the argon ions were implanted into graphite surface. Argon implantation has been found in highly ordered pyrolytic graphite surface sputtered with 5 keV argon ions [16]. As the argon ions slowed down and settled in graphite, argon-carbon collisions happened and induced irradiation damage, which supports above assumption that the artificial carbon thin layer was induced by irradiation damage. After rapid oxidation, the artificial carbon thin layer was removed and the argon was released. No argon signal was detected in Fig. 3(c).

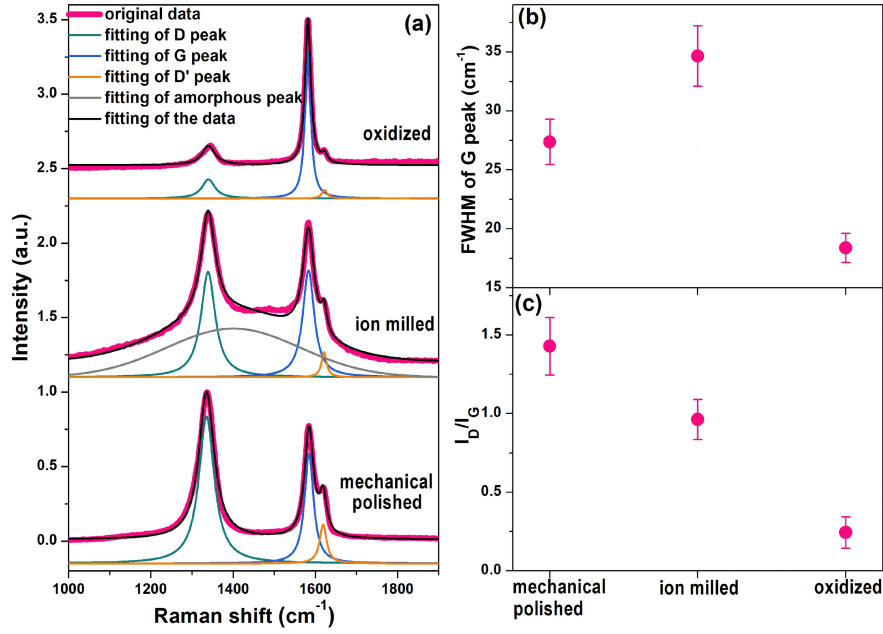
Fig. 4 (a) The Raman spectra and fitting curves of mechanically-polished, ion-milled and rapid-oxidized IG-110 graphite. (b) The FWHM of G peak. (c) The I_D/I_G ratio.

Fig. 4(a) shows the typical Raman spectra measured on IG-110 graphite surface after mechanical polishing, ion milling and rapid oxidation. Each spectrum has three peaks (the D peak located at $\sim 1340\text{ cm}^{-1}$, G peak at 1583 cm^{-1} and the D' peak at 1619 cm^{-1}). The intrinsic G peak originated from the in-plane symmetric stretching motion of C-C sp^2 bond and is the only peak that can be detected from defect-free graphite crystal [17]. The D peak involves a breathing mode of six-fold rings of carbon atoms and only can be excited in the presence of in-plane defects [18].

The full width at half maximum (FWHM) of the G peak and the ratio of the intensities of D and G peaks (I_D/I_G) has been widely used to analyze the microstructures of graphitic materials after various treatments [7,19]. The average value and the standard deviation (the error bar) of the FWHM and I_D/I_G ratio are shown in Figs. 4(b) and 4(c) respectively.

The Raman spectra clearly show the damage induced by each polishing step. Mechanical polishing induced broken graphite sheets with abundant boundaries which could raise the D peak intensity. Fig. 4(c) shows that the mechanically-polished graphite surface shows the highest I_D/I_G ratio (~ 1.4). Ion beam milling induced crystal disordering which causes a strong coupling between discrete G mode and a continuum of phonon states, resulting in peak broadening [20]. Therefore, the ion-milled graphite surfaces show the highest G peak width (Fig. 4(b)). After rapid oxidation, the G peak width and I_D/I_G ratio reduced to 19 cm⁻¹ and 0.28 respectively.

It is worth mentioning that the I_D/I_G ratio was reported to be inversely proportional to the in-plane graphite crystal size (L_a) [17,21], and this relationship has been used to obtain L_a from the Raman spectra measured on graphite sample's surface. However, Fig. 4 shows that the mechanical machining, grinding or polishing could raise the I_D/I_G ratio and thus underestimate the real L_a of graphite crystallites inside the sample. The Raman spectra measured on rapid-oxidized surface are believed to be more appropriate for calculating the L_a value.

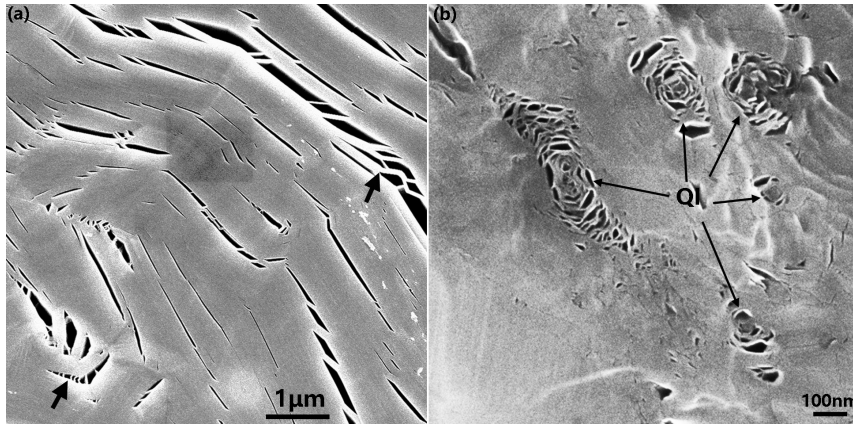
Fig. 5 The SEM images of ion-milled and rapid-oxidized IG-110 graphite surface. (a) A typical filler region showing abundant micro-cracks observed at a magnification of 5000 \times , and (b) the QI particles observed at a magnification of 40000 \times . The two arrows shown in (a) indicate graphite sheets bridging the micro-cracks.

Fig. 5(a) is a SEM image of rapid-oxidized surface showing a typical filler particle in IG-110 graphite. There are abundant micro-cracks in this filler region. Some cracks are bridged by small graphite sheets (indicated by the two arrows). The graphite sheets are

curved, deflected and folded in the filler. It is found that IG-110 is very rich in micro-cracks, which is consistent with its low coefficient of thermal expansion ($4 \times 10^{-6} \text{ K}^{-1}$) and deep volume shrinkage (-5% at 750 °C) during neutron irradiation [22,23]. The quinoline insoluble (QI) particles can also be clearly seen on graphite's surface after rapid oxidation. Fig. 5(b) shows several QI particles observed at a magnification of 40000 \times . The nano-sized graphite sheets with their c axis directing radially toward the center of the QI particles are clearly seen. There was an attempt to identify the QI particles on mechanically-polished graphite surface [24]. It was observed that the typical structure of QI particles was damaged by mechanical polishing. The IG-110 graphite is characterized to have a limited number of QI particles. The agglomeration of QI particles which was reported in another nuclear graphite (NBG-18) [25] is rare to see in IG-110.

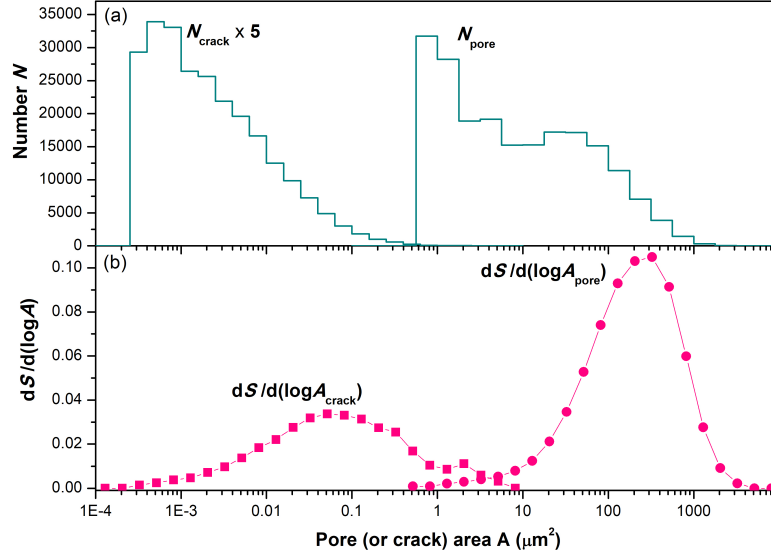
Fig. 6 (a) Distribution of pore (crack) area. (b) The porosity's distribution on pore (crack) area.

The pores and micro-cracks are shown as dark regions in the micrographs. A greyscale threshold value was selected to extract the pores and micro-cracks from the micrographs. Fig. 6(a) shows the distribution of the pore (crack) area. In total over 49000 cracks and over 200000 pores were identified. The number of cracks shown in Fig. 6(a) was multiplied by 5. There is much more tiny pores (cracks) than large pores (cracks). However, some pixel noise could be misidentified as tiny pores (or cracks). Furthermore, it is reported that the number of tiny pores could be easily altered by changing the greyscale threshold value [2]. Therefore, the number of tiny pores (cracks) shown in Fig. 6(a) could be misleading. Fortunately, these tiny pores are reported to have a limited contribution to porosity [2].

The porosity's distribution on pore (crack) area (A) is shown in Fig. 6(b). In this study, the porosity (S) is defined as the ratio of sum of each pore's (crack's) area to the whole image area. Because the pore (crack) area varied from 0.001 to 1000 μm², the vertical coordinate of Fig. 6(b) uses $dS/d(\log A)$ instead of dS/dA . It can be seen that the porosity's distribution has peaks at ~0.1 μm² and ~300 μm² for micro-cracks and pores respectively, far away from the peaks of pore numbers shown in Fig. 6(a). Because the porosity is mainly contributed by relatively large pores (cracks), the porosity's distribution was proved to be not sensitive to the selection of the greyscale threshold value [2]. Although the micro images of one graphite grade may be recorded by different microscopes and analyzed by different researchers, a stable and convincing porosity distribution can be obtained.

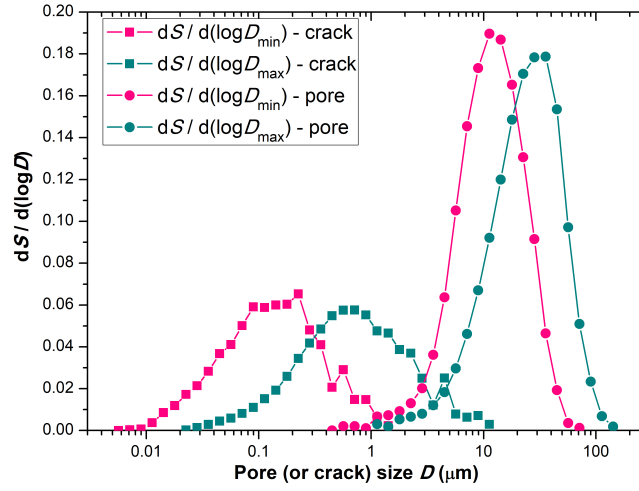
Fig. 7 The porosity's distribution on pore (crack) size.

A ellipse with the same moments of order 1 and 2 as the gas-escape pore or micro-crack was used to define the sizes of the pores or cracks. The lengths of major axis and minor axis of the ellipse are denoted as D_{\max} and D_{\min} of the pore (crack) respectively. The porosity's distributions on D_{\max} and D_{\min} are shown in Fig. 7. The peaks are located at $\sim 0.15 \mu\text{m}$ and $\sim 13 \mu\text{m}$ for D_{\min} while the peaks are located at $\sim 0.7 \mu\text{m}$ and $\sim 30 \mu\text{m}$ for D_{\max} . For micro-cracks, the D_{\max} and D_{\min} represents the length and width of the crack respectively. For pores with irregular shapes, the D_{\max} and D_{\min} only represents approximate sizes of the pores. For 3D pore structures reconstructed from X-ray tomography, the diameter of inscribed sphere of one pore was defined as the pore size and used to produce the porosity's distribution on pore size [3]. Using D_{\min} defined in this study, the $dS/d(\log D_{\min})$ of IG-110 graphite has been demonstrated be to consistent with porosity's distribution derived from X-ray tomography [2]. In other words, the D_{\min} is comparable with the diameter of inscribed sphere of graphite pores.

At last, a porosity of 14.2% is obtained in this study for IG-110 gas-escape pores, which is consistent with previous studies [1,2]. A porosity of 3.0% is obtained for IG-110 micro-cracks. The apparent density of the IG-110 sample was measured to be 1.771 g/cm³. Given the ideal graphite density of 2.26 g/cm³, the total porosity is calculated to be 21.6%. There is a gap between the total porosity (21.6%) and the sum (17.2%) of porosity values obtained for pores and micro-cracks, which can be explained as follows. If the graphite sheets in one crystallite are happened to be nearly parallel to the sample's surface, the lenticular micro-cracks will be shown as very shallow dishes on the surface and cannot be identified from the surface image. These missing micro-cracks exposed large cross-sectional area on the sample's surface, and have a considerable contribution to the calculated porosity. In addition, Only large QI particles can be seen at the magnification of 5000 \times . The tiny cracks in the QI particles shown in Fig. 5(b) cannot be captured at this magnification. Therefore, the true porosity of micro-cracks is actually underestimated by using the image processing method. However, the porosity's distributions shown in Fig. 6 and Fig. 7 are believed to be reliable and could be used as the input data for simulation of graphite behaviors.

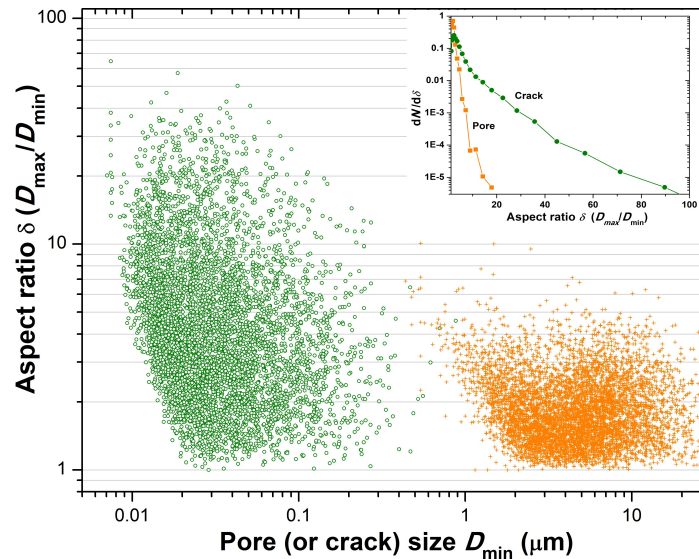
Fig. 8 The aspect ratio (δ) of pore (crack) vs D_{\min} . The inset shows the distribution of the aspect ratio.

The aspect ratio (δ) of a pore (crack) is defined as D_{\max}/D_{\min} . The aspect ratio vs D_{\min} is shown in Fig. 8. In order to explicitly show the distribution of aspect ratio, only one in seven cracks and one in twenty pores were randomly selected and shown in Fig. 8. Most of the pores have aspect ratio smaller than 4. In contrast, the aspect ratio of micro-cracks could be as high as 40. The inset of Fig. 8 shows the distribution of aspect ratio of pores and cracks.
