Asset management, condition monitoring and Digital Twins: damage detection and virtual inspection on a reinforced concrete bridge

Arnulf Hagen^a and Trond Michael Andersen^b

^aSAP Norway, Engineering Centre of Excellence/NTNU, Faculty of Engineering, Trondheim, Norway; ^bNorwegian Public Roads Administration, Division of Operation and Maintenance, Oslo, Norway

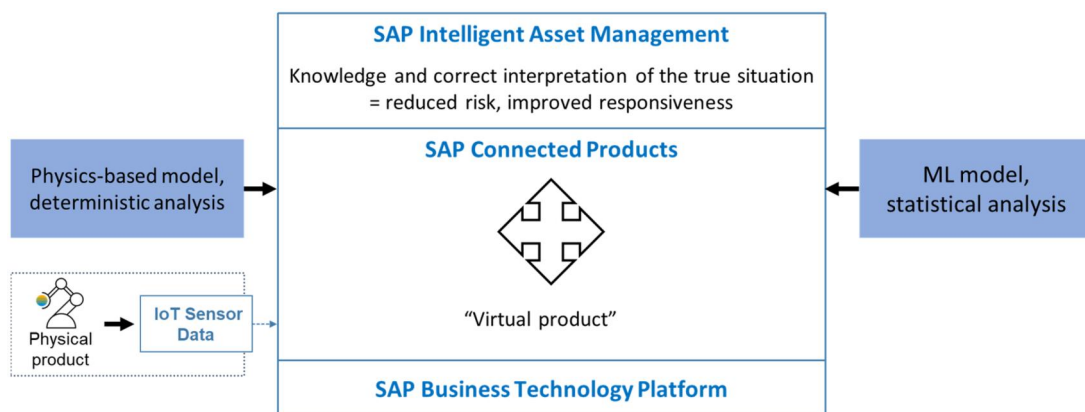
Figure 1. Principal sketch, Connected Products (at time of writing being discontinued) in an asset management context.

The situation under development in April 2021 was detected by remote observation using what constitutes the bridge's Digital Twin (Futai et al, 2022; Hagen, 2017) through SAP Connected Products as shown in Figure 1. Data from Internet of Things (IoT) sensors, accelerometers, and crack/gap gauges, mounted at key locations is sent to a cloud server where it is processed and transformed into physics-based indicators delivering results from, e.g. simulation models or other forms of algorithmic processes. The output can then be processed in ML algorithms that can be deployed to identify complex patterns of behavior and/or detect anomalies. In this context, physics-based approaches are both used as pre-processing before using ML for anomaly detection, and post-processing to improve explainability in cases where the ML models become complex and abstract.¹

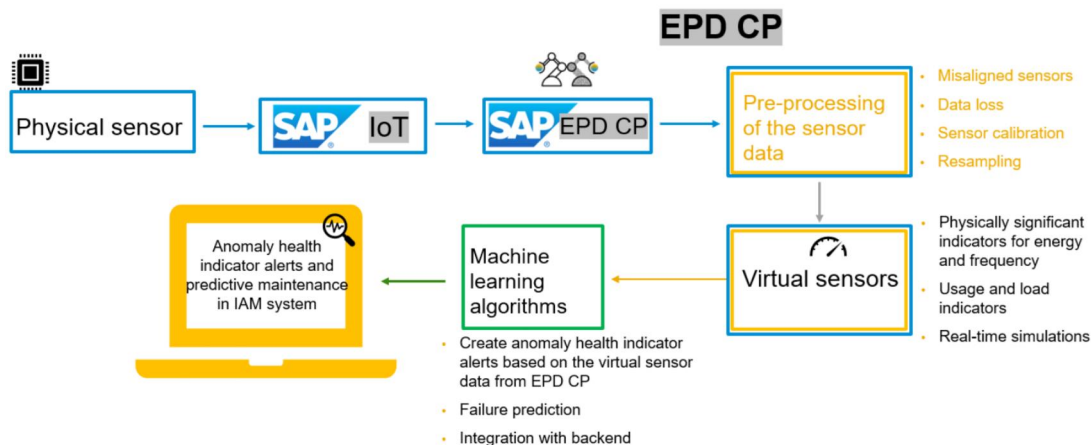
Figure 2. Schematic flow from sensor on a physical asset to the end user (human or machine).

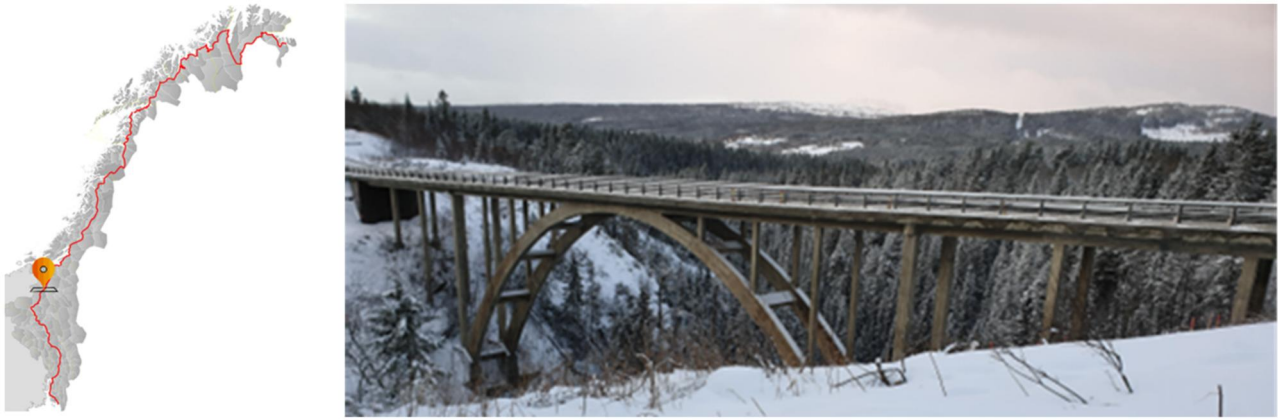
Figure 3. Stavå bridge on E6 as seen from the east, Trondheim to the left, Oslo to the right, tying together northern and southern Norway.

The 100-meter long Stavå Bridge as shown on Figure 3 is an arc bridge built in reinforced concrete more than 80 years ago. It has over the decades experienced gradually increased traffic, particularly from heavy vehicles, resulting in loads far exceeding those for which the bridge was initially designed and constructed. The increased speeds and weights, or traffic load in general, have over decades caused intensifying wear and tear on the bridge. Consequently, it has for the last decade or so been subjected to increased scrutiny in the form of regular and frequent physical inspections.

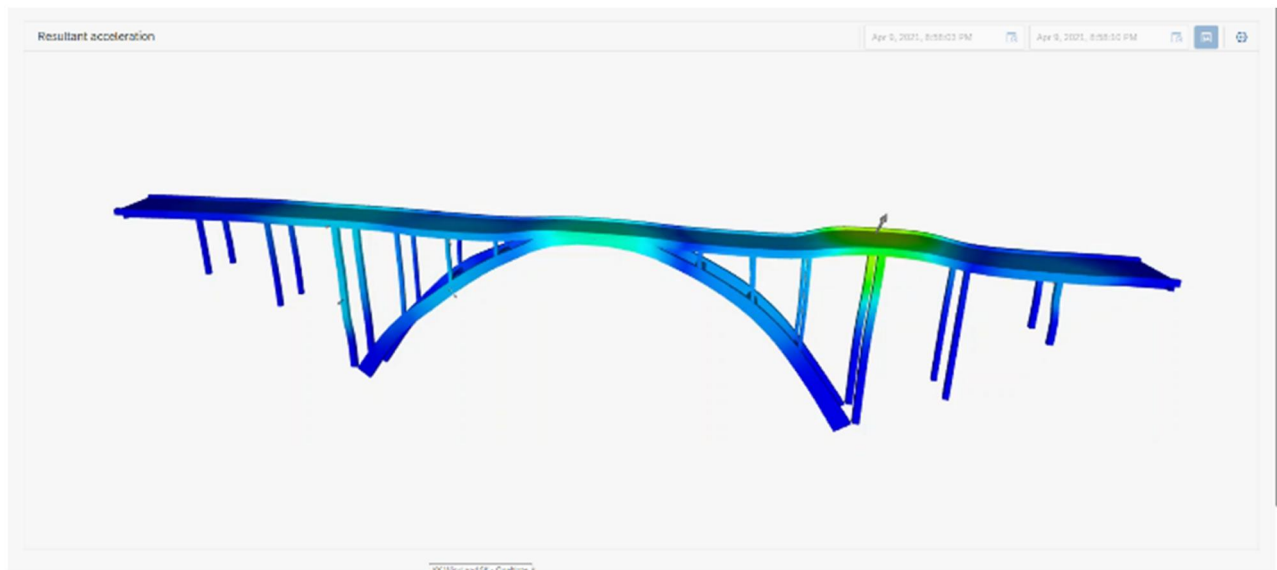
Figure 4. User interface example, here a screenshot of situation playback showing acceleration vectors.

Nonetheless, quite often a change in behaviour is in the dynamic response, as depicted in Figure 4, affecting how a structure responds under varying load conditions, altered traffic situations, environmental changes or other influences. This is particularly so here, with a bridge designed at a time when traffic was both significantly slower and significantly lighter. Thus, while traditional campaign-based inspections involving traffic control and closed-off lanes successfully have detected and monitored the development of cracks at

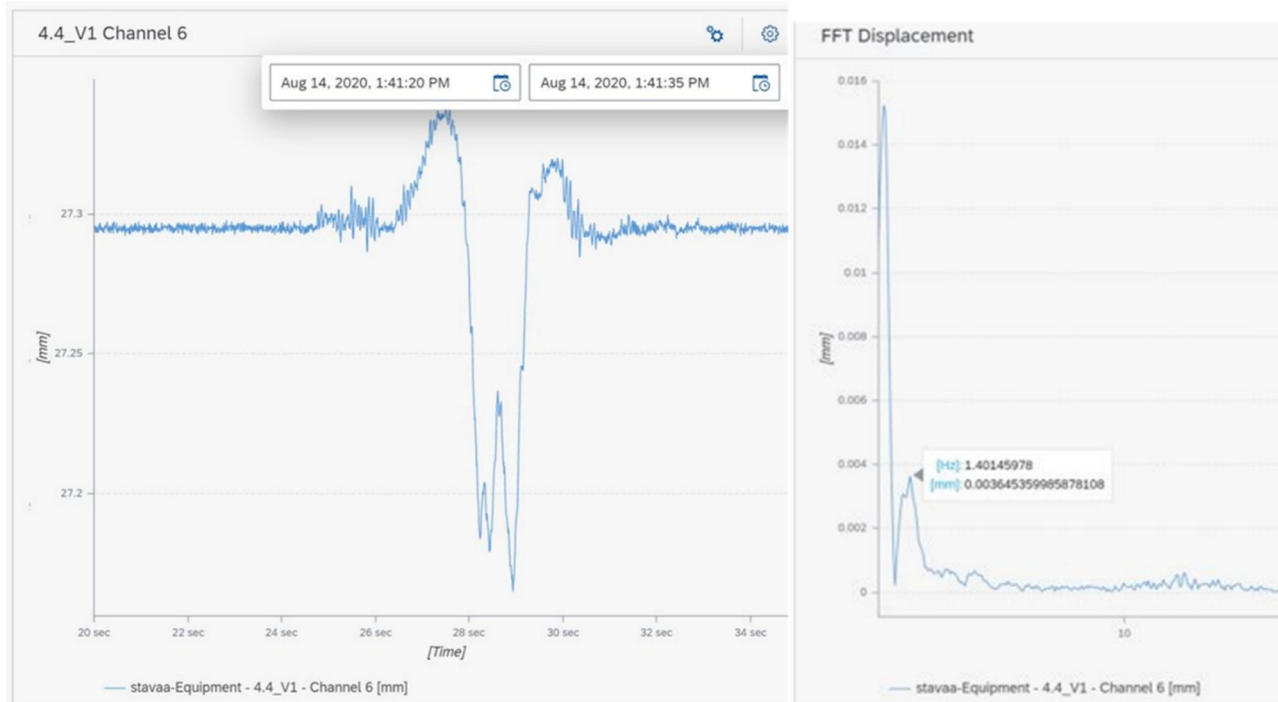
Figure 5. Dynamic response in crack gauge S1 in Figure 6, upon passage of a trailer truck (two mass centroids, as seen by the hump in the middle of the signal in second 28–29). The left graph shows the time domain view of non-calibrated distance gauge length, millimetre along the y-axis and time in seconds along x-axis (note that smaller measured value on the gauge equals widening of crack opening). The right graph plots the same signal in the frequency domain using FFT, normalized amplitude along y-axis, frequency in Hz along x-axis.

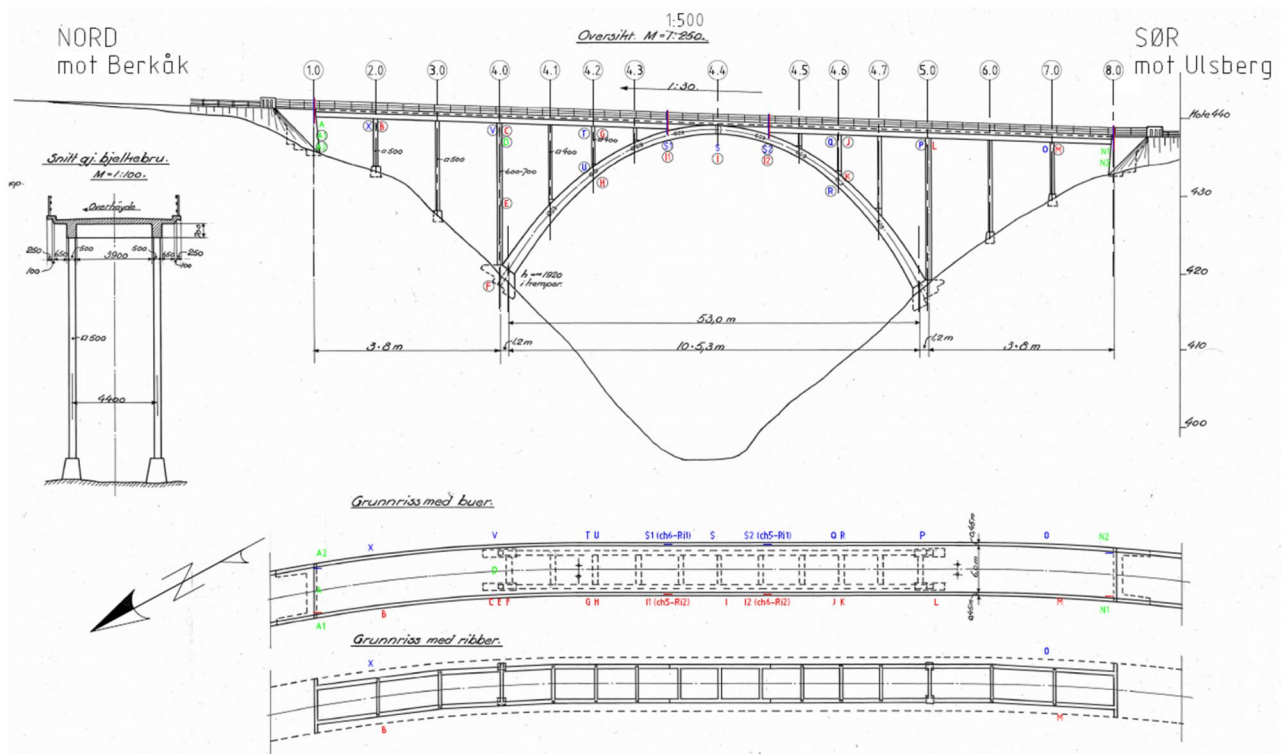
Figure 6. Stavå bridge seen from the west and from the top on original drawing from 1942, with location of sensors after 2019 upgrade. Blue on east side, red on west, green distance gauges at abutments. See description in text.

- 21 wireless and battery-driven⁷ tri-axial accelerometers (B-M, O-X), sampling at rate 64 Hz, to gain sufficiently complete understanding of the bridge's global behaviour.
- Four wireless, battery-driven gap sensors (I1-2, S1-2), sampling with rate 128 Hz, fitted on cracks located symmetrically on both sides of the road centerline about five meters north and south of bridge span midpoint, to monitor development of static, quasi-static and dynamic behavior.
- Four wireless, grid-connected distance gauges (A1-2, N1-2), sampling with rate 128 Hz, mounted on each side of the expansion joints at both abutments.

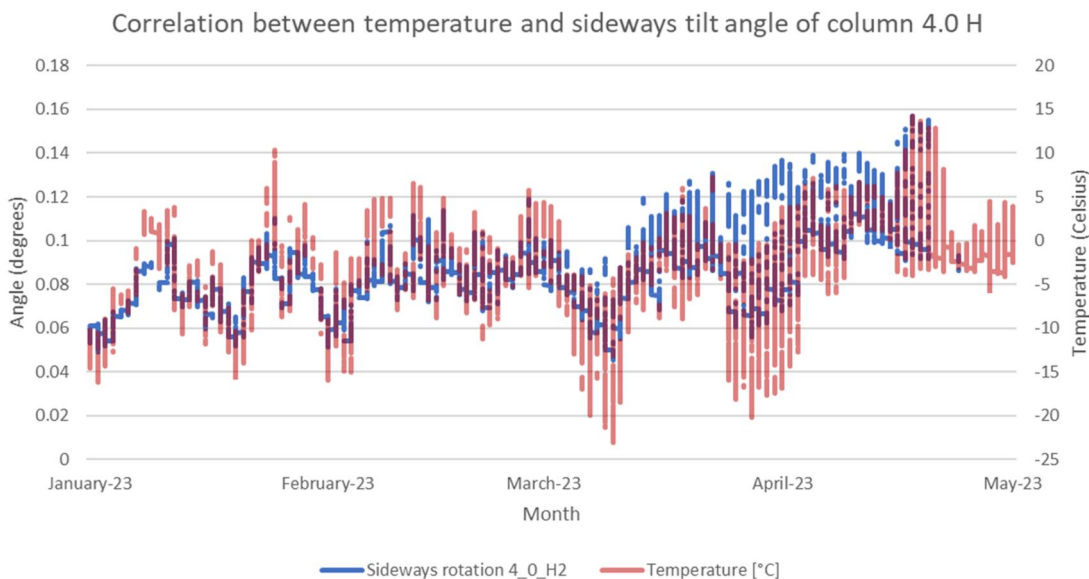
Figure 7. Four-month plot, temperature and sideways rotation of sensor E/4_0_H2 (midpoint H2 on column 4.0).

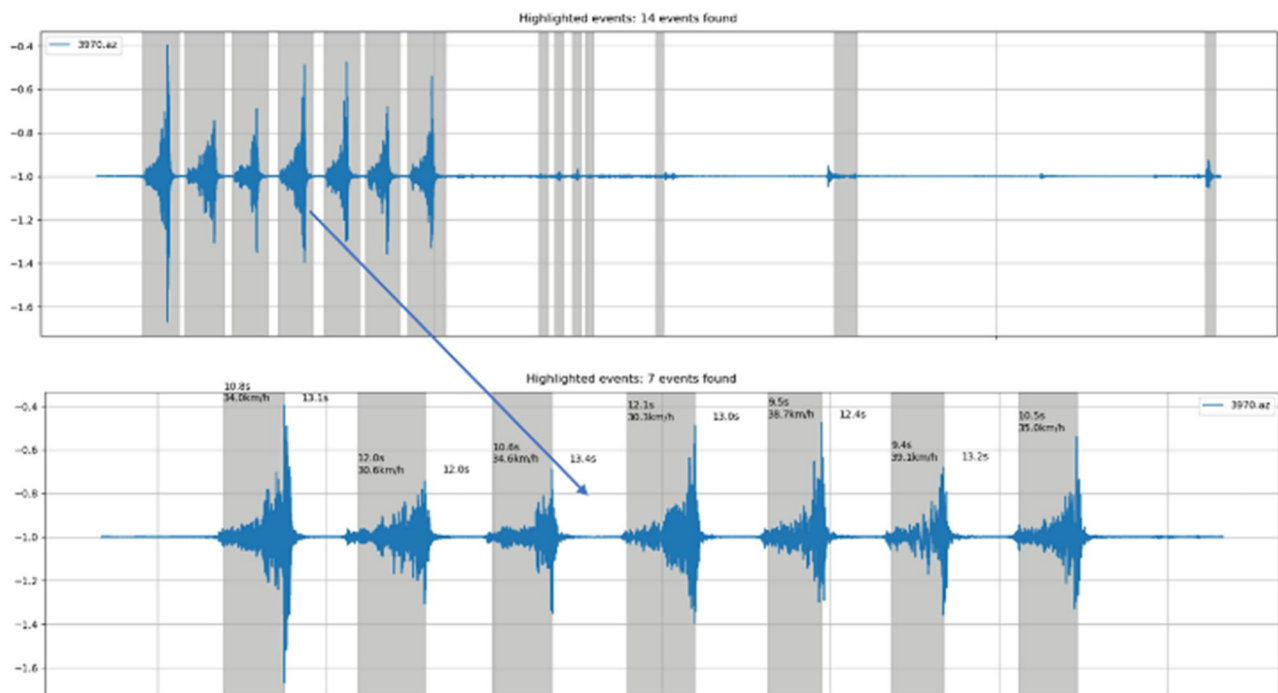
Figure 8. Routine machine-assisted screening singled out a set of events, here signal from accelerometer (later moved) at west on section 1. Vertical acceleration in g on y-axis, time on x-axis (time span, seven minutes in bottom detail plot).

previous maxima by an order of magnitude (Figure 8). The amplitude of vertical accelerations in the middle of the bridge span exceeded 0.5 g (5 m/s^2) and the calculated vertical displacement during the incident was as much as $\pm 4\text{ cm}$. While no design data was available to quantify the impact this would have on the structural health, it was nevertheless apparent that there was reason for concern. The pattern (speed, amplitude, pattern and pattern similarity, spacing in time) indicated that a column of heavy vehicles had crossed the bridge from the south. The camera was not functioning that period, but the direction could be deduced from the track of the peak of the sensor signals, for instance at the sensor near the north abutment (west on section 1.0) where values gradually built up for then to abruptly vanish. The speed was moderate, around $35\text{--}40\text{ km/h}$, and the individual crossings took place in regular intervals. It was consistent with military transport of heavy equipment. Though never officially confirmed, the incident was likely caused by retreating unit(s) from the NATO exercise Trident Juncture that had taken place in the mountains to the south of the bridge that week (NATO, 2018, 21).

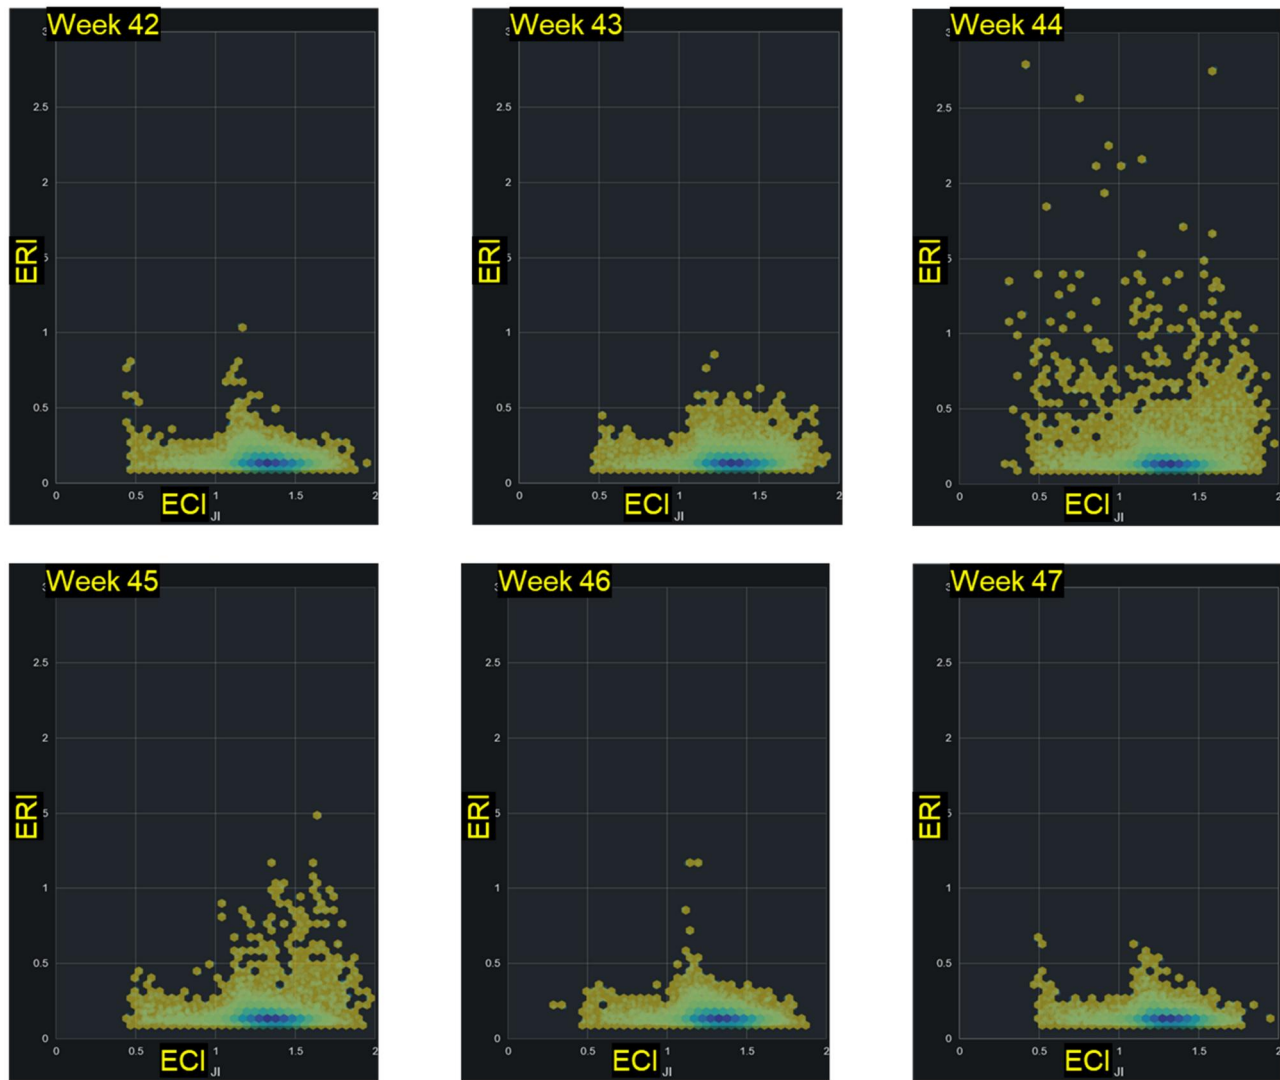
Figure 9. Results from sensor 5 (ref Figure 6), mounted east on section 4.4. Week-by-week scatter plots of ERI (m/s^2) on y-axis vs. ECI (dimensionless) on x-axis show all seconds above a noise threshold in the weeks 42–47. Week 44 (upper right) demonstrates a significant overrepresentation of very high values, especially in lower frequencies.

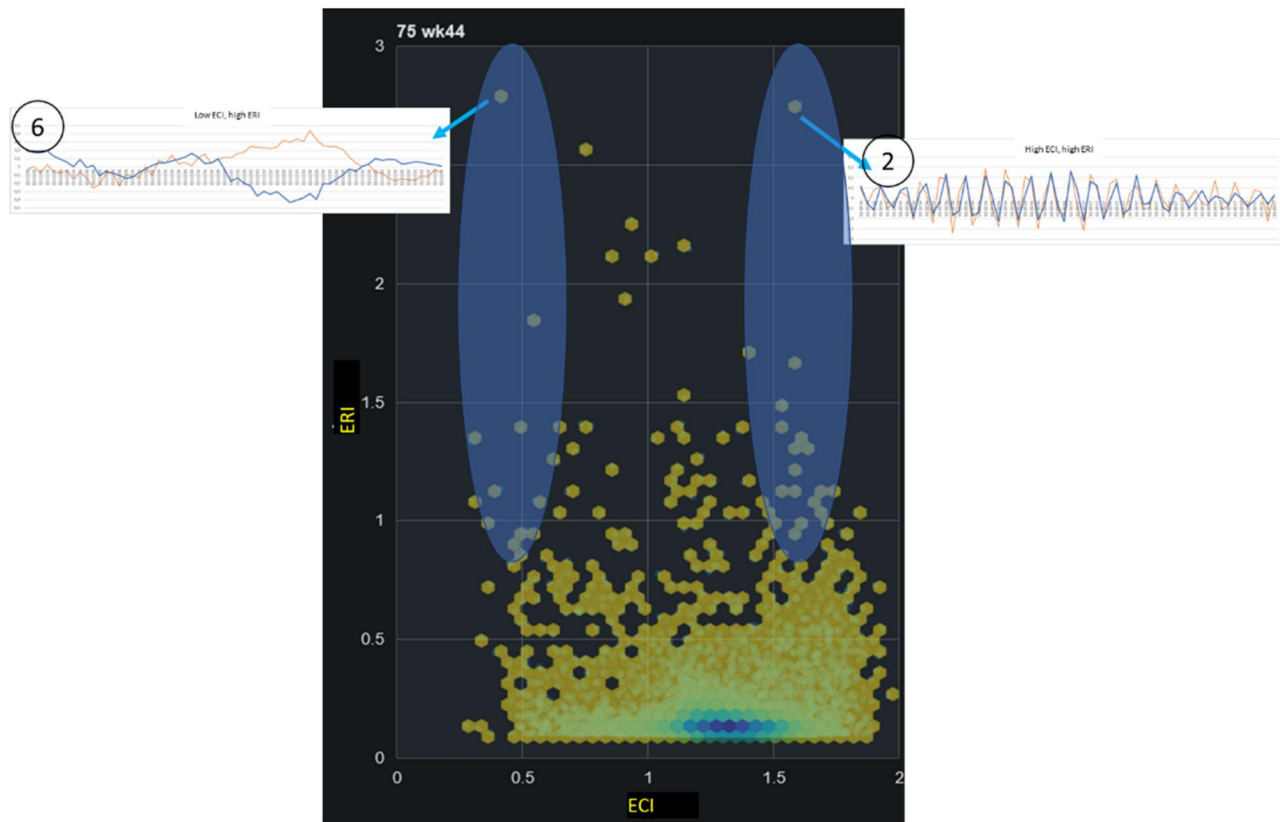
Figure 10. Embedded time-domain plot of two seconds in the middle of crossings 2 (11:10:56-57) and 6 (11:12:31-32), from two sensors S and I located on opposite sides of section 4.4 (middle). y-axes show vertical acceleration values in g, scaled ± 0.4 (2) and ± 0.5 (6), x-axes show time.

The embedded time series of crossing 6 in Figure 10 could support this. The two sensors accelerate with high

values in opposite direction, showing that the bridge deck at that section and at that moment twists. The right plots in Figure 11 are FFTs of the four second middle segments of the two crossings, spanning the time when the vehicles would be expected to cross the bridge span. The clearly dominating frequency of ~ 1 Hz on crossing 6 roughly corresponds to the first lateral natural eigenmode of about 1.4 Hz, adjusted for the added (assumed) mass of the transports. The bridge deck weighs about 300 tons total, roughly half of that being in the main span, while the combined weight of a battle tank and a transporter could reach up to 100 tons. This alone could explain a reduction of natural frequency of the combined system by about 20%.⁹

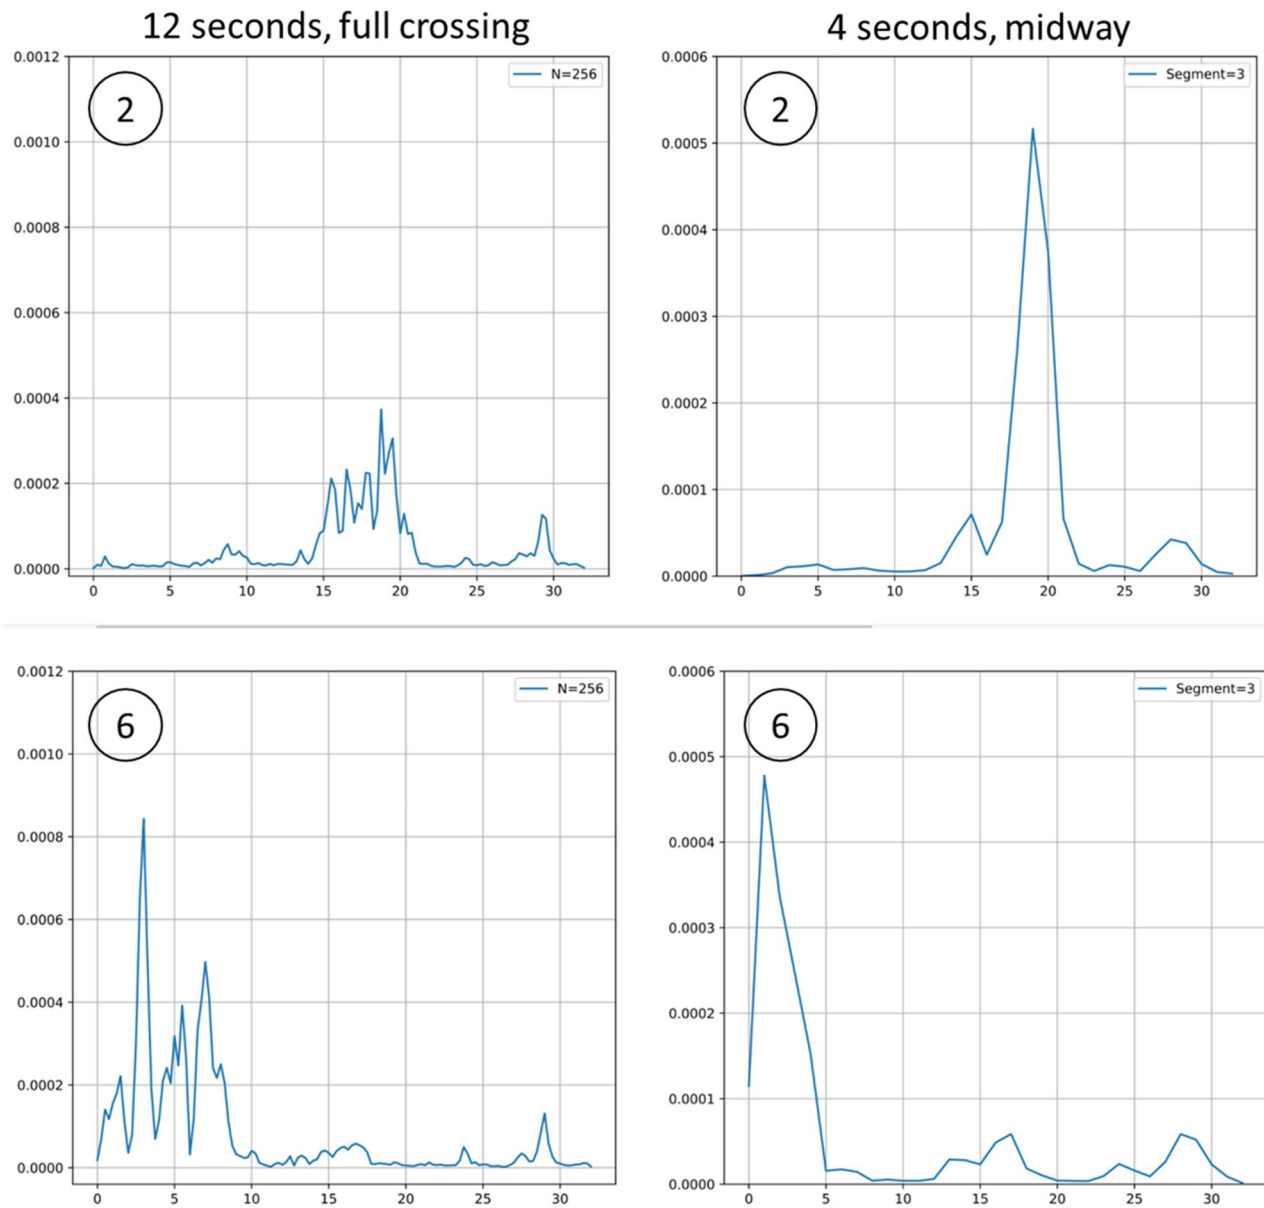
Figure 11. FFT (Welch, four seconds overlap) of lateral accelerations on sensor I, top graphs 2nd crossing, bottom graph 6th crossing (see Figure 10). Left graphs show FFT of full 12 s of crossing, right graphs four seconds in the middle of the time series. Vertical axes show a normalised frequency measure, horizontal axes show frequency in Hz.

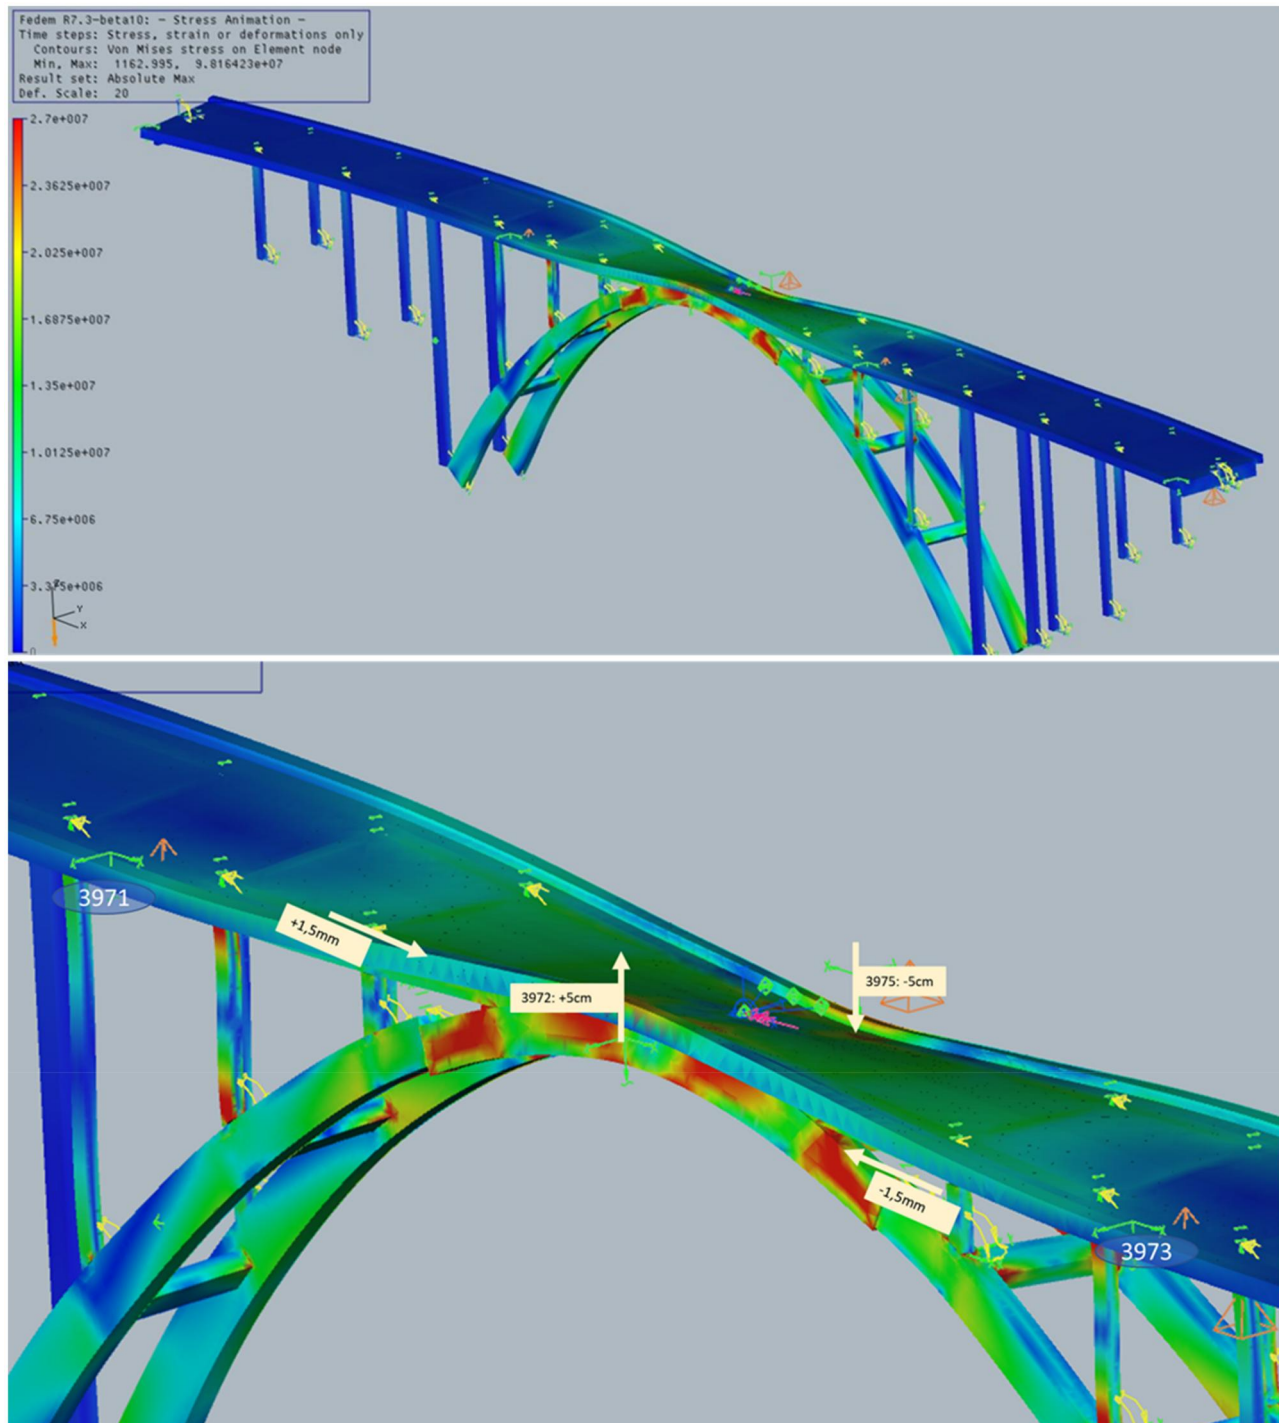
Figure 13. Result from applying a static load (torsional moment) on section 4.4 in a FEDEM model of the Stavå bridge, until deformations are similar to those calculated from accelerometer readings. Heatmap scales to 27 MPa.

Figure 13 shows result from an admittedly rather crude attempt to close this gap and quantify the effects in more common terms, forcing deformations at sensors I and S in the bridge middle by applying a static torsional moment at section 4.4 and inspecting the resulting stress heatmap.

The NPRA inspector acted resolutely, closed off the damaged lane with his car, arranged to cordon off the southeast entry point, ensuring vehicles slowed down and avoided the damaged area, made the necessary arrangements with a traffic watch company and did not leave the scene until a manual 24/7 traffic control was in place late that evening. Since then, only one heavy vehicle was allowed on the bridge at a time and the east lane was closed, in an arrangement that would stay in place until a temporary replacement bridge was completed a little less than a year later. Lack of such action could have resulted in accelerated damage progression, even more severely compromising the global structure through the ever-more-frequent and ever-more-powerful impacts. For instance, it would not be unexpected if the southwest bearing, the only remaining in the south, would be damaged by the increased loads and impacts. It could also be that one or more of the cracks at I1-2 or S1-2 would grow, considering the consequences for instance of the ‘wavelike’ motion seen in the bridge during the event (Figure 20) and the twisting mode documented in November 2018 (Figures 12 and 13).

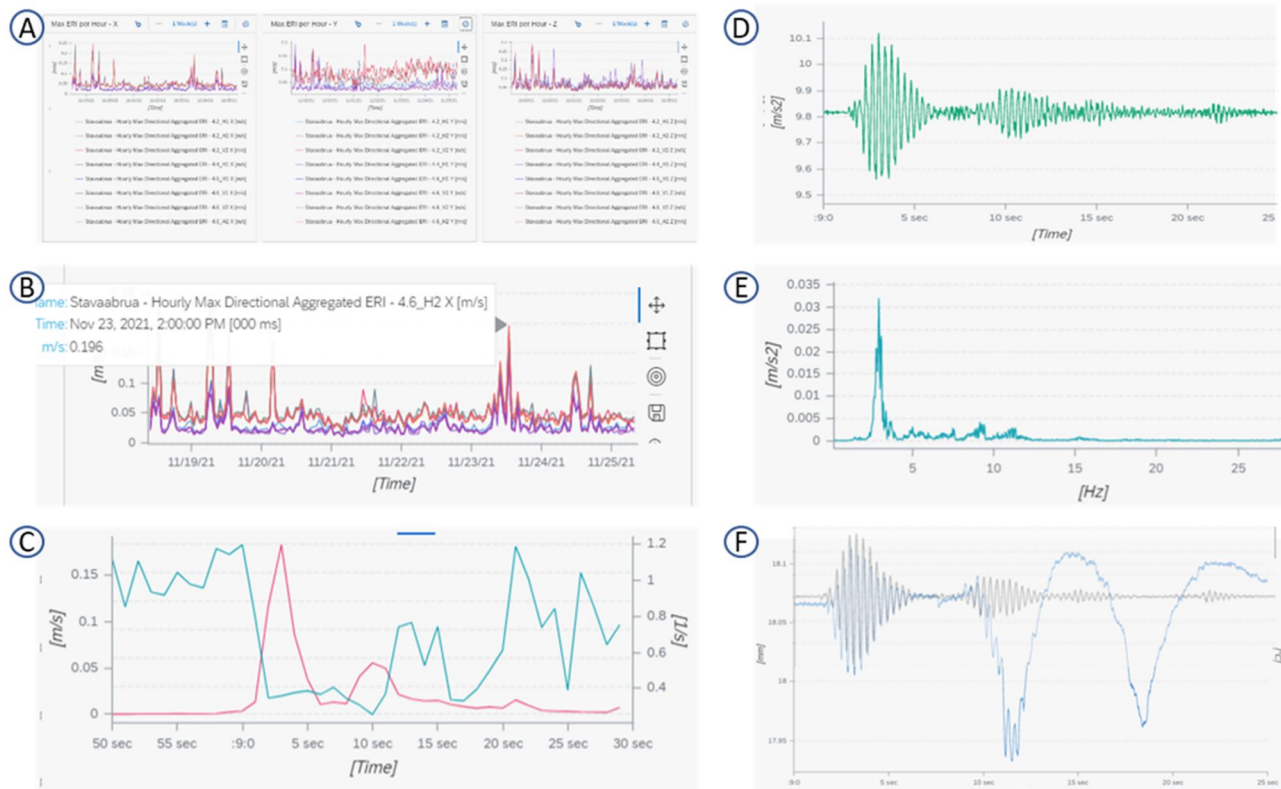
Figure 14. A set of views typically used to analyse a situation. Walkthrough/detailed description in text.

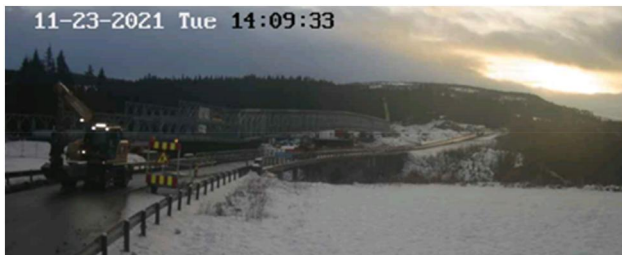
Figure 15. Two excavators crossing bridge cause an impulse on entry, giving rise to large horizontal responses in the first natural frequency, combined with high-frequency disturbance during crossing.

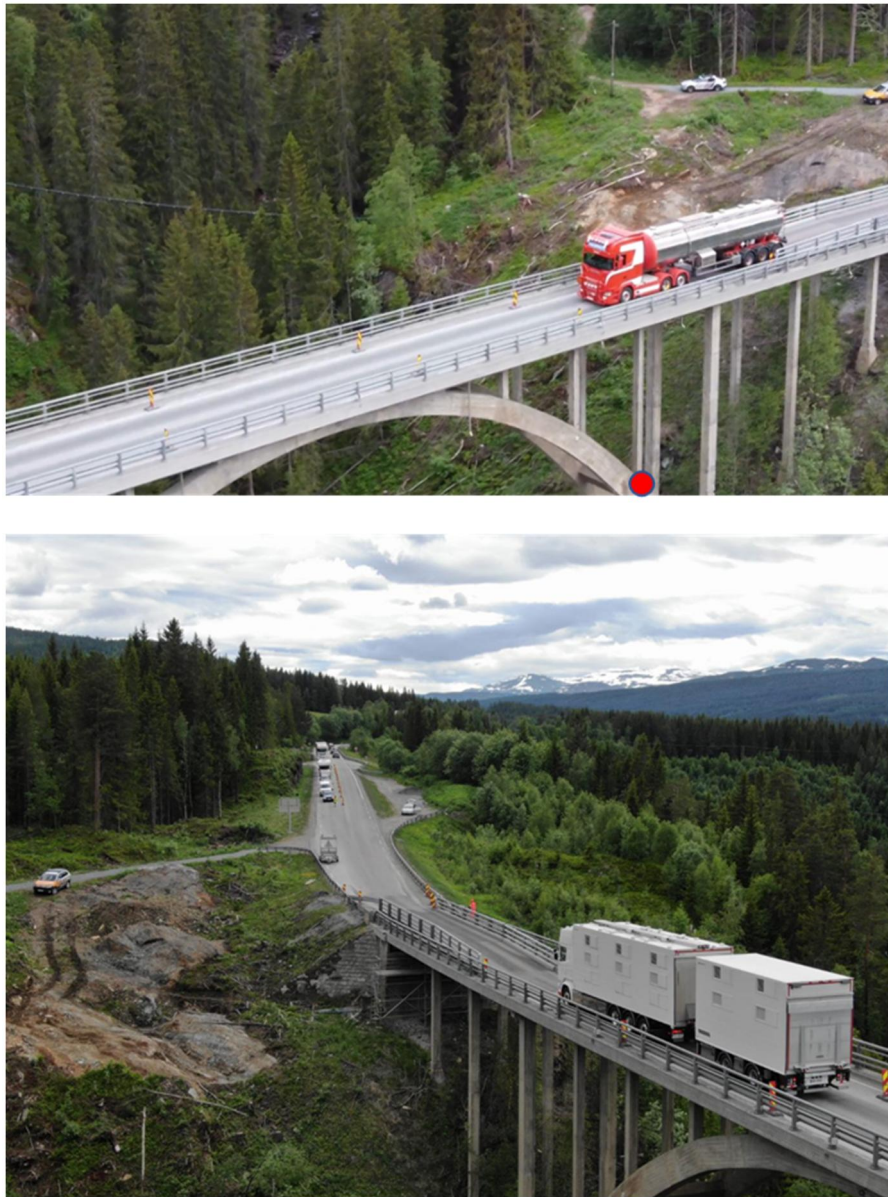
Figure 16. Repair done after April 2021, a ramp to offload the south abutment implied an elevation of a stretch of the road, picture showing northbound truck on top (location of sensor K marked by red circle), southbound on bottom. Photos: Kjetil Sletten.

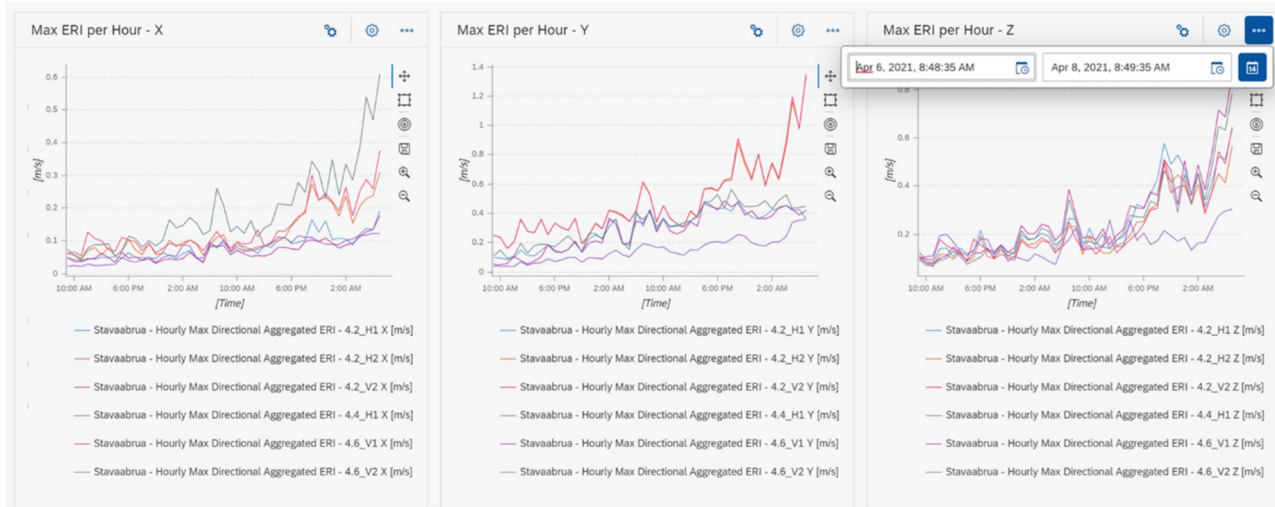
Figure 17. Plot of hourly maxima at key positions (from top, G, H, T, I, Q, R, ref Figure 6) on the bridge deck and arced columns in the period April 2nd to April 8th.

The development in maxima over those two days is shown in Figure 17. Preliminary analyses and system tests verified that the alerts were real, and not due to a technical glitch in the monitoring system. Something was taking place that caused the structure to respond increasingly more violently to quite normal traffic situations. Sensors located far apart showed the same tendency, proving that whatever was taking place influenced the global structure. It was also clear that the supporting arc columns at that time were affected the most (suffix 2 in Figure 17), especially in the lateral (y) direction, and especially in the north (section 4.2), while the

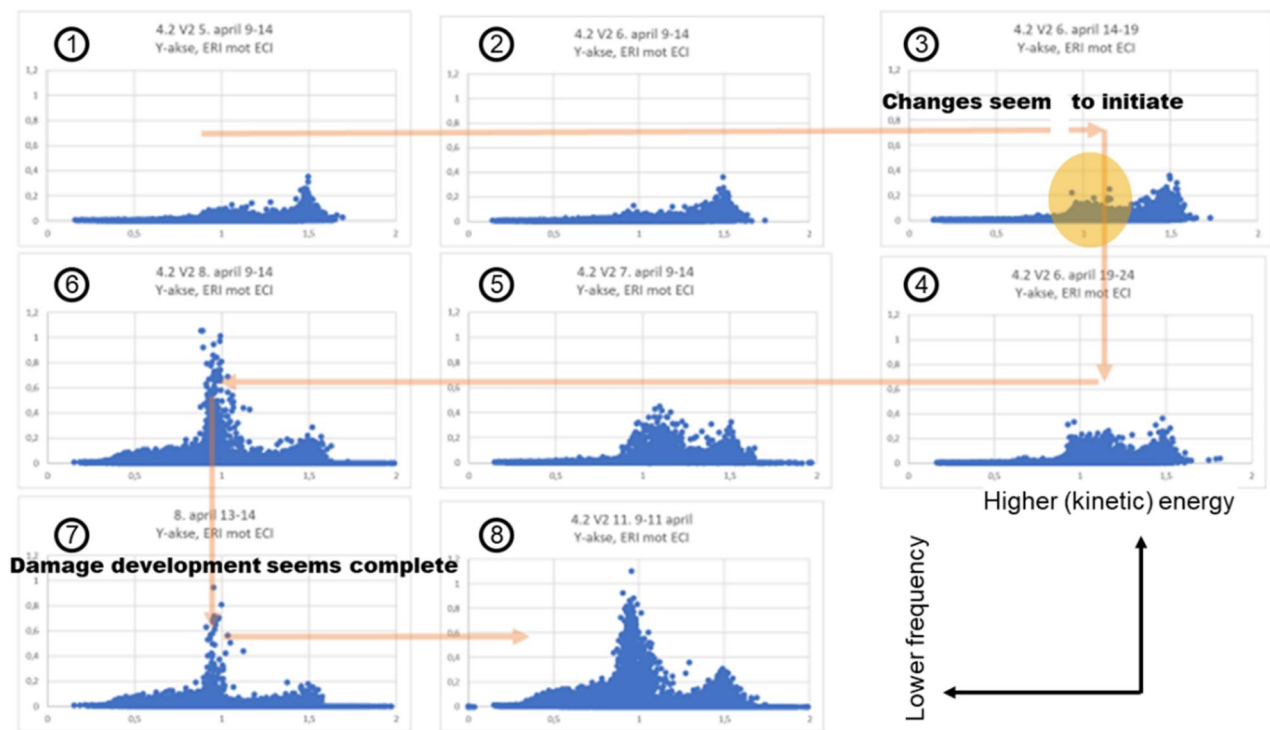
Figure 18. From original investigation, tracking development of lateral (y) motion in ERI-ECI on sensor U (section 4.2, east side, arc column) ref Figure 6. ERI (0–1.2) along y-axis, ECI (0–2) along x-axis. Description in text.

- 1: April 5th, 9–14.
- 2–4: April 6th, three consecutive five-hour periods between 9 and 24.
- 5: April 7th, 9–14.
- 6: April 8th 9–14.
- 7: April 8th, 13–14 (last hour of plot 6).
- 8: April 9th through April 11th, complete 72 hours of observations.

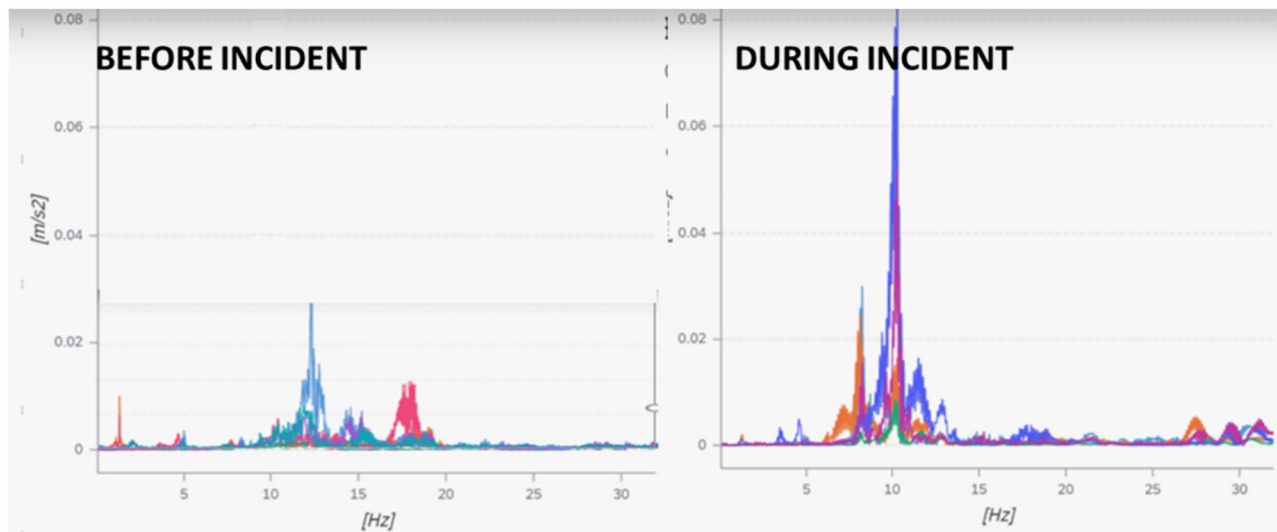
Figure 19. FFT Of the acceleration signal of all sensors during northbound bridge crossings, to the left before and to the right during incident, similar vehicles and speed as identified by pictures. Scales are the same in the two plots, 0.8 m/s^2 and 32 Hz .

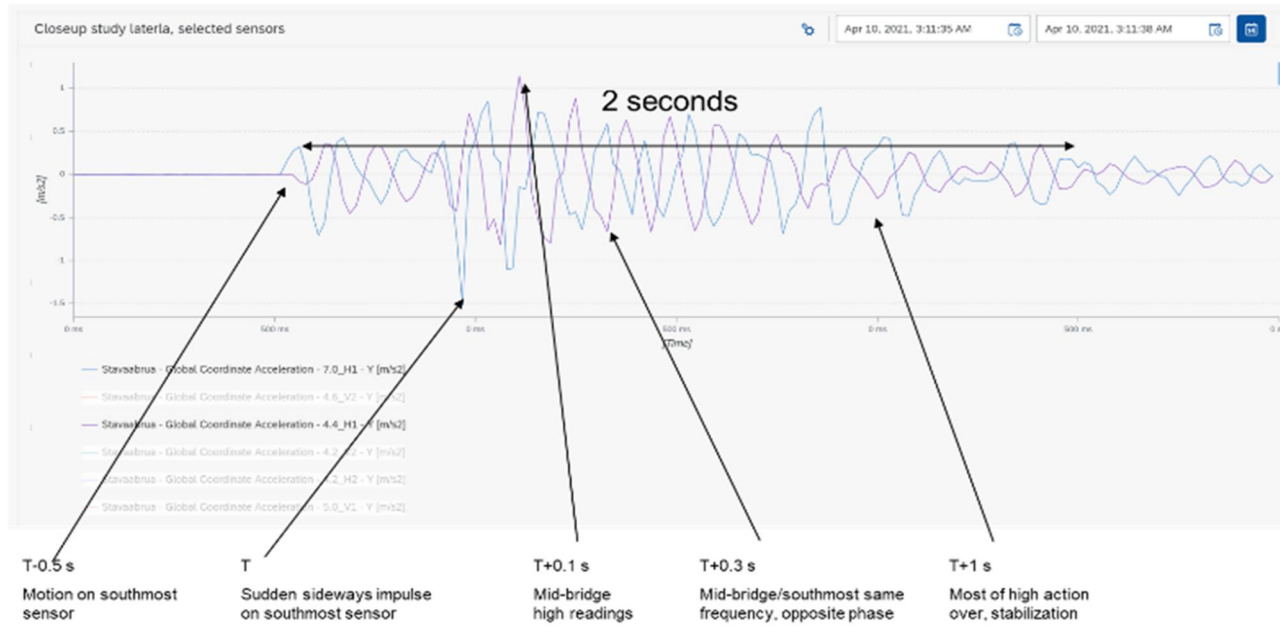
Figure 20. High-resolution view of acceleration signals om two sensors, M mounted at section 7, west side, and I at section 4.4, west side, over a 3-s period. The rapid development demonstrated that an impact occurred immediately after vehicle entry. (acceleration in m/s^2 on y axis, scale -1.5 to +1.1.).

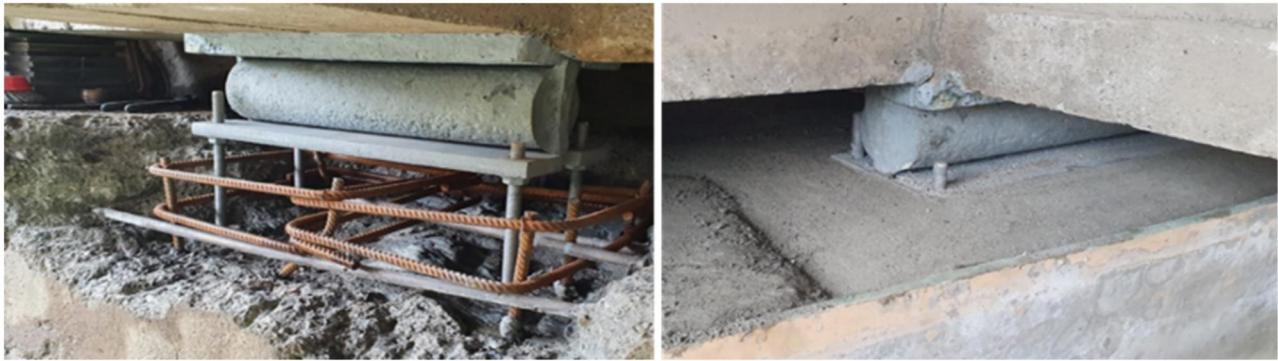
Figure 21. Cause, effect or both? Southeast roller bearing, before and after repair.

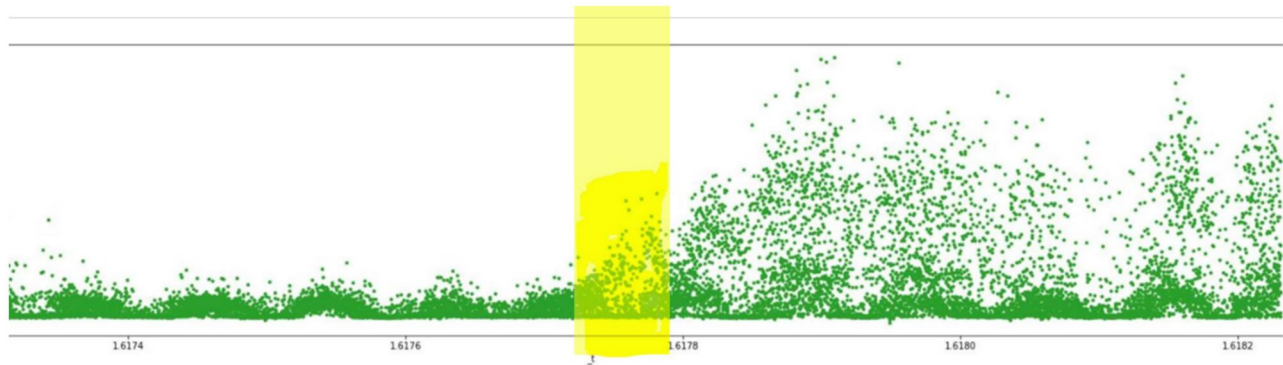
Figure 22. Plot of all individual sideways acceleration values on sensor U at section 4.2, east side, in the period April 2nd to April 12th (timescale epoch time, y-axis scale missing). Yellow field marks period from afternoon April 6th till noon April 7th.

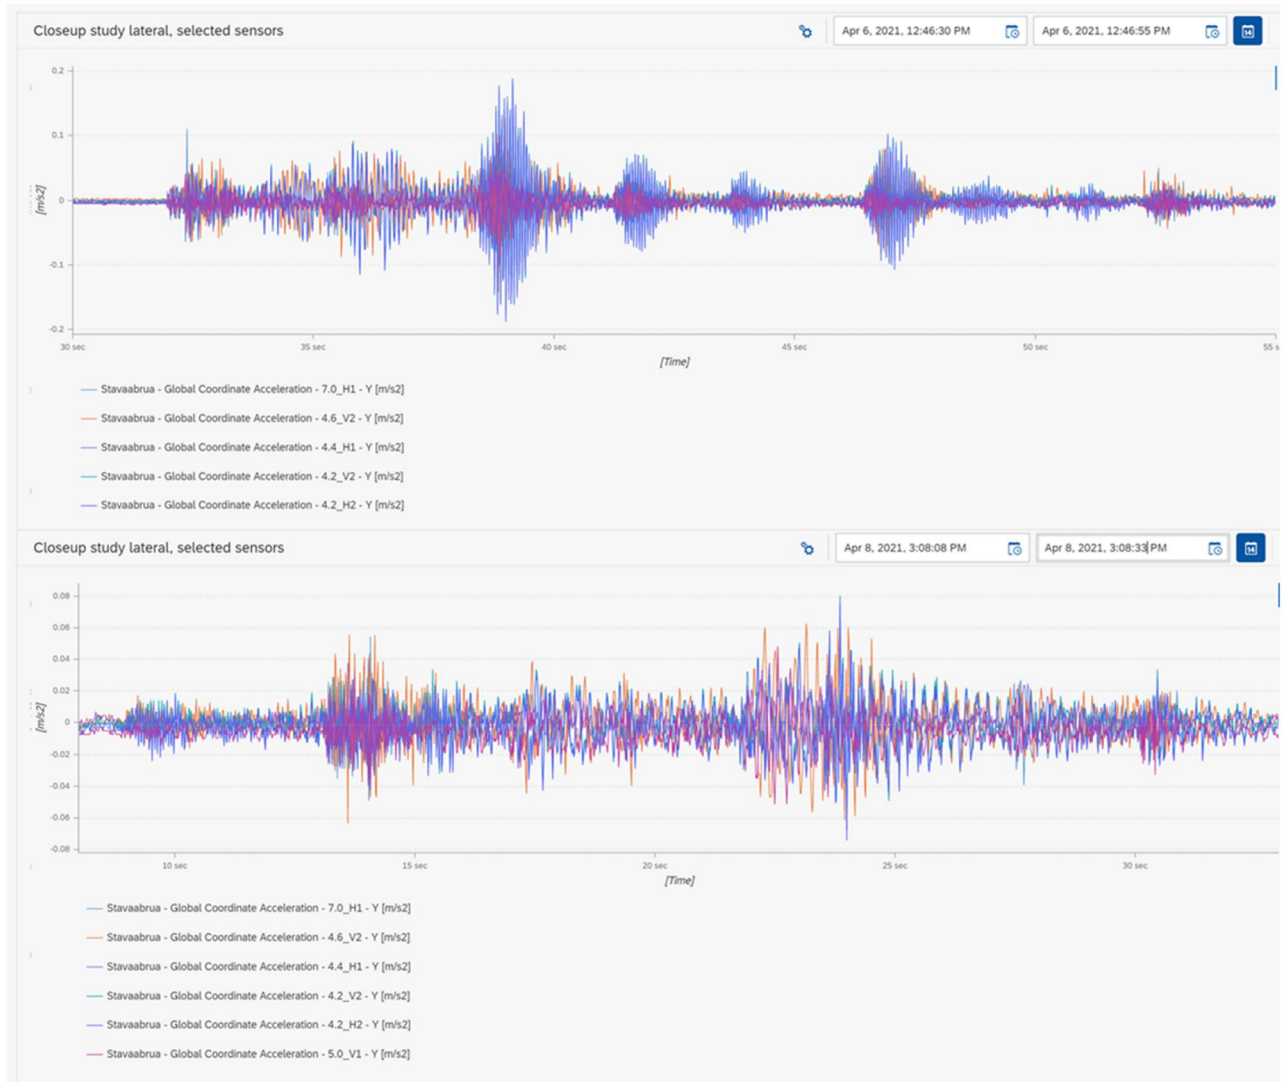
Figure 23. Time series (25 s) of lateral accelerations on selected sensors (from the top, M, R, I, T, G and P) during time of dynamite blasts, upper plot from April 6th with visible disturbances from what seems like cars crossing during the event (Stavå bridge being half a kilometre away from the blasts, it was assumed safe and not closed for traffic).

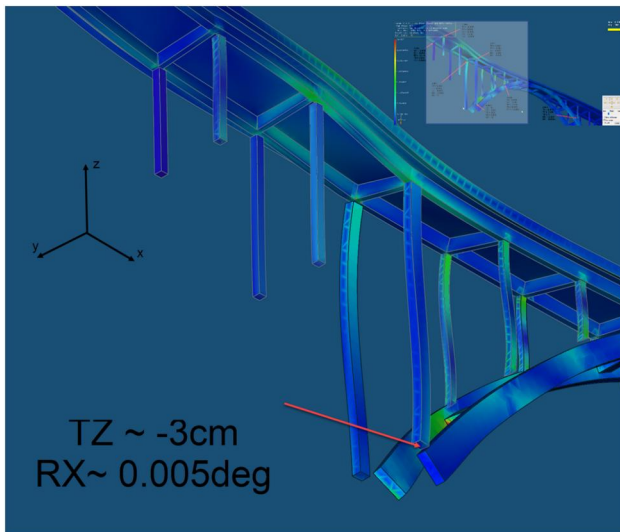
Figure 24. Finite element model (using FEDEM) of the Stavå bridge, releasing all degrees of freedom (including vertical support) under the northwest main foundation has the first order effect of a three cm sinkage.
