Asset management, condition monitoring and Digital Twins: damage detection and virtual inspection on a reinforced concrete bridge

Arnulf Hagen^a and Trond Michael Andersen^b

^aSAP Norway, Engineering Centre of Excellence/NTNU, Faculty of Engineering, Trondheim, Norway; ^bNorwegian Public Roads Administration, Division of Operation and Maintenance, Oslo, Norway

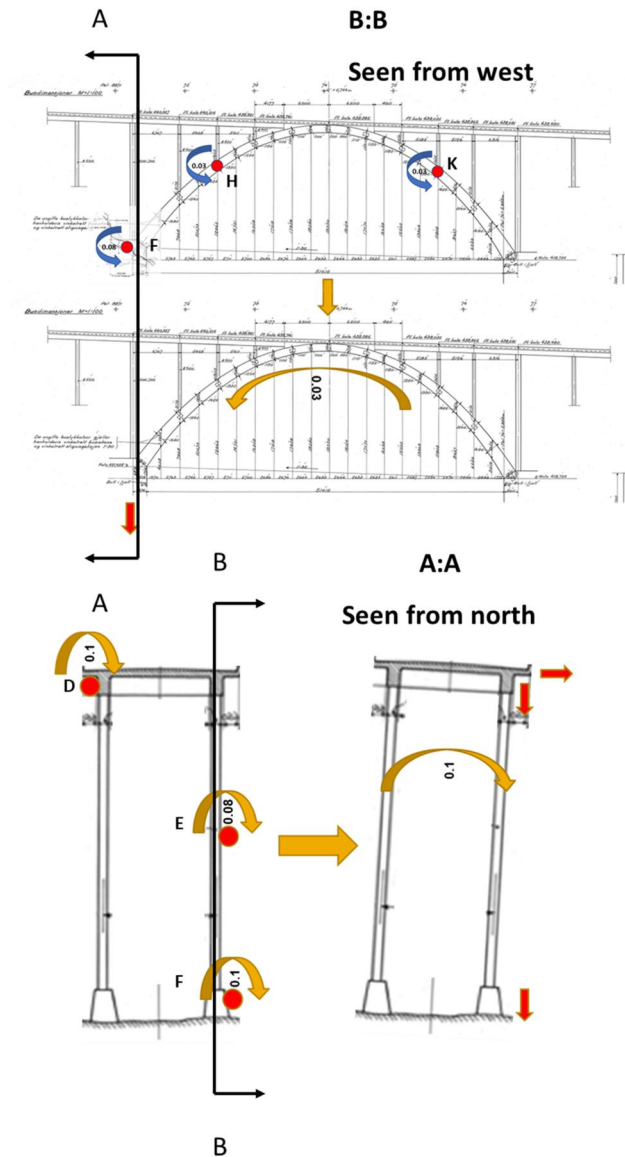
Figure 25. Key sensors (lettered references to Figure 6) showed readings consistent with rigid-body rotation of the bridge, counter-clockwise as seen from the west (top), clockwise as seen from the north (bottom).

Figure 25 illustrates the situation after 'transferring' the measured rotations at select locations to a rigid body motion. The result is consistent with leaning and heeling in the direction of one of the main foundations in northwest, which also rotates. Though not conclusive, this supports the hypothesis of sinkage and corresponding change in the static situation (possibly also resulting in crack growth or some other mechanism to 'relax' the structure), in turn having the potential to change the dynamic behaviour of the bridge. The gradual change might have caused a limit to finally be

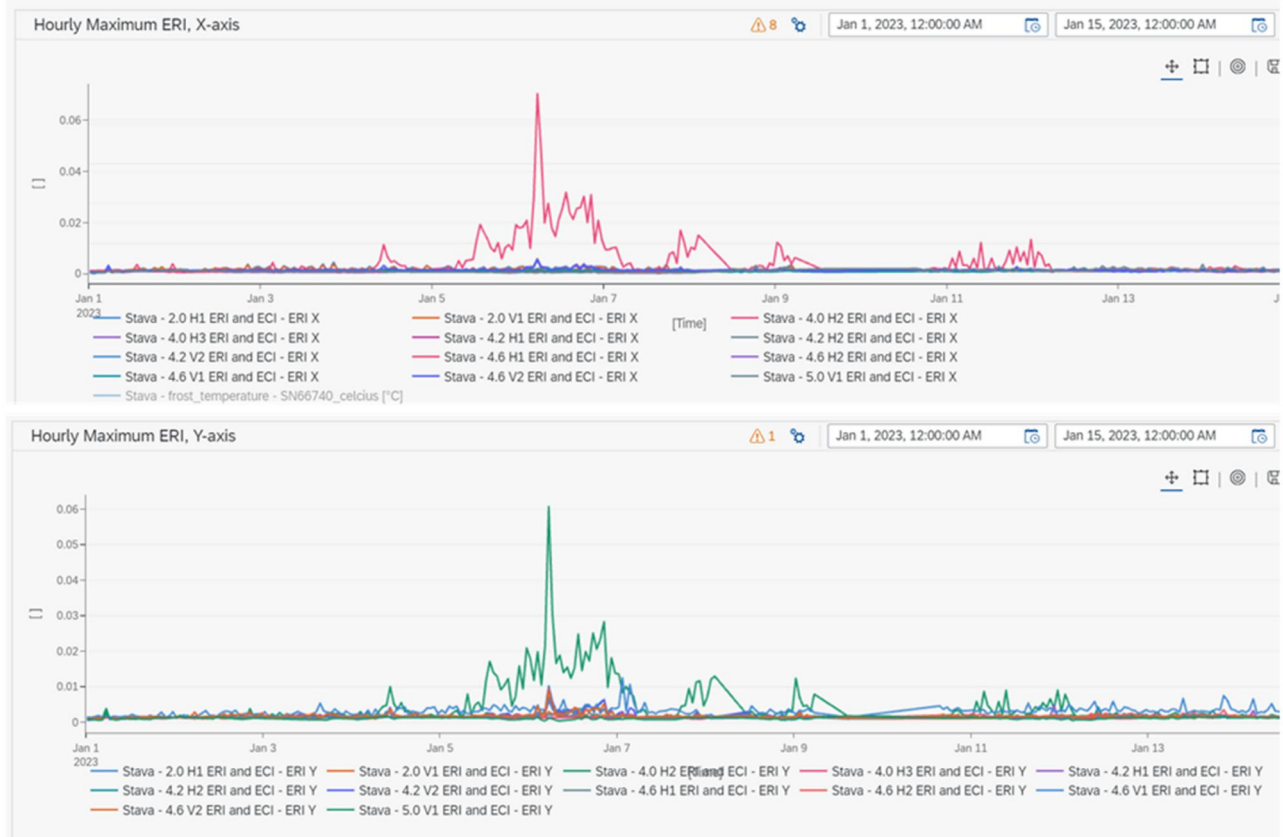
Figure 26. Inspecting hourly maxima of ERI in the horizontal plane between January 1st and January 15th, 2023, top being accelerations along x-axis (driving direction), bottom y-axis (across driving direction), peaking values on sensor E (4.0 H2, ref [Figure 6](#)) placed at the middle of northwest column.

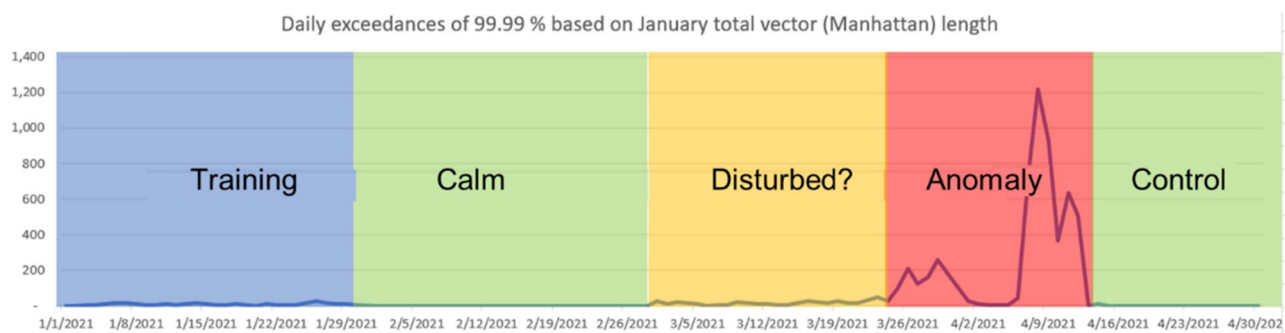
Figure 27. Daily alert count with all indicators merged into one Manhattan vector and an eight pr day (99.99 percentile) threshold value for alerts being set in January.

Another test applied a similar approach while using a Manhattan vector (arithmetic sum) of all nine indicators in Table 2. The training period was applied to set a quite 'alert tolerant' 99.99 percentile threshold (mean time between warnings expected to be 10 000 s, about eight pr day). The result is shown in Figure 27 Using this approach, the

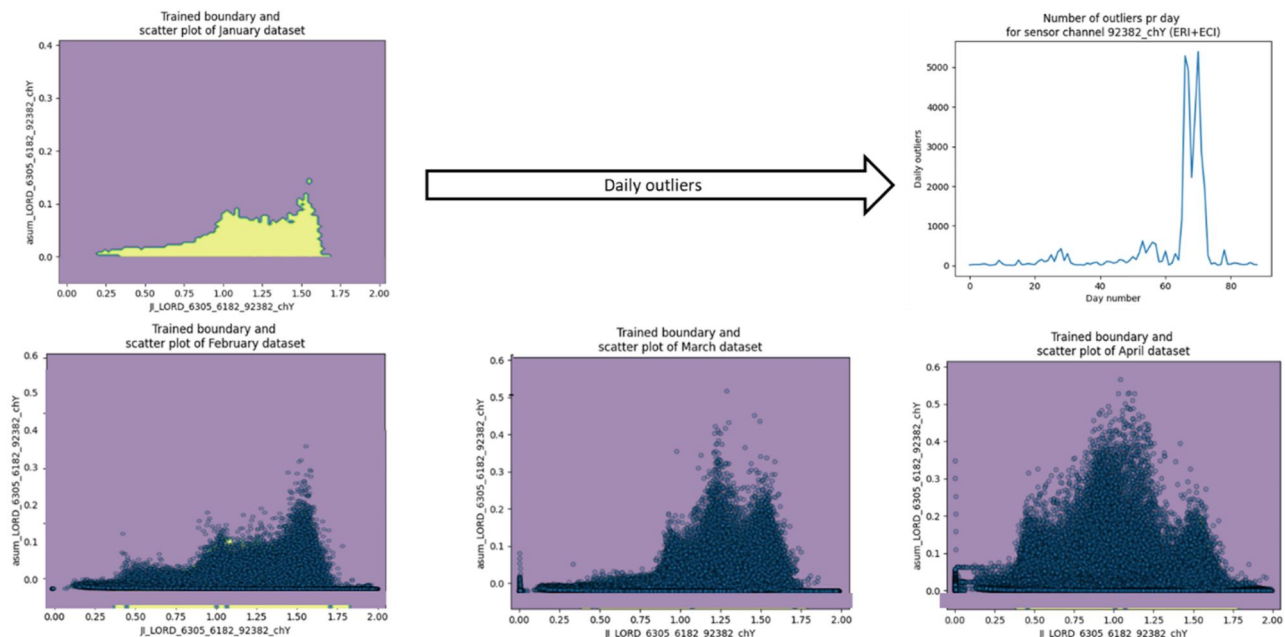
Figure 28. Upper left graph, visualized model generated from Isolation Forest algorithm applied to a combination of ERI and ECI for sensor Q, lateral (y) direction, trained on January 2021. Upper right graph shows count of daily reported anomalies, horizontal axis representing number of days since February 1st (through April 30th). The bottom graphs are scatter plots of all seconds, ECI (x-axis) against ERI (y-axis), superimposed on the model for the months of February, March and April.

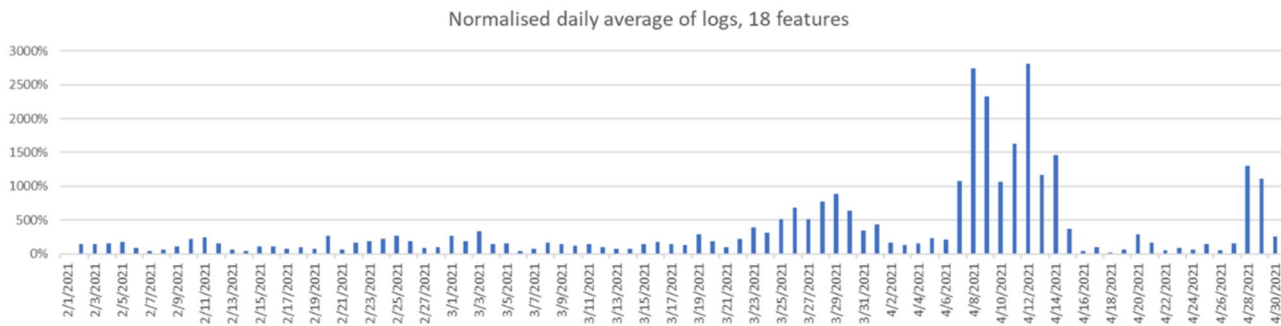
Figure 29. Normalised daily sum of logarithm of anomaly scores ‘harvested’ while running Isolation Forest on 18 features: ERI and ECI for G, Q and T in three directions. The peaks after April 12 (when measures were taken to restrict loads) are related to repair works.
