**Supplementary information for "Low-loss silicon nitride Kerr-microresonators
fabricated with metallic etch masks via metal lift-off"**

**I. REDEPOSITION, INCOMPLETE PATTERNING, AND EXCESS METAL BUILDUP:
CHARACTERISTIC ISSUES IN METAL LIFT-OFF AND THEIR SIGNATURES IN THE WAVEGUIDES**

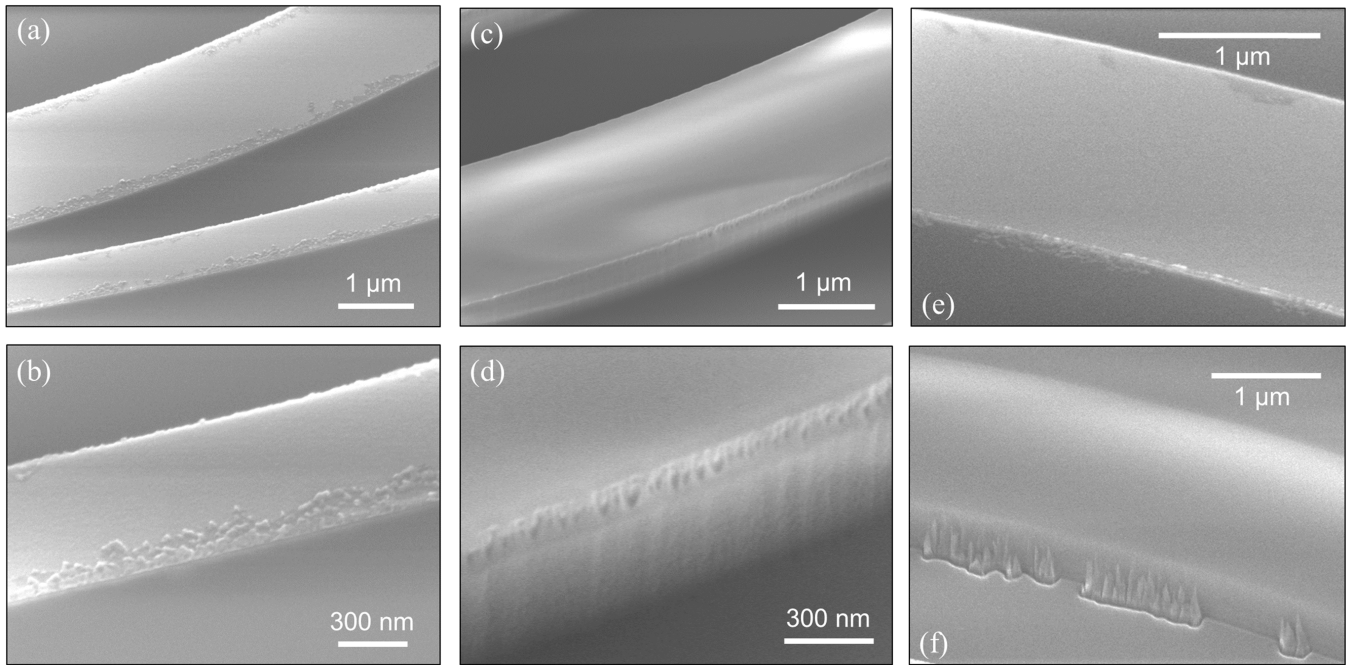
FIG. S1. SEM micrographs of lift-off defects and their effects post-etching. (a) SEM micrograph showing impartial lift-off with (b) zoomed focus on the extra metal and roughness along the perimeter of the metal mask. The metal mask is shown on the bare silicon nitride prior to etching. (c) SEM of etched ring resonator waveguide, prior to metal mask removal. (d) High magnification SEM of the sidewall in (c), showing roughness in the form of vertical striations transferred from the metal mask. (e) Lift-off defects extending past sidewall perimeter due to either impartial lift-off or metal re-deposition resulting in unwanted masking. The metal mask is shown on the bare silicon nitride prior to etching. (f) Partially etched "islands" due to the defect masking in (e).

While metal deposition and lift-off has the advantage of being a relatively simple addition to the subtractive fabrication flow, it introduces additional defect-prone steps that can carry flaws through to the final device in the subsequent etch. Aside from the quality of the metal layer (which determines the results in Fig. 6), metal deposition on the sacrificial resist sidewall, incomplete/partial lift-off, and re-deposition of the floated metal during lift-off are all potential pitfalls that must be considered and avoided. We highlight these three issues in Fig. S1. Partial lift-off due to sidewall deposition (Fig. S1a and S1b (zoomed)) can result in post-etch roughness transferred to the sidewall after etching, as seen in Fig. S1c and S1d (zoomed). In cases where the defects extend past the sidewall, or there is re-deposition of the lifted metal in the open areas (Fig. S1e), defects such as the partially etched "islands" along the waveguide sidewalls (seen in Fig. S1f) may be observed. For the issue of sidewall deposition resulting in poor mask edge quality and/or poor lift-off, targeting an "undercut" profile in the resist sidewall can aid in shielding the sidewall from unwanted metal deposition. If re-deposition in the subsequent lift-off stage is an issue, heating the solvent and/or performing the lift-off in an ultrasonic bath may help remove the lifted metal from the surface and away from the open area to be etched. We have found that SEM imaging can clearly identify the above defects associated with metal lift-off, providing a clear way to immediately identify workable devices.
