Autopsy on an RF-Processed X-band Travelling Wave Structure

F. Le Pimpec, S. Harvey, R.E. Kirby, F. Marcelja
 SLAC, 2575 Sand Hill Road, Menlo Park CA 94025 , USA

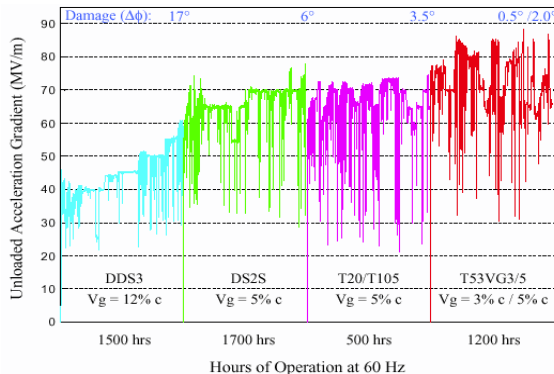
Figure 1: History operation at NLCTA of some 11.424 GHz TW structures

The Next Linear Collider (NLC) accelerating structures, running at 11.424 GHz, are expected to hold a steady operational surface gradient of 73 MV/m, without breakdown arcing. A development program for the required structure has been in progress at SLAC for several years. Possible RF structure candidates, Travelling Wave (TW) and Standing Wave (SW) are tested in a specially dedicated linac at SLAC, the Next Linear Collider Test Accelerator (NLCTA). So far, mixed results have been obtained during high electric field-processing of structures, cf Fig. 1. Part of the success in reaching the required gradient has been the great improvement in cleaning and handling the structure prior to RF processing. Results of the breakdown pattern analysis via RF or acoustic sensors Fig.2, have led to the necessity to cut open the structure. In this paper we will present some of the results of the analysis of the autopsy of the 53 cm long T53Vg3R TW structure.

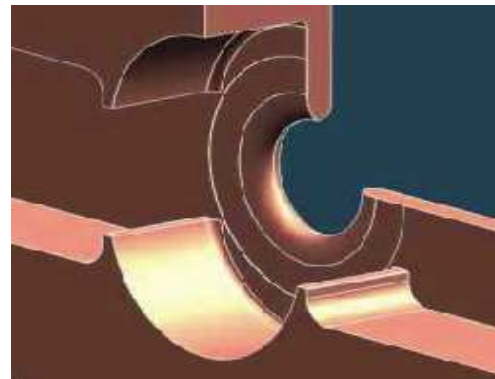
Figure 3: Input coupler design. The center is the cavity side with the first iris

The breakdown pattern localization Fig.2 reveals that most of the breakdown are occurring in the input coupler (IC) of the TW. In Fig.3 we can see that the input coupler is divided into two parts the waveguide section, left side of the picture and the cell side in the center. The feature separating the waveguide side and the cell side is denominated "horns". The gap between the top and bottom horn is ~ 9 mm.
