# Setups for eliminating static charge of the ATLAS18 strip sensors

**ABSTRACT:** Construction of the new all-silicon Inner Tracker (ITk), developed by the ATLAS collaboration to be able to track charged particles produced at the High-Luminosity LHC, started in 2020 and is expected to continue till 2028. The ITk detector will include 18,000 highly segmented and radiation hard n<sup>+</sup>-in-p silicon strip sensors (ATLAS18), which are being manufactured by Hamamatsu Photonics. Mechanical and electrical characteristics of produced sensors are measured upon their delivery at several institutes participating in a complex Quality Control (QC) program. The QC tests performed on each individual sensor check the overall integrity and quality of the sensor. During the QC testing of ATLAS18 strip sensors, an increased number of sensors that failed the electrical tests was observed. In particular, IV measurements indicated an early breakdown, while large areas containing several tens or hundreds of neighbouring strips with low interstrip isolation were identified by the Full strip tests, and leakage current instabilities were measured in a long-term leakage current stability setup. Moreov

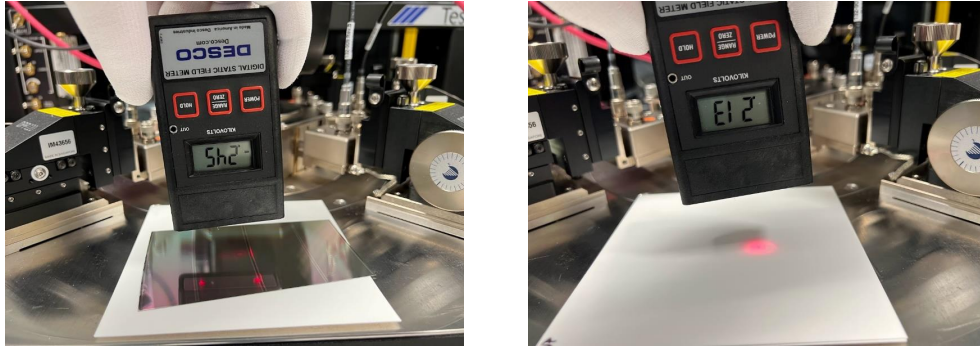
The QC sites have measured a significant electrostatic charge present on the surface of a considerable number of sensors and their plastic sheets, see Figure 1 for measurement in FZU. The plastic sheets are used to provide mechanical protection for the sensors within paper envelopes. The sensors themselves have a negative static charge, while the plastic sheets carry a positive charge. In both cases, the electrostatic charge can reach the values of several hundreds of volts per inch, see Figure 2.

**Figure 1.** Measurement of static charge on sensors and sheets with an electrostatic fieldmeter in FZU.

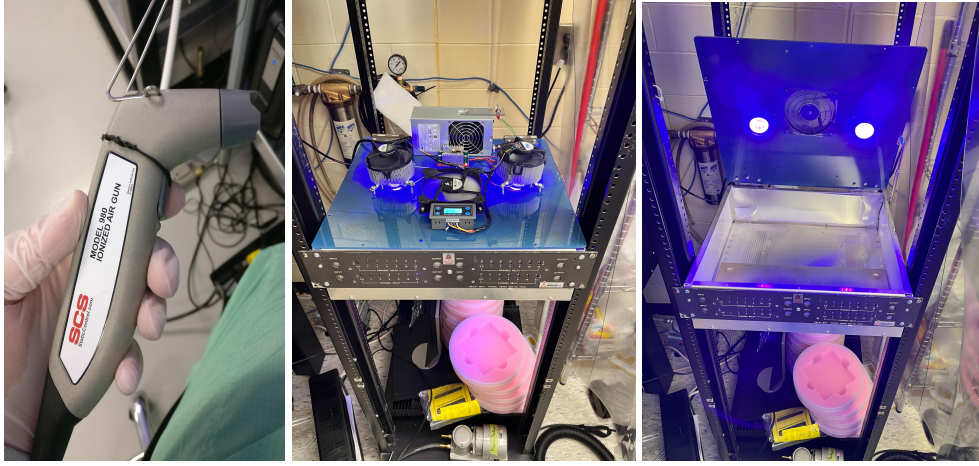
**Figure 3.** Carleton ion gun (left) and UV-A setup (middle and right).

In case the "Local trapped charge" event occurs on the sensor, this sensor can be permanently damaged. However, it is shown that the majority of affected sensors can be recovered by the application of specific recovery procedures, such as exposure to the intensive flow of an ionized gas, UV light irradiation, or a high-temperature treatment. All mentioned methods effectively dissipate the charges stuck in the surface of the SiO<sub>2</sub> passivation layers or in the interface between the passivation layer and the metal or silicon, by inducing additional charges, and thus stabilize the electrical characteristics of the affected sensors.

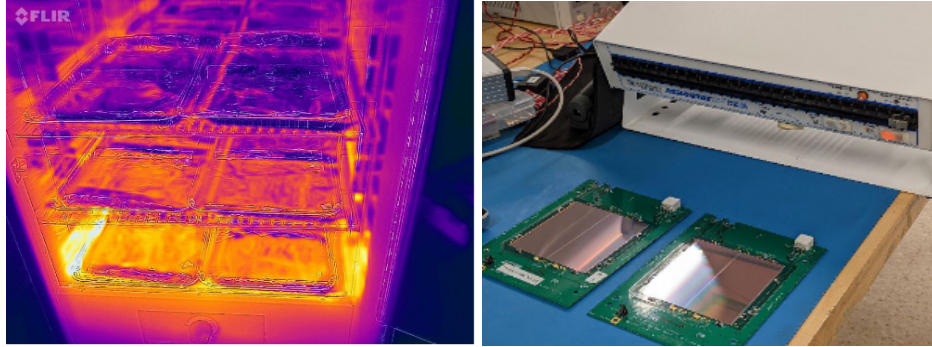
**Figure 4.** SCIPP baking oven (left) and ion blower setup (right).
