Experimental study on the gradual fracture of layers in multi-layer laminated glass plates under low-velocity impact

Alena Zemanová, Petr Konrád, Petr Hála, Radoslav Sovják,
Radim Hlužek, Jan Zeman, Michal Šejnoha

Abstract

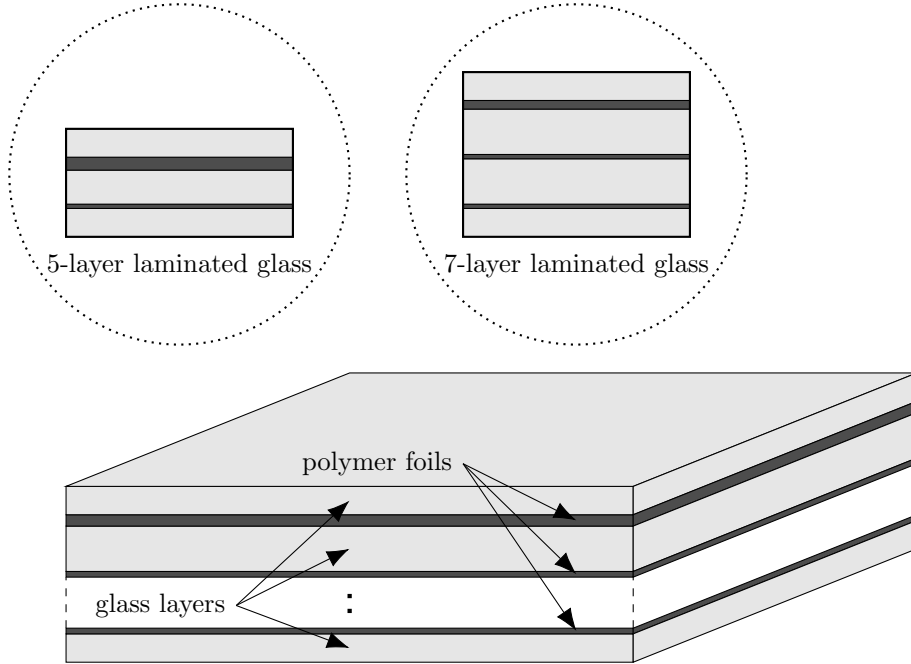
Figure 1: Scheme of multi-layer laminated glass plates.

Non-destructive and destructive impact tests were carried out on laminated glass units, where two different geometries (Figure 1) were selected for the experimental campaign, i.e., 5-layer laminated glass (5LG) containing three glass plies and two interlayers and 7-layer laminated glass (7LG) made from four glass plies connected with three interlayers.

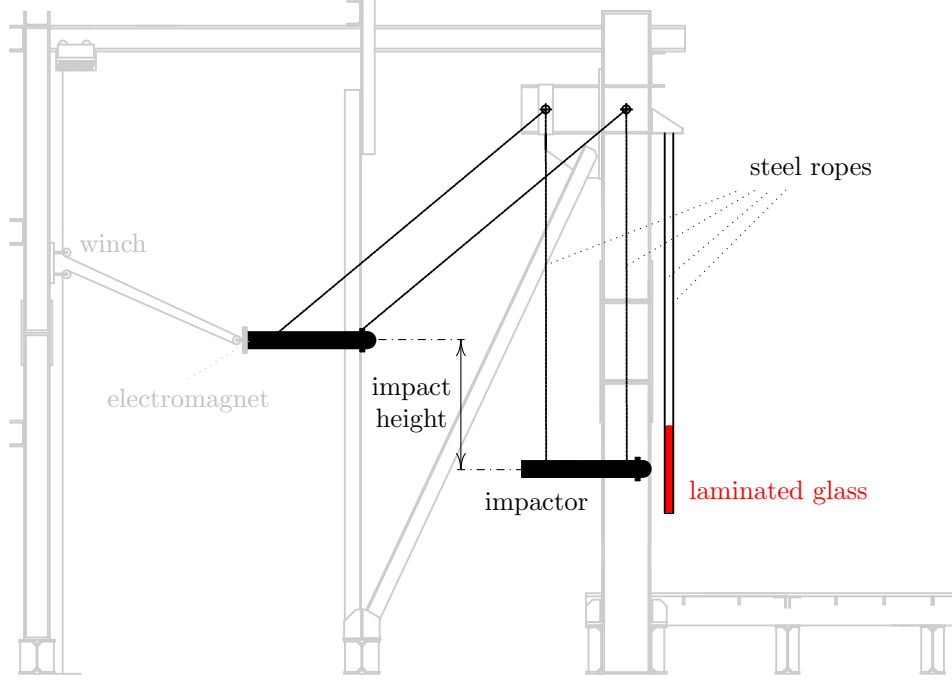
Figure 2: Side view of the pendulum impactor device.

The low-velocity impact was induced by a pendulum device, which works on the principle of a free-falling weight following a circular path (Figure 2). The sample of the laminated glass was suspended on a pair of steel ropes placed along the vertical sides of the glass sample with both sides approximately 50 mm from the vertical edges of the sample. In this way, steel ropes were wrapped around the bottom edge of the sample (Figure 3). Such type of supports is utilised in experimental modal or other dynamic analysis of structures to approximate the free boundary conditions [19].

The impactor had the shape of a cylinder with a hemispherical nose with a radius of 50 mm and 800 mm in length. The impact was carried out by lifting the 48.2 kg impactor to the prescribed height with a winch and an electromagnet and then releasing it onto a glass sample. After the impact, the sample started to move in the direction of the impulse along the circular path where it was captured to prevent multiple impacts.

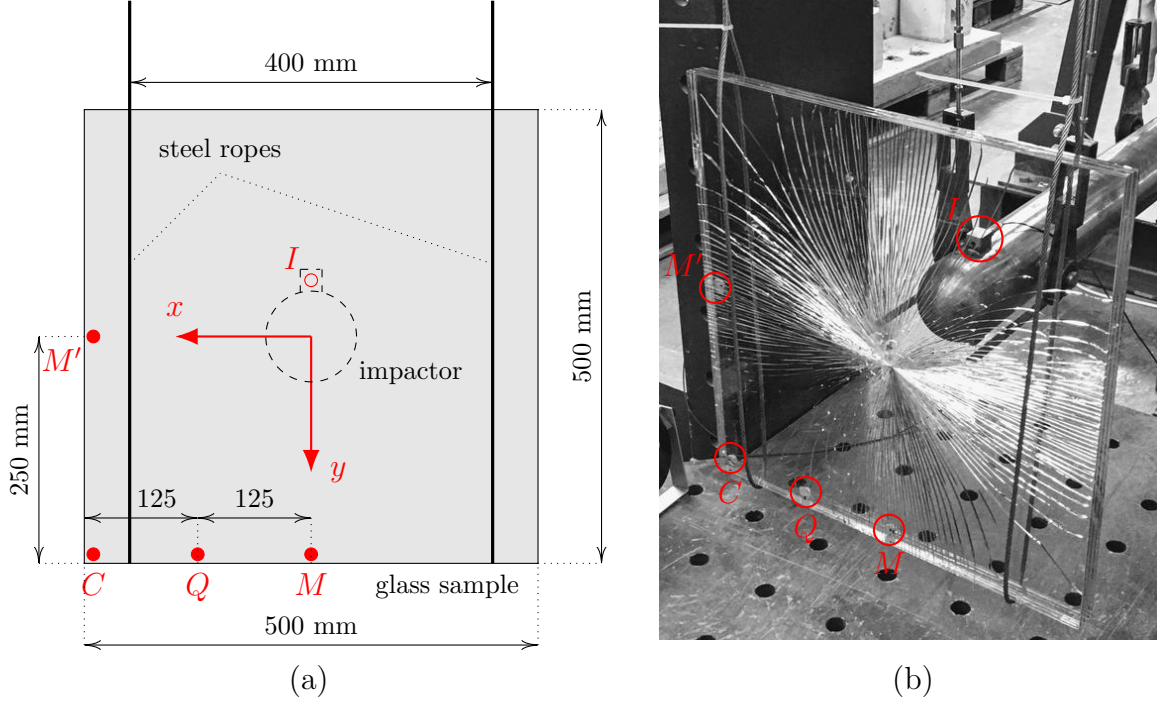
Figure 3: Positions of sensors: (a) scheme of the positions of four sensors C , Q , M , and M' on the impacted surface of a sample together with one sensor I on the impactor behind, (b) photo of an experimental setup with all sensors highlighted.

Five accelerometers with integral electronics (Model 350B04 Shear ICP® Shock Sensor, PCB Piezotronics) recorded the response of a laminated glass sample. Four of them were glued on the back face (the non-impacted outer surface) of each laminated sample (Figure 3), and one additional sensor was bolted to the impactor (Figure 3 (b)) to monitor the contact

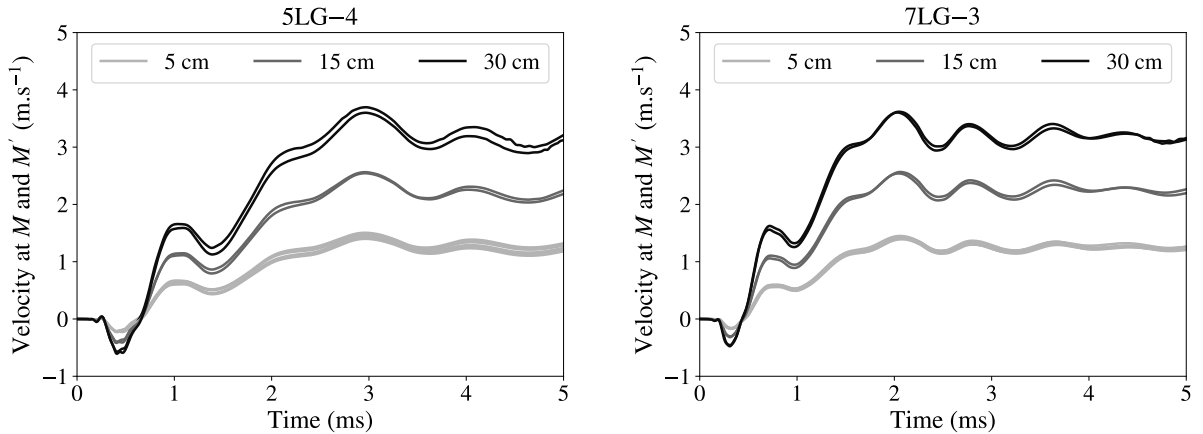
Figure 4: Comparison of velocities at positions M (0, 250, 0) mm and M' (250, 0, 0) mm derived from the corresponding sensors located in the middle of bottom and left edge (Figure 3) for a 5LG-sample and a 7LG-sample and three impact heights (5 cm, 15 cm, and 30 cm).

To analyse the response of samples, we derived velocities from measured accelerations using their time integration. For this purpose, we employed the classical Newmark scheme [47] in the form corresponding to the constant average acceleration method. Figure 4 compares the velocities at positions M and M' (Figure 3) that are located symmetrically about the diagonal axis. The response is plotted for three different impact heights (5 cm, 15 cm, and 30 cm) and two samples (with no visible failure for the selected impact heights) representing both geometries. The time axis range is set to cover the contact duration. The comparison of velocities from both sensors indicates that the steel ropes did not effect significantly the response during the contact because the differences were small and can more likely be attributed to other experimental uncertainties.

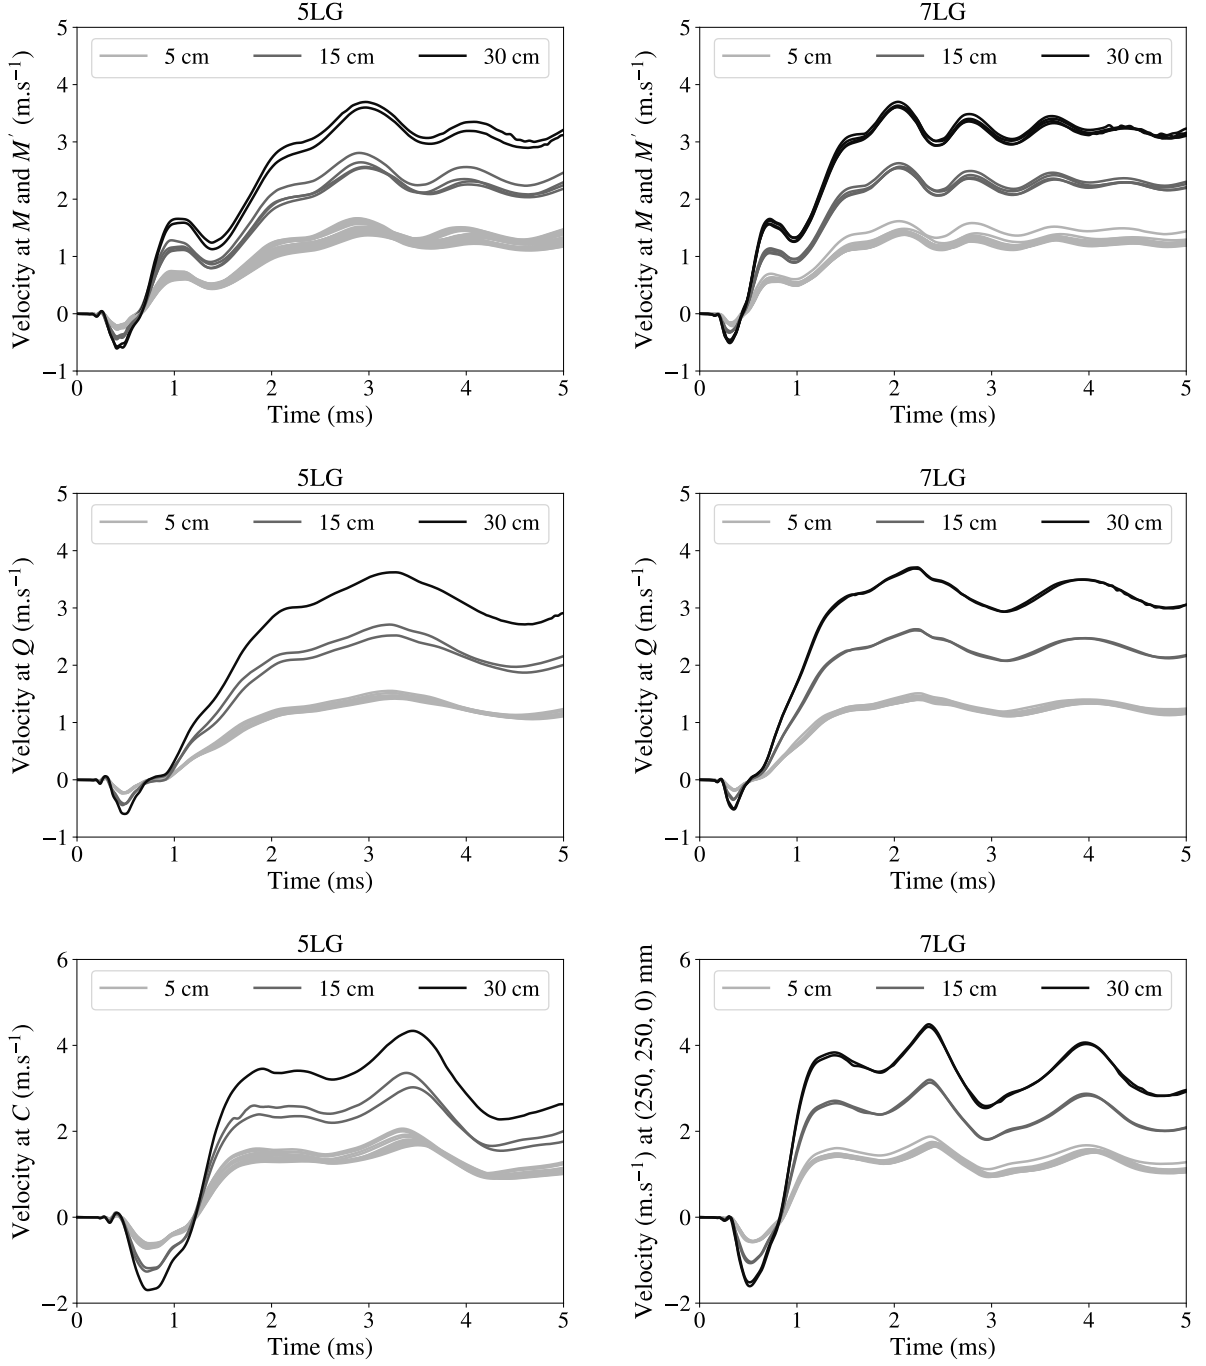
Figure 5: Assessment of the impact test repeatability by comparison of velocities for all non-destructive tests, samples, measured locations (Figure 3), and three impact heights (5 cm, 15 cm, and 30 cm).

Figure 5 summarises the velocities for all samples and non-destructive tests at three positions (midpoints of edges M and M' were plotted together) and three impact heights of 5, 15, and 30 cm. As can be seen, the testing method provides consistent responses for the same conditions. The uncertainties related to the experimental measurements are caused by a slightly eccentric impact (see ahead to Figure 23) and partially by imperfections in sample dimensions or positions of sensors. The oscillations of velocities, evident from Figures 4 and 5, correspond to vibrations of samples induced by the impact. Their frequencies were obtained from the fast Fourier transform (FFT) analyses of signals recorded from the impact test similarly to [37]. Before the FFT analysis, the initial and final part of the data from accelerometers on glass samples were eliminated in accordance with the instructions in [48] to have a sufficiently regular signal. We eliminated the initial data before the largest amplitudes (approximately 0.3–0.4 ms of a signal) and the final part (after 20 ms) with small oscillations affected significantly by the experimental noise (Figure 6).

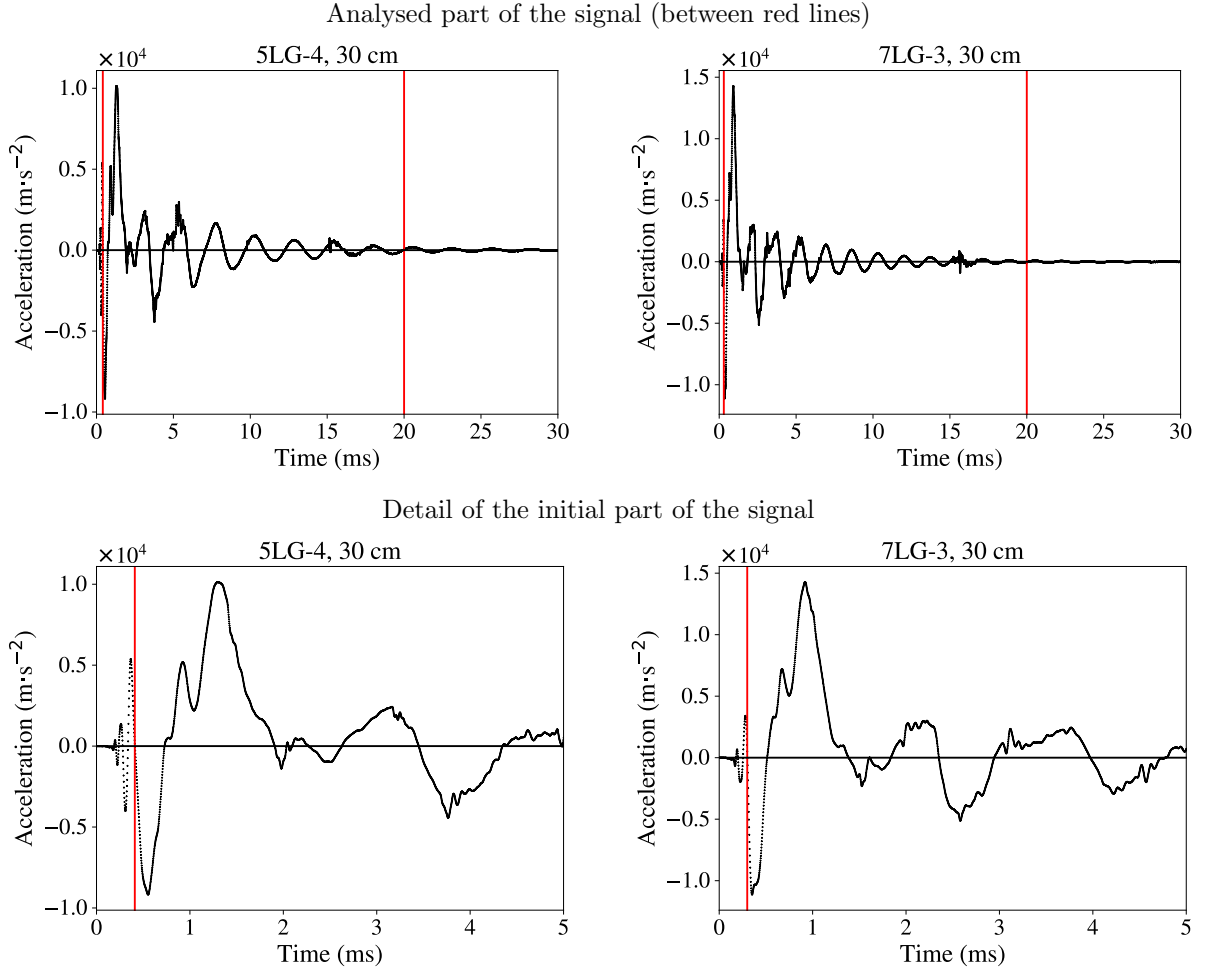
Figure 6: Accelerations recorded by the corner sensors C attached to the laminated glass samples; red lines define the part of the signals employed in the FFT analysis.

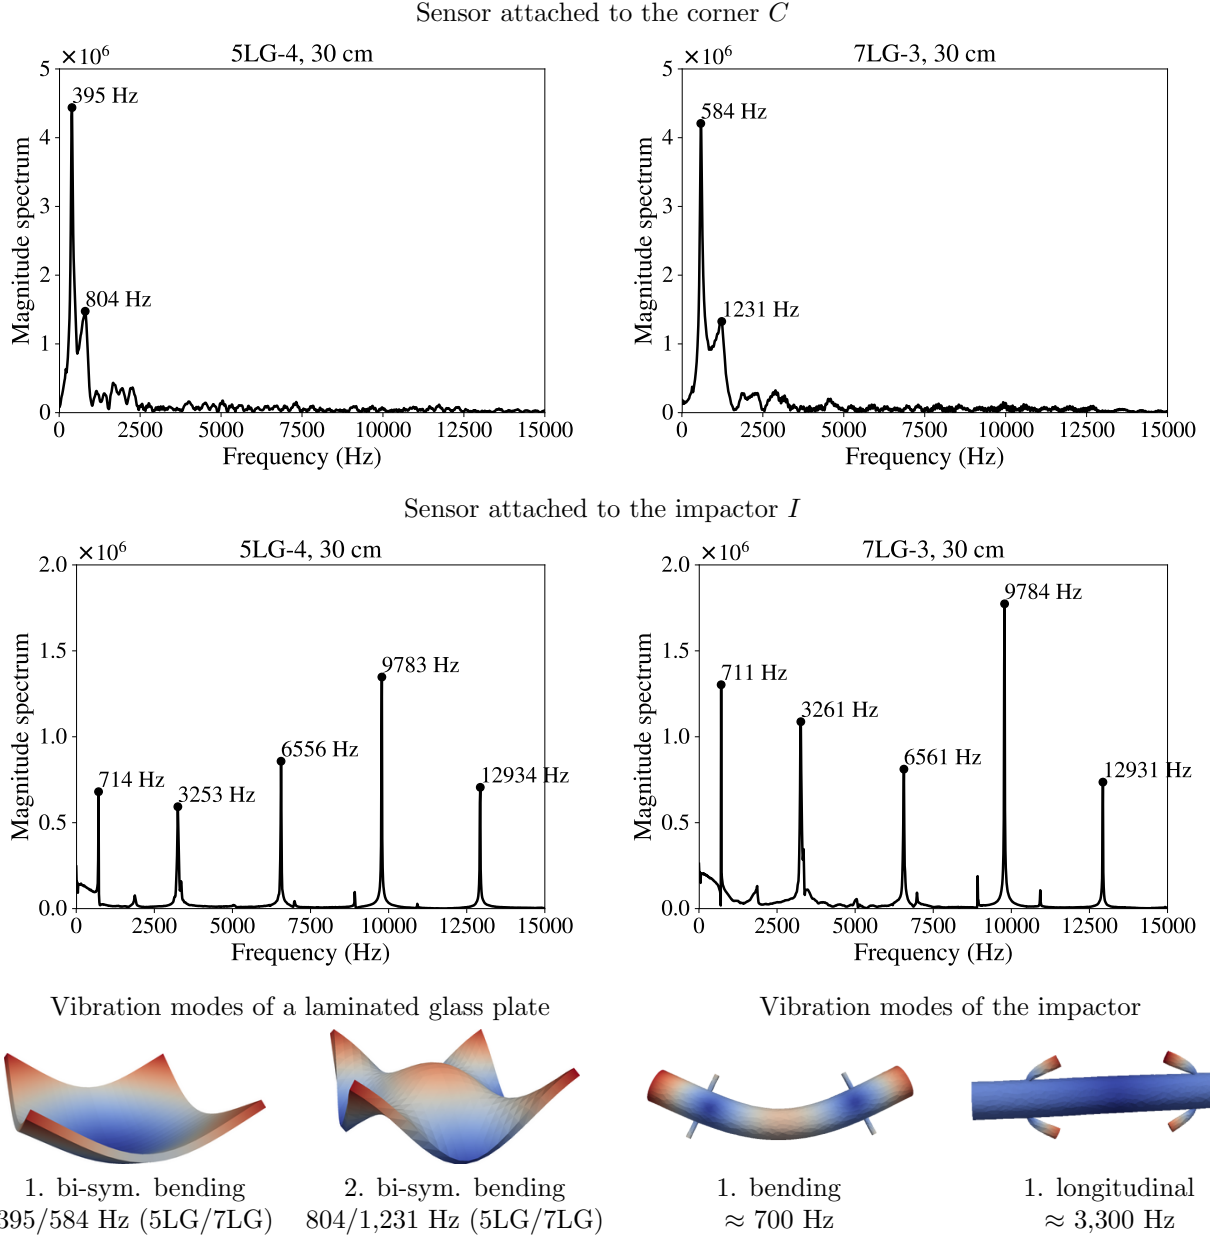
Figure 7: FFT-based signal analysis of accelerations recorded by sensors attached to laminated glass samples (C) and to the impactor (I) complemented with relevant vibration modes.

The natural frequencies of laminated glass plates were derived from the corner sensor and were compared with those of the impactor (Figure 7). The two dominant frequencies of samples correspond to the first bi-symmetric vibration modes excited by the impact. The numerical simulation of modal response of the impactor explained that the modes excited by the impact corresponded to the first and higher bending and longitudinal modes. We employed a standard material parameters of steel (Young's modulus of 210 GPa, Poisson ratio of 0.3, and density of $7,800 \text{ kg}\cdot\text{m}^{-3}$).

For the evaluation of contact forces, a sensor was attached to the impactor (Figure 3), and the recorded accelerations were multiplied by its mass (48.2 kg). The FFT analysis combined with the modal analysis for the impactor revealed that the signals included also the impactor's vibrations, and thus the corresponding frequencies had to be eliminated. Figure 8 shows the comparison of contact forces derived from raw and filtered data. The frequency corresponding to the most significant amplitudes observed for the non-filtered data matches that of the longitudinal vibration of the impactor (approximately 3,300 Hz), and the motion presumably corresponds to local oscillations of the sensor and not to the contact force (Figure 7). Thus, the signal was filtered with an 8th-pole Butterworth low-pass filter ($2\times$ CFC 1000 filter with the cut-off frequency of 1,650 Hz) to completely eliminate these undesired vibrations. The selected cut-off frequency is above dominant natural frequencies detected for glass samples (Figure 7).

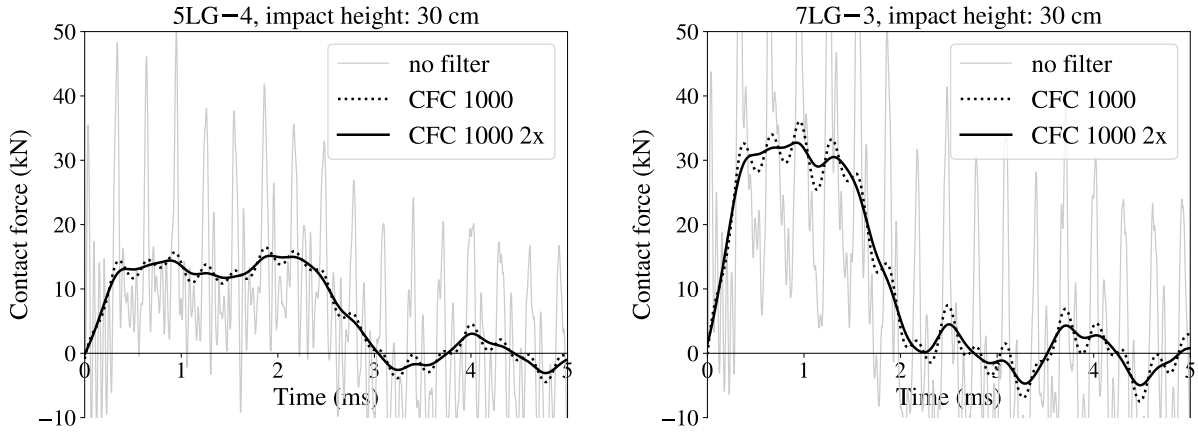
Figure 8: Comparison of contact forces derived from non-filtered and filtered accelerations for two non-destructive tests representing both types of samples.

As visible from the filtered evolution of contact forces (Figure 8), the acceleration of the impactor did not drop to zero after the contact, but some level of oscillations can be seen even after the impact. These vibrations correspond to the acceleration of the sensor due to the impactor's bending and the sensor's off-axis position (Figure 3). If we omit this additional vibration, the impacts resulted in 3 ms contact for 5LG-samples and 2 ms contact for the 7LG-samples. However, the first bending frequency of the impactor (approximately 700 Hz) is in the range of frequencies excited on laminated plates, and so their elimination is undesired. This impactor ringing must be kept in mind when validating numerical sim-

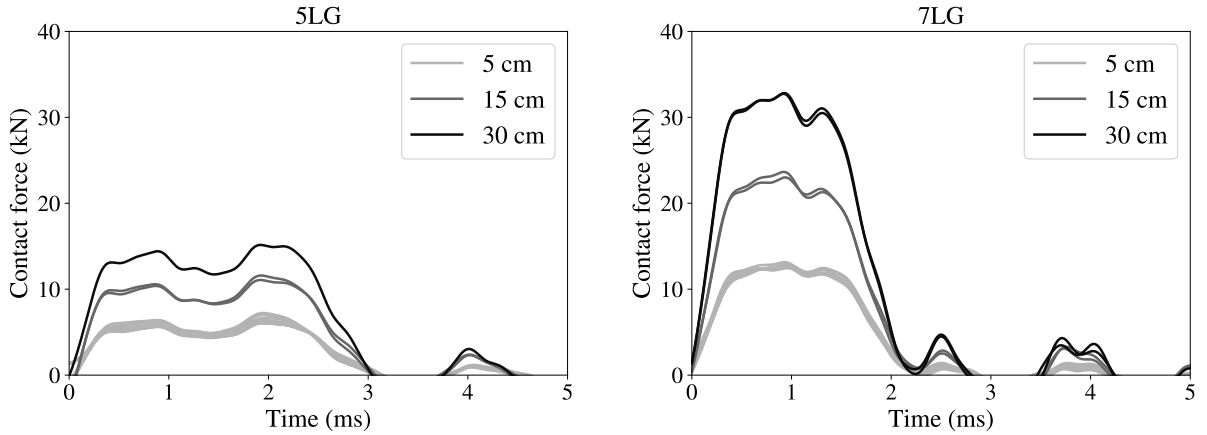
Figure 9: Comparison of contact forces ($2\times$ filter CFC 1000) for all non-destructive tests, samples, and three impact heights.

Figure 9 compares the contact forces for all unfractured samples (both geometries) and three impact heights. The contact duration was consistent and longer for the 5LG-samples, whereas the impact from the same height resulted in more than twice higher contact force for 7LG-samples. This observation highlights that an assessment of the impact resistance for different types of laminated glass based on the level of impact energy or height can be misleading for this type of boundary conditions, and the resultant contact force has to be evaluated as well.

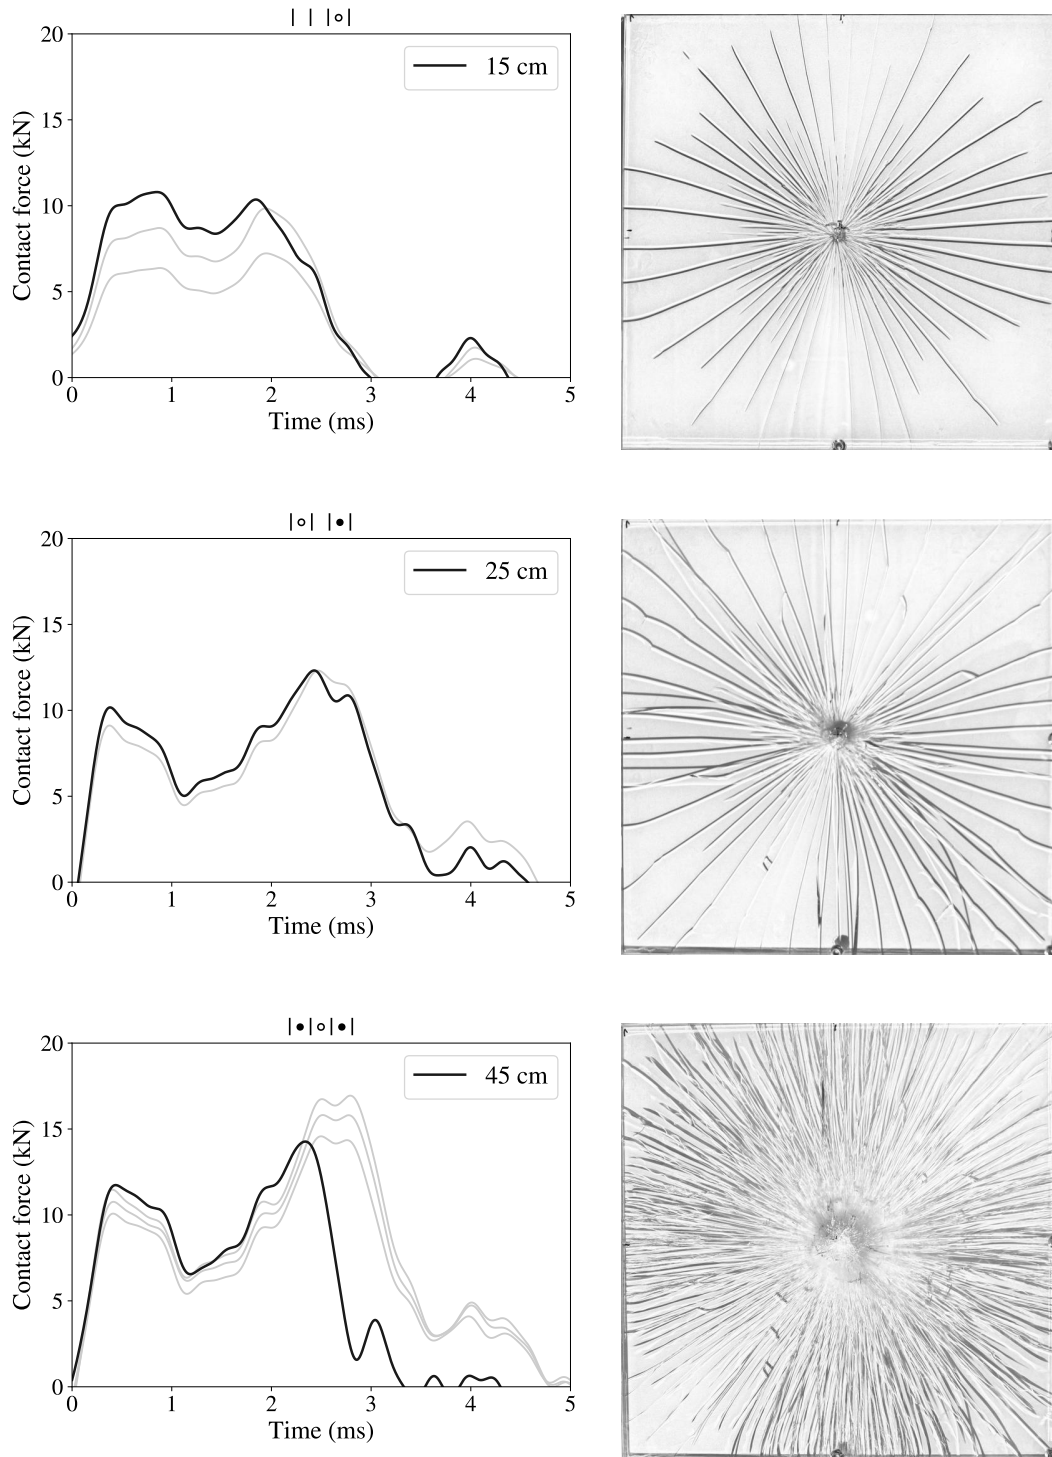
Figure 10: Evolution of contact forces (2× filter CFC 1000) and corresponding fracture patterns for 5LG-1. Black lines denote the contact forces during the destructive tests, whereas the grey ones correspond to the previous sequence of impact events at lower impact heights (increased by 5 cm for each following impact event).

The same strategy as in the previous section was employed to determine the contact forces during the destructive tests. We plot the results of this analysis in terms of contact forces for each sample independently (Figures 10–20) and complement them with distinctive fracture patterns. Recall that the evolution of contact forces exhibits the same trend for all non-destructive tests, their magnitudes only differ with an increasing impact height (Figure 9). When a previously intact glass layer fractured, the contact force deviates from the formerly consistent path. Then, a new shape of contact force can be observed, and its trend is again consistent for the increasing impact heights until the subsequent fracture of another glass layer(s). The contact duration was longer for samples with fractured layers as their modal response had changed.

The typical fracture pattern consisted of several radial cracks of different lengths, in some samples seldomly connected by a short parts of secondary cracks (e.g., Figures 10, 15, 18, or 20). The area under the impact point was often covered by a finer net of cracks especially on the impacted glass layer (see ahead to Figures 22 and 23). As expected, the density of fracture pattern increased with the impact energy.

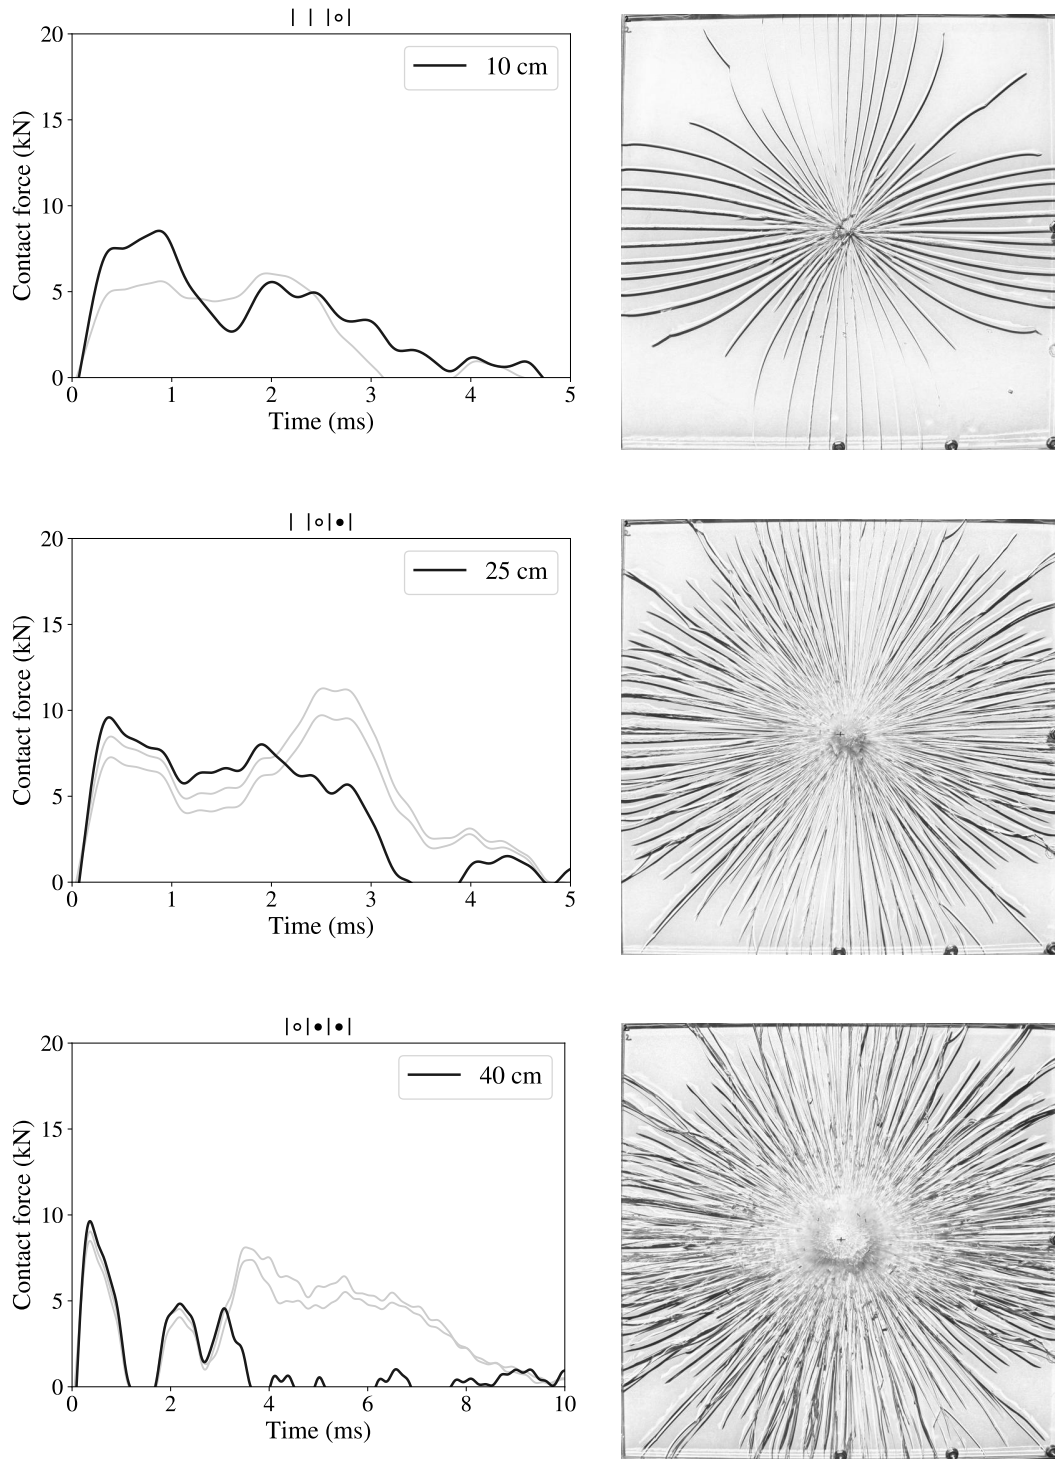
Figure 11: Evolution of contact forces ($2\times$ filter CFC 1000) and corresponding fracture patterns for 5LG-2. Black lines denote the contact forces during the destructive tests, whereas the grey ones correspond to the previous sequence of impact events at lower impact heights (increased by 5 cm for each following impact event).

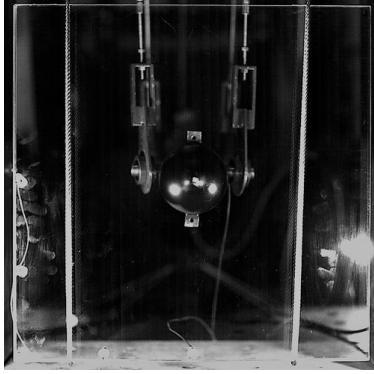
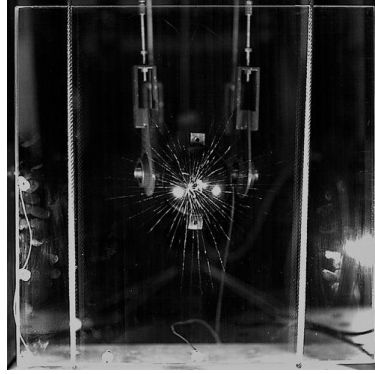
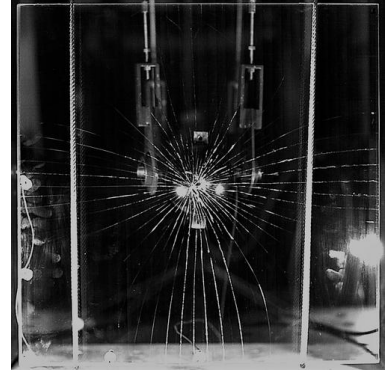
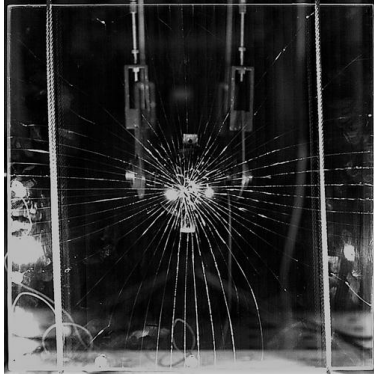
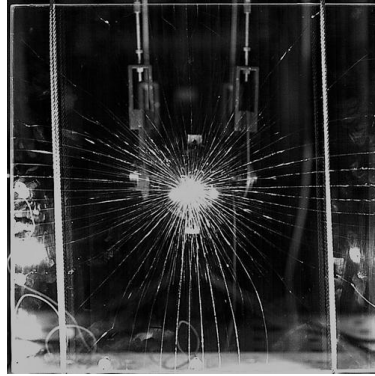
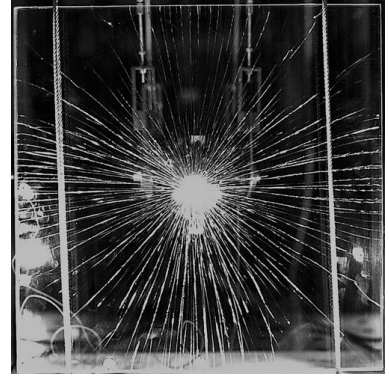
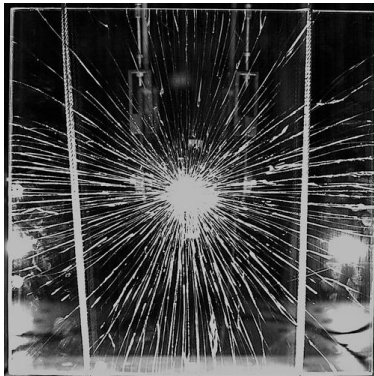
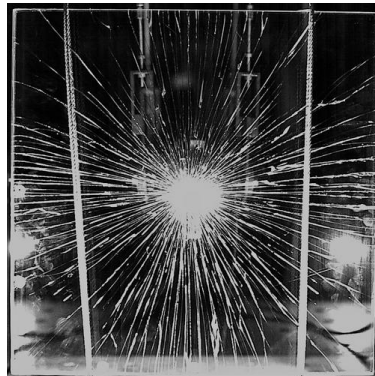
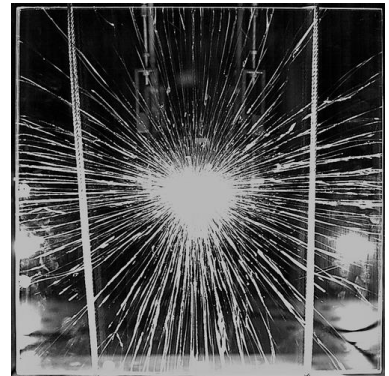
Figure 12: Evolution of cracks in 5LG-2 sample (frame rate 5,000 frames per second, i.e., time step 0.2 ms between two adjacent photos in a row).

For four samples (two per the same geometry), the evolution of fracture pattern was captured by a high-speed camera (Figures 12, 14, 19, and 21) with a 0.2 ms time intervals between two successive frames. The visibility of cracks depended on their opening during the vibration of a laminated glass plate. Therefore, we encourage the reader to compare the high-speed camera photos with the final fracture patterns captured on a white background after the impacts to detect all cracks (via their shadows) that developed during the contact.

The high-speed camera investigation also revealed that cracks spread quickly on the outer non-impacted surface and reached the edges within less than 0.4 ms (Figure 12 or 14). If the impacted layer fractured first, the cracks were mostly localised around the impact point and spread only occasionally towards edges (Figure 20). In many structural applications, the outer glass layers in multi-layer laminated glass are made of tempered glass due to its surface compressive stresses developed during the tempering process. This treatment leads to higher tensile strength, but it also modifies the fracture pattern of a glass sample that breaks into many small pieces. This behaviour is undesirable for the post-critical resistance because the fine net of crack would not remain localised under the impact point.

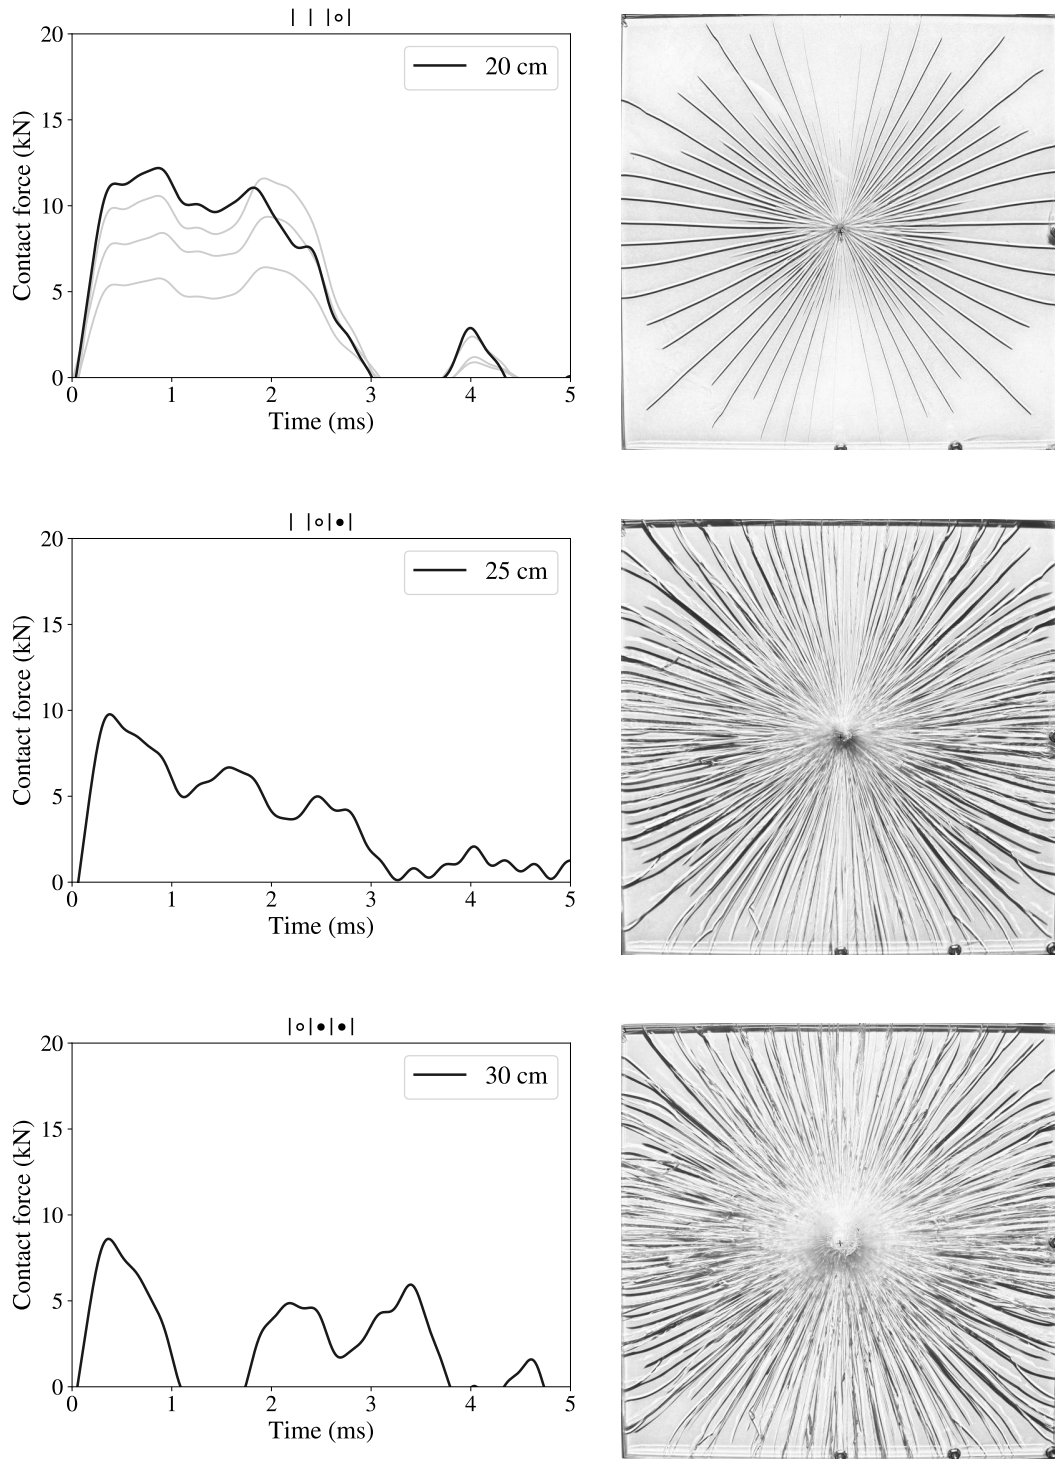
Figure 13: Evolution of contact forces ($2\times$ filter CFC 1000) and corresponding fracture patterns for 5LG-3. Black lines denote the contact forces during the destructive tests, whereas the grey ones correspond to the previous sequence of impact events at lower impact heights (increased by 5 cm for each following impact event).

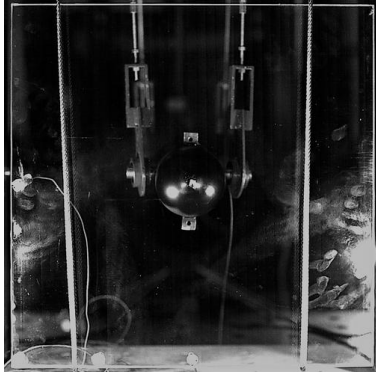
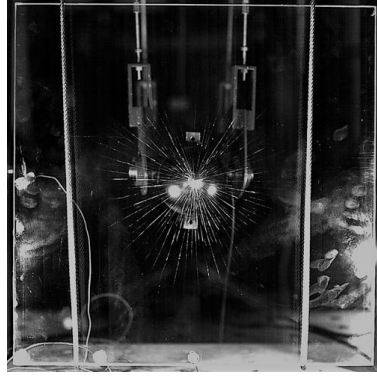
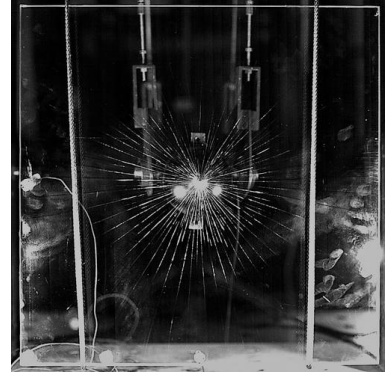
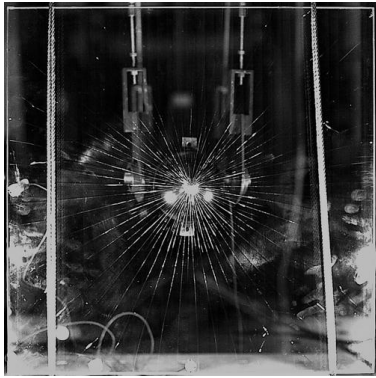
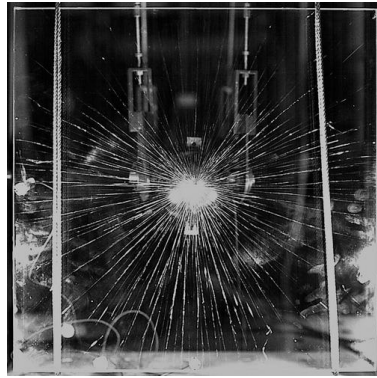
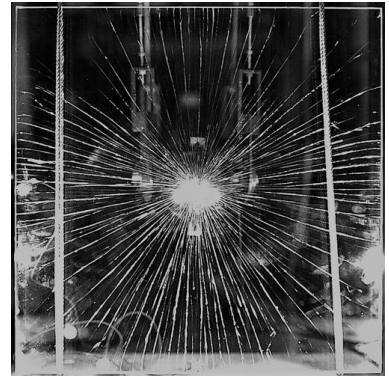
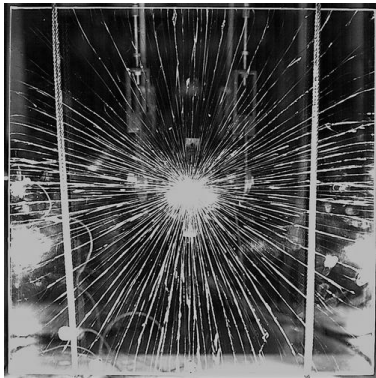
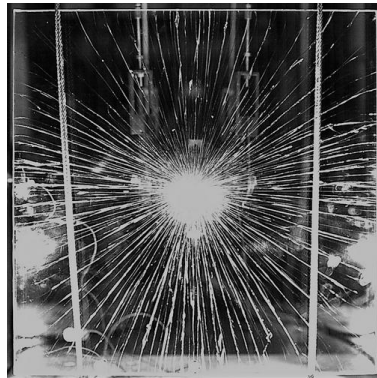
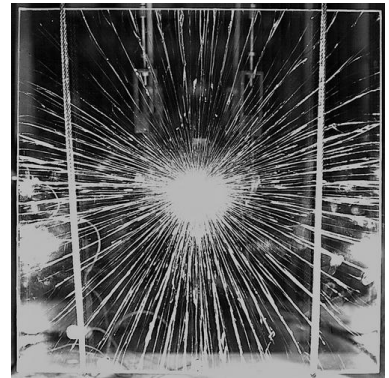
Figure 14: Evolution of cracks in 5LG-3 sample (frame rate 5,000 frames per second, i.e., time step 0.2 ms between two adjacent photos in a row).

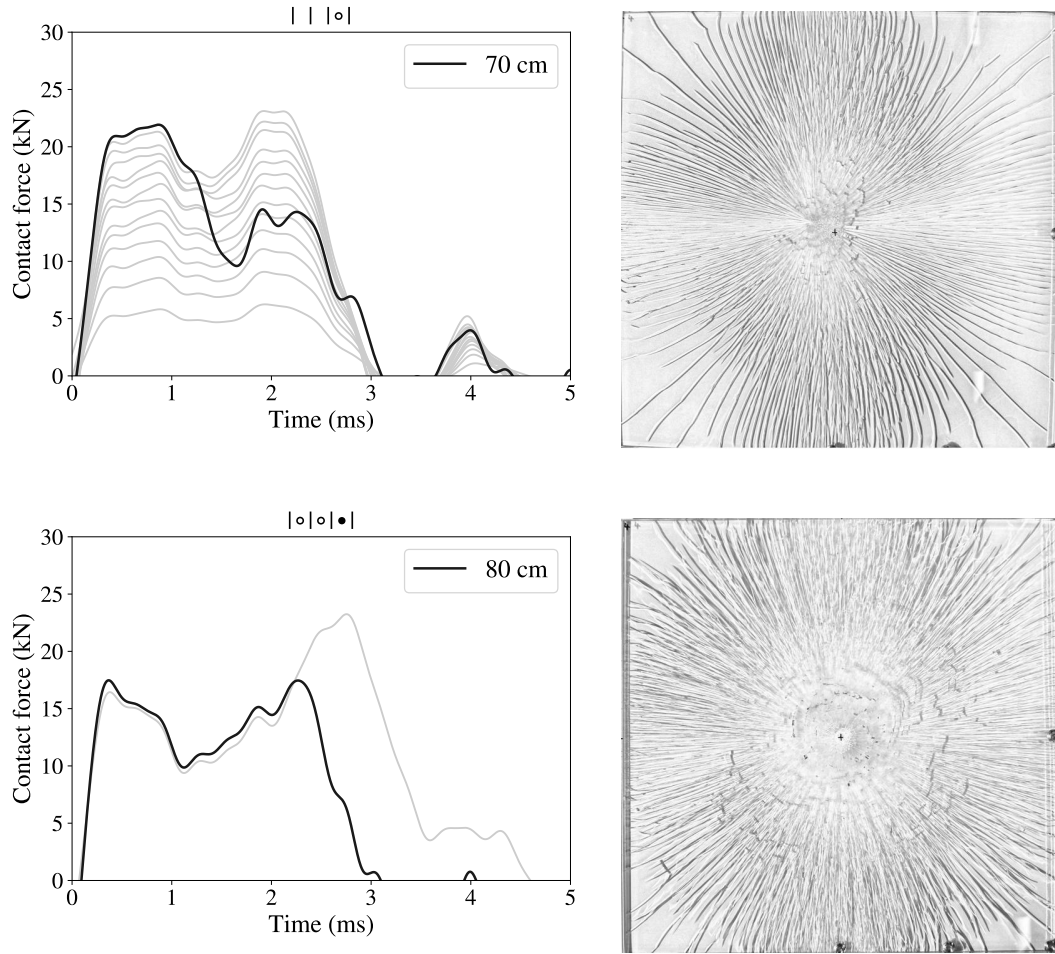
Figure 15: Evolution of contact forces ($2\times$ filter CFC 1000) and corresponding fracture patterns for 5LG-4. Black lines denote the contact forces during the destructive tests, whereas the grey ones correspond to the previous sequence of impact events at lower impact heights (increased by 5 cm for each following impact event).

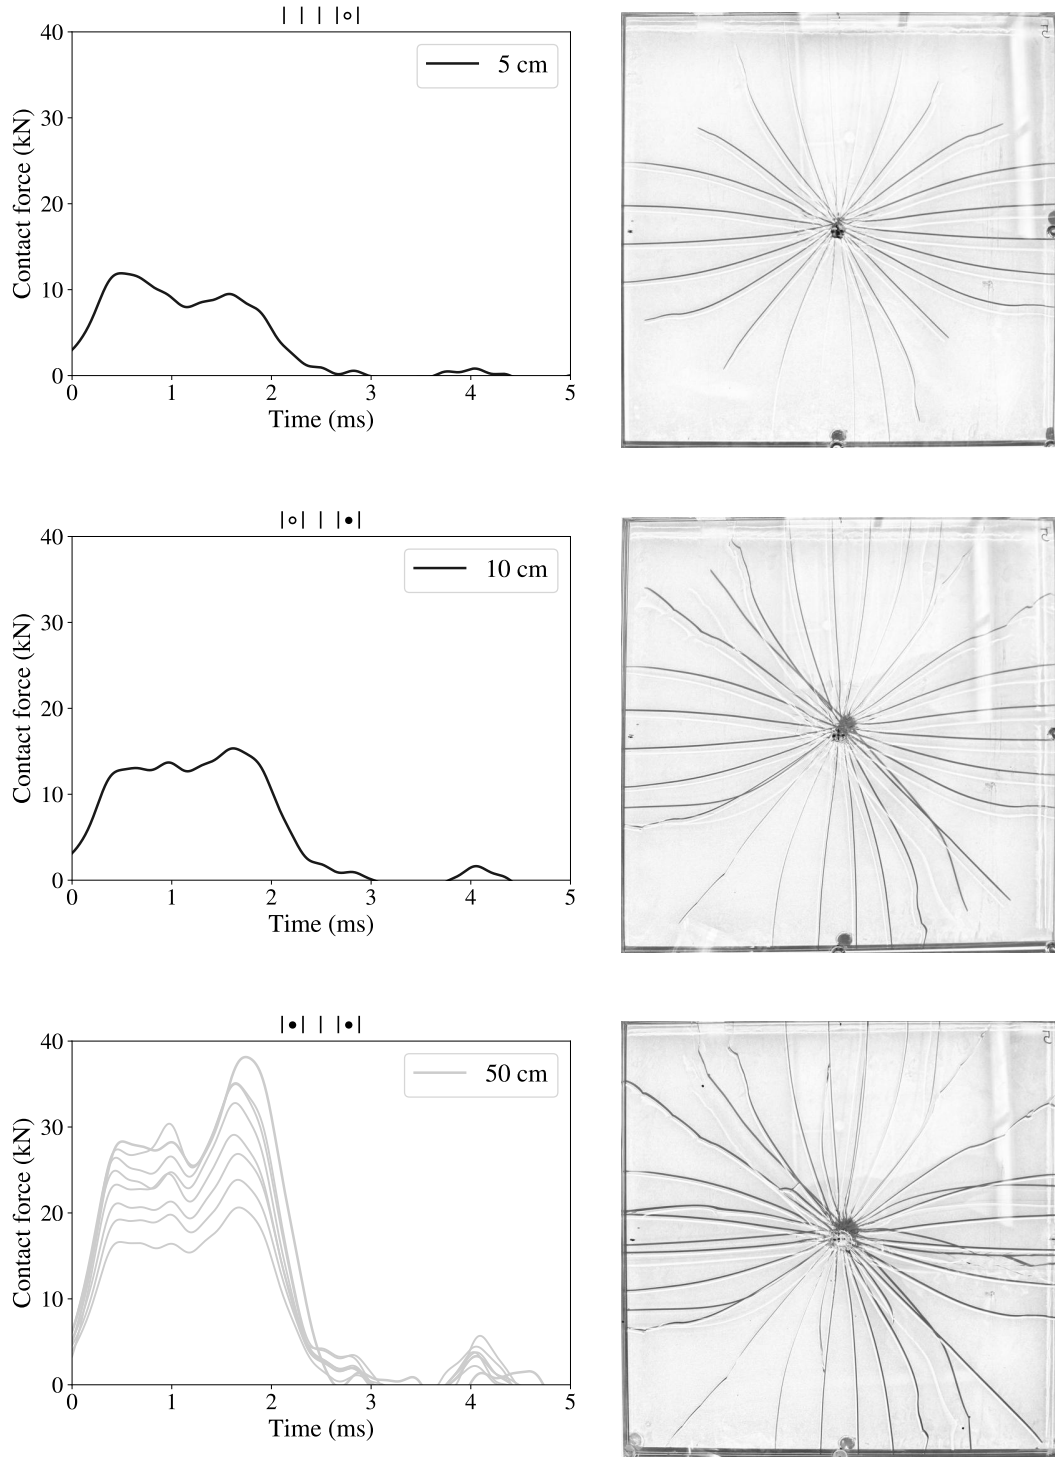
Figure 16: Evolution of contact forces ($2\times$ filter CFC 1000) and corresponding fracture patterns for 7LG-1. Black lines denote the contact forces during the destructive tests, whereas the grey ones correspond to the previous sequence of impact events at lower impact heights (increased by 5 cm for each following impact event).
