Experimental study on the gradual fracture of layers in multi-layer laminated glass plates under low-velocity impact

Alena Zemanová, Petr Konrád, Petr Hála, Radoslav Sovják,
Radim Hlužek, Jan Zeman, Michal Šejnoha

Abstract

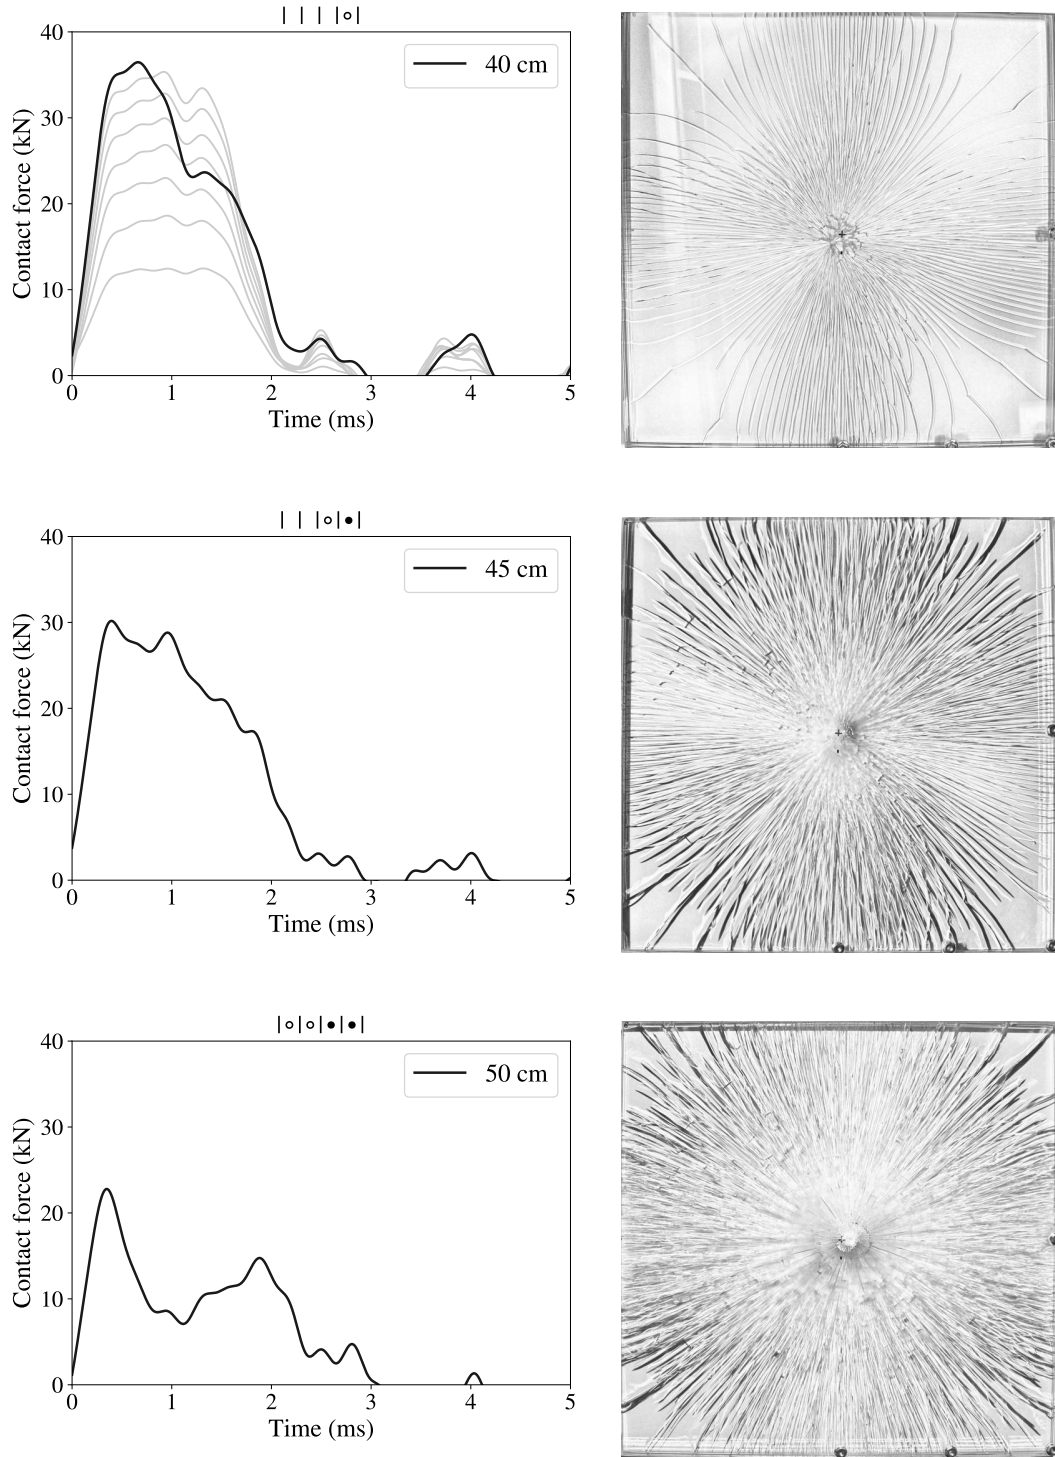
Figure 17: Evolution of contact forces ($2\times$ filter CFC 1000) and corresponding fracture patterns for 7LG-2. Black lines denote the contact forces during the destructive tests, whereas the grey ones correspond to the previous sequence of impact events at lower impact heights (increased by 5 cm for each following impact event).

The same strategy as in the previous section was employed to determine the contact forces during the destructive tests. We plot the results of this analysis in terms of contact forces for each sample independently (Figures 10–20) and complement them with distinctive fracture patterns. Recall that the evolution of contact forces exhibits the same trend for all non-destructive tests, their magnitudes only differ with an increasing impact height (Figure 9). When a previously intact glass layer fractured, the contact force deviates from the formerly consistent path. Then, a new shape of contact force can be observed, and its trend is again consistent for the increasing impact heights until the subsequent fracture of another glass layer(s). The contact duration was longer for samples with fractured layers as their modal response had changed.

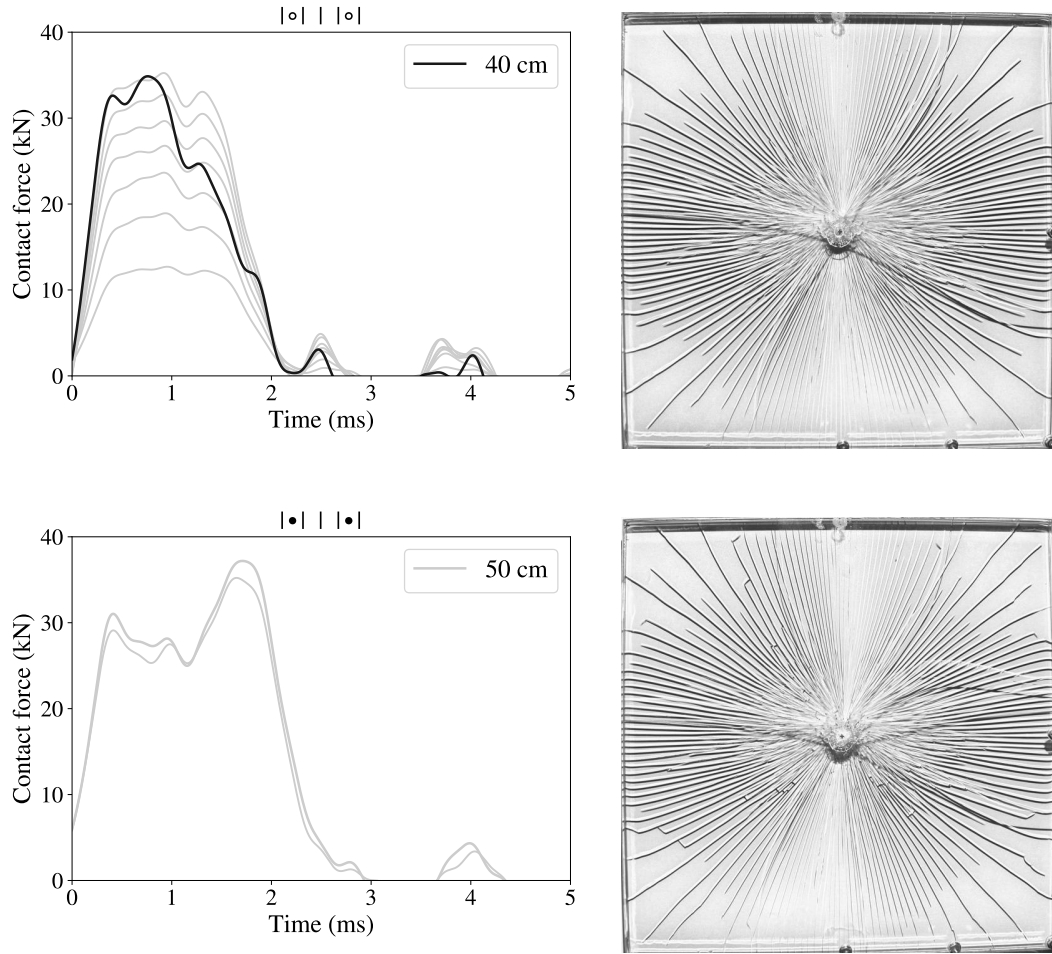
Figure 18: Evolution of contact forces ($2\times$ filter CFC 1000) and corresponding fracture patterns for 7LG-3. Black lines denote the contact forces during the destructive tests, whereas the grey ones correspond to the previous sequence of impact events at lower impact heights (increased by 5 cm for each following impact event).

The typical fracture pattern consisted of several radial cracks of different lengths, in some samples seldomly connected by a short parts of secondary cracks (e.g., Figures 10, 15, 18, or 20). The area under the impact point was often covered by a finer net of cracks especially on the impacted glass layer (see ahead to Figures 22 and 23). As expected, the density of fracture pattern increased with the impact energy.

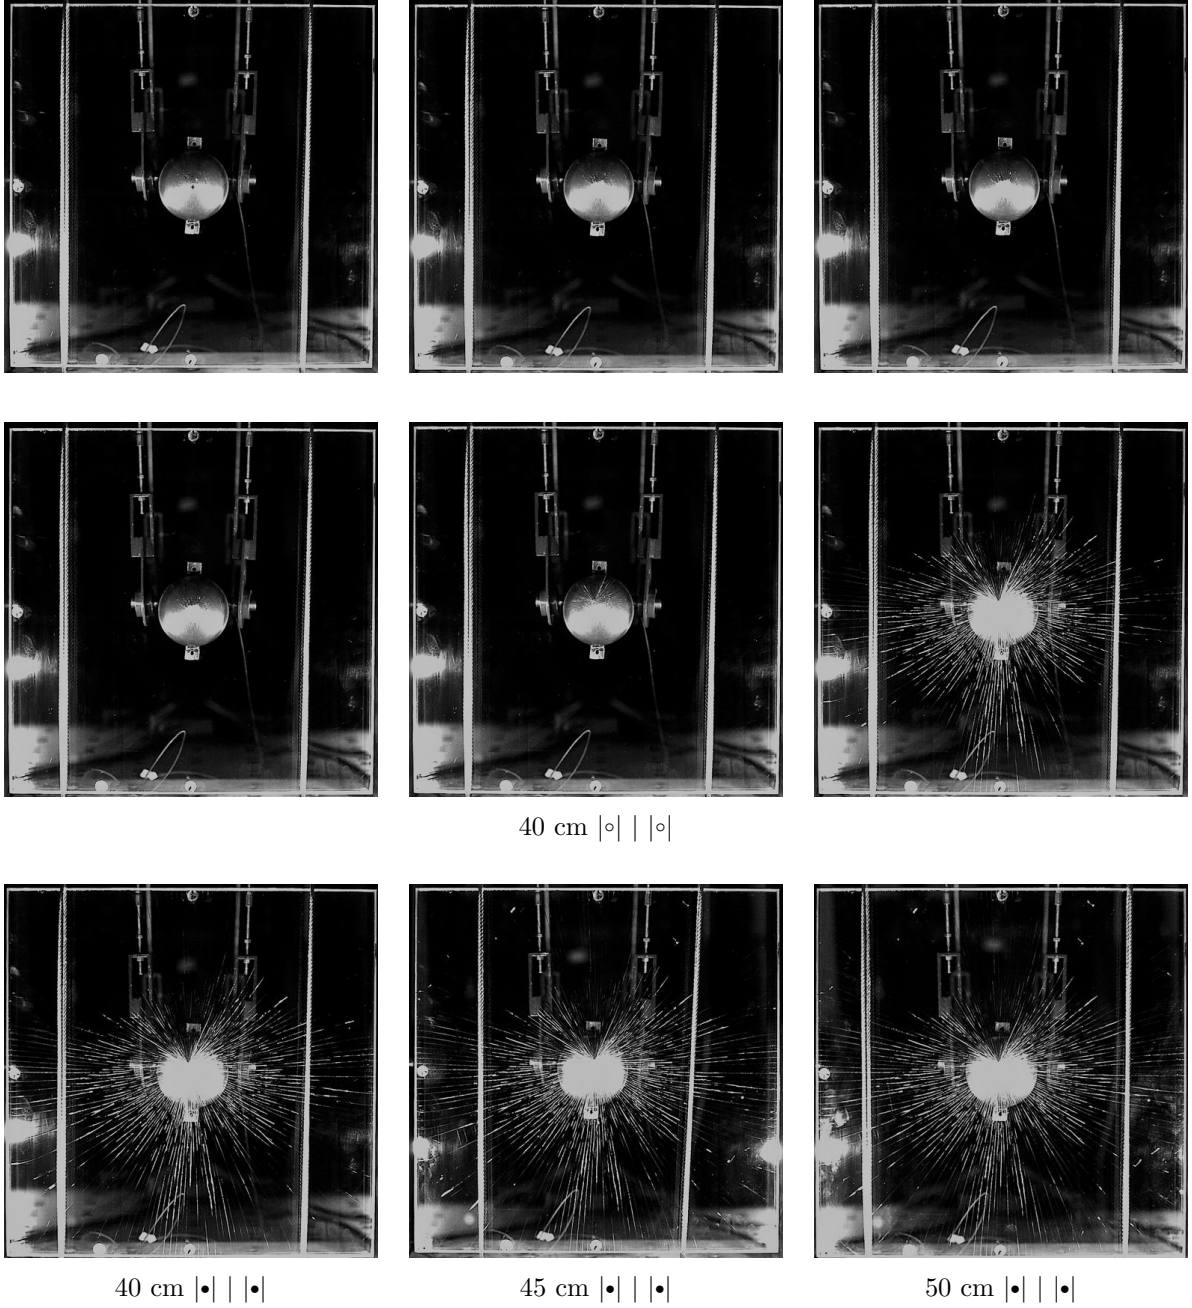
Figure 19: Evolution of cracks in 7LG-3 sample (frame rate 5,000 frames per second, i.e., time step 0.2 ms between two adjacent photos in a row).

For four samples (two per the same geometry), the evolution of fracture pattern was captured by a high-speed camera (Figures 12, 14, 19, and 21) with a 0.2 ms time intervals between two successive frames. The visibility of cracks depended on their opening during the vibration of a laminated glass plate. Therefore, we encourage the reader to compare the high-speed camera photos with the final fracture patterns captured on a white background after the impacts to detect all cracks (via their shadows) that developed during the contact.

The major changes in crack patterns occurred when the first glass layer(s) fractured. Further, the growth of cracks under consecutive impacts was small until the fracture of next glass layer; compare, e.g., fracture patterns for different impact heights but the same scheme of cracked layers (Figure 19). A visual comparison of patterns for the impact height of 50 cm shows that the fewest cracks appeared in the 7LG-1 sample where both outer glass layers fractured at relatively low impact energies. This suggests that the density of cracks is given by the initial power of the impact leading to fracture, and the additional impacts did not change the density of cracks significantly.

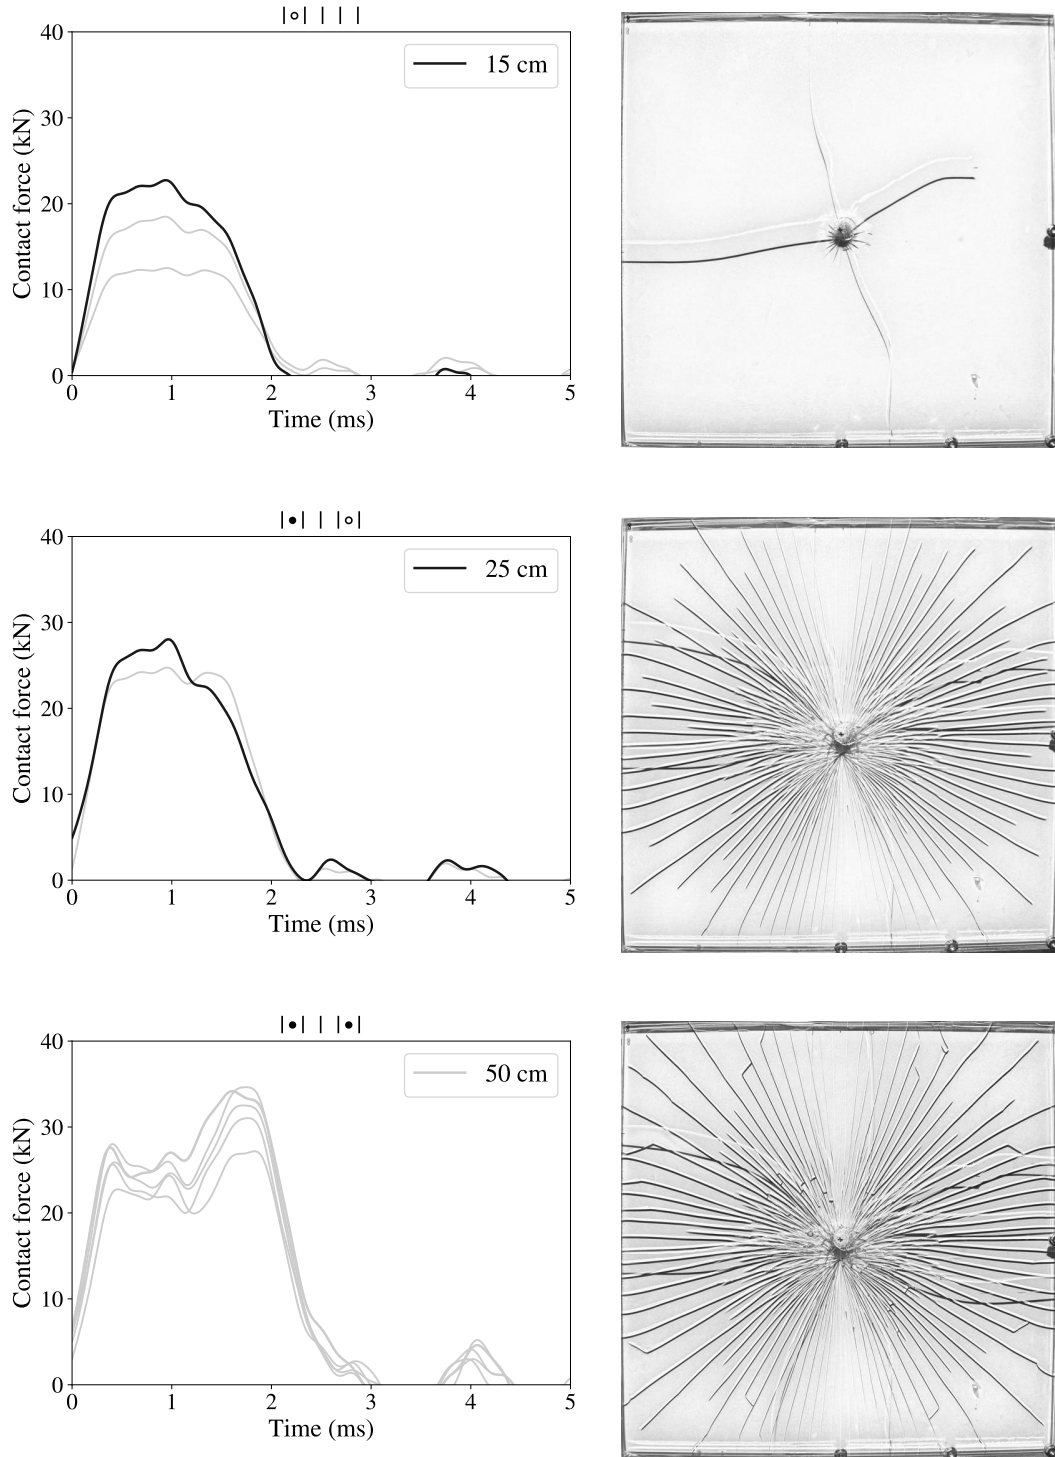
Figure 20: Evolution of contact forces ($2\times$ filter CFC 1000) and corresponding fracture patterns for 7LG-4. Black lines denote the contact forces during the destructive tests, whereas the grey ones correspond to the previous sequence of impact events at lower impact heights (increased by 5 cm for each following impact event).

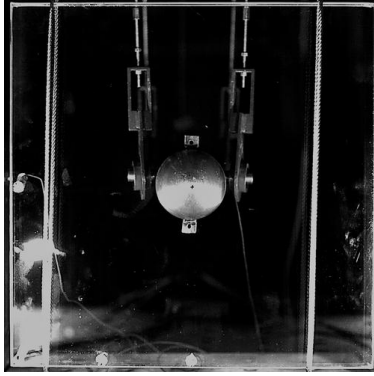
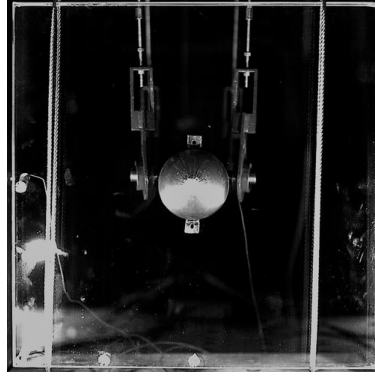
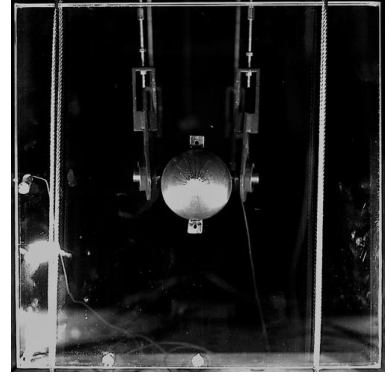
Figure 21: Evolution of cracks in 7LG-4 sample (frame rate 5,000 frames per second, i.e., time step 0.2 ms between two adjacent photos in a row).

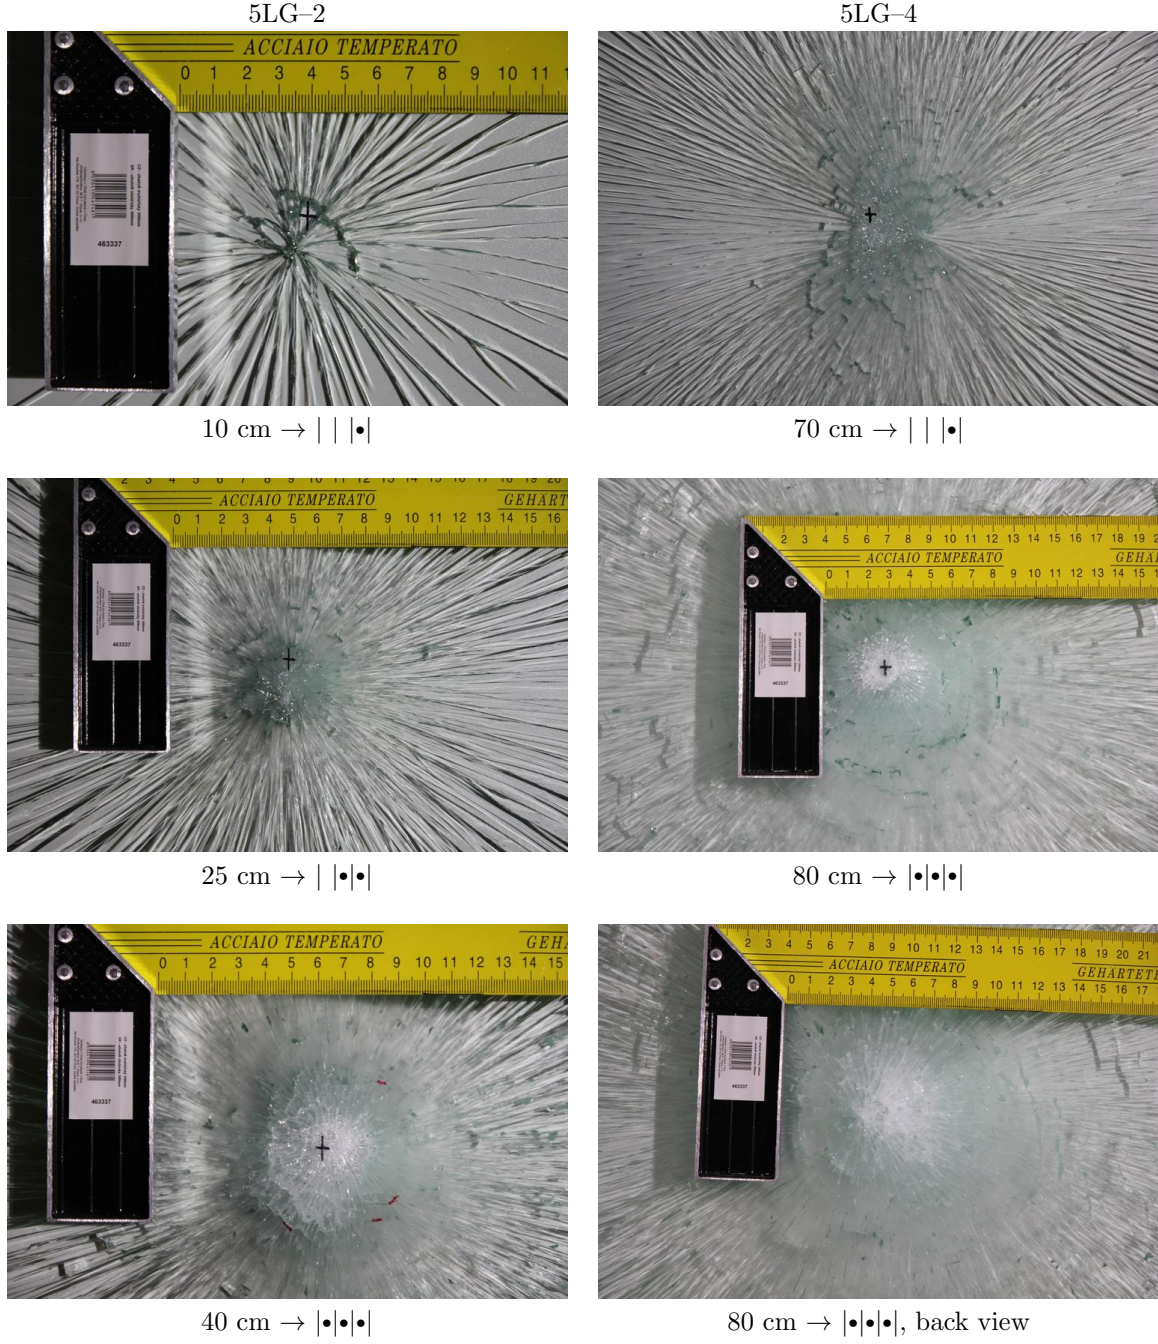
Figure 22: Details of crack patterns under the impact points for 5LG-samples seen from the impacted (no label) or non-impacted side (referred to as back view).

The details of starburst crack patterns under the impact point are summarised for four samples in Figures 22 and 23. We can observe that the centres of crack patterns in non-impacted glass layers do not coincide with the intended impact point (area) whereas the origins of the crack patterns in the impacted layers are significantly closer to this point (Figures 22 and 23). A sequence of images (Figure 19) also confirms that despite the impactor hit the centre of the plate with the tolerance less than 0.5 cm, the origin of the pattern in the back glass layer is located approximately 1.5 cm from the centre (Figure 23). Therefore, the reason is not the eccentric impact but more likely some invisible microflaw on the surface under tension. The changes in crack patterns under the impactor were minor as highlighted for some cracks and consecutive impact tests by different colours or marks in Figure 23.

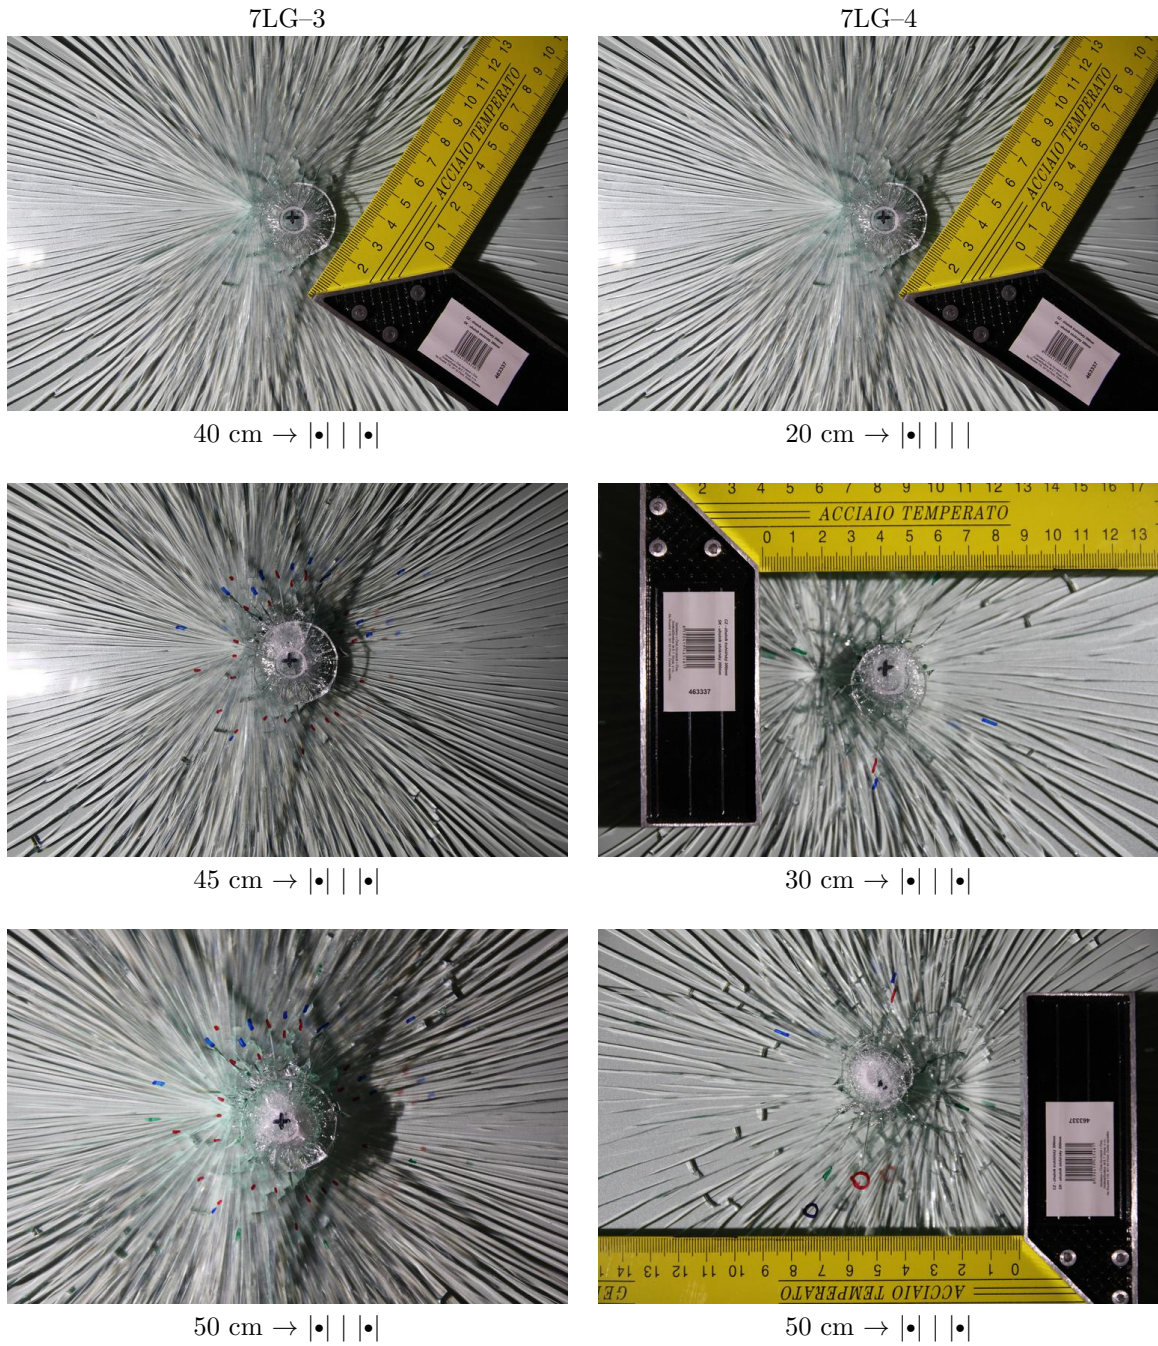
Figure 23: Details of crack patterns under the impact points for 7LG-samples seen from the impacted side.

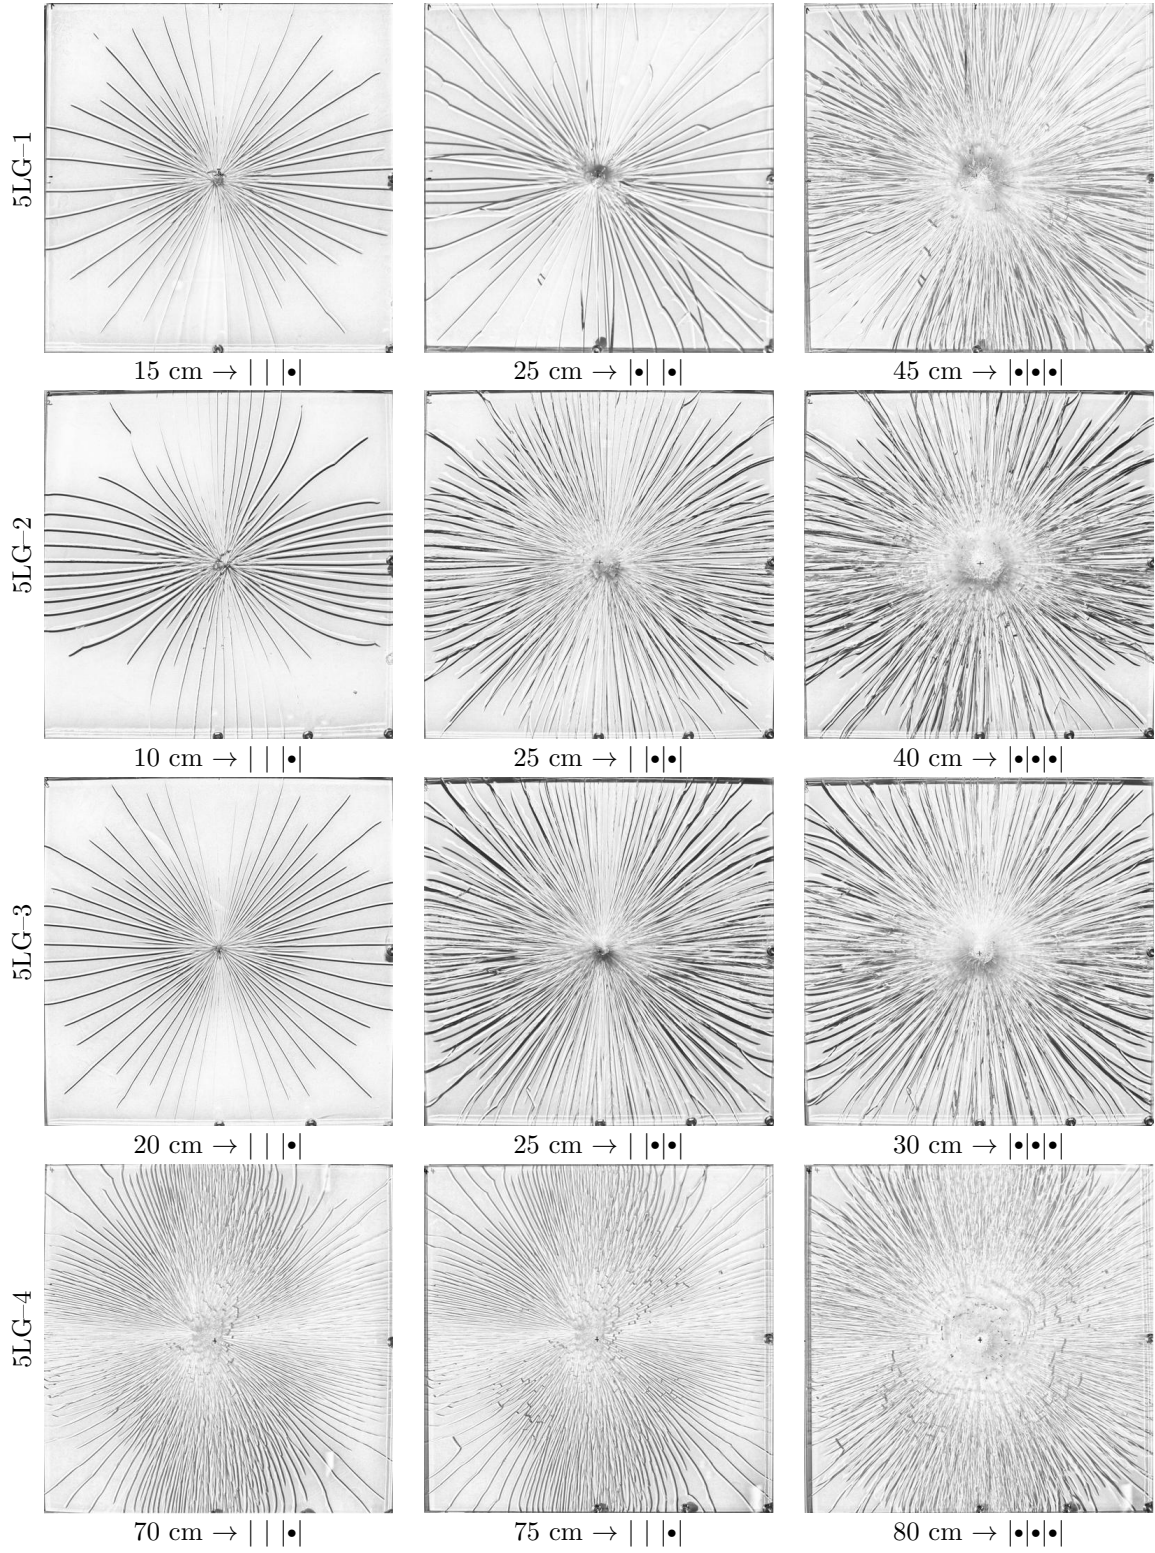
Figure 24: Fracture patterns for 5LG-samples corresponding to different impact heights complemented with the scheme of the cross-section with fractured layers marked by •. Photos are taken from the impacted side.

For both types of laminated glass, Figures 24 and 25 summarise all fracture patterns corresponding to the subsequent fracture of glass layers. The back layer fractured first for all 5LG-samples and the density of the radial cracks was comparable for three tested samples that fractured under the impact heights of 10, 15, and 20 cm. A significantly finer crack pattern on 5LG-4 corresponded to a more powerful impact. For 7LG-samples, the back glass layer fractured first in two cases and the front one in other two cases. Corresponding fracture patterns differ (first column in Figure 25) which indicates that the way of cracking was different in both outer glass layers.

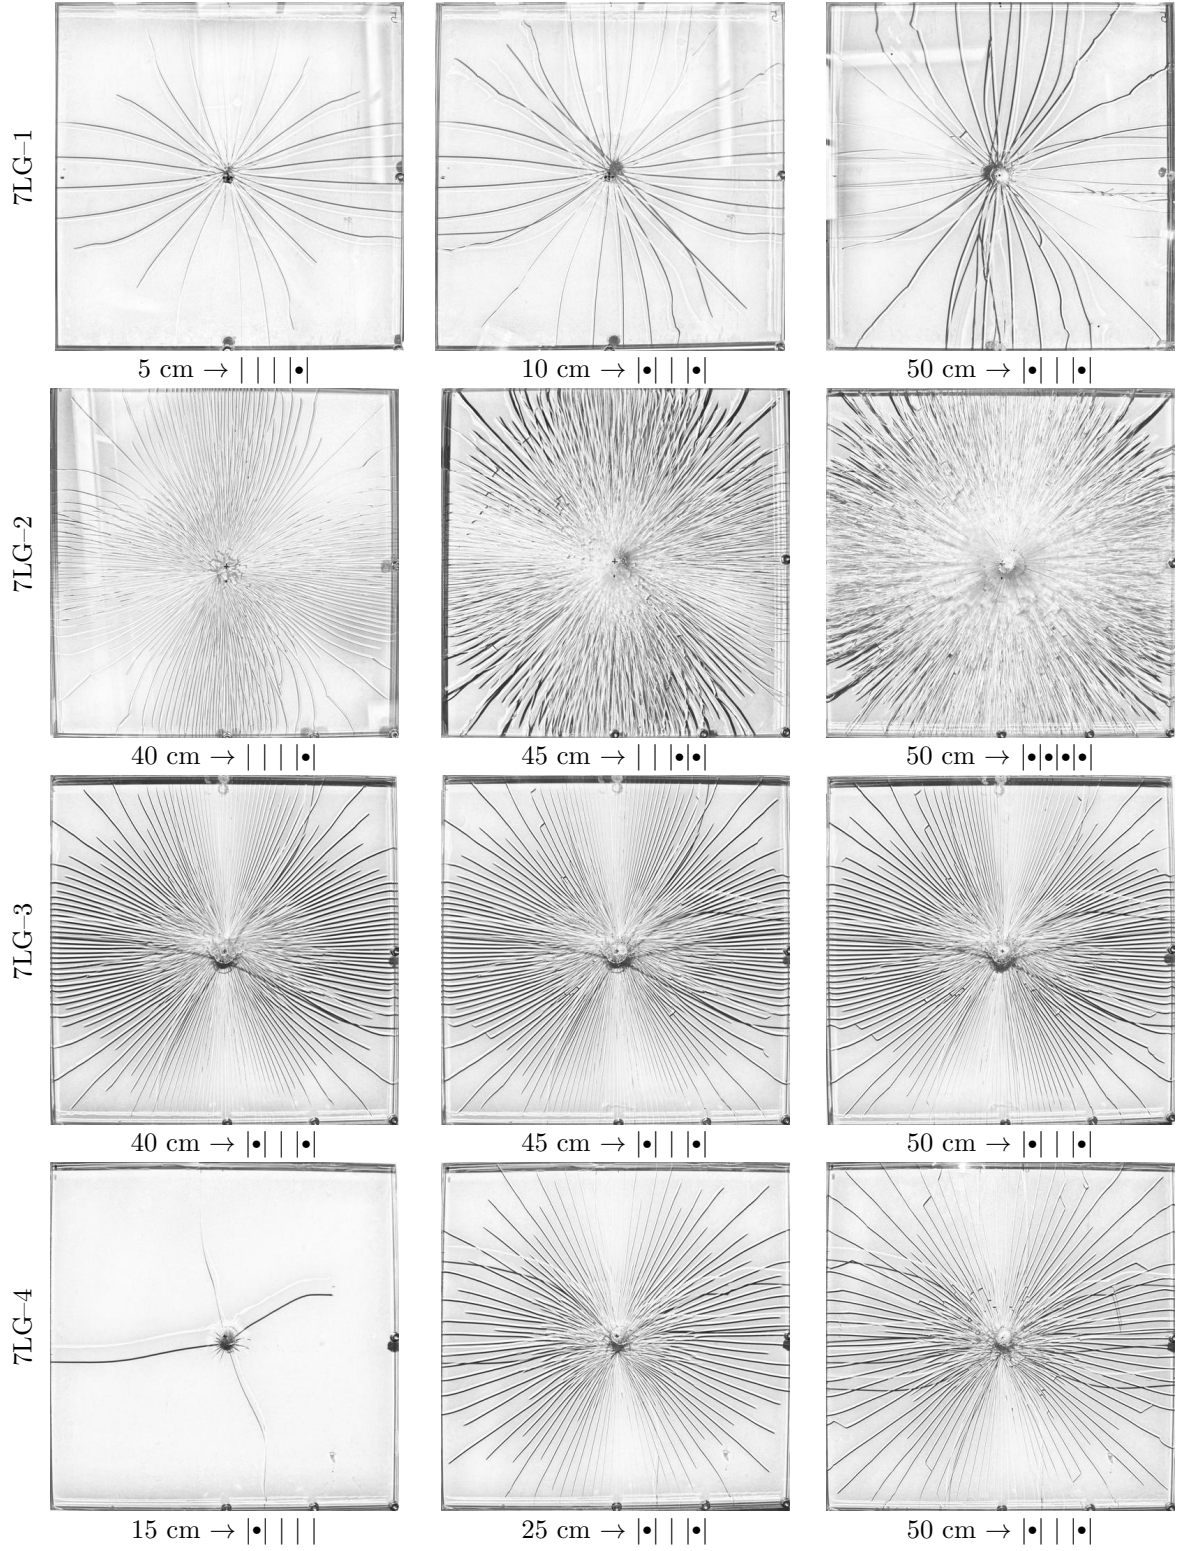
Figure 25: Fracture patterns for 7LG-samples corresponding to different impact heights complemented with the scheme of the cross-section with fractured layers marked by •. Photos are taken from the impacted side.

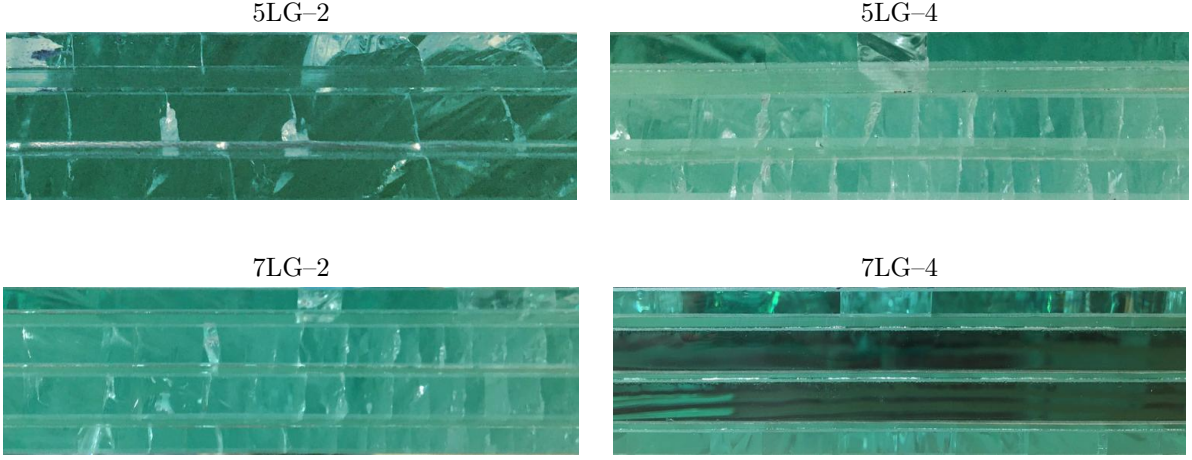
Figure 26: Side views of the final fracture patterns visible on samples' edges after all impact tests (the top glass layer is the impacted one).

The driving mechanisms of cracking for three-layer laminated glass was studied in [49]. The authors observed that the radial cracks initiated in the supported glass layer, and after a short time interval, the cracks propagated at the same in-plane locations in the impacted glass layer. In our impact tests, all glass layers did not generally fracture at one impact event, so the cracks did not completely propagate across the layers as can be seen in the side views on samples' edges (Figure 26). The more significant differences can be observed for the crack patterns on the impacted glass layer, which was underlied by a thicker PVB foil and where the cracks stayed mostly localised around the impact point (clearly visible, e.g., for 7LG-4 in Figures 20 and 26). The crack patterns partly differed also for the samples where glass layers fractured consecutively in the direction from the non-impacted surface to the impacted one (e.g., 5LG-2, 5LG-4, 7LG-2 in Figure 26).

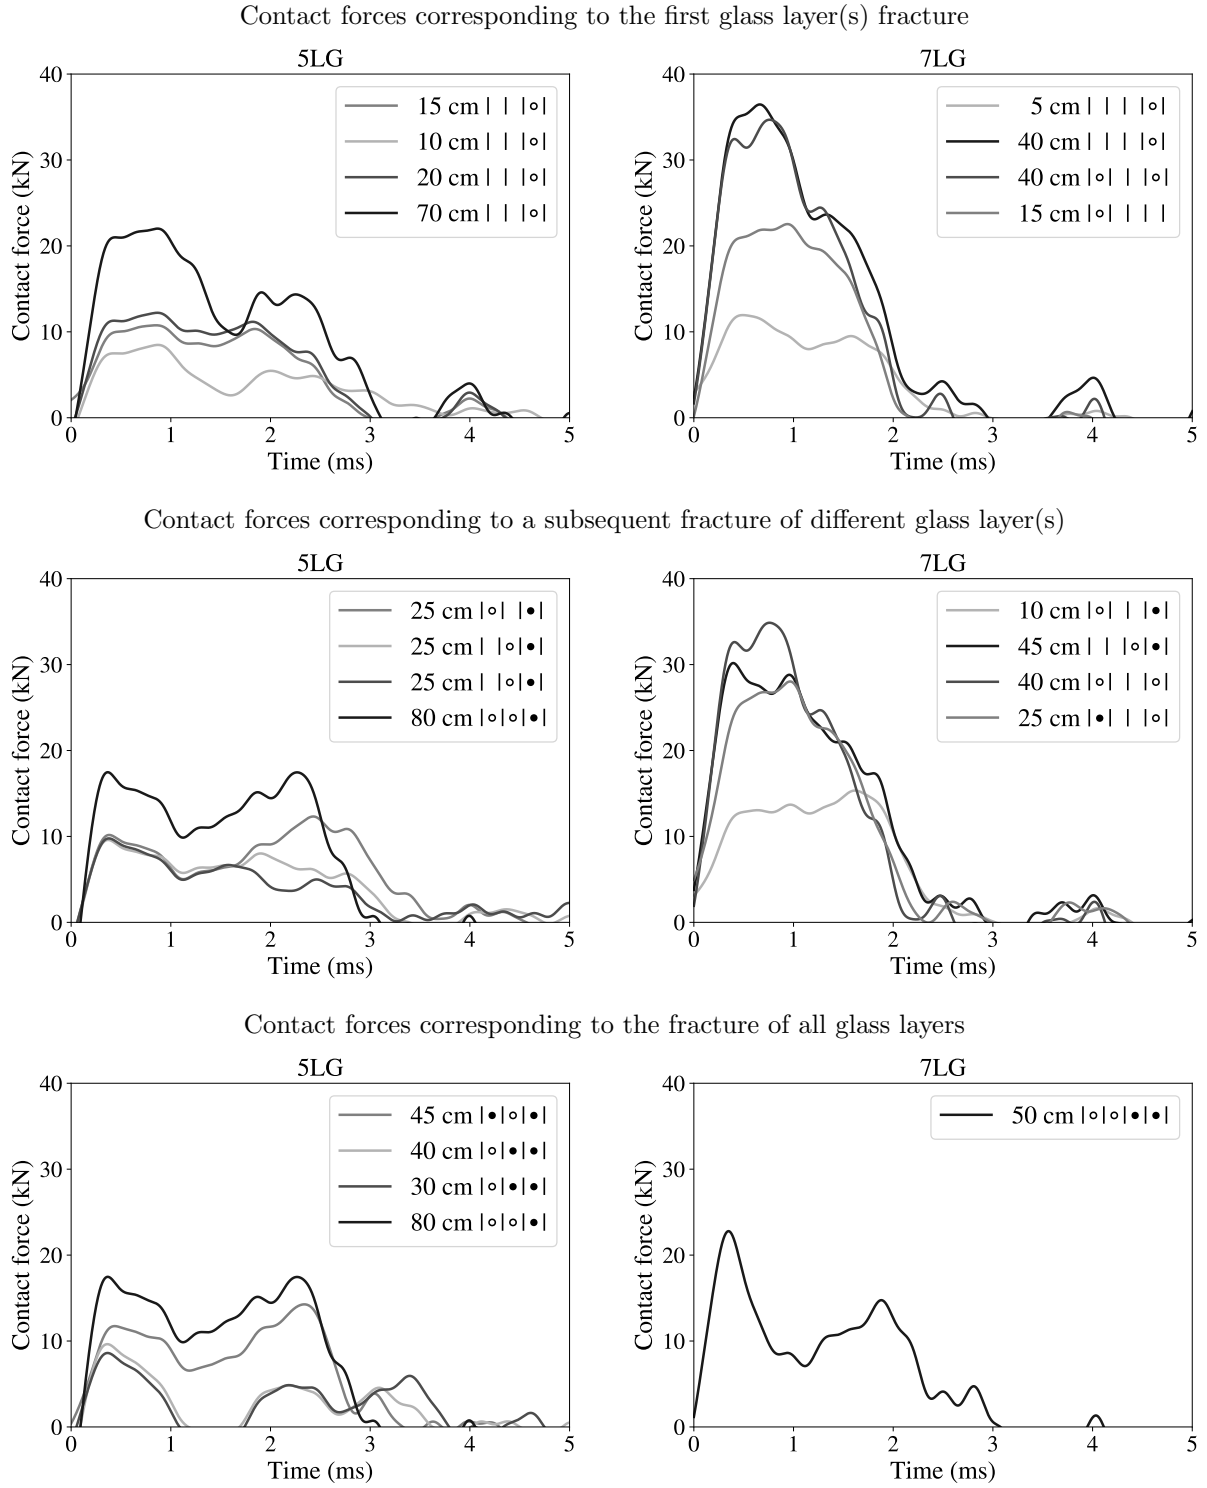
Figure 27: Comparison of contact forces ($2\times$ filter CFC 1000) corresponding to different stages of glass fracture.

The overview of breakage forces (presented in Figure 27) indicates that the 7LG-samples resisted mostly higher contact forces than the 5LG-sample. For both types of laminated glass, the scatter of forces is substantial due to the stochastic nature of tensile strength of glass. For 5LG-samples, the lowest peak value leading to the first glass layer fracture was less than 10 kN, whereas the largest value was over 20 kN. For 7LG-samples, the breakage force reached the value over 35 kN for two samples but was less than 15 kN in another case. Similar differences can be also seen for the peak contact forces leading to the fracture of subsequent glass layers.

The experiments confirmed that the samples with one or more fractured layers were in many cases able to resist similar or even higher contact forces than those leading to the fracture of the first or the previous glass layer. This effect is most obvious for the sample 7LG-1, where both outer glass layers fractured but the inner two intact glass layers resisted more than two times higher force without any failure (Figure 16). Notice also that the peaks of contact forces leading to the breakage of a glass layer were not always higher than the largest forces observed during previous less powerful impact events (samples 5LG-1, 5LG-2, and 5LG-4). This observation may indicate that some naked-eye invisible damage occurred during the previous contacts and/or the initial microflaws grew during previous impacts and caused subsequent failure [36].

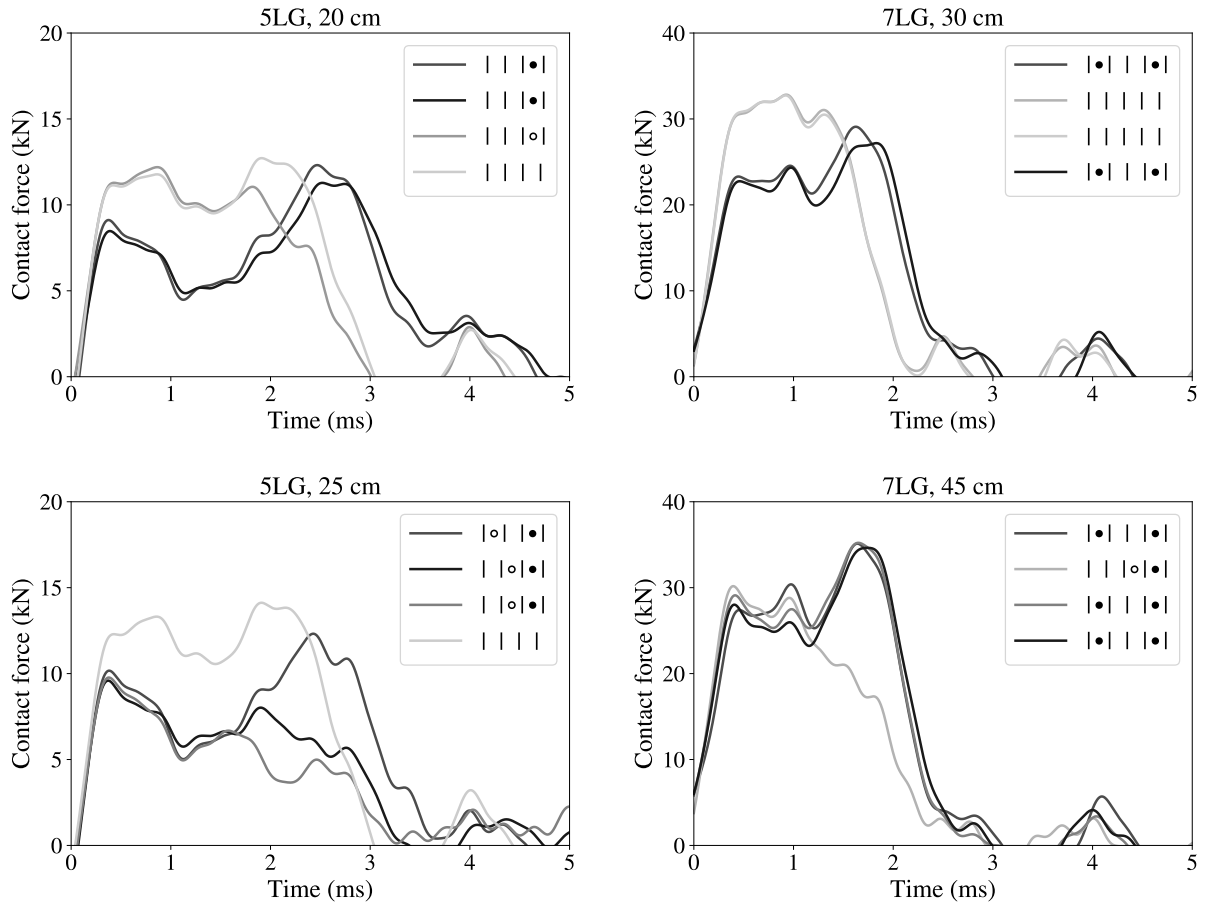
Figure 28: Comparison of contact forces ($2\times$ filter CFC 1000) for two different schemes of cracked layers in laminated glass samples.

Further, we tested if the same scheme of cracked layers provided the same evolution of contact forces. The very good level of conformity in the evolution of contact forces could already be seen for the post-fracture response of individual laminated glass samples (Figures 10–20). The comparison of contact forces acting on different samples (Figure 28) proves that the contact forces were consistent not only for non-destructive tests, but very similar evolutions developed also for the same scheme of fractured layers. For 5LG-samples

and the impact height of 20 cm, the contact forces differed only slightly, and the impact event resulted in approximately the same length of the contact and a similar peak value of the contact force. When the impact height was increased to 25 cm, the evolution of contact force followed initially the same path for three samples with the same scheme of cracked layers until the fracture of another glass layer. Almost identical contact forces can be also found for the 7LG-samples with both outer glass layers fractured (Figure 28).

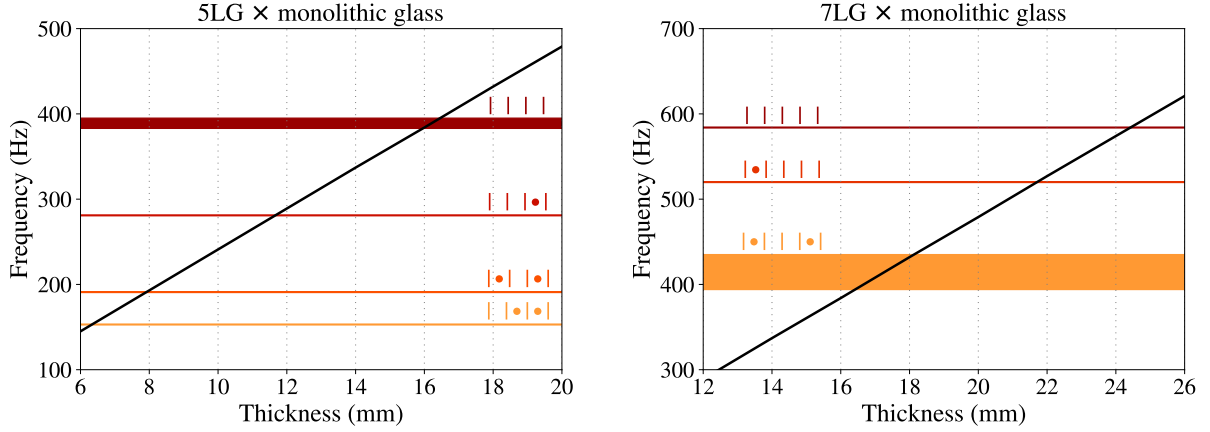
Figure 29: Comparison of the natural frequencies corresponding to the first bi-symmetric mode shape derived from FFT-based analysis for laminated glass samples against numerical predictions for monolithic glass plate (black line; Young’s modulus of glass 72 GPa, Poisson’s ratio 0.22, density $2,500 \text{ kg}\cdot\text{m}^{-3}$).

Next, the thicknesses of equivalent monolithic glass plates (with the same first natural frequencies) can be obtained from Figure 29. The natural frequencies of monolithic glass plates were derived numerically (employing the Young’s modulus of glass 72 GPa, Poisson’s ratio 0.22, and density $2,500 \text{ kg}\cdot\text{m}^{-3}$). The 5LG-samples vibrated similarly to a 16 mm-thick glass ply (the sum of the nominal thicknesses of glass layers together). If the back glass layer fractured in 5LG-samples, the natural frequencies corresponded to a monolithic glass plate thicker than 11 mm (the sum of nominal thicknesses of both unfractured layers). A difference in the first natural frequencies can be seen for 5LG-samples with only undamaged middle or front (impacted) glass layer. The first scheme provided the response comparable to an 8 mm-thick glass plate (the middle layer was 6 mm thick), whereas the second one to an approximately 6 mm-thick glass sample (the impacted layer was 5 mm thick).

For the undamaged 7LG-samples, the dynamic response corresponded to a 24.5 mm-thick glass plate (less than 26 mm—the nominal thicknesses of glass layers in a 7LG-sample together). If the impacted glass layer fractured, the response was comparable to a 21.5 mm-thick glass plate (the total thickness of unfractured glass layers was 21 mm). A wider range of obtained natural frequencies can be seen in Figure 29 for 7LG-samples with both outer glass layer damaged, when their modal response corresponded to a monolithic glass with the thickness of 16–18 mm.
