# The effect of manganese and silicon additions on the corrosion resistance of a polycrystalline nickel-based superalloy

E. Anzini<sup>1</sup>, N. Glaenzer<sup>2</sup>, P. M. Mignanelli<sup>3</sup>, M. C. Hardy<sup>3</sup>, H. J. Stone<sup>2</sup>, S. Pedrazzini<sup>1</sup>

<sup>1</sup> Department of Materials, Imperial College London, Exhibition Road, SW7 2AZ, London, UK. <sup>2</sup>Department of Materials Science and Metallurgy, University of Cambridge, 27 Charles Babbage road, Cambridge, CB3 0FS, UK. <sup>3</sup> Rolls-Royce plc, PO Box 31, Derby DE24 8BJ, UK.

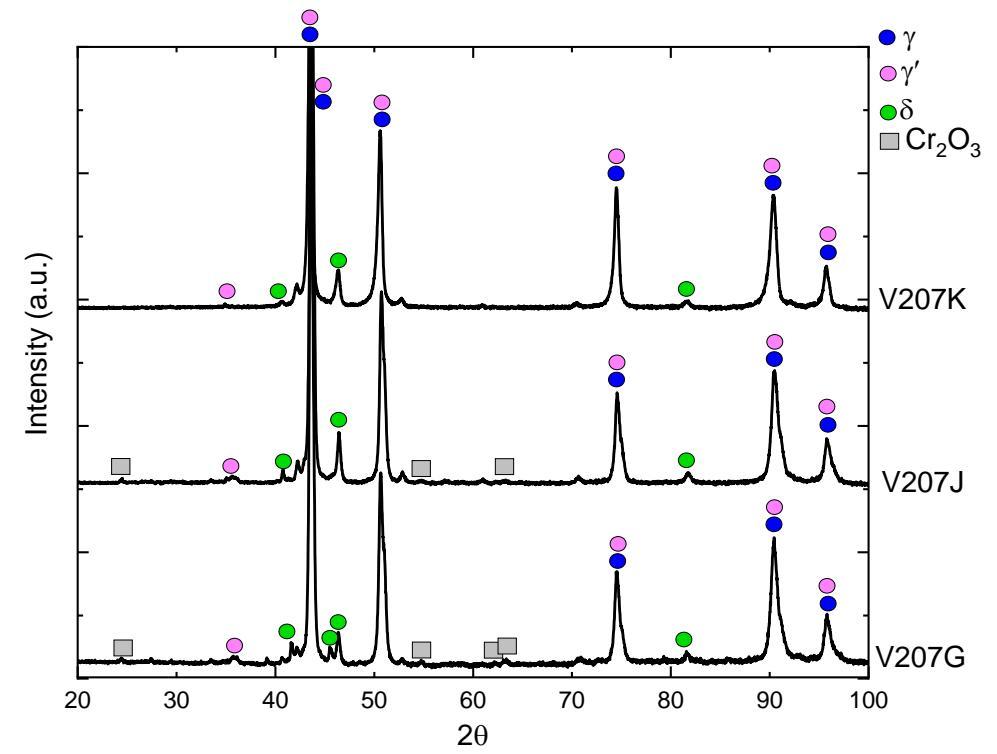
Phase identification in the as-produced material was initially performed through XRD. Diffractograms of the 3 alloys are shown in Figure 1. For all variations of the alloy the cubic Ni FCC- $\gamma$  phase was identified, with a lattice parameter of 3.59 Å (obtained by matching all the available peaks between 2 $\Theta$ =10-100°). The alloying additions had no obvious effect on the lattice parameter of the  $\gamma$  phase. The presence of stable intermetallic Ni<sub>3</sub>Nb  $\delta$  phase and ordered superlattice L1<sub>2</sub> structure  $\gamma'$  Ni<sub>3</sub>Al phase was also confirmed by XRD. The presence of manganese did not cause any additional phases to be detected by XRD. The presence of 0.5 wt% silicon, however, caused an increase in the intensity of the Bragg diffraction peaks associated with the  $\delta$  phase. Reflections from common borides or carbides such as M<sub>23</sub>C<sub>6</sub> (generally found at grain boundaries) or MC (bulk) were also not identified despite some of them being visible in the SEM micrograph in Figure 2, likely due to their low volume fraction being beyond XRD resolution.

Figure 1: X-ray diffractograms of the V207 K, J and G alloys in their as-hot isostatic pressed condition.

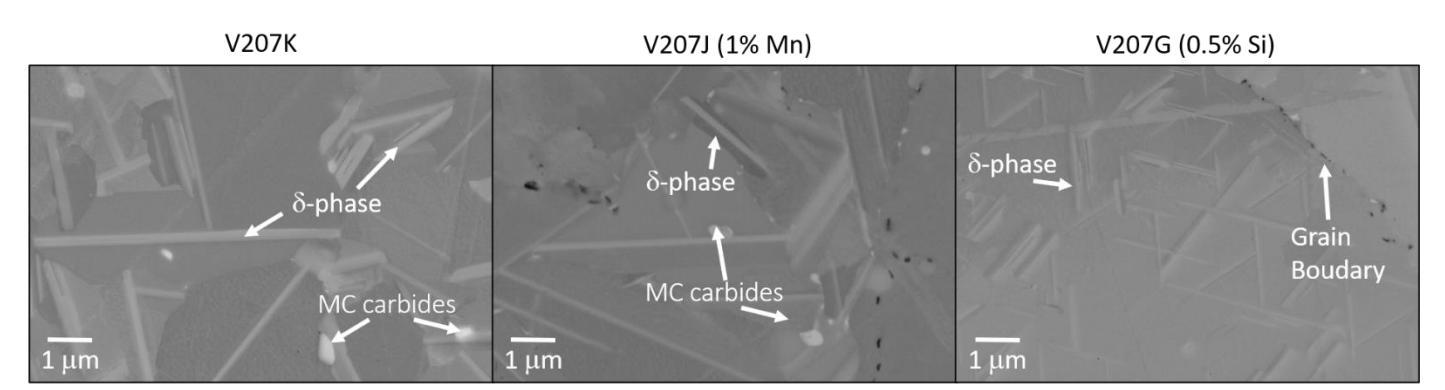
Figure 2 shows backscattered electron imaging (BEI) micrographs of the V207 K, J and G alloys heat treated at 750°C for 24 hours under vacuum. Elongated features with light grey contrast, believed to be the  $\delta$ intermetallic phase were visible in all the alloys. The V207G appears to have a larger fraction of smaller particles compared to the other 2 alloys, though detailed measurements are beyond the scope of this project. Carbides were also visible, spherical particles with a bright appearance in the BEI images, consistent with the appreciable refractory metal contents expected in these phases. The darker particles located at grain boundaries are postulated to be either carbides or borides, but their volume fraction was insufficient for XRD identification.

Figure 2: BEI SEM micrographs of the V207 K, J, and G alloys after heat treatment at 750°C for 24 hours under vacuum.

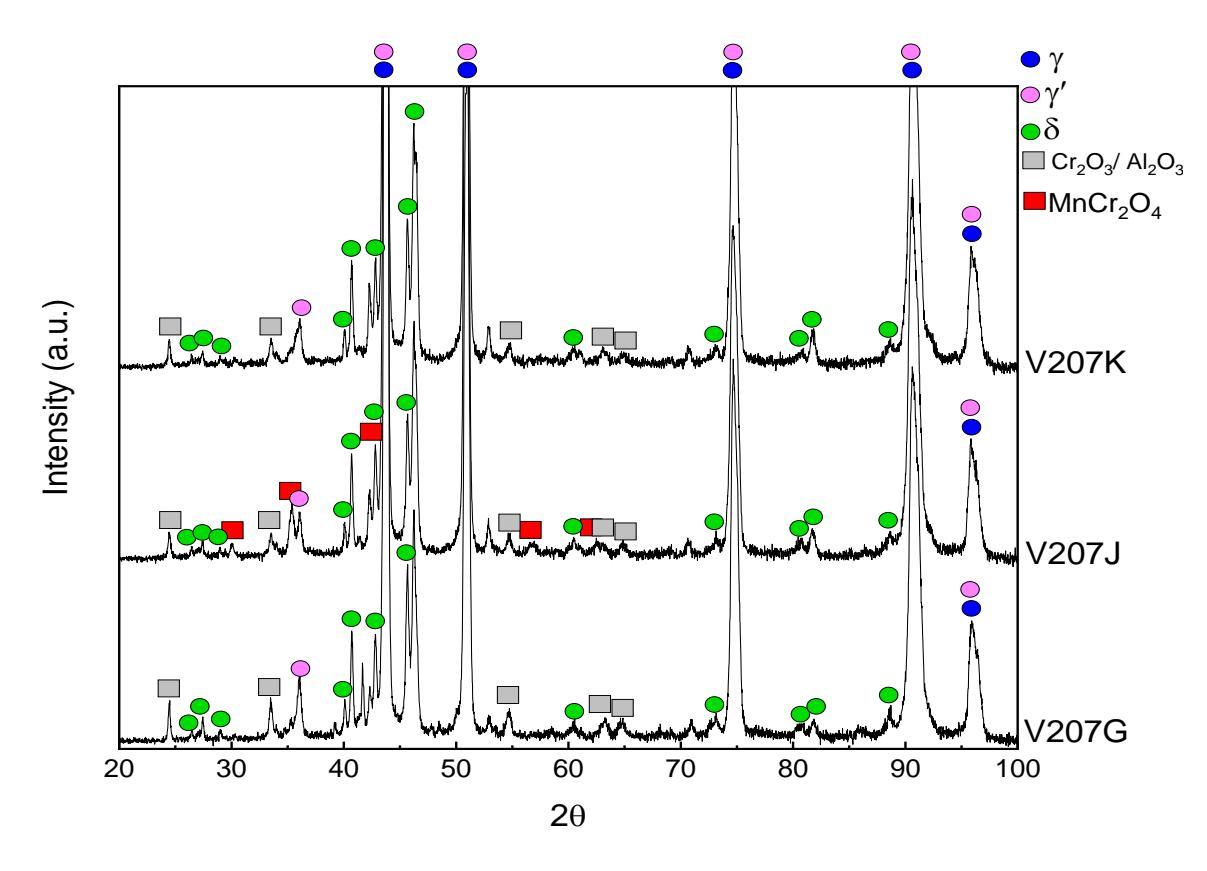
XRD was performed on the samples exposed in air for 100 hours for oxide phase identification (after 24 hours the oxide scale was too thin for accurate phase identification using a lab-based X-ray diffractometer). The X-ray diffractograms are shown in Figure 3. The presence of  $Cr_2O_3/Al_2O_3$  was identified, but due to the two phases having the same (Corundum) crystal structure and similar lattice parameters, the corresponding peaks mostly overlapped and were therefore labelled as both. The presence of  $MnCr_2O_4$  was confirmed on the V207J alloy, in addition to the  $Cr_2O_3/Al_2O_3$  phases. This is consistent with previous work which showed through atom probe tomography that the surface oxide scale on this alloy after 100 hours at 800 °C was also a combined  $MnCr_2O_4/Cr_2O_3$  scale [8]. After the 100-hour oxidation exposure the presence of  $\gamma$ - $\gamma'$  phases were also confirmed in the bulk alloys (as expected), though the heat treatment caused further precipitation of  $\delta$ , shown by the increased relative peak intensity. No NiO, TiO<sub>2</sub>, SiO<sub>2</sub>, Ta<sub>2</sub>O<sub>5</sub>, TiN or any oxides and spinels of Fe could be confirmed by XRD.

*Figure 3: X-ray diffractogram of the V207K, V207J (Mn-containing) and V207G (Si-containing) alloys after a 100-hour furnace heat treatment at 750°C in air.*

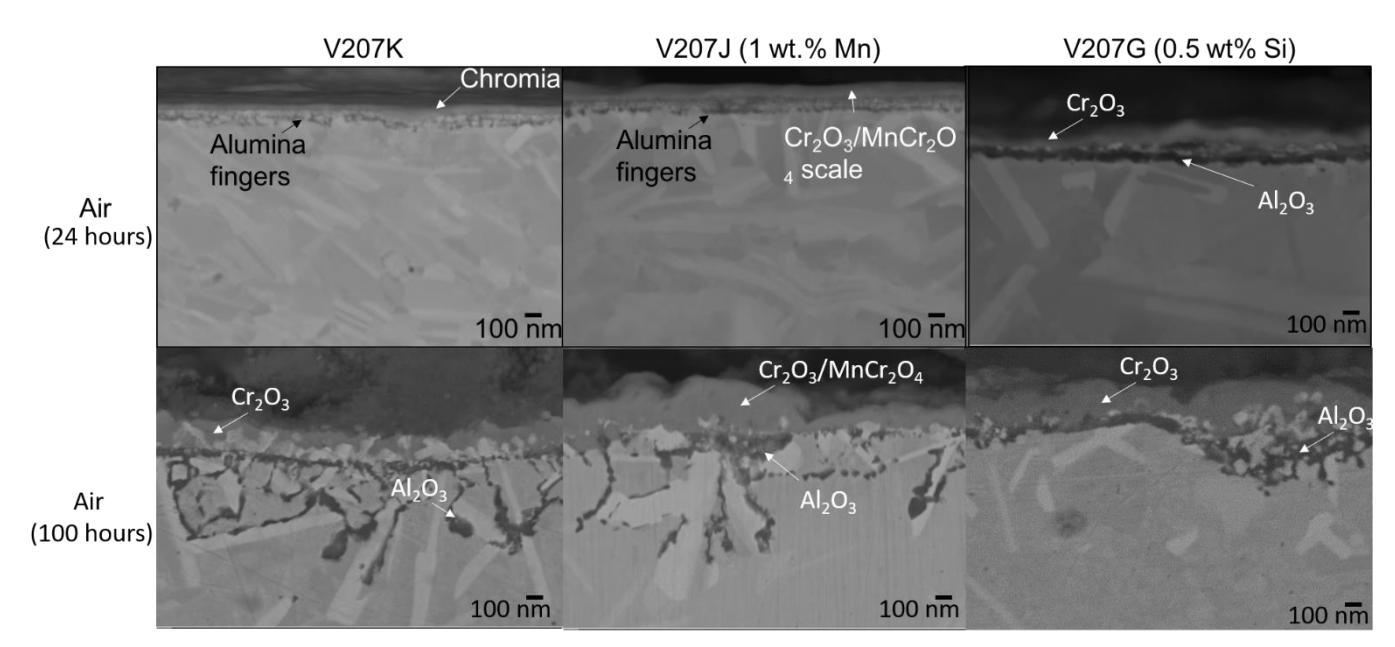
Figure 4 shows backscattered SEM micrographs of the V207 K, J and G alloys, oxidised for (top) 24 hours and (bottom) 100 hours in air at 750°C. After 24 hours, the V207K and V207J alloys have an overall thinner oxide scale than V207G consisting of a continuous upper layer of  $Cr_2O_3$  with inner  $Al_2O_3$  intrusions. The addition of 1 wt% Mn did not appreciably alter the morphology or the thickness (within the error margin) of the oxide scale formed in 24 hours, though it is expected that the upper layer will be a combination of  $Cr_2O_3/MnCr_2O_4$  in the V207J alloy and only of  $Cr_2O_3$  in the V207K alloy, as previously established through atom probe tomography [18]. The presence of 0.5 wt% Si, however, significantly altered the morphology of the oxide scale formed on the V207G alloy. A continuous dual-layer chromia and alumina scale formed, with white nanoparticles (likely to be tantalum oxide, though beyond the resolution of the XRD in Figure 3) at the interface between the two layers. The overall damage depth is ~2x thicker than the V207K alloy after this short-term heat treatment, as shown in Table 2.

After 100 hours the morphology of each oxide scale on the V207K and V207J alloys remains unchanged but the thickness of the V207G (Si-containing) is 2-3x thinner than both other alloys due partly to a lack of subscale alumina intrusions, as shown in Figure 4 and Table 2. V207G alloy oxidises faster in the early stages, but the growth rate of the oxide scale is slower than the base V207K and Mn-containing V207J counterparts. It should be noted that though representative micrographs were selected, the oxide scales were inhomogeneous, as shown by the standard deviation values of the thickness of the oxide scales, shown in Table 2 (measured using ImageJ).

Figure 4: BEI SEM micrographs of the V207 K, J and G alloys, oxidised for (top) 24 hours and (bottom) 100 hours in air at 750°C.

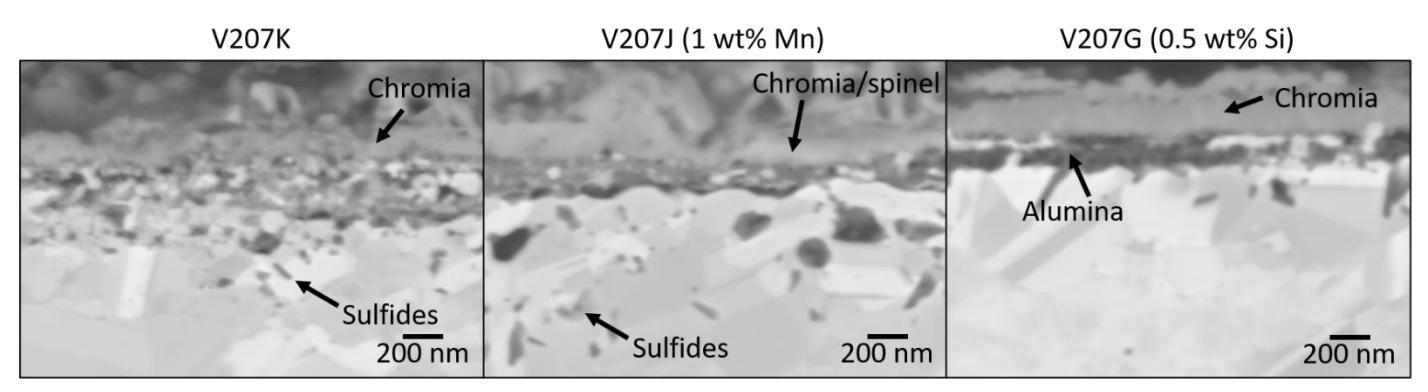
X-ray diffractograms of the alloys exposed to air + 370 ppmv  $SO_{2/3}$  showed that the combined oxide/sulfide scale after 24 hours was too thin to be identified within the resolution of the instrument, therefore these samples were characterised primarily though SEM, as shown in Figure 5.

Figure 5: BEI SEM micrographs of the V207 K, J and G alloys exposed to 370 ppmv SO<sub>2/3</sub> gas in air for 24 hours at 750°C.

Figure 5 shows BEI micrographs of the samples exposed to air + 370 ppmv SO<sub>2/3</sub> for 24 hours at 750 °C. From the morphology and location of the surface damage, it was found that the V207K alloy has suffered more extensive damage from the oxygen/sulfur exposure than the equivalent sample oxidised in air for 24 hours, shown in Figure 4. The surface has a relatively thin, porous scale and internal alumina/sulfide formation beneath. The V207J alloy (Mn-containing) formed a thicker, less porous surface layer, though unlike for the V207K alloy, it retained enough integrity to reduce the extent of internal oxidation and alumina/spinel formation. It is noteworthy that due to the presence of Mn, the depth of damage has increased. The V207G alloy (Si-containing) exhibited the least surface damage under SO<sub>2/3</sub> exposure for 24 hours at 750°C, with a solid dual surface layer and no visible sub-scale intrusions. Some white particles are visible at the interface between the two surface layers in Figure 5, which are postulated to be tantalum oxide. The lighter appearance of these particles in backscattered imaging mode is indicative of heavy element presence, which according to the literature could be either tantalum oxide or a titanium-tantalum spinel [13], [19], [20]. Total thickness (damage depth) measurements are presented in Table 3 and show that the V207G alloys exhibited half the depth of damage compared to alloys V207J and K.

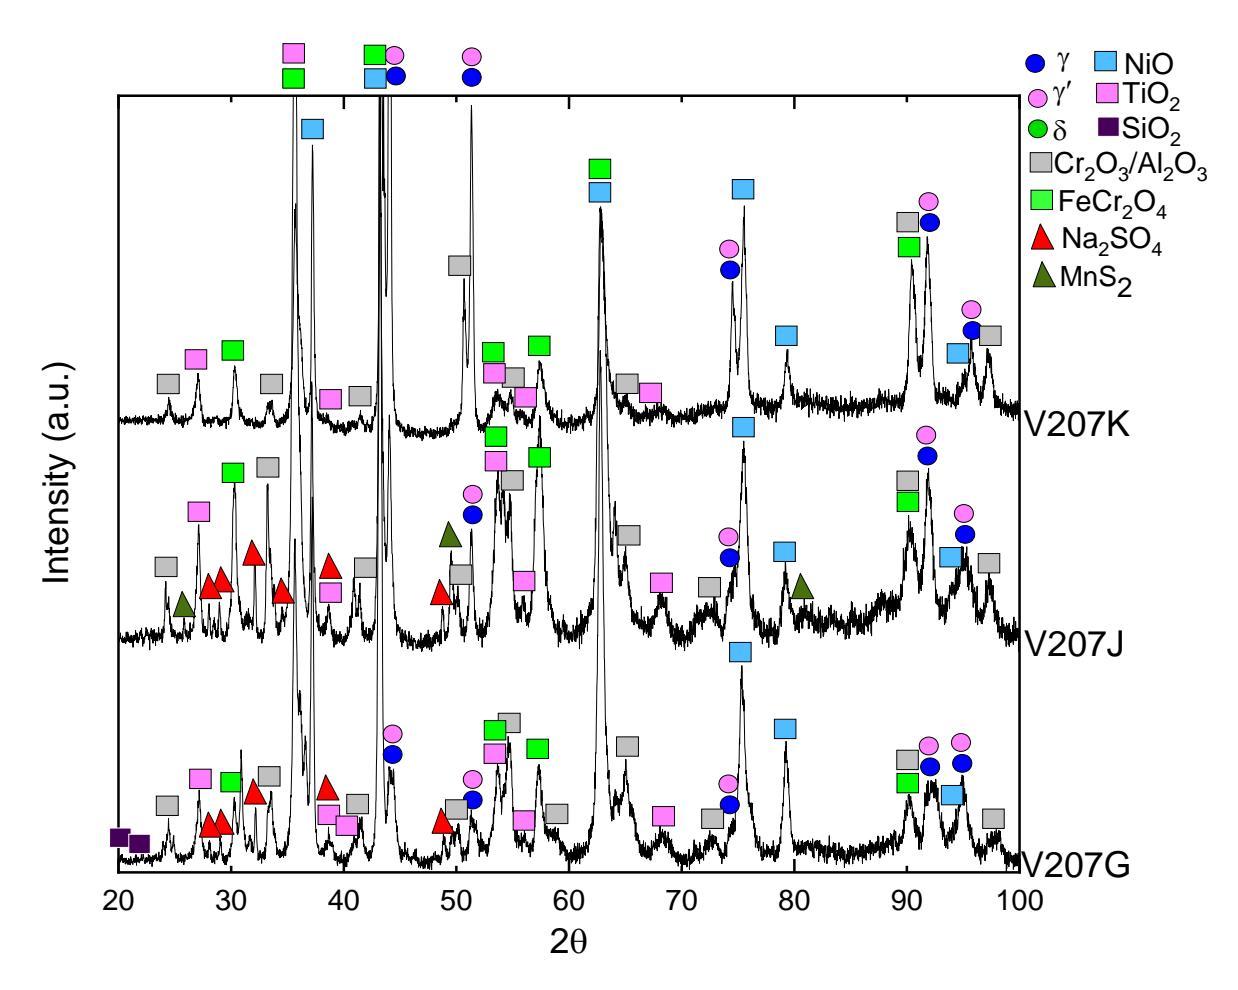
The phases formed through coupled SO<sub>2/3</sub> and sea salt exposure at 750 °C for 24 hours were confirmed by Xray diffraction, shown in Figure 6. Diffraction peaks from the  $\gamma$  and  $\gamma'$  phases were still present, though the thickness of the surface scale was sufficient to mask some of the bulk phases. Within the diffraction patterns, peaks from the NiO, FeCr<sub>2</sub>O<sub>4</sub> spinel, TiO<sub>2</sub>, and Cr<sub>2</sub>O<sub>3</sub>/Al<sub>2</sub>O<sub>3</sub> phases were identified. The diffraction pattern obtained from alloy V207J also contained some evidence of MnS sulfides. The presence of silicon in the V207G alloy caused SiO<sub>2</sub> to be detected, although in extremely small amounts. The diffraction patterns from the V207J and V207G samples both contained peaks from Na<sub>2</sub>SO<sub>4</sub>, which was not part of the original alloy and was not added as a salt on the surface, therefore it is product of the reactions occurring during the heat treatment. A Bragg diffraction peak at  $2\Theta$ =30.9° in the V207G alloy could not be identified from any of the expected phases.

Figure 6: X-ray diffractogram of the V207K, V207J (Mn-containing) and V207G (Si-containing) alloys after a 24-hour furnace heat treatment at 750 °C in air with 370 ppmv SO<sub>2/3</sub> and salt.

The addition of sea salt (compared to the sulfidation experiment) promoted the following reaction steps: the NaCl also reacts with the SO<sub>3</sub> and  $H_2O$ , to create hydrochloric acid and sodium sulfate (shown by XRD in Figure 6) according to Reaction A below.

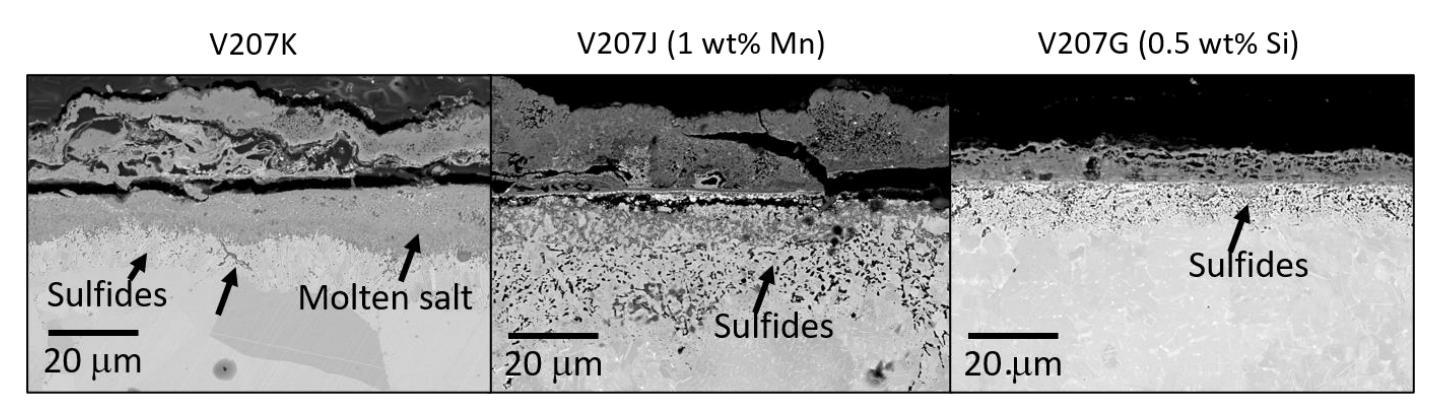
Figure 7 shows BEI micrographs of cut and polished sections of the alloys after exposure to salt and 370 ppmv SO<sub>2/3</sub> in air at 750°C for 24 hours. The base alloy V207K was seen to have formed a thick uppermost oxide scale with severe spallation and visible evidence of oxide scale fluxing on the underlying substrate. Some internal oxidation and sulfidation was also observed beneath this external scale. The addition of 1wt% Mn did not visibly change the thickness or the spallation rate of the uppermost scale of the V207J alloy when compared to V207K. Despite this, the presence of Mn has visibly reduced oxide scale fluxing although it extended the overall damage depth (including the depth of internal oxidation/sulfidation). The V207G alloy (0.5 wt% Si) has the best resistance to environmental degradation under these conditions out of the 3 alloys analysed. However, the effect of the exposure on the surface scale is visible in the form of porosity (compared to Figures 4-5). Some internal oxidation and/or sulfidation underneath the surface scale was also visible, but to a lower extent compared to the V207K and V207J alloys. The surface scale is non-uniform, with wide variability captured by the damage depths mean and standard deviation values shown in table 6. More detailed SEM-EDX analysis of the phases formed on the surface of each alloy is shown in Figures 8-13.

Figure 7: BEI SEM micrographs of the V207 K, J and G alloys exposed to 370 ppmv SO<sub>2/3</sub> gas and sprayed with sea salt in air, for 24 hours, at 750°C.

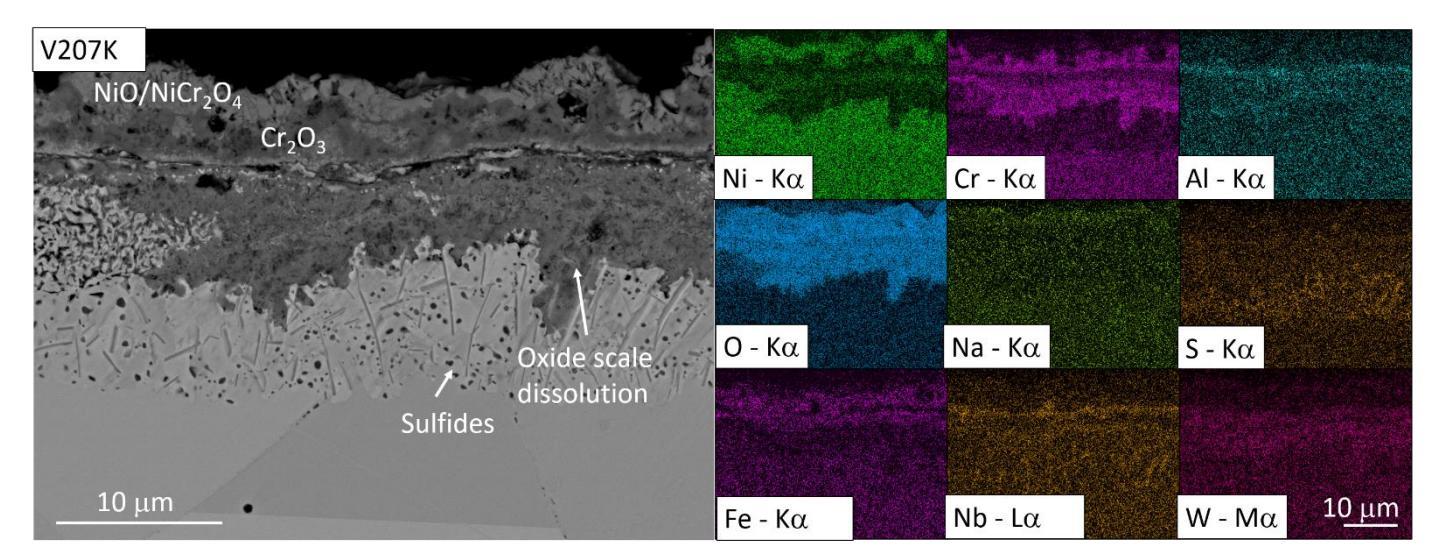
A BEI SEM micrograph is shown in Figure 8 of the environmental damage on the baseline alloy V207K along with corresponding EDX elemental maps of the same region. The EDX data provided evidence of the location of the phases which were identified by XRD within the surface scale. In this case, the external scale is made of NiO, with an underlying Cr<sub>2</sub>O<sub>3</sub> scale and the Fe-containing spinel FeCr<sub>2</sub>O<sub>4</sub>. There is evidence of dissolution of the chromia scale into the underlying alloy, extending the damage further when compared to the same alloy exposed without the salt, as shown in Figure 5.

Figure 8: BEI SEM micrograph and associated EDX elemental distribution maps of the V207K alloy sample exposed to air, 370 ppmv SO<sub>2/3</sub> and salt.

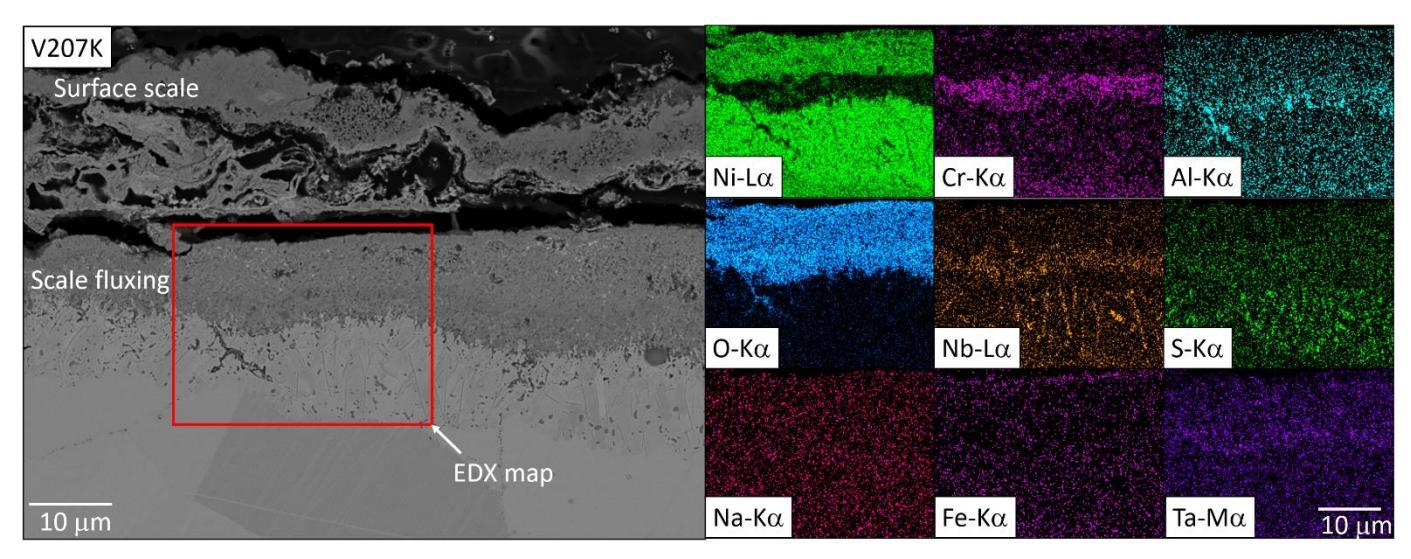
Figure 9 shows a higher magnification image of the scale formed on the V207K alloy following exposure to air, with 370 ppmv  $SO_{2/3}$  and salt, along with EDX elemental distribution maps of the region indicated by the

red box. These data confirm the presence of a 10-20  $\mu$ m denuded zone (Ni-rich and Cr-depleted in the EDX map) underneath the surface scale, which also contains evidence of internal oxidation and sulfidation. A distinct lack of alumina intrusions are observed compared to the oxidised sample (only one intrusion in the field of view). No evidence of chlorine was detected. Elongated, needle-like Nb sulfides have formed underneath the oxide scale. Niobium sulfides, much like most other refractory metal sulfides, have been previously reported to grow through sulfur ingress, which was speculated to be a result of them being anionic diffusers [21]. Their Cd(OH)<sub>2</sub>-type crystal structure, made of two planes of sulfide ions with a plane of cations in between allows these structures to accommodate different metal-sulfur ratios, therefore allowing for a wide range of non-stoichiometric compositions to form [22], [23] depending on the local sulfur partial pressure [24], which can all be summarised using the general chemical formula Nb<sub>1+δ</sub>S<sub>2</sub>. Nb has also been known to form carbo-sulfides [25]. The wide stoichiometric variation, coupled with the low volume fraction made the sulfides difficult to identify unambiguously in the X-ray diffraction patterns, Figure 6. Comparison with the SEM micrographs in Figure 8 and 9 shows the extent of non-uniformity of the surface scale, including localised spallation.

Figure 9: BEI SEM micrograph and associated EDX elemental distribution maps showing a close-up detail of the V207K alloy sample exposed to air, 370 ppmv SO<sub>2/3</sub> and salt (overview show in in Figure 8).

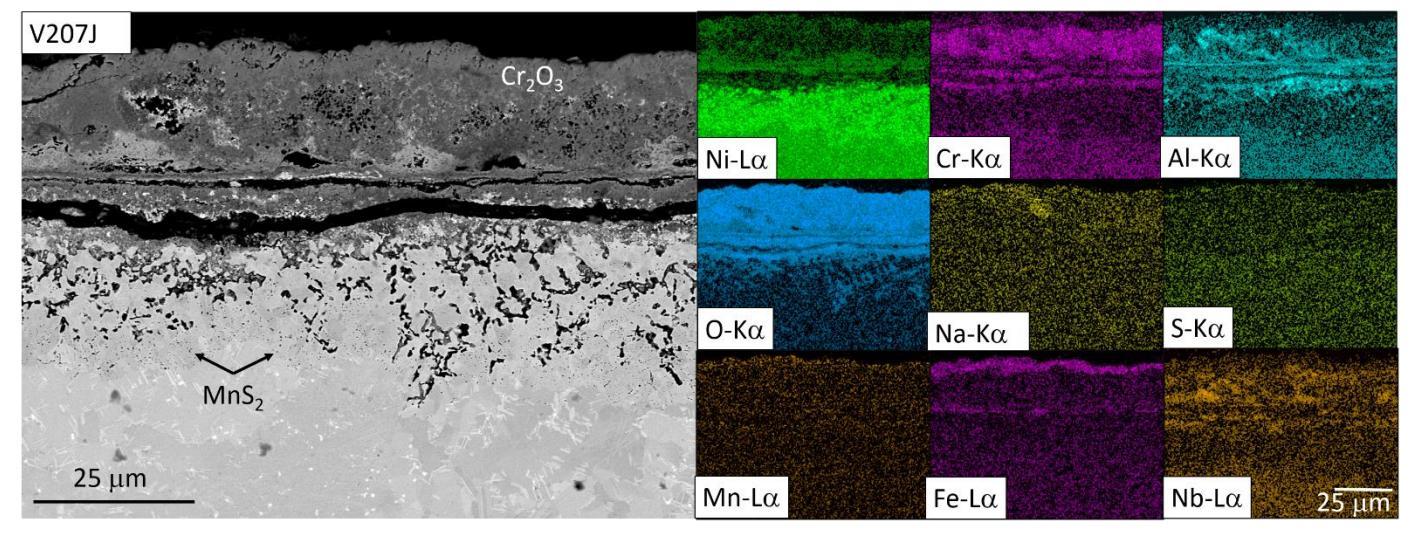
The SEM-EDX analysis of the V207J alloy (Mn containing) sample exposed to SO<sub>2/3</sub> and salt is shown in Figure 10. The MnCr<sub>2</sub>O<sub>4</sub>/Cr<sub>2</sub>O<sub>3</sub> scale is visible, along with some Al<sub>2</sub>O<sub>3</sub>. In this alloy, Nb<sub>2</sub>O<sub>5</sub> is visible in the surface scale, as well as an uppermost Fe-containing spinel, which the XRD data in figure 6 indicated should be FeCr<sub>2</sub>O<sub>4</sub>. Some evidence of oxide scale dissolution (fluxing) is visible in this sample as well, though not to the extent observed on the V207K alloy in Figures 8 and 9. Surface scale spallation is evident in Figure 10. The  $\gamma'$  denuded zone underneath the Cr<sub>2</sub>O<sub>3</sub>/MnCr<sub>2</sub>O<sub>4</sub> scale is enriched in Ni. Manganese sulfides formed underneath the Al<sub>2</sub>O<sub>3</sub> intrusions, shown more in detail in Figure 11. The damage depth was almost double that of the V207K alloy, due partly to the presence of manganese sulfides. In this alloy, no evidence of niobium sulfides was observed. Na<sub>2</sub>SO<sub>4</sub> was unambiguously identified in this sample using the X-ray diffractogram in Figure 6, which according to the EDX map in Figure 10 is likely to be located towards the outer surface of the oxide scale.

Figure 10: BEI SEM micrograph and associated EDX elemental distribution maps of the V207J alloy sample exposed to air, 370 ppmv SO<sub>2/3</sub> and salt.

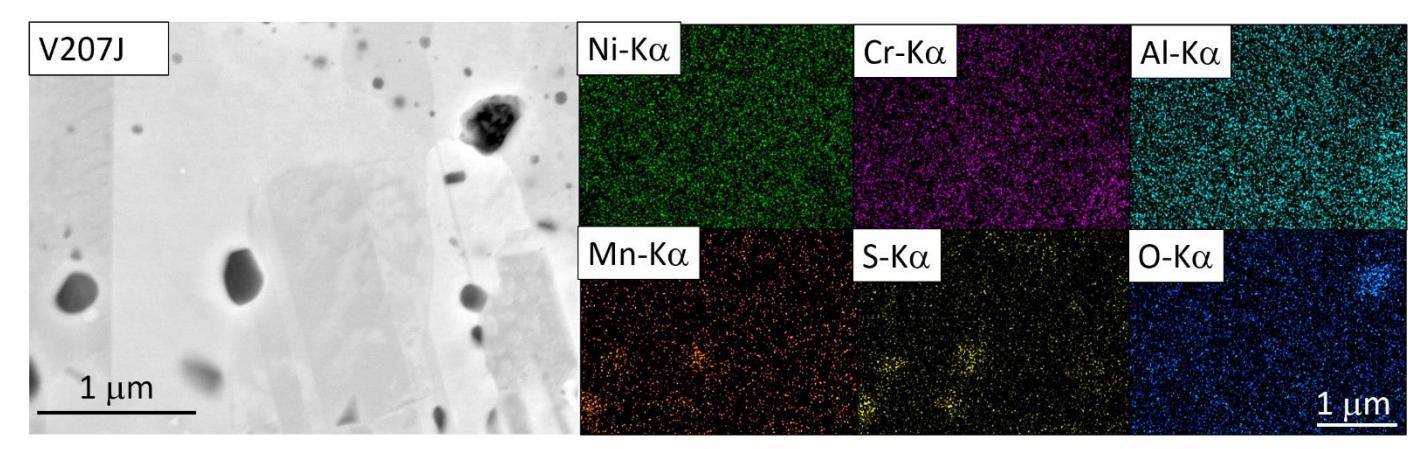
Figure 11: BEI SEM micrograph and associated EDX elemental distribution maps showing a close-up detail of the V207J alloy sample exposed to air, 370 ppmv  $SO_{2/3}$  and salt (overview show in in Figure 10).

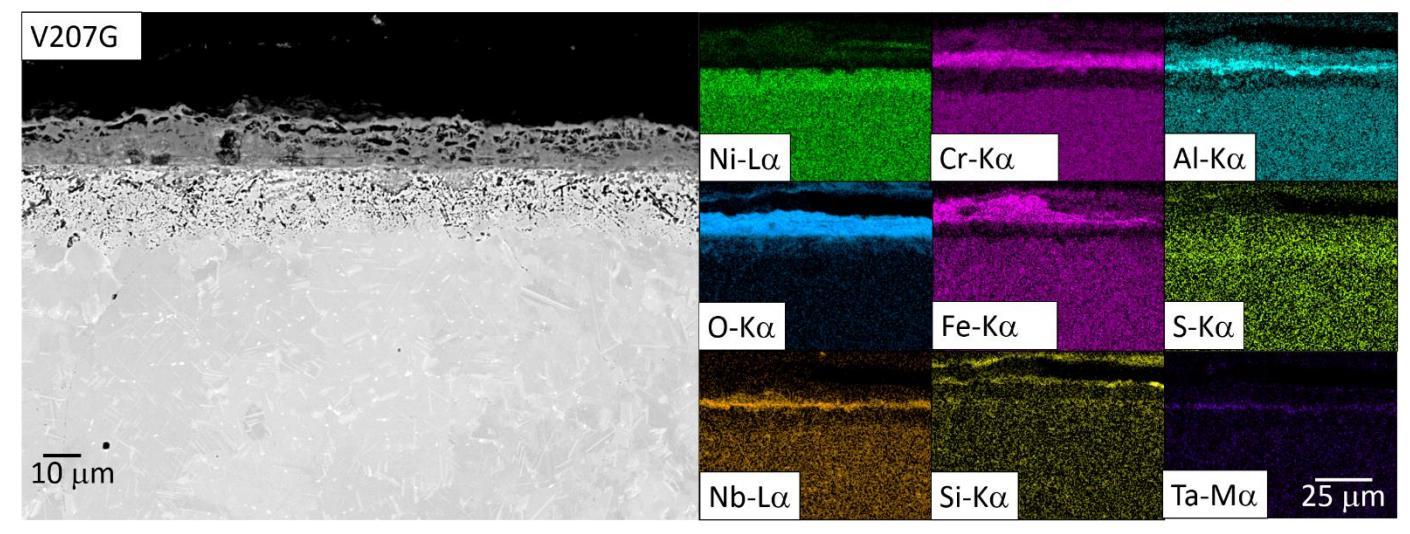
Figure 12 shows a backscattered SEM micrograph and associated EDX maps of the V207G (Si-containing) alloy exposed to  $SO_{2/3}$  and salt for 24 hours at 750°C. The surface scale consisted of a dual-layer chromiaalumina scale, though the chromia was interspersed with FeCr<sub>2</sub>O<sub>4</sub> spinel. Nb was observed in the form of distinct particles at the oxide-metal interface, which appear Si-rich (Figure 13), possibly Nb silicides, though their presence could not be confirmed by XRD. Figure 14 shows a higher magnification view of the area underneath the surface scale, within the  $\gamma'$  denuded zone. The Si and O elemental maps indicated that SiO<sub>2</sub> formed as intrusions underneath the oxide scale. Niobium sulfides were also observed, though only lower amounts of smaller niobium sulfide particles than in the V207K alloy, with a Ni-enriched zone ( $\gamma'$  denuded zone) surrounding them.

Figure 12: BEI SEM micrograph and associated EDX elemental distribution maps of the V207G alloy sample exposed to air, 370 ppmv SO<sub>2/3</sub> and salt.

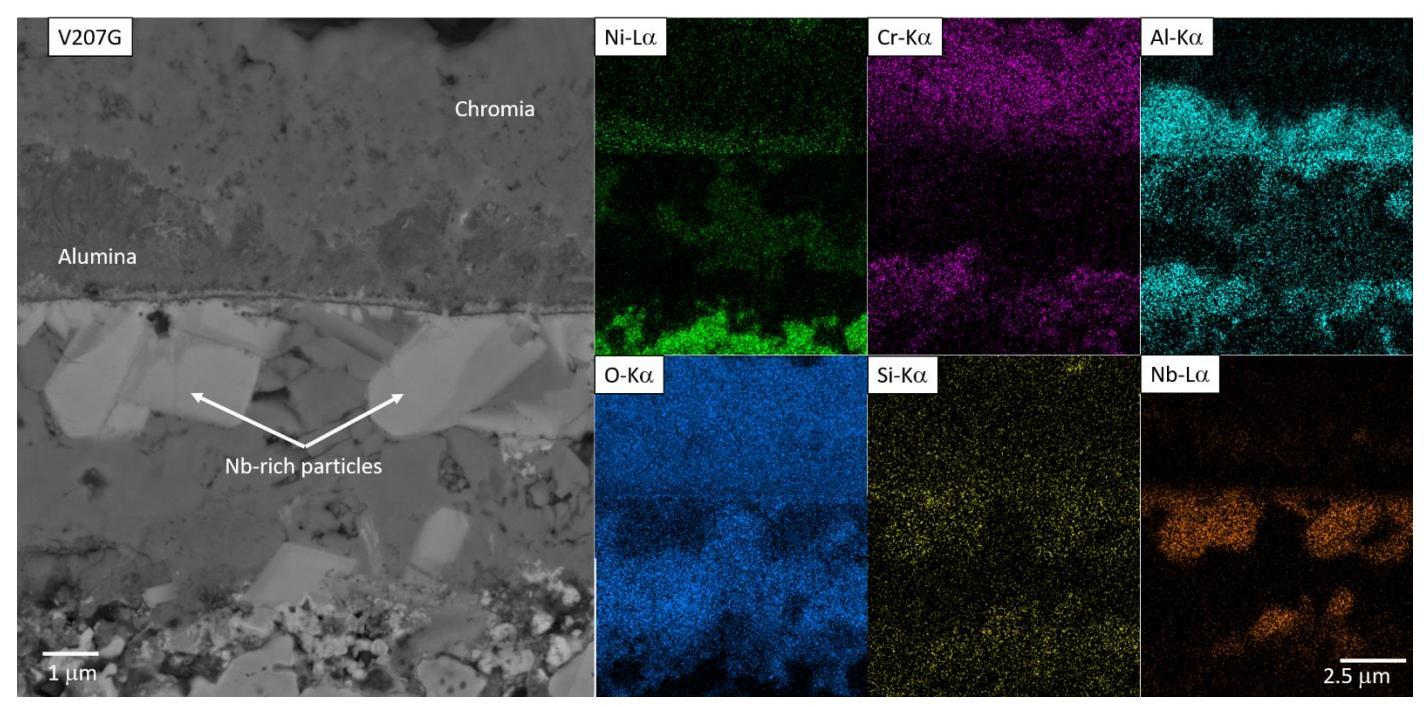
Figure 13: BEI SEM micrograph and associated EDX elemental distribution maps of the interface between the inward growing and outwards growing oxides, showing the presence of Nb-rich particles.

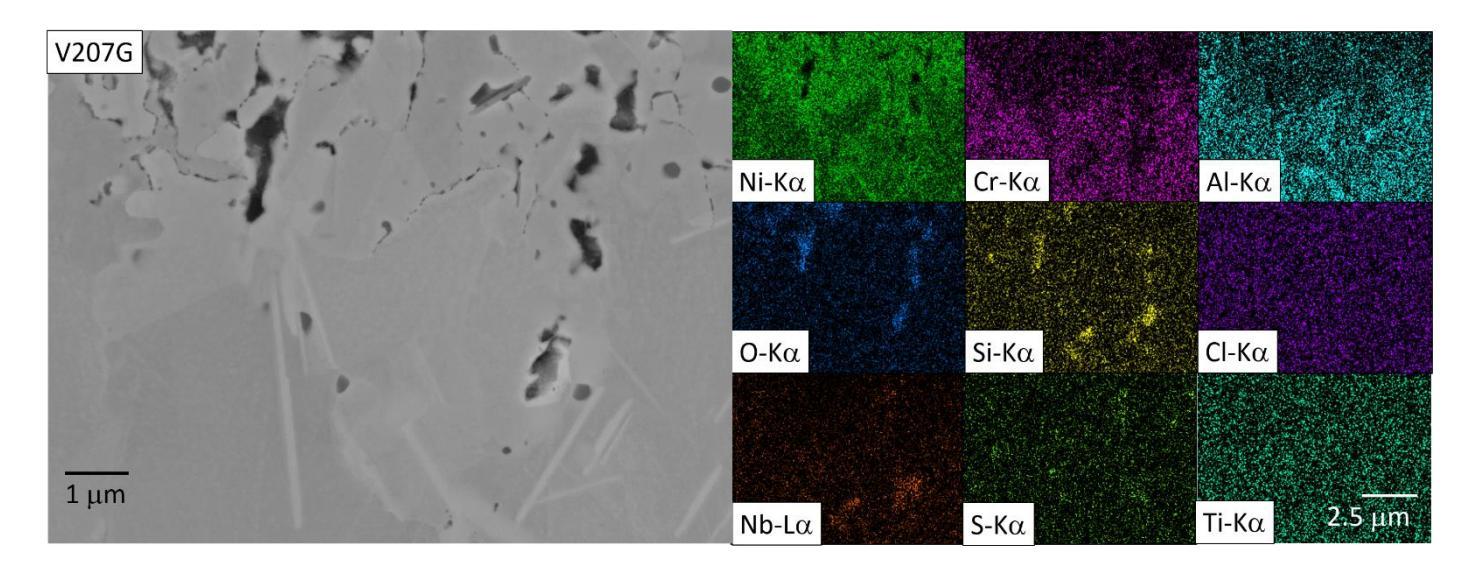
Figure 14: BEI SEM and associated EDX elemental distribution maps showing a close-up detail of the internal oxidation and sulfidation products found on the V207G alloy sample exposed to air, 370 ppmv SO<sub>2/3</sub> and salt (overview show in in Figure 12).

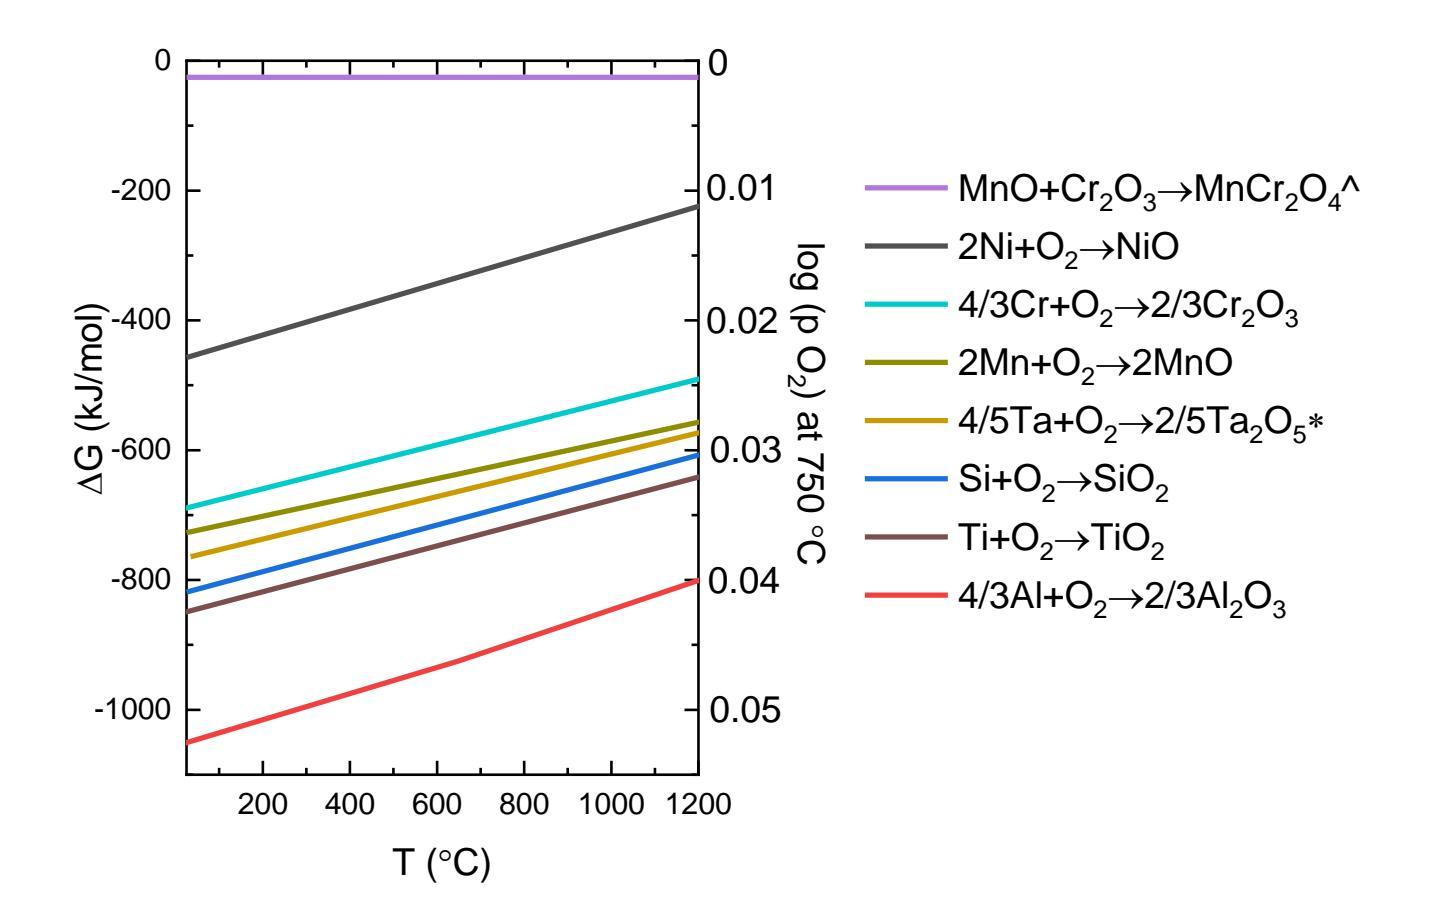
*Diagram 15: Ellingham diagram of oxide formation, taken and adapted from a variety of databases* [26], [27] *and journal papers* [28].

Based on the alloy baseline composition (V207K), according to diagram 15 a multi-layered scale of NiO, Fe<sub>2</sub>O<sub>3</sub>, Cr<sub>2</sub>O<sub>3</sub>, Al<sub>2</sub>O<sub>3</sub> may be expected to form on the V207K alloy. However, due to kinetic considerations, not all of the thermodynamically stable oxides and spinels were observed and only chromia and alumina were identified. NiO has a tendency to form in the earliest stages of oxidation, due to the relative abundance of nickel in the alloy compared to other alloying elements allowing Ni to have a shorter mean free path of diffusion towards the surface [29]. However, NiO is a relatively less stable oxide, therefore the growth of chromia and alumina quickly supersedes its formation as they may form at lower partial pressures of oxygen [30]. The V207J (Mn-containing) alloy also formed MnCr<sub>2</sub>O<sub>4</sub> spinel, in addition to Cr<sub>2</sub>O<sub>3</sub> and Al<sub>2</sub>O<sub>3</sub> (as observed in a previous study [31]), whereas the V207G (Si containing) alloy formed some  $SiO_2$  which could be detected by XRD but were not located in the SEM-EDX analysis. Low concentrations of Si added to other nickel-based superalloys (0.5 wt% or less) have previously been shown to cause the localised formation of silica nanoparticles as opposed to a continuous scale [13]. The nanoparticles were located between the Cr<sub>2</sub>O<sub>3</sub> and Al<sub>2</sub>O<sub>3</sub>, a location which is consistent with the partial pressures of formation predicted by the Ellingham diagram in diagram 15. In some alloys, silicon has also been shown to promote the formation of a continuous layer of alumina, as opposed to disconnected alumina intrusions found underneath the surface scale [13], [32], [33].

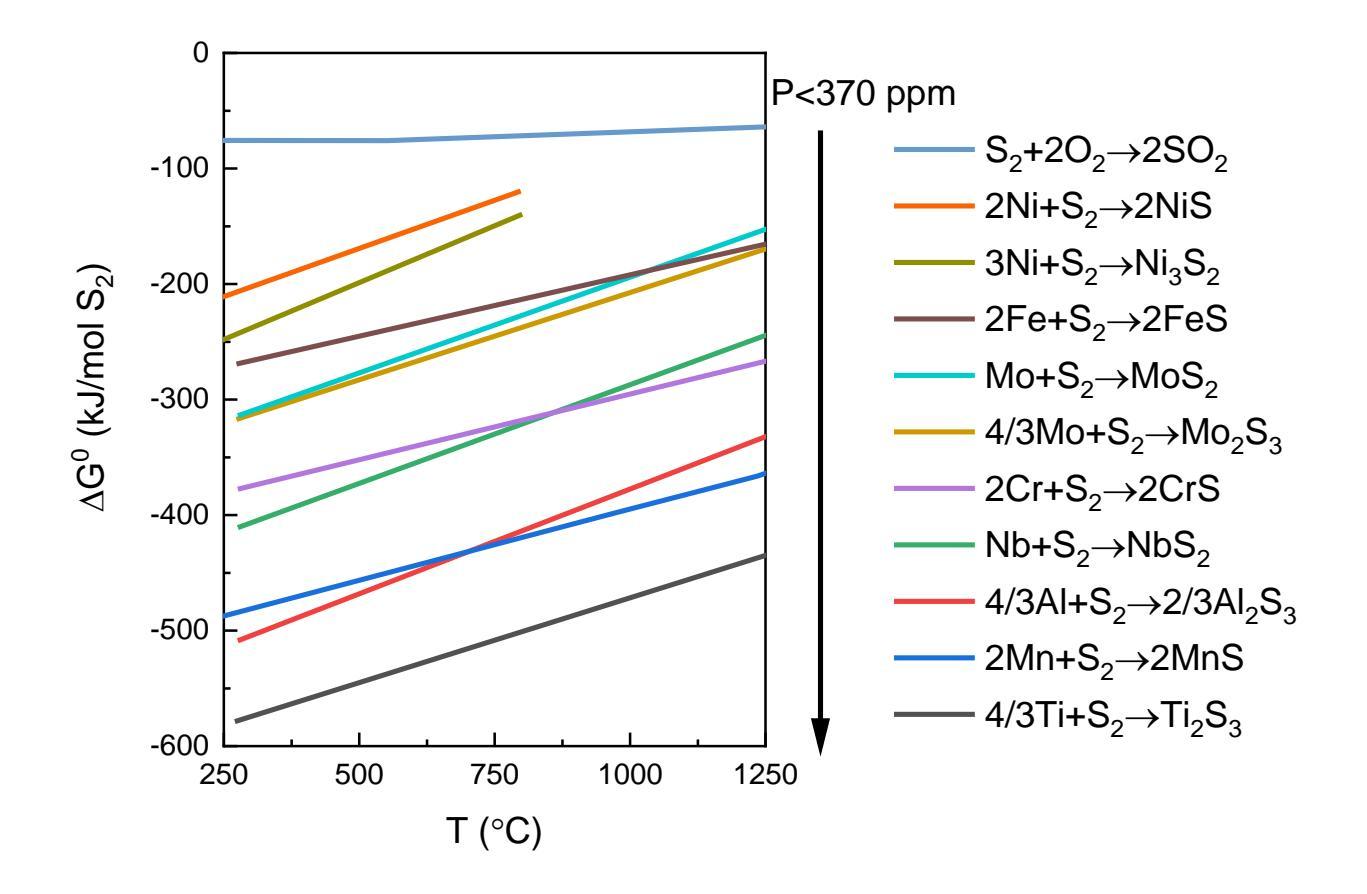
**Diagram 16:** Ellingham Diagram for selected sulfides, normalised by mol S<sub>2</sub>. Data sources: SO<sub>2</sub> [36], NiS [37], Ni<sub>3</sub>S<sub>2</sub> [37], FeS [38], MoS<sub>2</sub> [38], Mo<sub>2</sub>S<sub>3</sub> [38], CrS [39], NbS<sub>2</sub> [36], Al<sub>2</sub>S<sub>3</sub> [38], MnS [37], Ti<sub>2</sub>S<sub>3</sub> [38].

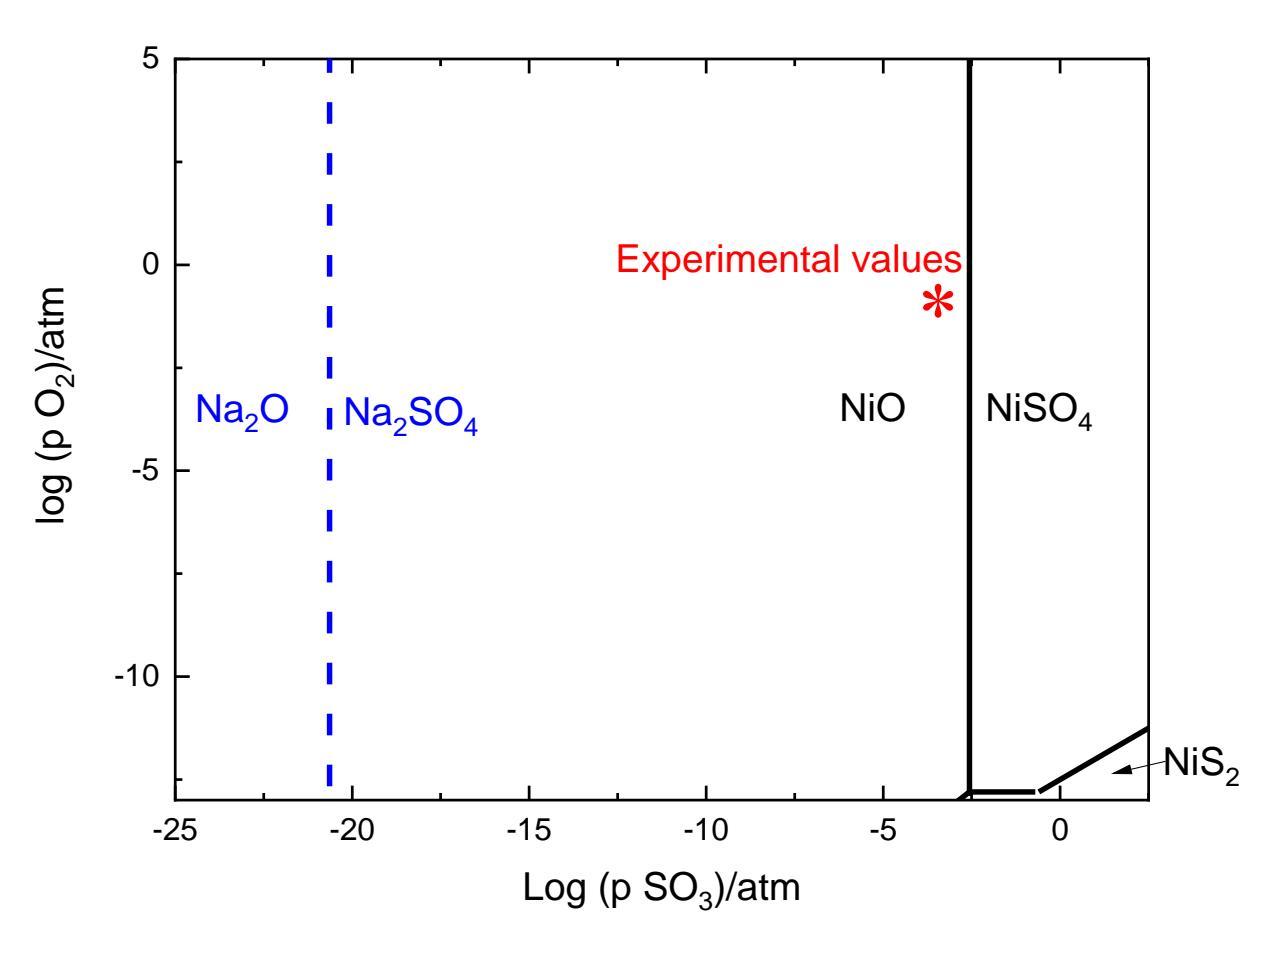
T=750°C

Diagram 17: Phase stability diagram of Ni-S-O (black solid lines) overlayed with the phase stability diagram of Na-S-O compounds (blue dashed lines) at 750 °C and in red an indication of the experimental parameters used in the present study. Data obtained and adapted from [40].
