PREPARED FOR SUBMISSION TO JINST

8<sup>TH</sup> INTERNATIONAL CONFERENCE ON MICRO-PATTERN GASEOUS DETECTORS 14-18 October 2024 Hefei, China

# Development of the high-rate capable DLC-RPC based on the current evacuation pattern

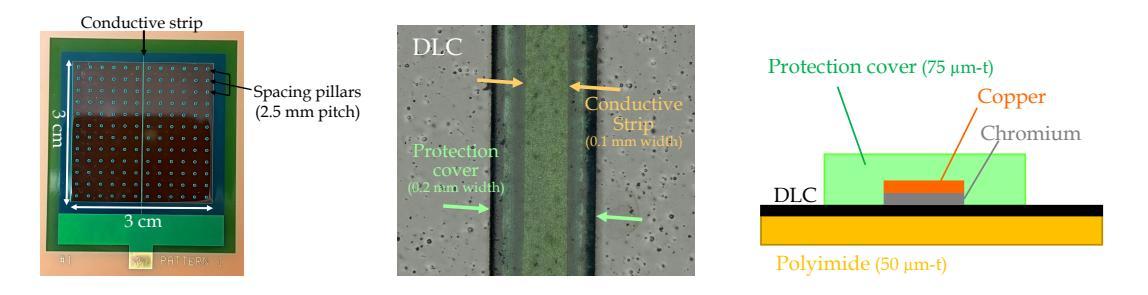
Figure 1 shows the DLC-RPC electrode with the current evacuation pattern. DLC was directly sputtered onto the 50 µm thick polyimide film. The conductive current evacuation pattern was implemented on the DLC layer and covered with the protection cover whose material is the same as the pillars. This pattern was formed by the lift-off process. Chromium was sputtered onto the DLC layer, followed by copper sputtering onto the chromium layer. This sandwich structure is motivated by the good adherence of chromium with DLC. This electrode has the pillars (~365 µm thick, 0.6 mm diameter, 2.5 mm pitch), the current evacuation pattern (0.1 mm width), and  $3 \times 3 \text{ cm}^2$  of the active region. The variation of the pillar thickness was measured to be below 10 µm. The surface resistivity of DLC was measured to be  $6 - 15 \text{ M}\Omega/\text{sq}$ . Different electrode samples with 0.2 mm and 0.8 mm widths of the protection cover were tested to investigate the width needed to avoid discharge. According to the results and discussions in Reference [1], the voltage drop will be down to 100 V at the expected operation voltage in the muon beam in this configuration.

**Figure 1**. Pictures and a schematic of the DLC-RPC electrode with the current evacuation pattern. (Left) Overview. (Center) Enlarged view of the strip structure. (Right) Cross-section of the strip structure.

The electrode shown in Figure 1 was used as an anode electrode. A bare DLC sputtered polyimide was used as a cathode electrode, in which the surface resistivity of DLC was measured to be  $10 - 15 M\Omega/sq$ . These electrodes were placed facing each other to form the DLC-RPC gas gap. This gap was filled with  $C_2H_2F_4/SF_6/iC_4H_{10}$  (94/1/5). The signals were induced to an aluminum strip outside the gas gap, amplified by 38 dB, and then input to the DRS4 waveform digitizer [4].

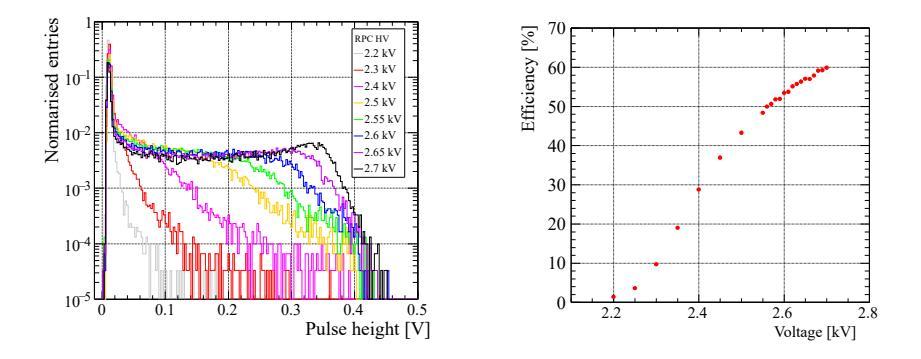
Figure 2 shows the performances of the DLC-RPC for the  $\beta$ -ray from a <sup>90</sup>Sr source. In this measurement, the  $\beta$ -ray was collimated with 2 mm in diameter and irradiated far from the conductive pattern to avoid instability due to the strip structure. The hit rate was O(1 kHz) at that time. The *n*-gaps efficiency can be estimated with the single-gap efficiency  $\epsilon_1$  by  $\epsilon_n = 1 - (1 - \epsilon_1)^n$ . The measured efficiency of 60 % is enough to reach a target efficiency of 90 % with four gaps. In addition, the target efficiency can be achieved even with a drop of 100 V – 150 V.

**Figure 2.** Performance of the DLC-RPC for the  $\beta$ -ray. (Left) Pulse height spectra. (Right) Detection efficiency. Efficiencies were calculated with a 20 mV signal threshold, which corresponds to a 25 fC threshold in the induced charge to the readout strip.

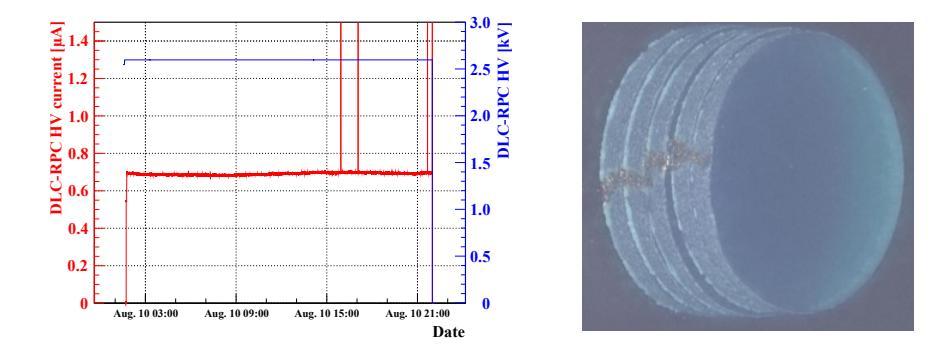
Finally, long-term stability was measured. O(100 kHz) of  $\beta$ -ray was continuously irradiated to the whole region. The left plot in Figure 3 shows the operation status. The voltage was applied at 2.6 kV, which is 30 - 50 V lower than the target voltage. Discharges suddenly occurred after about 14 hours and the DLC-RPC eventually tripped after 20 hours. The discharge created a current path on the pillar, as shown in the right picture in Figure 3, and prevented further operation.

Figure 3. Status of the long-term operation. (Left) Operation voltage and measured current. (Right) Picture of the damaged spacing pillar.

We have described the measured performance is promising to fulfill all the requirements. On the other hand, the long-term instability, caused by materials inside gaps, is problematic in the MEG II experiment. Since low surface resistivity can cause such instability, it should be adjusted to safer ranges (above  $20 \text{ M}\Omega/\text{sq}$ ). Besides, the avalanche charge could gradually burn the polymer in the pillars, eventually leading to the discharges as shown in Figure 3. Ionic contamination of residuals from resist developing process could reduce the current paths. We will investigate solutions to suppress the instability.
