ATLAS silicon module assembly and qualification tests at IFIC Valencia

ABSTRACT: ATLAS experiment, designed to probe the interactions of particles emerging out of proton proton collisions at energies of up to 14 TeV, will assume operation at the Large Hadron Collider (LHC) at CERN in 2007. This paper discusses the assembly and the quality control tests of forward detector modules for the ATLAS silicon microstrip detector assembled at the Instituto de Física Corpuscular (IFIC) in Valencia. The construction and testing procedures are outlined and the laboratory equipment is briefly described. Emphasis is given on the module quality achieved in terms of mechanical and electrical stability.

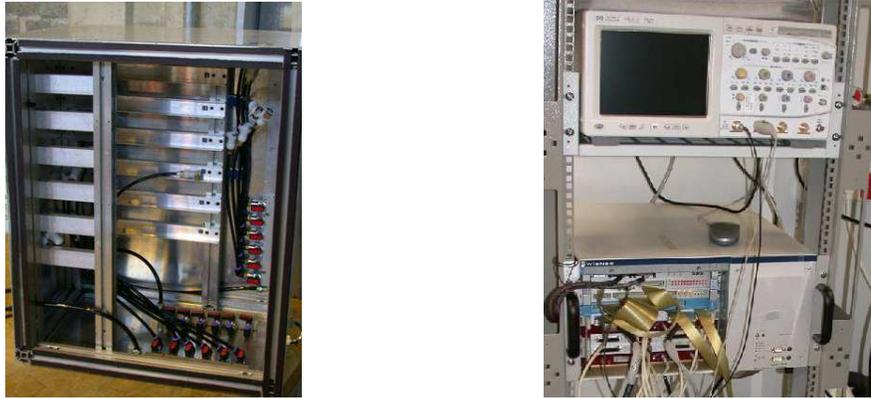
Figure 11: Electrical tests setup: the light-proof box (left) and the readout boards installed in the VME crate (right).

In all the measurements performed, the ASICs are powered with three standard SCT low-voltage power supplies, SCTLV, and read out electrically via a system, comprising one SLOG, one MUSTARD and one AERO board, installed in two VME crates as pictured in Fig. 11 (right). Two SCTHV high voltage units provided detector bias to the modules. A second complete setup including the respective readout system was also built, to serve as a backup in the event of failure of the first one. A detailed description of the SCT readout system is given in Refs. [19, 7].

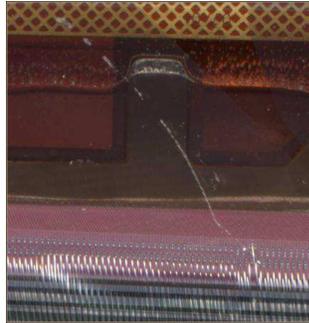
(c) #71: scratched fan-in.

Figure 24: Cases of accidental damage to modules.

Scratches. Two cases in sensors, two in fan-ins and one in spine ceramic. This is mostly due to accidents while handling the components or the assembled modules. In some cases the wire bonds were also affected resulting in failed electrical tests (many unbonded or low-gain channels).
