# Nanoscale Investigation of Microcracks and Grain Boundary Wetting in Press Hardened Galvanized 20MnB8 Steel

Grain boundary wetting as a preliminary stage for zinc induced grain boundary weakening and embrittlement in a Zn coated press hardened 20MnB8 steel was analyzed by means of electron backscatter diffraction, Auger electron spectroscopy, energy dispersive X-ray analysis, atom probe tomography and transmission electron microscopy on the nanometer scale. Microcracks at prior austenite grain boundaries were observed and structures that developed after microcrack formation were identified. Zn/Fe intermetallic phases with grain sizes smaller than 100 nm in diameter are present at the crack surfaces and at the wedge-shaped crack tips. In order to get a complete picture, including the microstructure before cracking, an undeformed, electrolytically coated reference sample which underwent the same heat treatment as the press hardened material was investigated. Here, Zn, in the order of one atomic layer or less, could be found along prior austenite grain boundaries several micrometers away from the actual Zn/Fe phases in the coating. Such a grain boundary weakening by Zn wetting of p

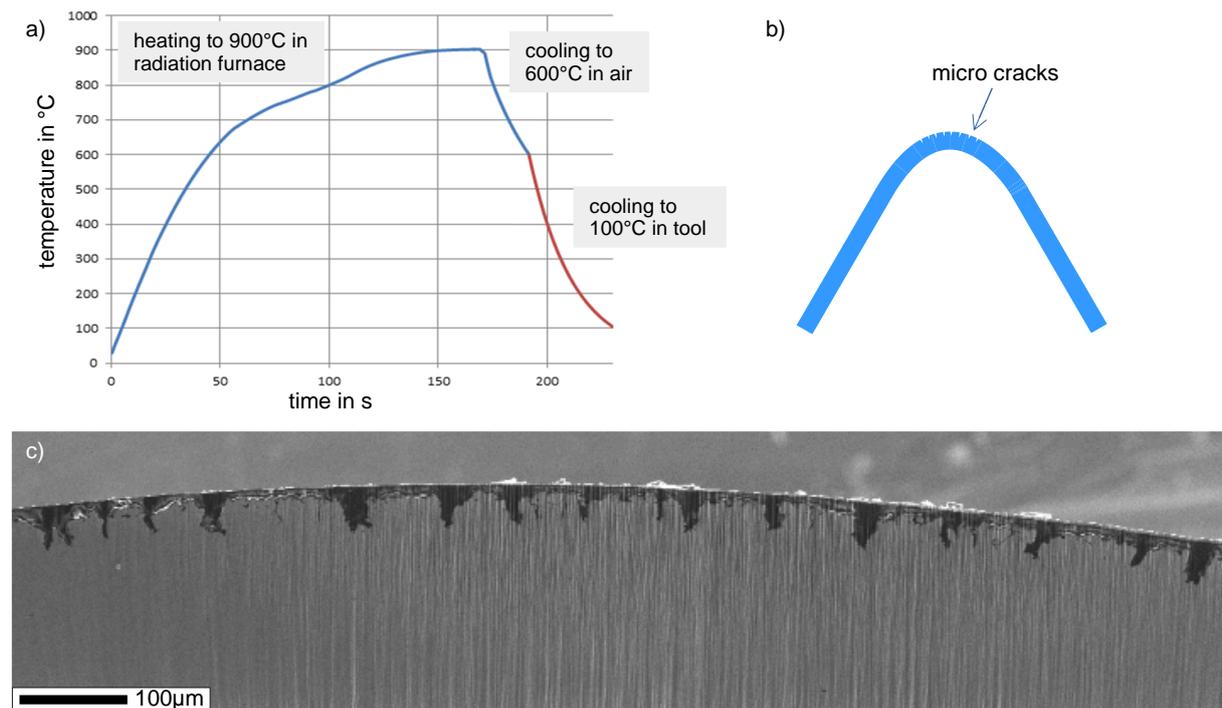
Fig. 1. a) Thermal processing curve of the PHS-sample (hot-dip galvanized 20MnB8) in order to simulate realistic production conditions and provoke microcracking, b) sketch of the deformed sample with microcracks at the stretched surface, and c) secondary electron image of micro-cracks (filled with epoxy resin to avoid redeposition during sample preparation) at the bent surface in a cross section view.

To simulate MIE cracks, we deformed sample strips with sizes around 20x120 mm in a die [17]. First, the strip of the Zn-coated base material was heated in a radiation furnace to 900°C and annealed for 45 seconds at a temperature above 870°C. The sample was subsequently cooled in air to 600°C and finally bent in the tool reaching a temperature of 100°C as presented in the thermal processing curve in Fig. 1a. This precooling down to 600°C corresponds to the industrial process preventing so-called 1<sup>st</sup> order LMIE due to liquid Zn. Cracks appeared at the stretched coating-steel surface, as indicated in Fig.1b, and continue into the base steel, as depicted in Fig. 1c, a SEM cross section image.

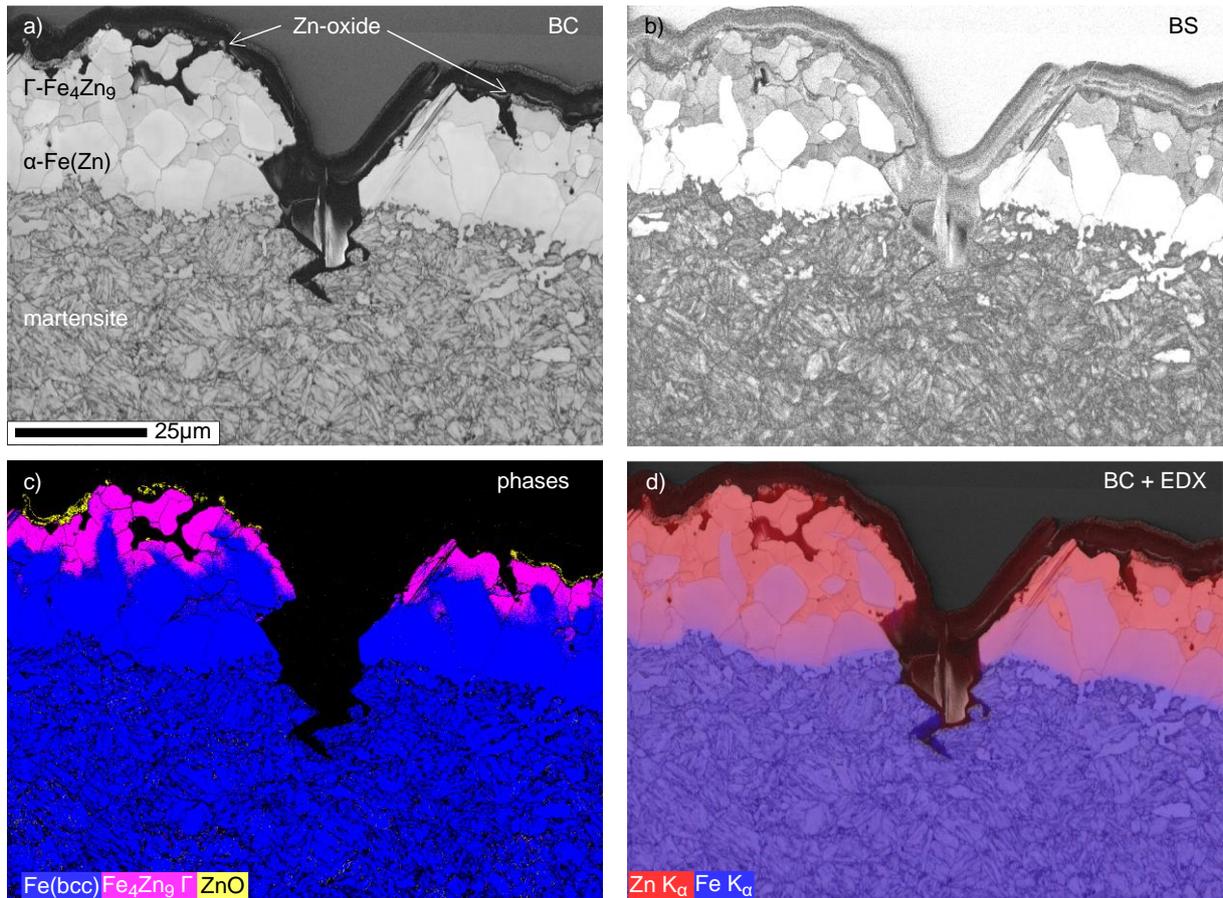
Fig. 2. Cross section of a crack in the hot-dip galvanized, deformed sample: a) EBSD band contrast; b) band slope contrast, c) overlay of ferrite,  $\Gamma$ -phase and zincite and d) an overlay of band contrast and EDX Zn  $K_{\alpha}$  and Fe  $K_{\alpha}$

The first analyzed structure was taken from the hot dip galvanized PHS strip, which was deformed during cooling. The cross section of the sample was subsequently investigated via EBSD and EDX in the SEM Zeiss supra35 and the results of this measurement is presented in Fig. 2. The general

structure of the coating system is indicated in the band contrast (BC) image of Fig. 2a. Starting with the base steel, it is i) martensite, ii) Zn-saturated ferrite ( $\alpha$ -Fe(Zn)), iii) Zn/Fe-phases (mostly  $\Gamma$ -phase), iv) ZnO (zincite if crystalline). In the band slope (BS) image (Fig. 2b), martensite can be clearly distinguished from ferrite. The dark regions correspond to martensite, due to the high density of sub-grain boundaries and dislocations. Fig. 2c shows the EBSD phase map, in which the three phases bcc-Fe (martensite and  $\alpha$ -Fe(Zn)),  $\Gamma$ -phase and ZnO are shown. Close to the  $\alpha$ -Fe(Zn), the  $\Gamma$ -phase was partially incorrectly identified as bcc-iron phase, because the crystal structures of both phases are too similar. Another feature, that is well visible as dark areas in the  $\Gamma$ -phase region, are pores reaching from the surface far into the  $\Gamma$ -phase. Fig. 2d combines the BC with the EDX Zn  $K_{\alpha}$  and Fe  $K_{\alpha}$  maps. A sharp boundary is visible in  $\alpha$ -Fe(Zn) grains that touch the bulk martensite, where the Zn concentration decreases from about 30 wt% to approximately 0 wt%. This leads to a small region of Zn-free ferrite ( $\alpha$ -Fe) grain sections separating the Zn in the  $\alpha$ -Fe(Zn) grains from the bulk martensite. Similar findings of an additional phase separation the  $\alpha$ -Fe(Zn) from the bulk martensite at the interface region was found in related Zn-coated steel systems [14, 24] and is discussed further below. The measured chemical concentration in the Zn-rich part of the  $\alpha$ -Fe(Zn) is in wt%: Fe 69.5, Zn 29.8, Al 0.2, Mn 0.2, Si 0.1, Cr 0.1. In the underlying martensite the following concentrations in wt% were found: Fe 97.6, Zn 0.2, Al 0.2, Mn 1.4, Si 0.2, Cr 0.3. No extended Zn-phases were observed in the crack in the martensite region.

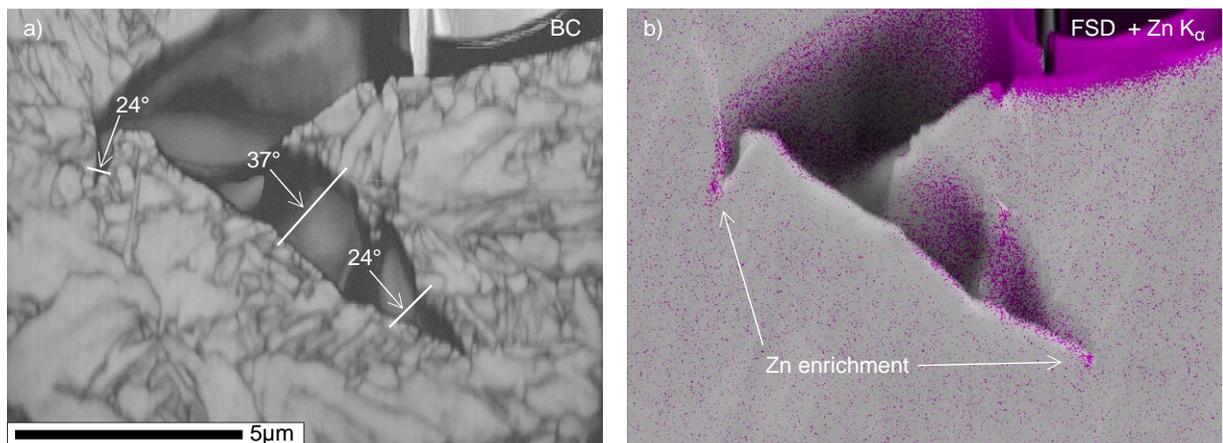
Fig. 3. a) EBSD band contrast mapping of the crack tip and b) front scatter detector image overlaid with EDX Zn  $K_{\alpha}$  signal.

The surrounding area of a crack tip (see Fig. 3) was analyzed with the same techniques as the survey mapping, but at higher magnification. The fine martensitic structure around the crack can be seen in Fig.3a. The Zn  $K_{\alpha}$  EDX map shown in Fig.3b reveals that the crack surface is covered with Zn. Furthermore, the Zn concentration at the two marked crack tips is higher compared to the remaining cracked surface. Fig. 3a shows also some misorientation angles from opposite sides of the crack tips. The austenite grains that are present at higher temperatures, transform into martensite during rapid cooling. The transformation follows the Kurdjumov-Sachs mechanism, which predicts the orientation relation of martensite grains to its prior austenite grain. No possible grain orientation between  $21.06^{\circ}$  and  $47.11^{\circ}$  does exist according to this relation [25, 26] for martensite grains originating from the same austenite grain. Thus, martensite grains exhibiting an angle between these values have to originate from different austenite grains. And indeed, the measured misorientation angles of grains from opposite sides of the crack tip between  $24^{\circ}$  and  $37^{\circ}$  indicate cracking along prior austenite grain boundaries (PAGBs). This is in good agreement with recent results by Takashi et al. [7].

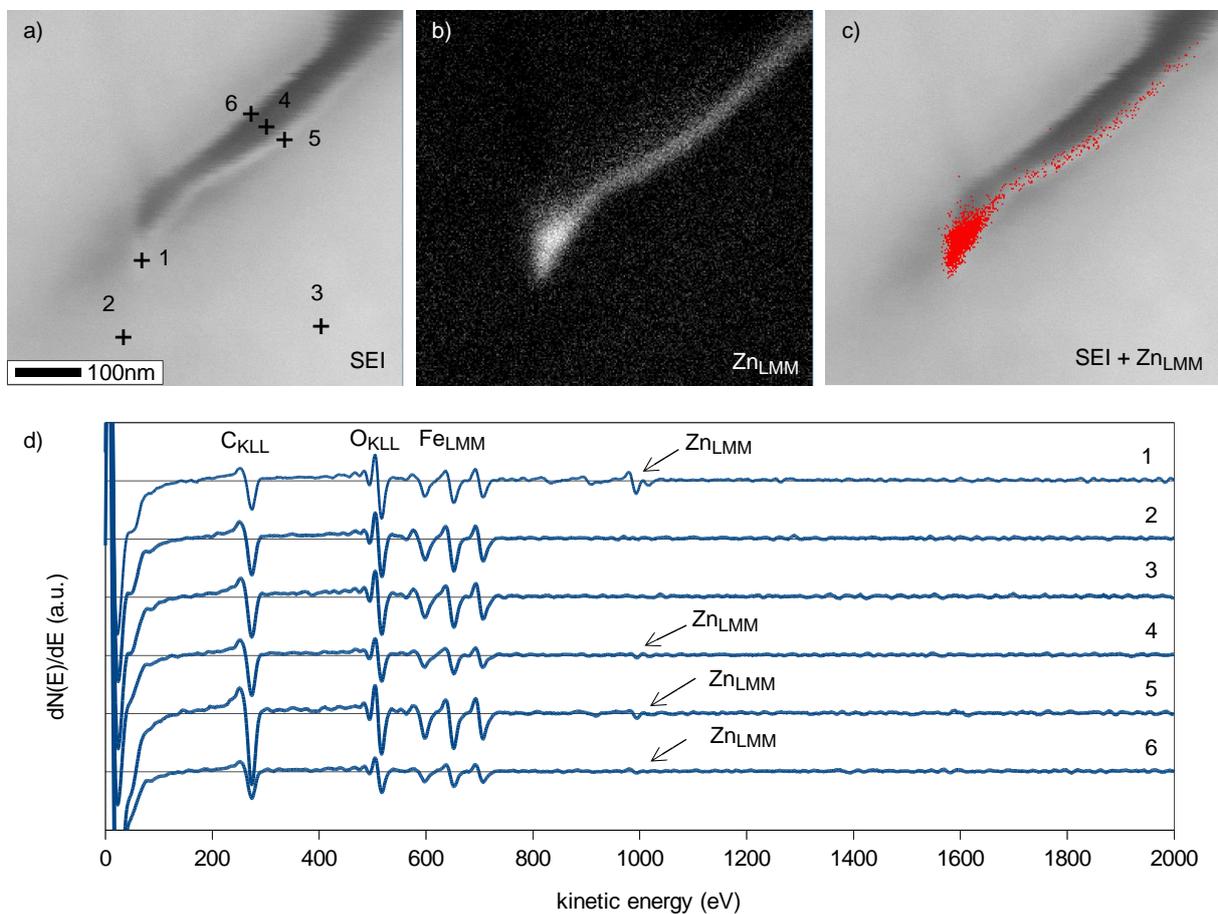
Fig. 4. a) Secondary electron image of a crack tip in the hot-dip galvanized, deformed sample, prepared with cross section argon sputtering, b) corresponding  $Zn_{LMM}$  Auger mapping, c) the overlay of both and d) Auger derivative spectra. The surface of the crack is covered with Zn. The crack tip was a  $\alpha$ -Fe(Zn) wedge smaller than 100nm before oxidation.

To get a deeper insight into the composition of the crack tip, Auger measurements were performed (see Fig. 4). Since EBSD mapping leads to carbon contamination in the map area and Auger electron spectroscopy is extremely surface sensitive, a new crack similar to that one shown in Fig. 3 was chosen for AES measurements. Fig. 4a shows the secondary electron image of a similar crack tip from the same sample, where six Auger spectra (Fig. 4d) were taken at the marked positions. Oxides and carbon contamination form rapidly during sample handling after preparation in ambient atmosphere. Therefore, traces of C and O are present in all spectra, which is not further discussed on the assumption that this does not affect the distribution of the other elements. On the contrary,

oxidation can even help to reduce the mobility of Zn and to fix the original Zn-distribution. The only two other elements which can be observed in the spectra are Fe and Zn. First, this is a proof that the sample preparation is suitable, because no re-depositions of elements like Cr, Ni, Cu or Al from the stainless steel walls of the sputter chamber or from Al- and Cu-tapes used to protect the sample is present. Fe is found in all spectra, while Zn only occurs at the crack surface (spectra 4-6) and at the crack tip (spectrum 1). No Zn can be found in spectra 2 and 3, which indicates the absence of significant Zn bulk diffusion. The Zn concentrations in spectra 4-6 are comparably low, deviations could be explained by the different angles of the surfaces facing the detector. The highest Zn concentration is found in spectrum 1 at the crack tip. A quantification of this spectrum gives the following concentration in at%: C 45.5, O 33.8, Fe 14.3, Zn 6.4. The Fe/Zn ratio of  $\sim 7/3$  indicates that the material at this position was a Zn-Fe phase with 30 at% Zn before oxidation. Furthermore, the Auger mapping (Fig 4b and 4c) using the  $Zn_{LMM}$  signal reveals a triangular, pointy shape of the Zn-enriched area at the crack tip along the crack direction.

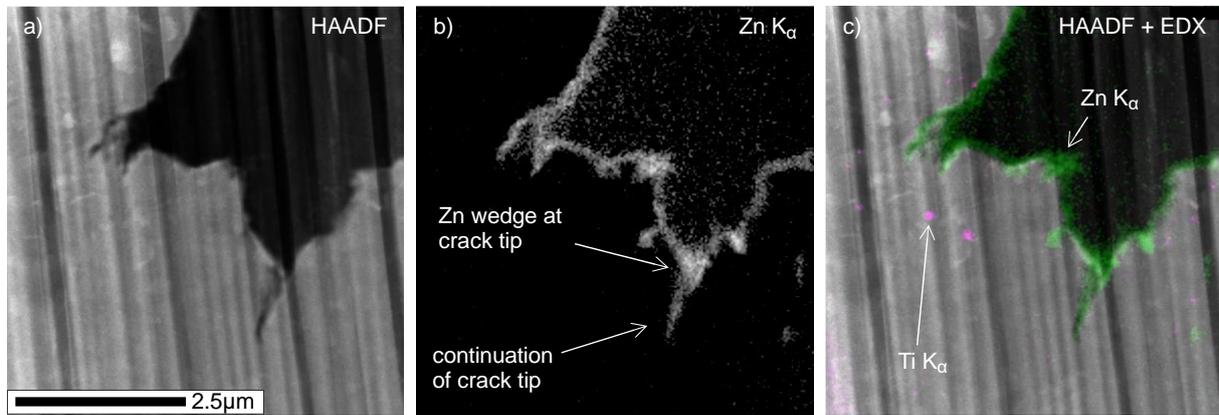
*Fig. 5. a) HAADF STEM image of a crack tip in the hot-dip galvanized, deformed sample. b) Zn EDX mapping made in TEM and c) overlay of both. The Zn distribution shows, that the surface of the crack is covered by Zn. It also shows the Zn wedge at the crack tip. There is also a continuation of the Zn into the base material, observable at the tip of the Zn wedge.*

An additional crack of the analyzed sample was prepared as a FIB-lamella for STEM investigations. Fig. 5a shows the HAADF image of the analyzed area. The dark area in the top right corner is the crack, filled with epoxy resin to avoid re-deposition onto the surface during FIB-cutting. The vertical strips are thickness variations of the lamella, a well-known FIB-preparation artefact called curtaining effect, resulting from the inhomogeneous surface and grain structure of the complex steel sample. The lamella was subsequently analyzed with EDX. Fig. 5b shows the Zn  $K_{\alpha}$  map, where three different

aspects are evident. It indicates three effects. First, it confirms the observation made in Fig. 4d that Zn is present at the crack surface. Second, it also shows a triangular shaped Zn phase at the crack tip similar to Fig. 4b and c. Third, a new finding is that Zn penetrates further into the steel at the tip of the Zn wedge. The position of the Zn at the edge of the crack is confirmed in Fig. 5c, which displays the overlay of the HAADF STEM image with the Zn  $K_{\alpha}$  map. Additionally, a further structure found in this EDX measurement is displayed, small precipitates containing the alloying element titanium.

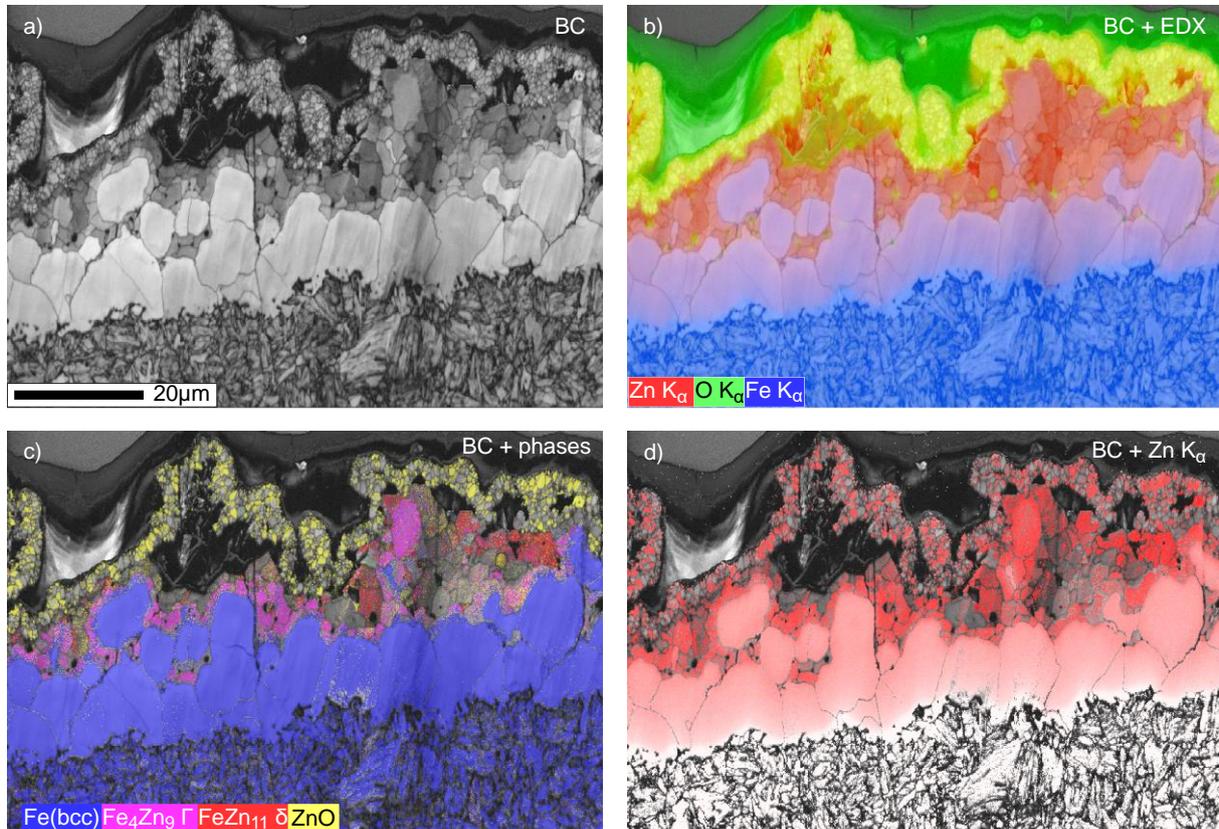
Fig. 6. Cross section of a electrogalvanized, undeformed sample: a) EBSD band contrast; b) overlay of band contrast with EDX Zn  $K_{\alpha}$ , O  $K_{\alpha}$  and Fe  $K_{\alpha}$ ; c) overlay of band contrast with ferrite,  $\Gamma$ -phase,  $\delta$ -phase and zincite; d) overlay of band contrast with EDX Zn  $K_{\alpha}$ .

The cross section of the sample was polished and subsequently measured via EBSD and EDX similar to the first, deformed sample. Fig. 6a shows the band contrast image of a sample surface cross section. Overlays of this band contrast with EDX data and EBSD phases are shown in Fig. 6b-d. As expected, and proofing our experimental concept, we found similar structures as in the bent sample shown in Fig. 2. The bulk consists of martensite. The next layer is composed of  $\alpha$ -Fe(Zn). Here again, a sharp internal boundary occurs where the Zn concentration increases from approximately 0 to 30 wt% leading to a thin Zn-free region within the  $\alpha$ -Fe grains located at the  $\alpha$ -Fe(Zn)/martensite interface. This Zn-free ferrite region is an almost continuous layer across the entire interface, interrupted only by some regions where the Zn-containing  $\alpha$ -Fe(Zn) grains touch the martensitic base steel directly (see Fig. 6 and Fig. S2 in the supplementary section). The next layer consists of  $\alpha$ -Fe(Zn) surrounded by Zn/Fe-phases ( $\Gamma$ - and  $\delta$ -phase). The top layer is a continuous crystalline ZnO film with large pores beneath. This ZnO layer is thicker for the unbent sample in contrast to the sparse occurrence of ZnO on top of the bent sample. The reason is that the Zn layer of the bent sample is created by hot-dip galvanizing and galvannealing, in which the liquid Zn bath contains approximately 0.15 wt% Al. This leads to an additional  $Al_2O_3$  layer on top of the coating, which reduces Zn oxidation [27]. This missing  $Al_2O_3$  of the electroplated sample displayed in Fig. 6 leads to the formation of the

thicker ZnO layer. Within the sensitivity of the combined EDX/EBSD measurement, no Zn is detected below the internal  $\alpha$ -Fe(Zn) zinc boundary (see Fig. 6 and Fig. S2 in the supplementary section).

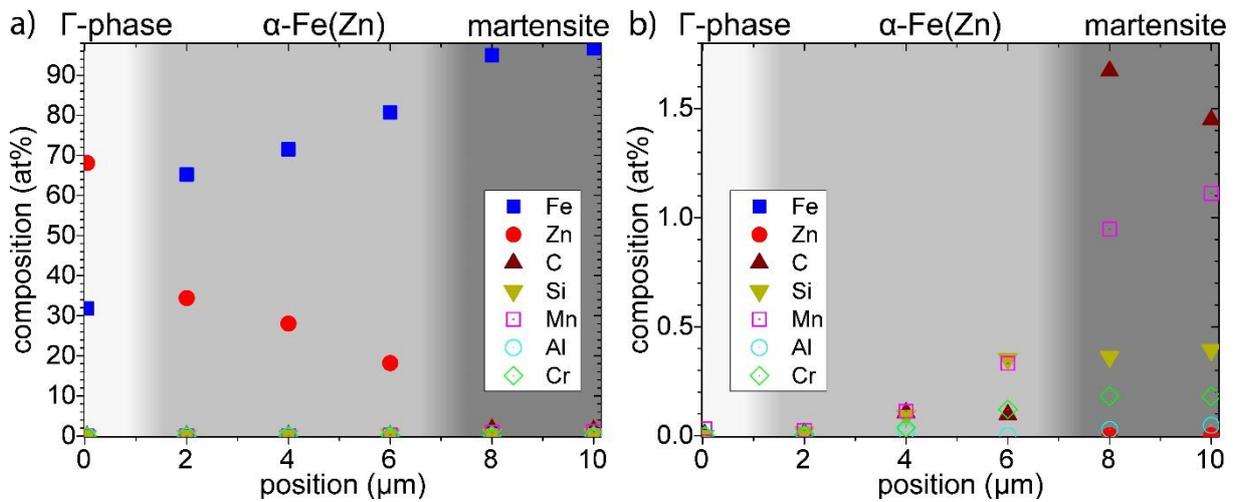
Fig. 7. Elemental compositions determined by APT at the electrogalvanized, undeformed sample: a) shows the chemical composition of the Zn coating system and the base steel, ranging from the  $\Gamma$ -phase over the  $\alpha$ -Fe(Zn) to the martensitic base steel (left to right). Each set of datapoints at the different positions represents an individual APT measurement. More details can be found in the supplementary materials (Fig. S1-S3). b) presents a magnified view of the low concentration regime from 0-1.8 at%. The graph shows the data from liftout number one (see supplementary Fig. S1 and S3 for reference). The exact values can be found in table S1 in the supplementary section.

To obtain a detailed elemental composition, APT measurements were performed. As explained in more detail in the supplementary section (see Fig. S1-S3), multiple APT tips were measured along an approximately 10  $\mu\text{m}$  long so-called liftout. In this way we generated the composition profile from the  $\Gamma$ -phase and the  $\alpha$ -Fe(Zn) to the martensitic base steel shown in Fig. 7. The composition of the  $\Gamma$ -phase is 31.9 at% Fe, 68.1 at% Zn and a small amount of 0.033 at% Mn, which is very close to the stoichiometric composition of  $\text{Fe}_4\text{Zn}_9$ . A clear gradient in Zn composition with decreasing Zn content towards the base steel is present in the region of the  $\alpha$ -Fe(Zn) phase. The Zn composition at the exact interface to martensite cannot be determined here, since the composition profile consists of discrete APT measurement points being approximately 2  $\mu\text{m}$  apart. The graph shows differently steep increasing concentrations of Si, Mn, Al, Cr as well as C towards the base steel. The exact compositions of each APT measurement can be found in Table S1 in the supplementary section. The martensitic base steel exhibits a composition of approximately 0.4 at% Si, 1at% Mn, 0.03-0.048 at% Al, 0.18 at% Cr and 1.45-1.67 at% C. The Zn composition was found to be extremely low at only 0.002-0.003 at% (i.e. 20-30 ppm). The C content is higher than the nominal composition of 1 at% which could be an enrichment of C during the  $\alpha$ -Fe(Zn) formation on the steel base side due to a low solubility of the

formed phase. Other reasons could be local variations in C concentration, as well as C contaminations during any of the preparation steps.

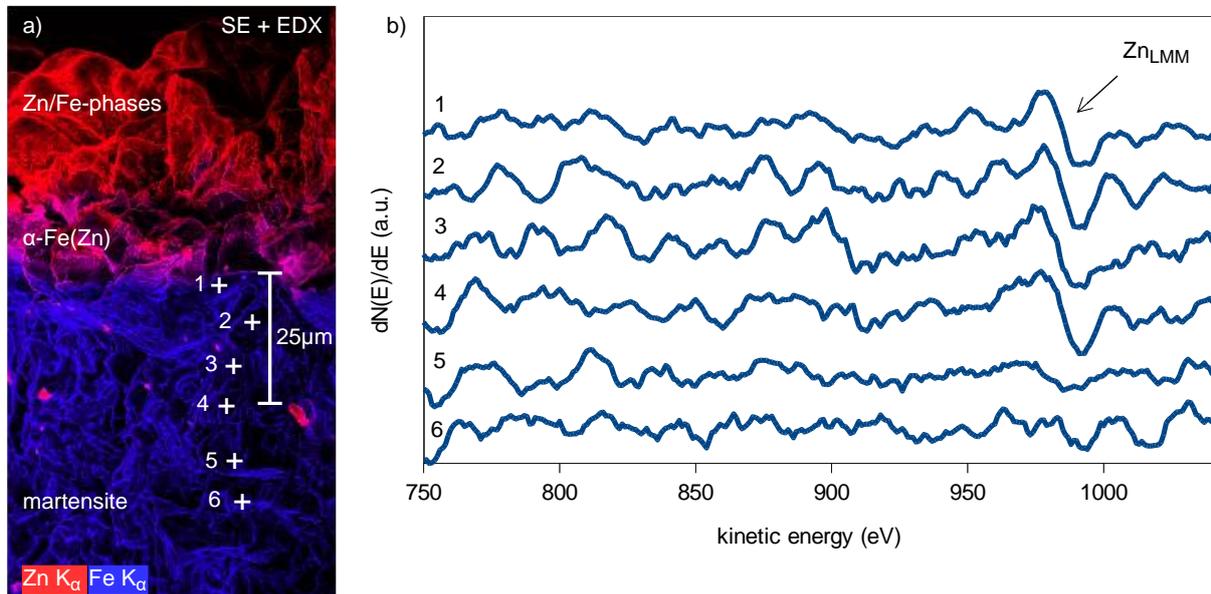
Fig. 8. Six Auger measurement positions at a fractured surface of the electrogalvanized, undeformed sample prepared in a UHV fracture stage mounted to the Auger instrument. a) shows the overlay of the secondary electron image with the EDX Zn  $K_{\alpha}$  and Fe  $K_{\alpha}$  mappings. The corresponding differentiated Auger spectra are displayed in b). One can see, that Zn can be detected down to 25 $\mu$ m below the Zn boundary in the  $\alpha$ -Fe(Zn) layer. Subsequently the area was EDX mapped in an SEM to ensure the correct Auger measurement positions below the  $\alpha$ -Fe(Zn).

If this sample contains PAGBs weakened by Zn, they should open up preferentially during fracture [3]. Thus, we look for the presence of Zn in the martensite base steel below the  $\alpha$ -Fe(Zn) on fractured surfaces prepared with a fracture stage, which is attached to the Auger instrument. This allows us to analyze the fractured surface *in situ* via Auger electron spectroscopy without leaving the ultra-high vacuum. In this way, we can avoid any surface contamination or oxidation. Fig. 8a shows such a fractured surface, where six Auger spectra measurement positions are marked. The image is also overlaid with an EDX mapping of the fractured surface that was performed after the Auger measurements. The EDX map reveals the interface between  $\alpha$ -Fe(Zn) and martensite. The positions of the measured point spectra are all positioned beneath this interface. The only small regions with Zn in the martensite are fracture splinters and were avoided for the spectra measurements. Fig. 8b shows the Auger spectra, which were taken around the Zn energy range. A significant  $Zn_{LMM}$  peak was found in spectra 1-4, which means that Zn is still present on the fractured surface 25 μm away from the  $\alpha$ -Fe(Zn)/martensite interface in the martensitic steel region. The Zn concentration of spectrum 4 was quantified by taking a complete spectrum from 0 to 2000 eV (not shown here), which resulted in a Zn concentration of approximately 0.6 at% Zn. This Zn concentration found by AES on the fracture surface is much higher than the Zn content of the martensitic matrix determined by APT to be 0.002 at%. These results show that the fracture surface exhibits a local enrichment in Zn i.e. a Zn enriched GB that was weakened and therefore opened up preferentially upon fracture as intended with this experiment. The Zn concentration determined by AES is much lower than Zn concentrations measured at ferrite grain boundaries by Allegra et al. [28] after long time diffusion experiments. However, if the information depth of AES is estimated to be a few nm, the AES result of 0.6 at% Zn can be an amount of a Zn monolayer or a comparably thick Zn-Fe phase at the fractured surface. This is the same order of magnitude of the unwanted element as in the studies of Luo et al. [29] on a simpler system, in which a bilayer of Bi was found responsible for LMIE of austenite grain boundaries in Ni. For SEM-EDX it is impossible to determine such low Zn concentrations at surfaces, because the information depth is several hundreds of nm. And, indeed, no Zn was detected (besides the splinters

that formed during the *in situ* fracture in the AES chamber) in the martensite regions with SEM-EDX on the fractured surface.

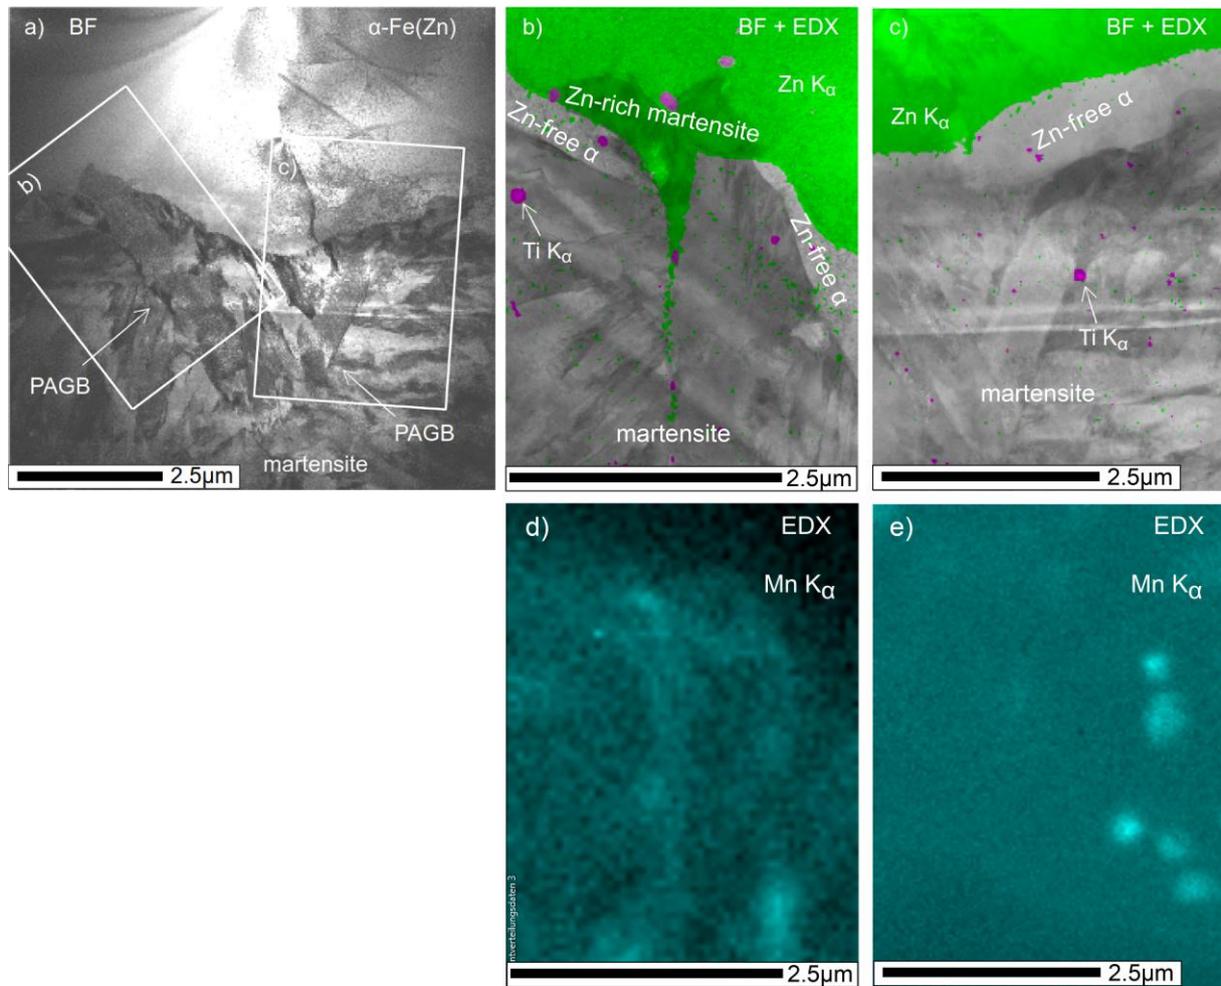
Fig. 9. STEM measurements at the electrogalvanized, undeformed sample. a) shows a STEM bright field image of a prior austenite grain in the martensite below the  $\alpha\text{-Fe(Zn)}$ . b) depicts the corresponding EDX signal of Zn  $K_\alpha$  (green) and Ti  $K_\alpha$  (purple) in an overlay with the bright field image, which shows the  $\alpha\text{-Fe(Zn)}$  at the top. One can also see Zn along the prior austenite grain boundary. c) shows the EDX mapping for the second, neighboring austenite grain boundary, where no Zn wetting was observed. d) and e) are the corresponding Mn  $K_\alpha$  maps for the two PAGBs.

We successful prepared a lamella from the undeformed electroplated sample in order to perform an EDX-STEM analysis with higher sensitivity. Fig. 9a shows a bright field STEM image of a prior austenite grain. On top of it lies the  $\alpha$ -Fe(Zn) layer identifiable by a more homogeneous light gray color. Below, the lath-like structure of martensite is visible. Its high dislocation density, as well as internal stress leads to a more complex appearance. One can recognize two GBs enclosing a group of martensite grains, which, according to our interpretation, represent a prior austenite grain. The GBs are marked by two EDX mapping areas and arrows pointing toward them. The GB displayed in Fig. 9b was confirmed to be a PAGB via transmission Kikuchi diffraction. The misorientation between the

two neighboring grains was measured to be approximately  $5^\circ$ , which is clearly between the two possible orientations according to Kurdjumov-Sachs,  $0^\circ$  and  $10.53^\circ$  [25, 26]. The EDX-mappings were recorded over several hours in order to have sufficient counts for a reliable signal evaluation of elements with low concentration. Fig. 9b exhibits a Zn enrichment along the PAGB deep into the martensite, where Zn penetrates into the base steel at least  $3\mu\text{m}$ . Following the PAGB, no Zn could be measured any more after a few  $\mu\text{m}$ . Either the coverage of the GB decreases really below the detection limit, or it is a geometrical effect. The PAGB plane could be oriented in such a way that it is not parallel to the e-beam anymore, which would lower the small signal to the noise level.

Interestingly, this specific PAGB which is clearly Zn-covered is directly touching the Zn-containing region of the  $\alpha\text{-Fe(Zn)}$  i.e. no Zn-free ferrite is present. In this region, the Zn-free lower part of the  $\alpha\text{-Fe(Zn)}$  is missing and replaced by two small Zn-containing martensite grains. Another observation can be made in the EDX mapping of the second PAGB displayed in Fig. 9c. At this PAGB no Zn could be found and no diffusion of Zn along the PAGB is present, instead a continuous layer of Zn-depleted ferrite separates the Zn-saturated part from martensite base material. In this region, the Zn concentration decreases abruptly from 30 wt% to approximately 0 wt% within the  $\alpha\text{-Fe(Zn)}$  grain. This observation matches the results from SEM-EDX and EBSD seen in Fig. 2 and 6. For

comprehensiveness, also the Ti signal is shown in these maps, which was the second alloy element we found to have a distinct distribution and forms different precipitates in the PAGBs surrounding. Fig. 9d and e display the corresponding Mn  $K_{\alpha}$  signal. We found an increased Mn content in the surrounding of the Zn wetted PAGB. In the region of the second, non-Zn-wetted PAGB no Mn segregation correlated with the GB could be observed. At the same time small regions with significantly increased Mn content are present. These Mn enriched regions are presumably Mn rich precipitates such as Mn-Cr-carbides present in the 20MnB8 steel, which partially dissolve during the annealing step above 870°C. Additional measurements at different lamellae reveal similar results. We found in most cases at least one Zn-wetted grain boundary in about 10 $\mu$ m large lamellae, but not all PAGBs were wetted. This supports our argument that only some specific PAGBs are Zn-covered.

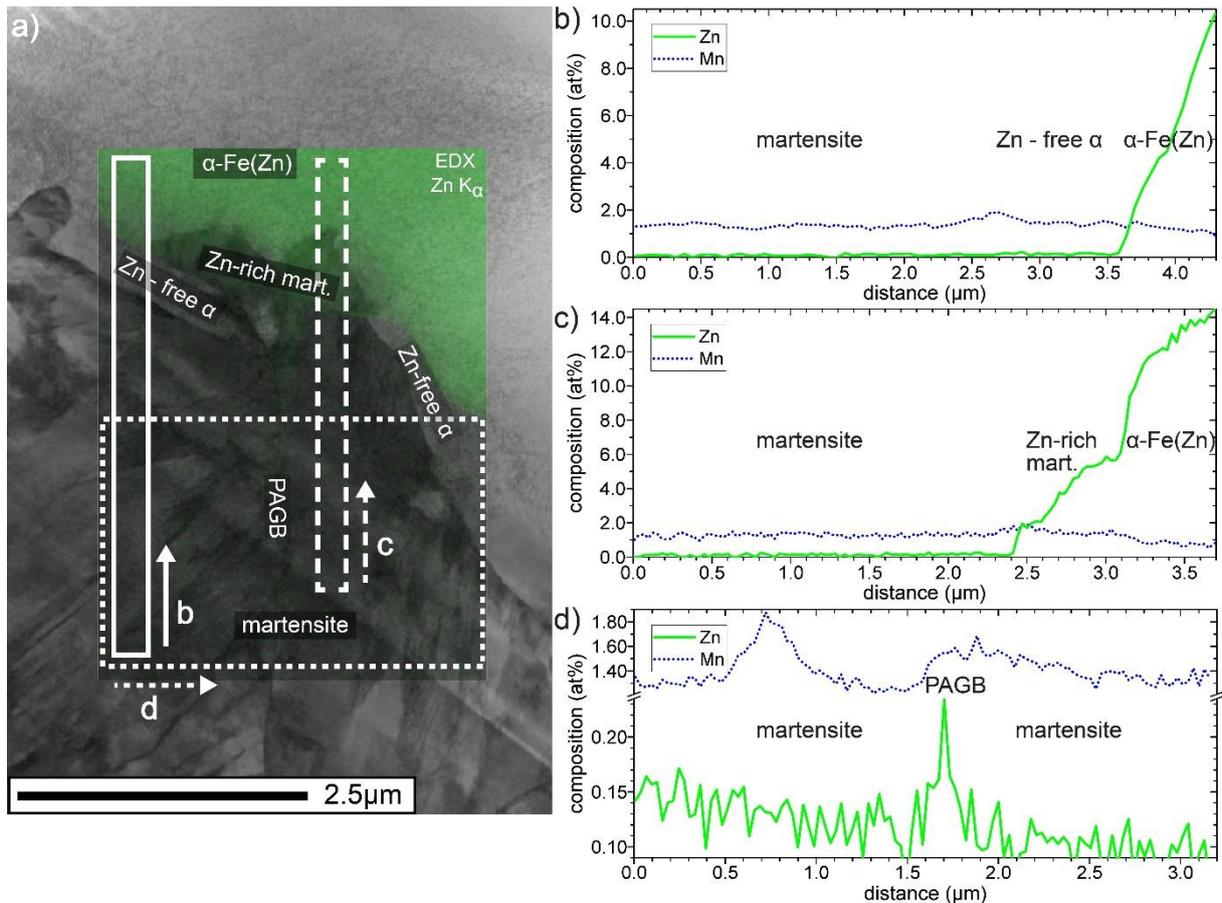
Fig. 10. a) is the combined Zn  $K_{\alpha}$  (green) and Fe  $K_{\alpha}$  (red) mapping in an overlay with the bright field image of the wetted PAGB from the electrogalvanized, undeformed sample. b) displays the quantitative line profile of the corresponding rectangular region in Fig. 10a starting at the arrow and crosses the Zn-free ferrite. c) is the corresponding line profile through the Zn-containing martensite. d) shows a quantitative line profile obtained from the corresponding rectangular region in a). Here the line profile is generated from the sum spectra of all horizontal lines from left to right and display the concentration changes cutting through the PAGB.

Different line scans are extracted from the mapping of Fig. 9 as indicated in Fig. 10a. Fig. 10b shows a line profile starting in the martensite and crossing the Zn-free ferrite into the  $\alpha$ -Fe(Zn). It can be clearly seen that the Zn signal decrease abruptly at the interface  $\alpha$ -Fe(Zn)/Zn-free ferrite to almost zero. The decrease is even more abrupt than shown, because the interface between the two phases is not perpendicular to the extracted line profile, thus the signal is smeared out due to geometrical reasons. For comparison, Fig. 10c is a line profile from the martensite through the Zn-containing martensite into the  $\alpha$ -Fe(Zn). Here the Zn signal exhibits a small plateau of around 6at% Zn at the position of the Zn-containing martensite, which fully fits to a possible Zn-solubility in austenite during annealing according the phase diagram in ref. [23] (see Fig. 11). Both line profiles display additionally the Mn signal. Due to the general accuracy of EDX quantification, statements about the Mn are only possible to a limited extent. However, it seems that a small Mn increase is present at the interface martensite/Zn-free ferrite in Fig. 10b, after that the Mn decreases continuously which is also in accordance to the APT measurements (Fig. 7b). In Fig. 11c on the other hand, it seems that the Mn content is slightly increased in the Zn-containing martensite, which was at the annealing stage, Zn-containing austenite. This points to the importance of Mn, additionally to C, in the stabilization of the different phases (e.g. austenite during quenching) at the coating – steel interface. We summed up all spectra from horizontal lines in the marked rectangle of Fig. 10a to the quantitative line profile in Fig. 10d. This line profile reveals the extremely low concentration of Zn along the grain boundary. The increased Mn content at the PAGB is also displayed. Due to noise and the Cu  $K_{\beta}$  (8.9keV) peak, which overlaps Zn  $K_{\alpha}$ , the statistical threshold for the quantification cannot be set so that the Zn concentration reaches zero far away of the GB. The increased Zn concentration at the GB is clearly visible and lies above the background. An estimation of the interaction volumes of AES and STEM, which are the same order of magnitude, shows that AES and STEM-EDX quantification values of 0.6 at% and 0.2at% fit well together. This strongly indicates the presence of a small amount of Zn or a Zn-Fe-phases at PAGBs. Wetting with nm or sub-nm thick layer or more complicated GB complexions several  $\mu$ m deep along the PAGBs are conceivable.

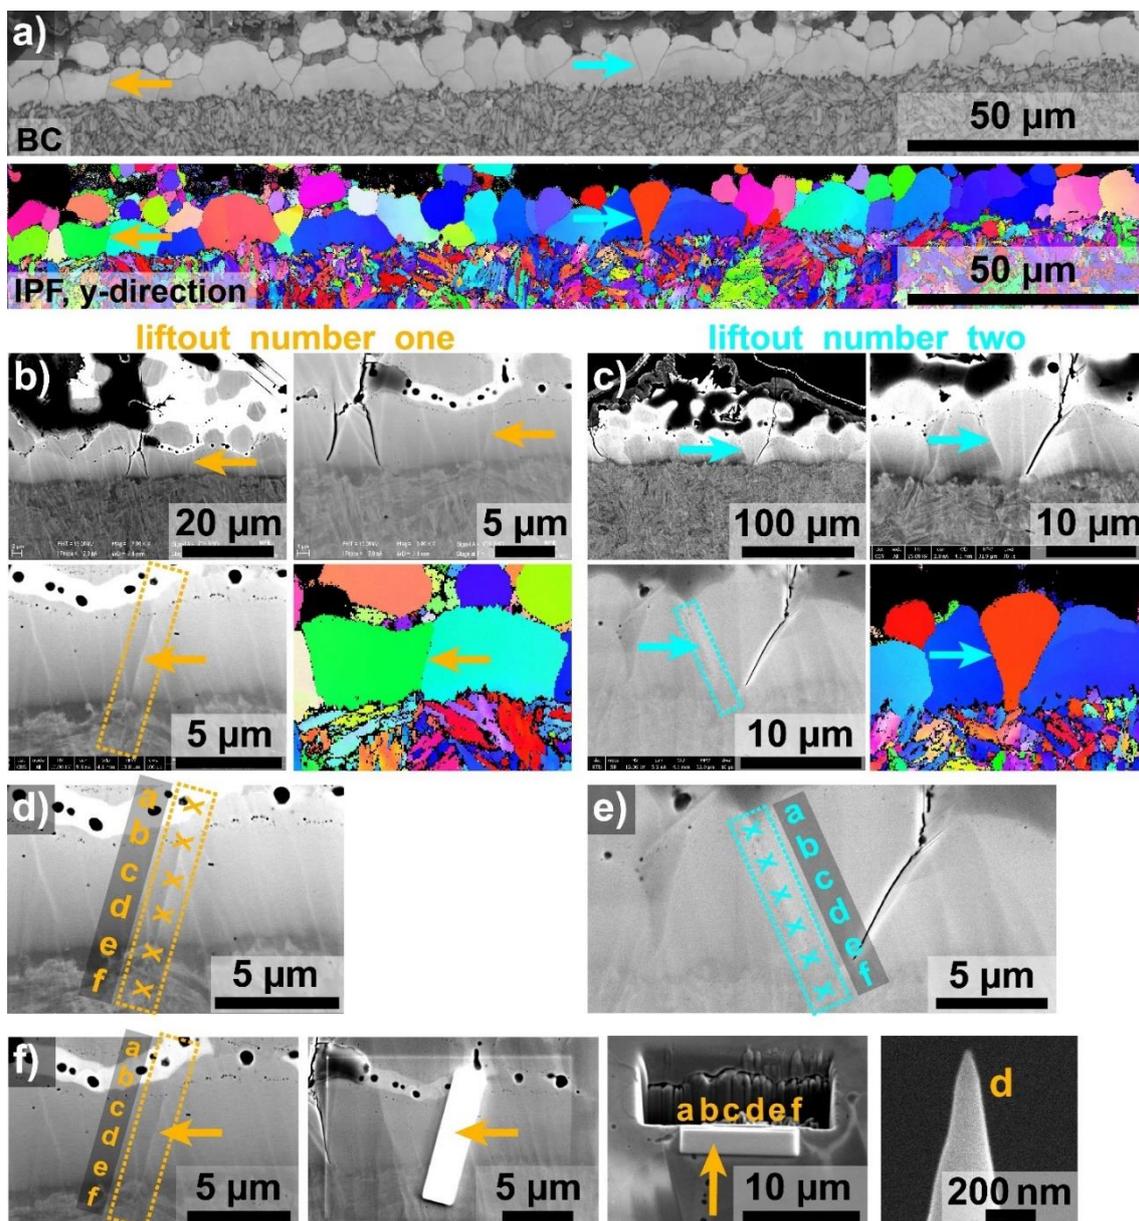
Supplementary figure S1:

Figure S1. This figure illustrates the atom probe tomography (APT) liftout procedure and how composition profile graphs were obtained from multiple APT measurements. a) shows a large-scale EBSD mapping of the interface region between Zn coating (top) and martensitic base steel (bottom). A band contrast (BC) image (top), as well as an inverse pole figure (IPF) map (bottom) are shown in a). The projection axis for the IPF map is perpendicular to the steel/coating interface (i.e. y-direction). Such mappings were used to screen a large number of potential grain boundaries and identify suitable ones for an APT liftout. We targeted grain boundaries that lead straight into the martensite so that we would be able to follow the GB into the martensitic microstructure and contain a GB within the APT tip (i.e. we targeted the arrangement shown in Fig. 8 b where the Zn containing  $\alpha$ -Fe(Zn) directly touches the martensite without the occurrence of the Zn-free ferrite). Two GBs along which we performed a liftout are marked by orange and cyan arrows. b) and d) show the grain boundary that was lifted out for liftout number one (orange highlighting color) at different magnifications in backscattered electron (BSE) micrographs as well as the corresponding zoom to the IPF EBSD mapping, c) and e) show the grain boundary of liftout number two (cyan highlighting color). d) and e) mark the positions of the individual APT tips that were produced from the liftout. Each cross represents an individual APT tip, hence an individual APT measurement that yields a chemical composition at the position of the cross. The results of the chemical composition analysis are shown in the form of a graph in Fig. S3 and S4, and in tabular form in table S1 and S2. f) shows a few snapshots of the liftout procedure performed: first a promising GB is identified. A rectangular region around the GB is covered with a protective Pt deposit to preserve the GB during the subsequent FIB milling. Material is removed adjacent and underneath the Pt deposit using FIB milling. The remaining wedge-shaped material is lifted out using a micromanipulator, chopped into individual segments (here 6 segments) which are placed on Si posts and sharpened into needle shaped APT tips by annular FIB milling.
