# Nanoscale Investigation of Microcracks and Grain Boundary Wetting in Press Hardened Galvanized 20MnB8 Steel

Grain boundary wetting as a preliminary stage for zinc induced grain boundary weakening and embrittlement in a Zn coated press hardened 20MnB8 steel was analyzed by means of electron backscatter diffraction, Auger electron spectroscopy, energy dispersive X-ray analysis, atom probe tomography and transmission electron microscopy on the nanometer scale. Microcracks at prior austenite grain boundaries were observed and structures that developed after microcrack formation were identified. Zn/Fe intermetallic phases with grain sizes smaller than 100 nm in diameter are present at the crack surfaces and at the wedge-shaped crack tips. In order to get a complete picture, including the microstructure before cracking, an undeformed, electrolytically coated reference sample which underwent the same heat treatment as the press hardened material was investigated. Here, Zn, in the order of one atomic layer or less, could be found along prior austenite grain boundaries several micrometers away from the actual Zn/Fe phases in the coating. Such a grain boundary weakening by Zn wetting of p

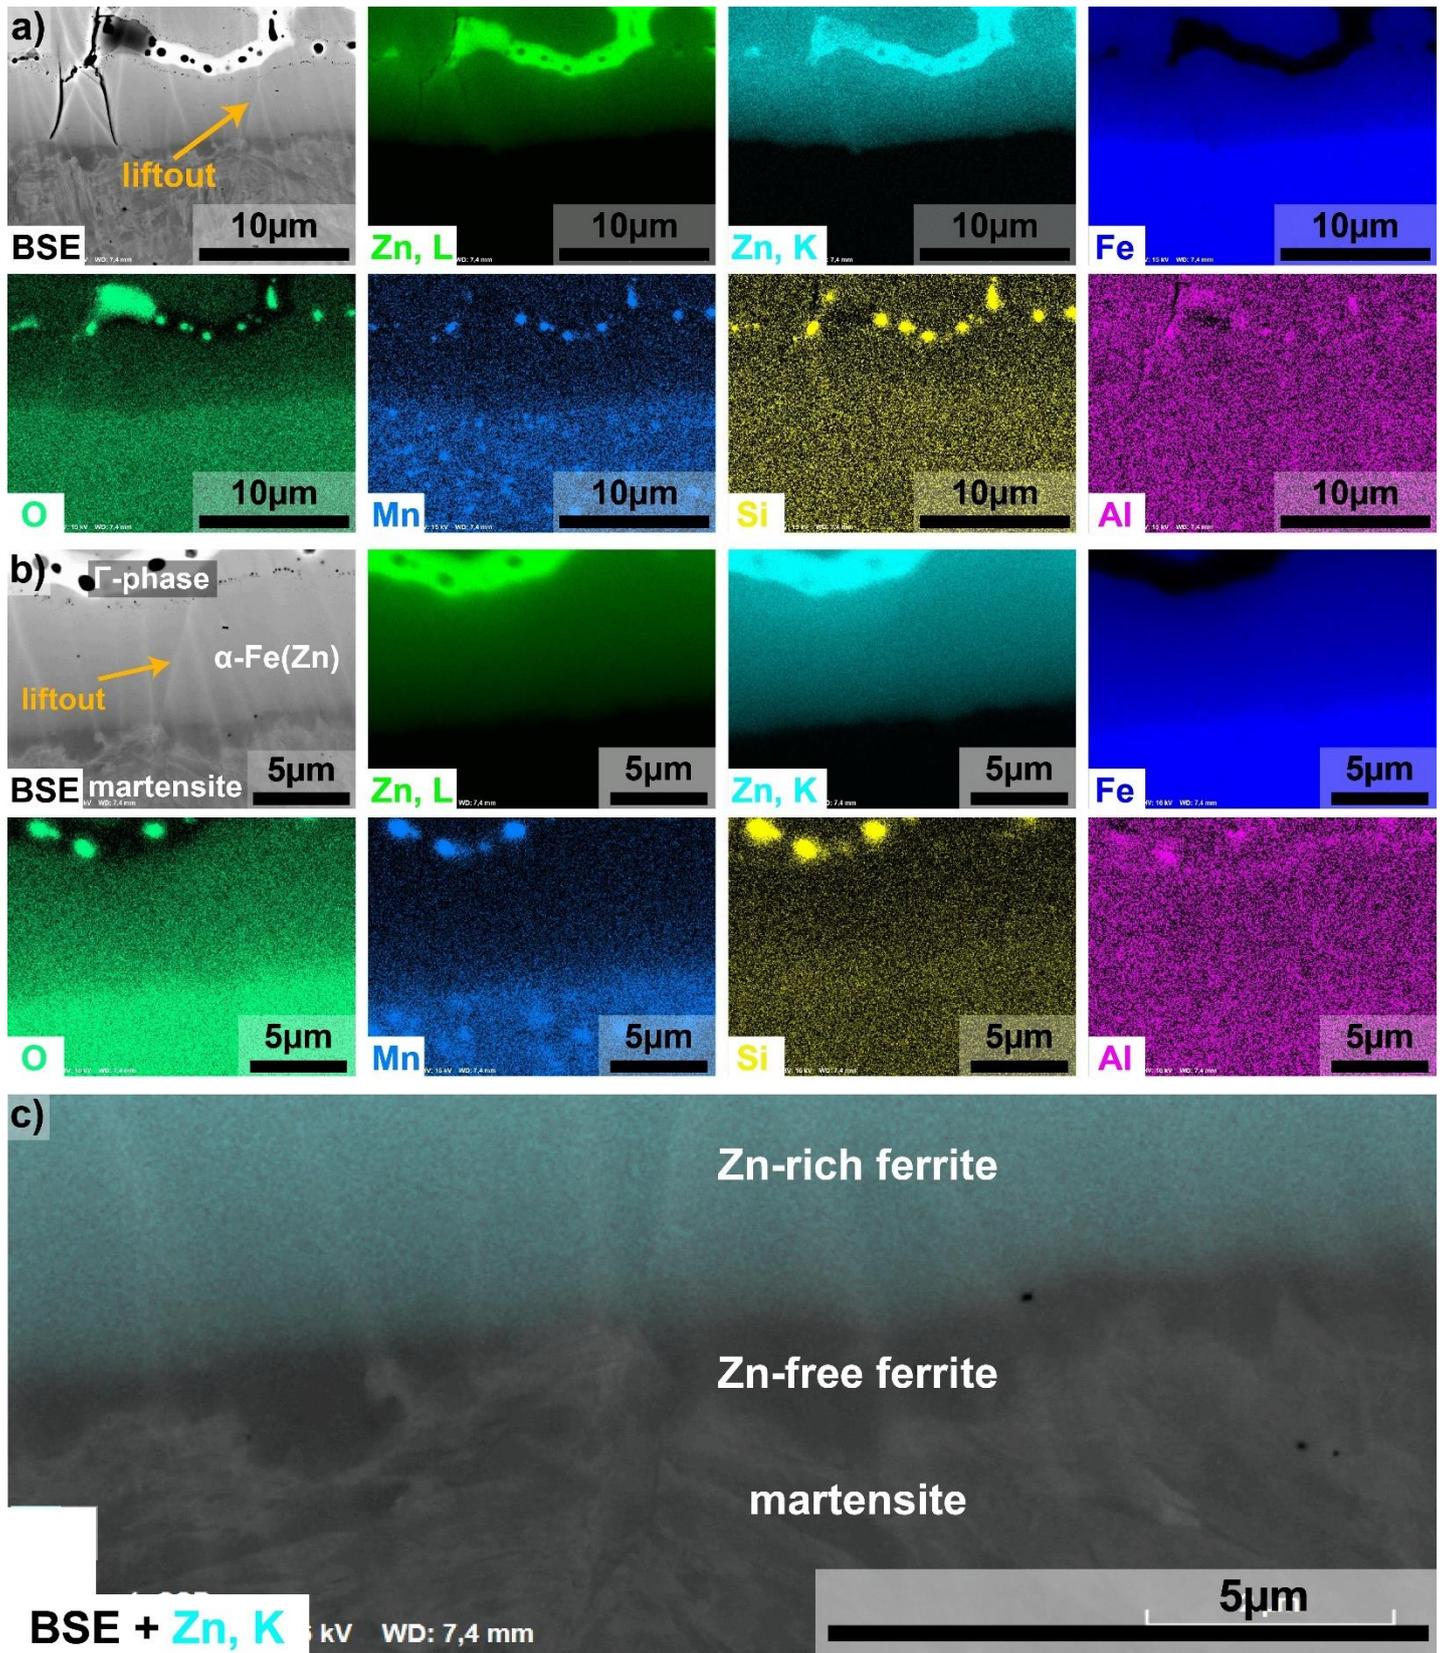
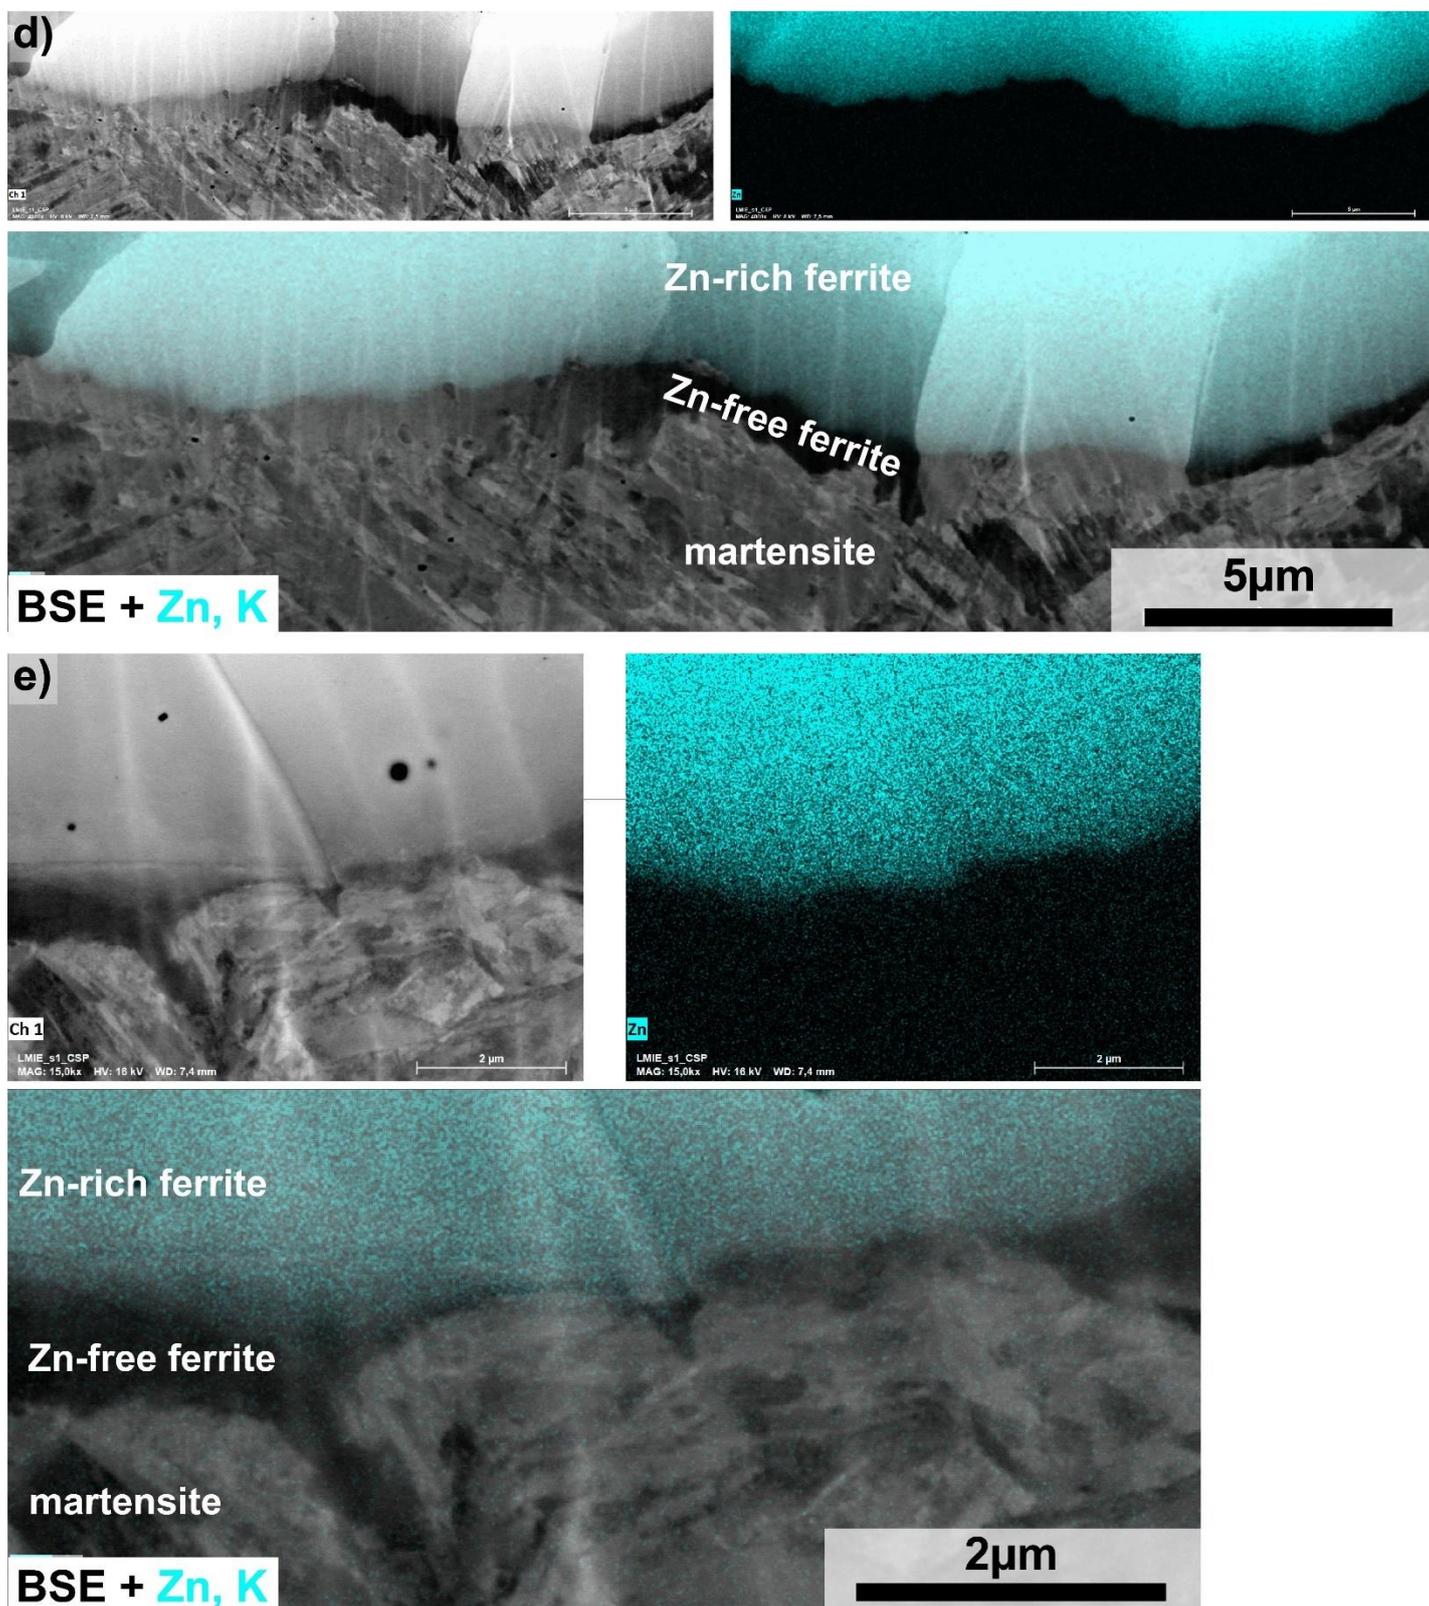
Supplementary figure S2:

Figure S2. EDX mapping of the boundary lifted out for the APT measurement set number one at different magnifications. a) covers a larger area of the Zn coating region. b) is a magnified view of the liftout region. Mappings using both L and K line are shown for Zn. K lines are used for all other elements. The electron micrograph was acquired using backscattered electrons (BSE). Different features are discernable in the elemental mappings:  $\alpha$ -Fe(Zn) at the top, a band of  $\Gamma$ -phase in the region of  $\alpha$ -Fe(Zn), the martensitic base steel at the bottom and Si-Mn-oxides inside the  $\Gamma$ -phase. These Si-Mn-oxide particles seem also slightly enriched in Al. There appear to be some Mn-rich particles in the martensitic base steel, but it seems that the resolution of the SEM-EDX mapping here is not sufficient to clearly resolve them. c) shows an overlay of the BSE micrograph with the Zn EDX signal clearly demonstrating the layer of Zn-free ferrite separating the martensitic base steel from the Zn-rich ferrite ( $\alpha$ -Fe(Zn) phase). d) and e) depict two additional examples Zn EDS mappings overlaid with BSE micrographs.

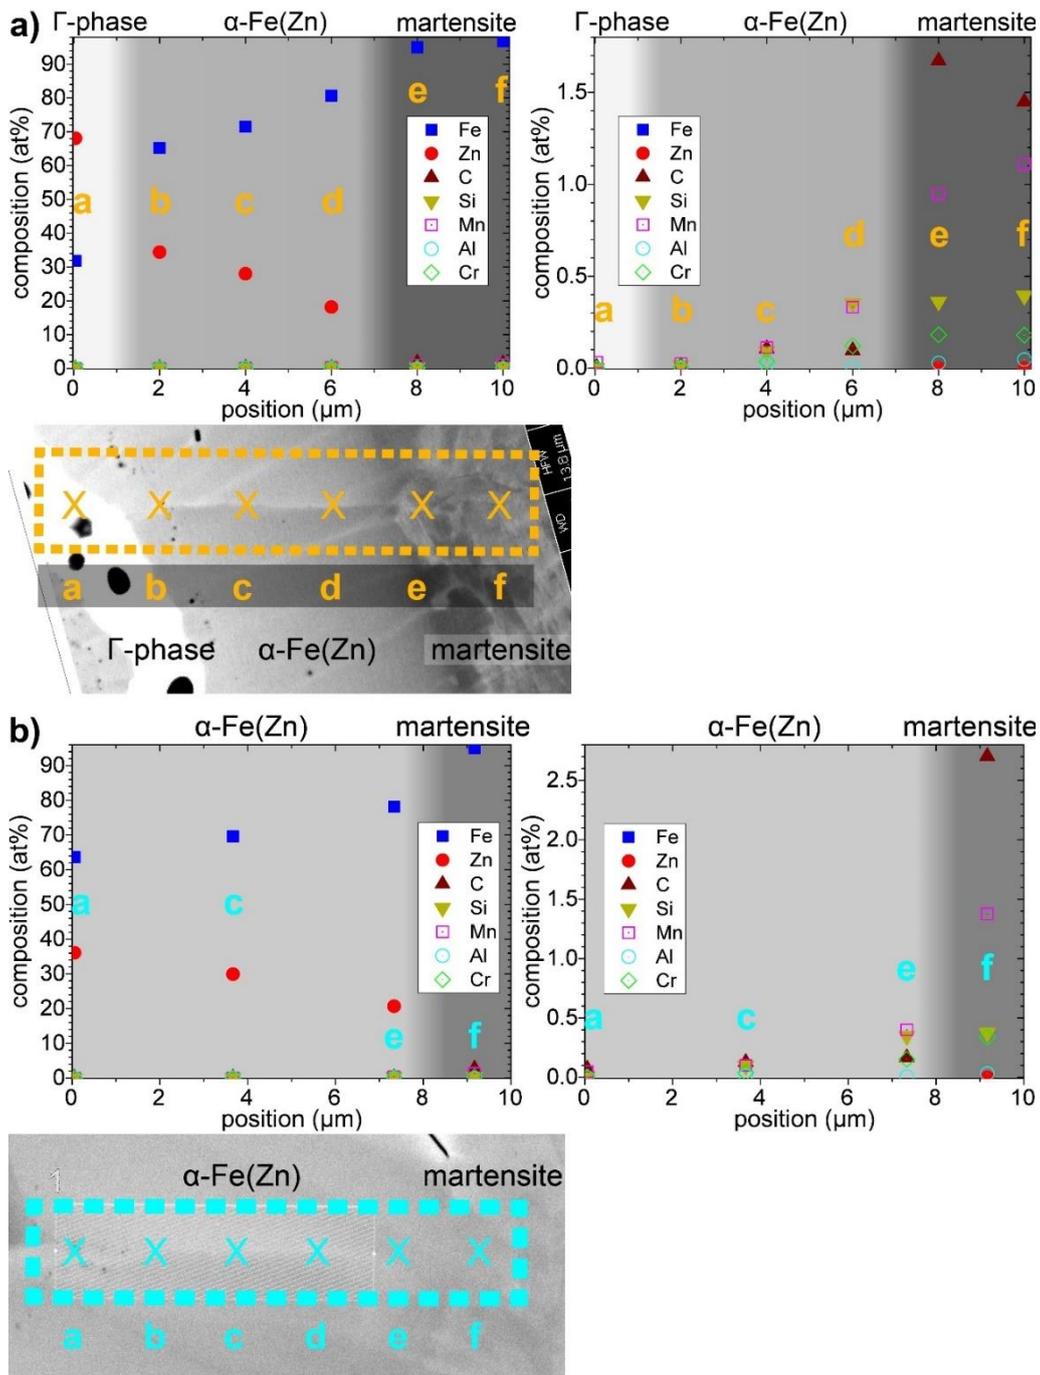
Supplementary figure S3:

Figure S3. Composition profiles along the Zn coating into the martensitic base steel (from left to right). a) shows the chemical composition of the 6 APT measurements from liftout number one (see Fig. S1 and S2). The electron micrograph underneath the graph is aligned in such way that the markings of the APT tip positions on the micrograph are aligned with the data points in the graph. Already from the micrograph it is apparent that the first APT measurement (number 1) is placed inside the  $\Gamma$ -phase, the next three APT measurements (number 2-4) are located inside  $\alpha$ -Fe(Zn) while the last two measurement (number 5, 6) are in the martensitic base steel. b) is the same as a) but for liftout number two. Unfortunately, two APT tips (number 2 and 4) fractured prematurely, which is why the corresponding data points in the graph are missing. Here only APT tip number 6 is located in the martensitic base steel, all other APT tips are within the  $\alpha$ -Fe(Zn) phase. The results of liftout number two are shown here, to demonstrate the reproducibility of the results obtained despite the small volume analyzed in each individual APT measurement. The same gradient of decreasing Zn concentration and increasing Mn, Si and Cr gradient moving towards the base steel is found in both sets of measurements. The C composition of the martensite is higher than the nominal composition of approximately 1 at% in both measurements in liftout one as well as the single measurement in this region in liftout two, which could be an enrichment of C during the  $\alpha$ -Fe(Zn) formation on the steel base side due to a low solubility of the formed phase. Other reasons could be due to local variations in C concentration, as well as C contaminations during any of the preparation steps.

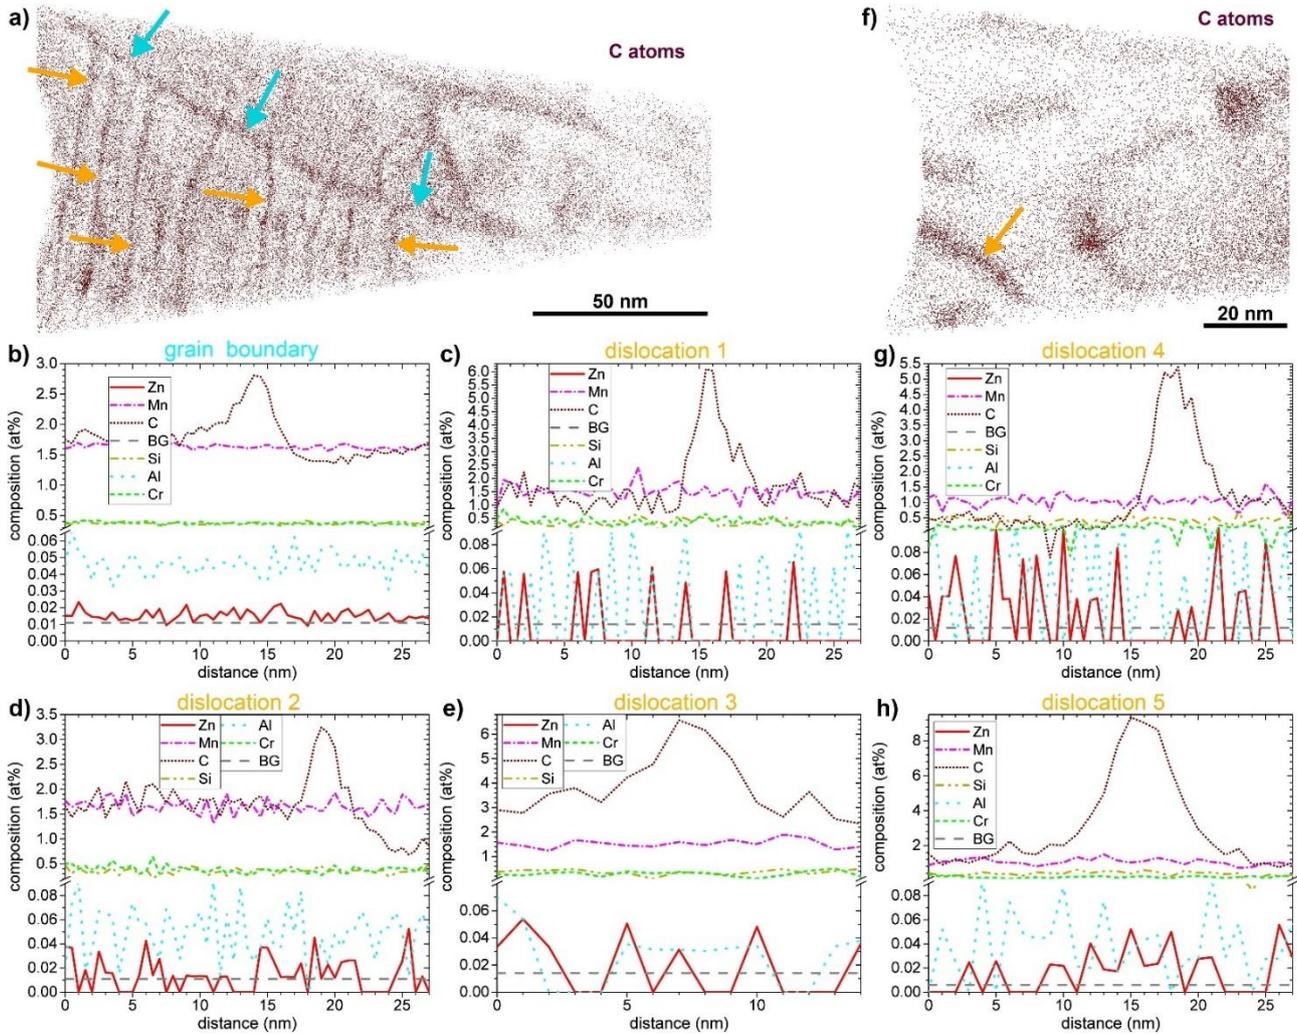
## Supplementary figure S4:

Figure S4. APT analysis of segregation to grain boundaries and dislocations. The top of this figure shows so-called atom maps (i.e. all C atoms in a thin slice through the dataset) of two different measurements in the martensitic region. A GB is marked by cyan arrows, some dislocations are marked by orange arrows. b) corresponds to the composition profile through the boundary marked by cyan arrows in a). The composition profile was calculated along a cylinder of 20 nm diameter across a straight segment of the boundary. Note that the Zn composition in b) is higher than the aforementioned 0.002 at% which is due to the fact, that the Zn composition given for the martensitic matrix was corrected for the background, but for the graph we decided to show the uncorrected values together with the background (BG) in the graph. The BG was determined separately for each composition profile. c)-e) show profiles through different dislocation from the APT dataset in a). g) and h) show profiles through two different dislocations from the APT dataset in d). The atom map shown in a) corresponds to the reconstruction of APT tip number 6 from liftout number 1. The graphs in b), c), f) and g) are extracted from this dataset. The atom map shown in d) corresponds to the reconstruction of APT tip number 6 from liftout number 2. The graphs shown in e) and h) are extracted from this dataset.

It is apparent that the dislocations as well as the GB are marked by strong C enrichments. However, no other elements show any segregation tendency to the GB or dislocations. For the APT liftouts, we target grain boundaries in the  $\alpha$ -Fe(Zn) that continued straight into the martensite and where no Zn-free ferrite section was present (see Fig. S1 and S2). Unfortunately, we could not unambiguously identify a PAGB in the APT measurements. The GB marked by cyan arrows in a) in the martensitic region is visible due to its C enrichment. However, no Zn segregation is present at this GB (as apparent in b)). Due to missing crystallographic information, we cannot determine whether this GB is a PAGB which does not show any Zn wetting or if it is simply a random martensite boundary. We think that usually not all PAGBs are covered with Zn and due to the difficult pre-identification of potential Zn-wetted GBs, there is only a low probability of finding a Zn-wetted PAGB within APT tips with a limited number of attempts.
