Transverse Hydraulic Fracture Initiation: Insights from Intermediate-Scale Hydraulic Fracture Tests

Jeffrey Burghardt^{a,*}, Hunter Knox^a, Chris Strickland^a, Vincent Vermeul^a, Pengcheng Fu^b, Craig Ulrich^c, Mark McClure^e, Mathew Ingraham^d, Paul Schwering^d, Timothy Kneafsey^c, Doug Blankenship^d, EGS Collab Team¹

Abstract

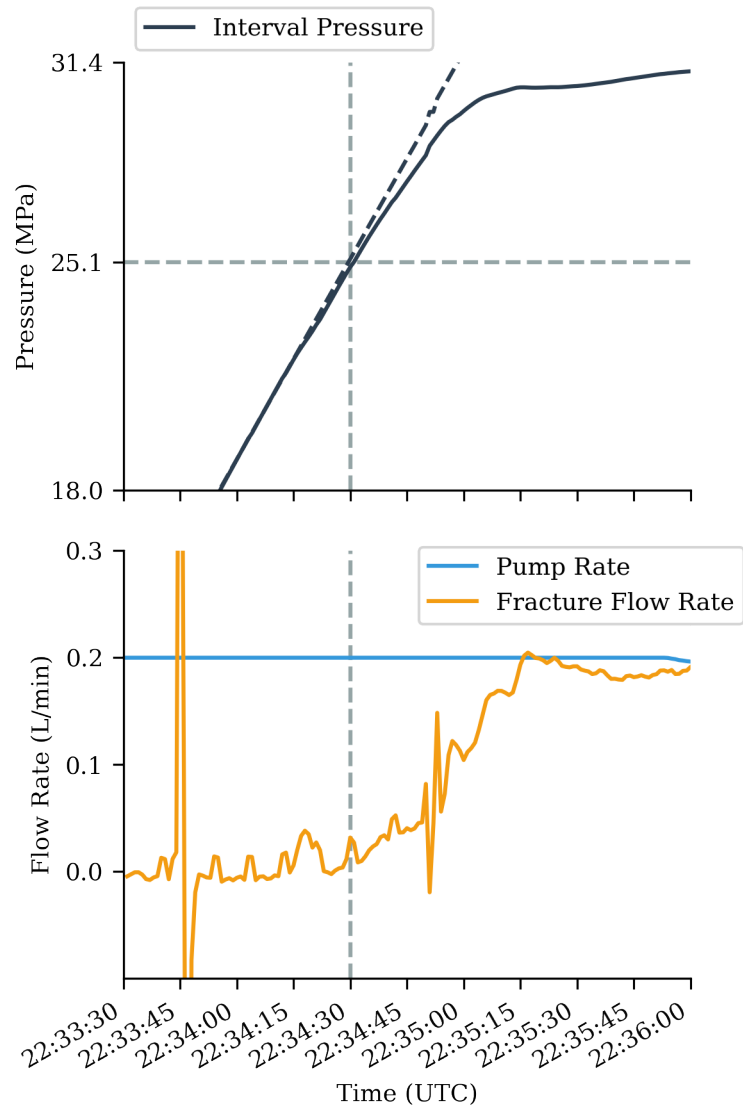
Figure 1: Plot of pressure and volume data during breakdown of the May 21, 2018 stimulation

Figure 1 shows a plot of the data acquired during the breakdown phase of the May 21 stimulation of the notch located at 43.2 m (142 ft). The slope of the linear portion of the injection pressure vs. time curve, together with the pump rate of 200 mL/min, was used to calculate a system compressibility of 62.7 MPa/L. The fracture initiation pressure, indicated by the horizontal dashed line shows where the pressure vs. time curve deviates downward from the linear trend, was estimated to be 25.1 MPa (3646 psi). As can be seen in Figure 1, the injection pressure continued to rise considerably following

fracture initiation, with no significant local maximum and subsequent decline as is often observed in hydraulic fracture initiation.

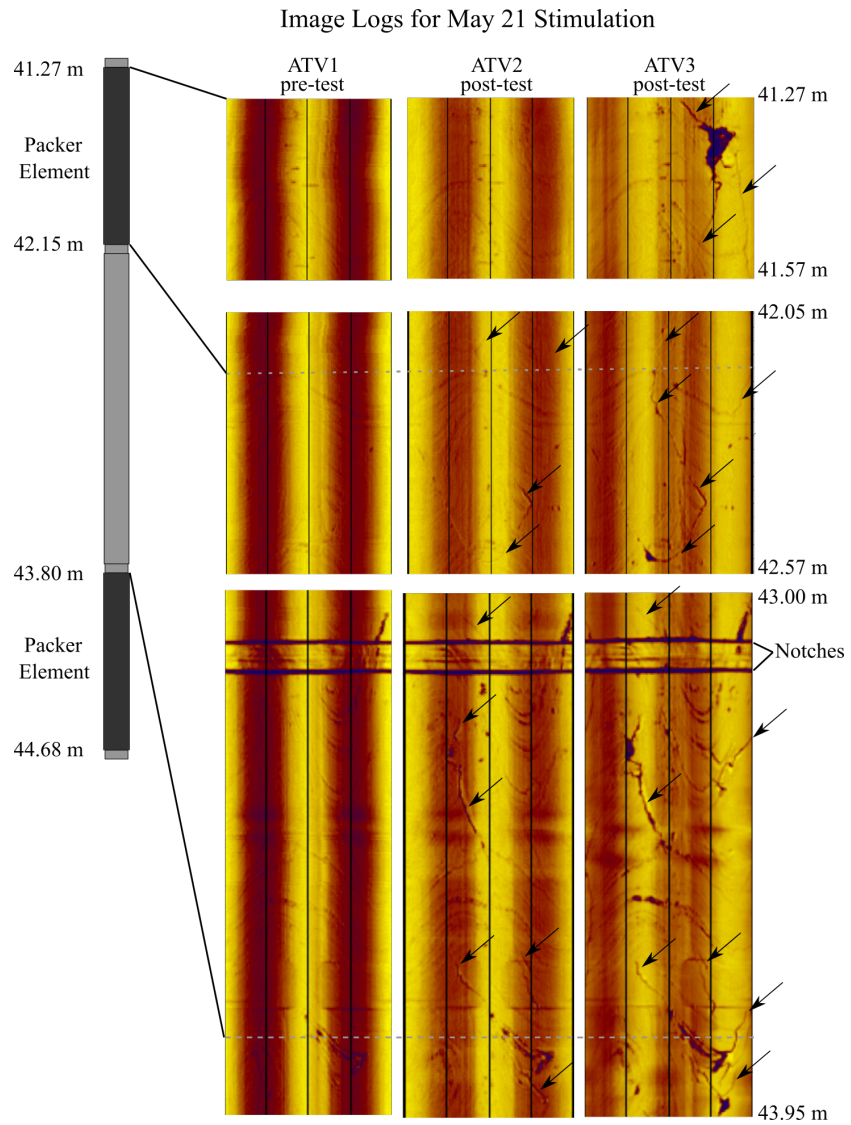
Figure 4: Acoustic (ATV) image logs collected over the zone stimulated on May 21; ATV1 was collected prior to the stimulation, ATV2 was collected shortly after the stimulation, and ATV3 was collected in January 2020 after subsequent higher pressure stimulations at this zone; the left most edge of each log is magnetic North, which is within a few degrees of the top of the borehole

Figure 4 shows acoustic televiewer (ATV) logs that were collected in the borehole both before the stimulation (ATV1), in late May 2018 (ATV2), and again in January 2020 (ATV3). Induced fractures are identified with the thin black arrows and the two notches present in the zone are also identified. A schematic of the straddle packer system along with key alignment depths are shown in this figure for reference. These induced fractures are all sub-longitudinal to the borehole and are located primarily on the top and bottom of the sub-horizontal borehole within the interval. The induced fractures do not appear to be aligned with either the foliations or any obvious natural fracture. There are also indications of a sub-longitudinal fractures extending underneath the packers, most prominently in ATV3. These fractures were likely the cause of the rapid decline in the overnight shut-in test, and subsequent observations of leakage past the upper packer. Since the pressure rapidly

declined well below any of the in situ stresses it appears that the fracture retained considerable conductivity even when mechanically closed.

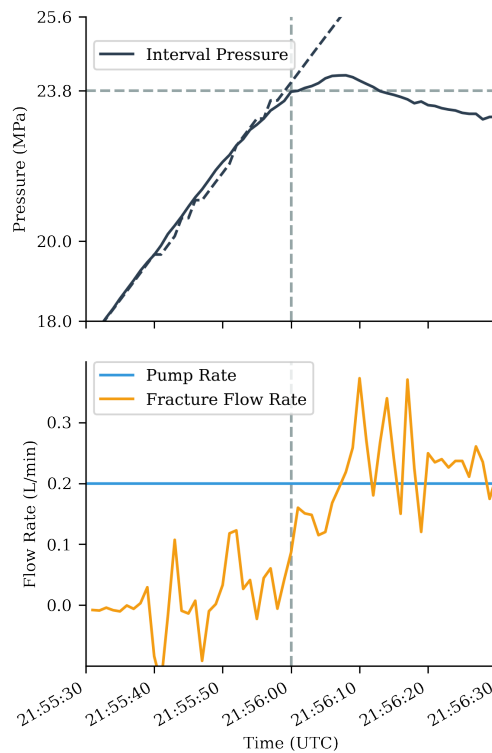
Figure 5: Plot of pressure and volume data during breakdown of the May 22, 2018 stimulation

Figure 5 is a plot of the data acquired during the fracture initiation phase of the May 22, 2018 stimulation at the notch located at 50 m (164 ft). The system compressibility during the pressure building phase of this test was estimated to be 70.5 MPa/L, and the fracture initiation pressure is estimated to be 22.5 MPa (3272 psi). Following fracture initiation the injection pressure rose to a peak of 24.2 MPa (3509 psi), and then declined to 23 MPa, then steadily rose to 25.4 MPa at the end of the injection. Evidenced in the lower plot of this figure, as the borehole pressure declined following the peak pressure, the flow rate of fluid into the borehole slightly exceeds the pumping rate momentarily due to borehole storage effects.

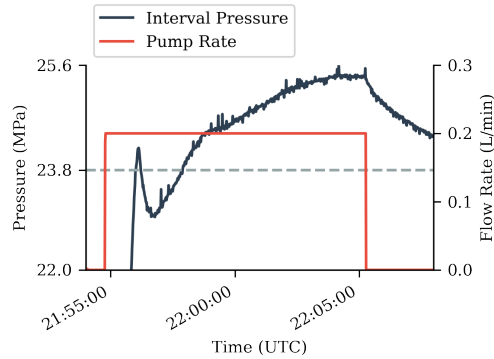
Figure 6: Plot of data during entire 1.8 L total injection for the May 22, 2018 stimulation conducted. This, and subsequent similar tests was performed by first using the pump in a constant pressure mode until a constant flow rate was achieved. Once the required flow was above approximately 50 mL/min the test continued as a step-rate test with a constant injection rate. Following this step pressure/rate test a constant rate injection at 0.4 L/min was performed until an additional 23.5 L at been injected, which was anticipated to produce a fracture radius of approximately 5 m (16.4 ft). The well was then shut in overnight. The next day another step pressure/rate test was performed followed by another period of constant rate injection at 5 L/min until the fracture had intersected the production well, after which another step pressure/rate test was performed.

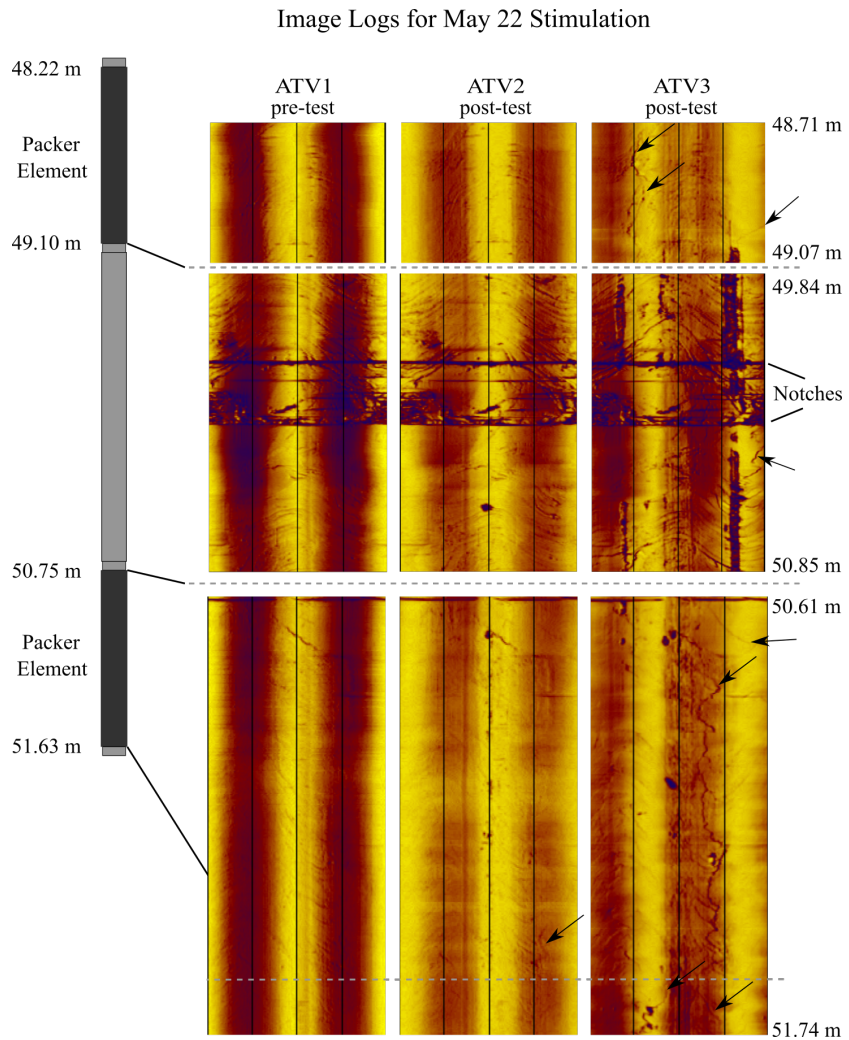
Figure 7: Acoustic (ATV) image logs collected over the zone stimulated on May 22; ATV1 was collected prior to the stimulation, ATV2 was collected shortly after the stimulation, and ATV3 was collected in January 2020 after subsequent higher pressure stimulations at this zone; the left most edge of each log is magnetic North, which is within a few degrees of the top of the borehole

the initial stimulation discussed above. Another ATV log was collected in January 2020 after a long term thermal circulation test had been conducted from this notch. Figure 7 shows a comparison of the pretest OTV and ATV logs and the two post-test ATV logs. The details of the long term thermal circulation test is beyond the scope of this article but it is mentioned since it likely had an impact on the extension of the fractures observed between the May 2018 and January 2020 ATV logs shown in Figure 7.

Unlike the May 21 stimulation, no induced fractures are evident in the image logs collected at the end of May 2018 with a possible exception of one under the lower packer. After the May 2018 ATV log was collected it was concluded that, as with the Jeffrey et al. (2015) study, the lack of an apparent induced fracture meant that the fracture initiated from the notch, which would not be expected to create any signature on the image log. Alternatively, it could not be ruled out that the fracture opened/sheared a plane of weakness in the rock and closed in a way that left no signature on the image log.

The image log collected in January 2020 after the long term thermal test at this location offers additional insight. There is what appears to be precipitated minerals on this portion of the well from the long term test that obscure portions of the January 2020 image log. This is believed to be what caused the long thick streaks just above and below the notches seen in ATV3 in Figure 7. Beyond this precipitate, one of the most apparent differences observed in the January 2020 image log is the obvious longitudinal fractures underneath both the upper and lower packers. Only a small section of the fracture below the lower packer can be seen in the May 2018 image log, so

the formation of these fractures likely occurred during later higher pressure testing. En echelon fractures can be observed on the January 2020 image log at 50.3 m. These seem to be aligned with the foliations, but some ligaments of the fracture extend across foliations. Some opening of foliations also appears likely at 50.5 m. This, combined with the concentration of the precipitated minerals at this location, suggests that the primary outflow of water during the long term thermal test was through the foliation planes above and below the notches.

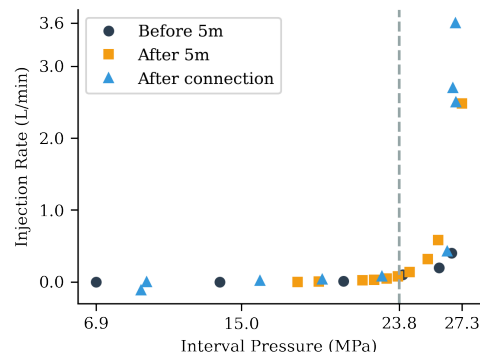
Figure 8: Results of multiple step-rate tests on the May 22, 2018 stimulation

Figure 8 shows the results of these three step pressure/rate injection tests. In this figure “After connection“ means after the connection to the production well was made. A larger pump was used for the “after 5m” and “after connection” step-rate tests. Owing to the larger full-scale range, the uncertainty in the flow measurements in these tests is larger (approximately ± 50 mL/min). Because of this the lower rate measurements have a larger

analysis of the pressure transient analysis following the initial 2.1 L injection. Specifically, significant flow into the fracture occurs at approximately 22-23 MPa (3192-3336 psi), which is close to the picked closure pressure of 21.8 MPa (3162 psi). Also, a vertical asymptote occurs in the data at approximately 27 MPa (3916 psi), which is an indication of the fracture propagation pressure. This leads to an estimated net pressure of 4-5 MPa (580-725 psi), which is slightly more than the pressure transient analysis estimate. During the shut-in period there is very little flow into the fracture, so friction losses due to tortuosity do not play a role. Therefore, a reasonable interpretation is that the difference between the estimate of the net pressure from the step-rate test and the shut-in transient test is due to near-borehole tortuosity friction loss of 1.3-2.3 MPa.

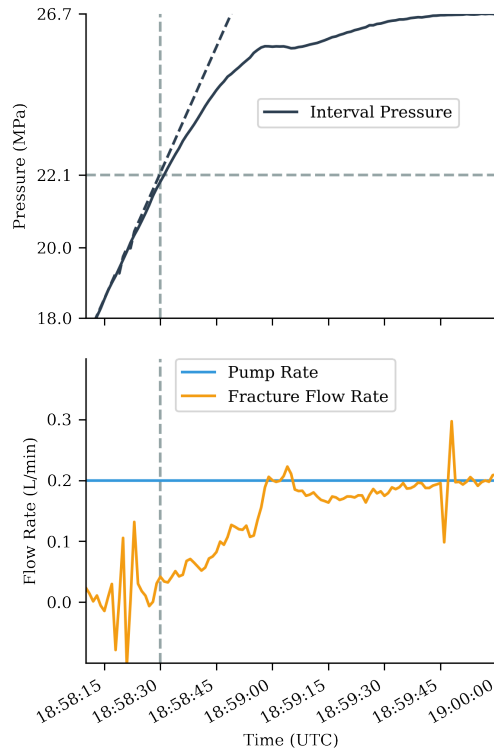
Figure 9: Plot of pressure and volume data during breakdown of the July 18, 2018 stimulation

Figure 9 is a plot of the pressure and flow data acquired during the fracture initiation phase of the July 18, 2018 stimulation at the notch located at 39 m (128 ft). Figure 10 shows the data during the entire 2 L injection. Fracture initiation occurred at 22.1 MPa (3201 psi), after which the pressure continued to increase, reaching a momentary peak at 25.7 MPa (3272 psi), followed by a brief decline, and another rise to approximately 26.6 MPa (3858 psi).

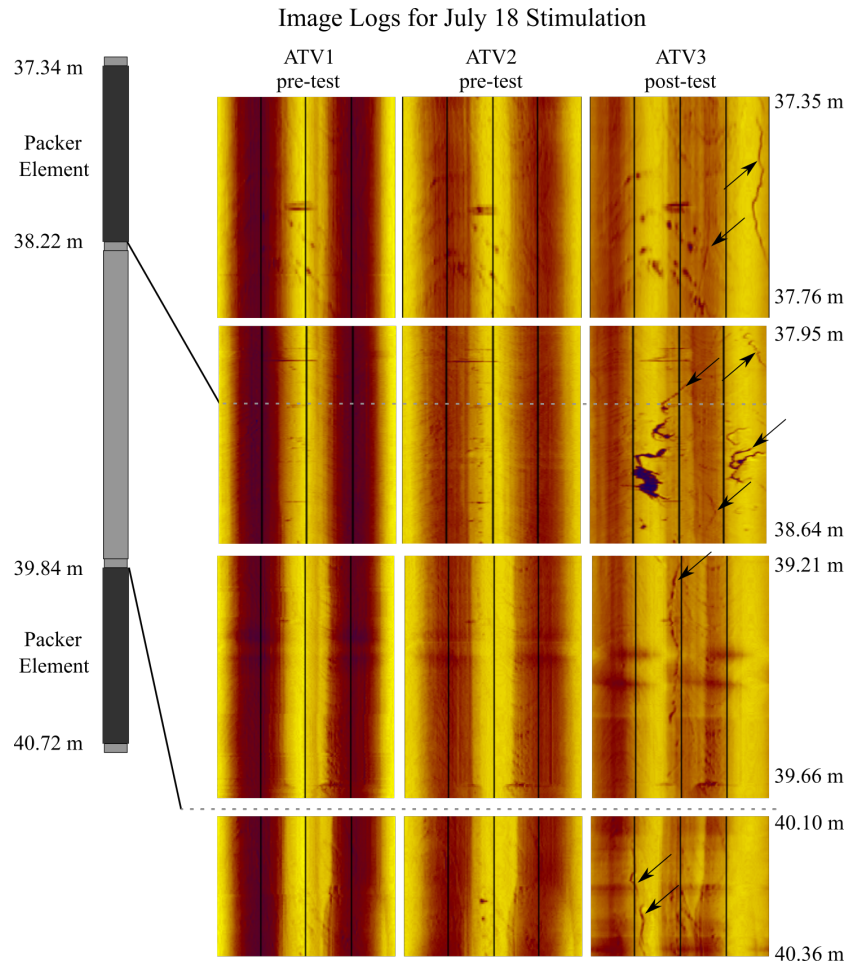
Figure 11: Acoustic (ATV) image logs collected over the zone stimulated on July 18; both ATV1 and ATV2 were collected prior to the stimulation while ATV3 was in January 2020 the stimulation; the left most edge of each log is magnetic North, which is within a few degrees of the top of the borehole

Figure 11 shows pre- and post-test image logs from the interval tested in the July 18 test. Sub-longitudinal fractures can be observed under the upper packer at 37.4 to 37.5 m, and again from 38 to 38.6 m. These fractures are rotated approximately 10 degrees from the top and bottom of the well with some en echelon fracturing. This suggests that the principal stresses are not well aligned with the well at this location. A longitudinal fracture can be seen within the pressurized interval, spanning 39.2 to 39.6 m, just below the notch. Longitudinal fractures can also be seen underneath the lower packer from 40.15 to 40.35 m and again at 40.55 to 41.02 m. Similar to the fractures
