Coherent Fourier Scatterometry for detection of killer defects on silicon carbide samples

Abstract

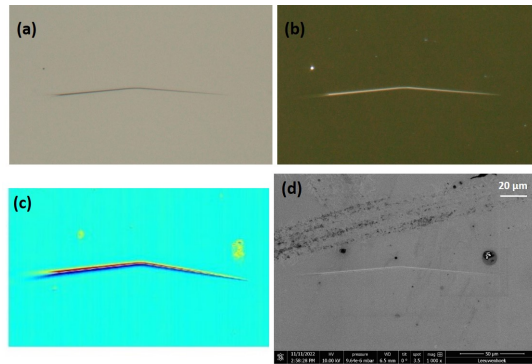
Figure 2: (a) and (b) BF and DF images of the stacking fault defect, respectively. (c) CFS scan map of the stacking fault defect, and (d) SEM image of the same defect.

Extended defects with a planar shape are generally classified into three different groups named, stacking fault, stacking fault propagated, and stacking fault complex. Stacking faults usually appear triangular with a distant outline on the surface of SiC wafers. Propagated stacking faults have a trapezoidal structure. Our sample did not contain any stacking fault propagated and therefore we only have results for the stacking fault. Here, Figure 2(a)-(d) show the BF and DF images, the CFS scattering map and SEM image, respectively. One can clearly see that although all methods are able to detect the defect, CFS shows a better visibility with respect to the background as compared to the other techniques. In addition, when comparing BF and DF images with CFS, the latter recovers the object even if it is not in one plane on the substrate but could extend deep into the substrate.

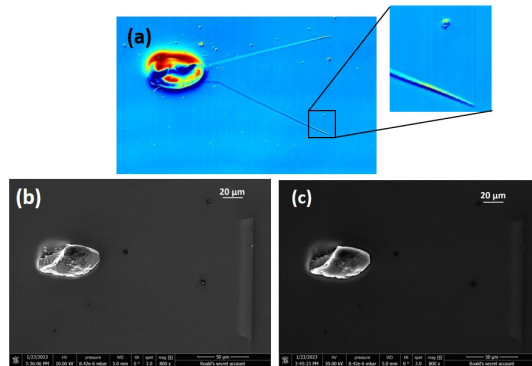
Figure 6: (a) CFS scan map, (b) and (c) are SEM images of the same defect with 10 and 30 KV, respectively. In the inset in 6(a) we highlight the parts of the defect that is not clearly observed with other techniques.

Figure 5(a) shows the BF image of a polytype inclusion, while Figure (b) and (c) are both DF images with different powers. Figure 5(c) is saturated in order to reveal parts of the defect that are buried. Figure 6(a) shows the scattering CFS map and Figure 6(b) and (c) the SEM image of the same defect. The two SEM images are obtained at 10 and 30 KV, respectively to also highlight different parts of the defect. By comparing these images, one can see that with CFS, the triangle next to the big spherical defect is clearly revealed (see also the inset of Figure 6(a)) while all other techniques (BF, DF and SEM) fail to image it properly. We believe that this is due to two reasons: first, the contrast was too low, and second, the triangle is in a different depth than the downfall. This is one scenario where both optical microscopy and SEM would fail to have a comprehensive inspection due to the low penetration depth and/or low contrast. Therefore, when it comes to very narrow and features that lie partially outside the sample plane, CFS can outperform the conventional methods and become a complementary tool to them. The comparison between the results of all techniques indeed shows good consistency and demonstrates CFS's capability in visualizing and locating killer defects.
