An extreme thermal cycling reliability test of ATLAS ITk Strips barrel modules

ABSTRACT: At the end of Run 3 of the Large Hadron Collider (LHC), the accelerator complex will be upgraded to the High-Luminosity LHC (HL-LHC) in order to increase the total amount of data provided to its experiments. To cope with the increased rates of data, radiation, and pileup, the ATLAS detector will undergo a substantial upgrade, including a replacement of the Inner Detector with a future Inner Tracker, called the ITk. The ITk will be composed of pixel and strip sub-detectors, where the strips portion will be composed of 17,888 silicon strip detector modules. During the HL-LHC running period, the ITk will be cooled and warmed a number of times from about -35°C to room temperature as part of the operational cycle, including warm-ups during yearly shutdowns. To ensure ITk Strips modules are functional after these expected temperature changes, and to ensure modules are mechanically robust, each module must undergo ten thermal cycles and pass a set of electrical and mechanical criteria before it is placed on a local support structure. This paper describes the thermal cycling Quality Control (QC) proce

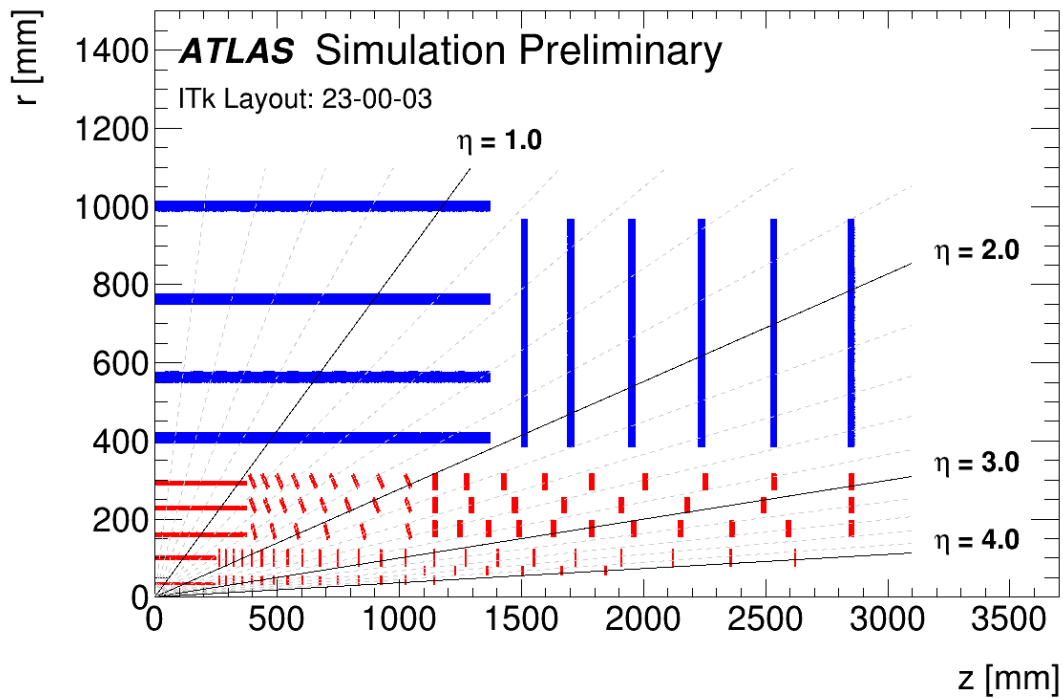
Figure 1: The ITk layout [2].

During Long Shutdown 3 (LS3) of the Large Hadron Collider (LHC) running schedule, the accelerator complex will be upgraded in order to increase the instantaneous luminosity of its particle beams. This upgraded phase of the LHC, the HL-LHC (High-Luminosity LHC), is estimated to deliver 3000-4000 fb⁻¹ of proton-proton collisions to the LHC experiments [1]. An increase in instantaneous and integrated luminosity of this magnitude requires the LHC experiments to be upgraded to cope with higher rates of data and long term effects from radiation damage, in addition to an increased number of simultaneous interactions known as pileup. As a part of the ATLAS detector's upgrade for the HL-LHC, the Inner Detector (ATLAS tracker) will be entirely replaced by a fully silicon tracker composed of pixel and strip subdetectors, called the Inner Tracker (ITk), partitioned into a barrel and end-caps with different geometries, as shown in figure 1.

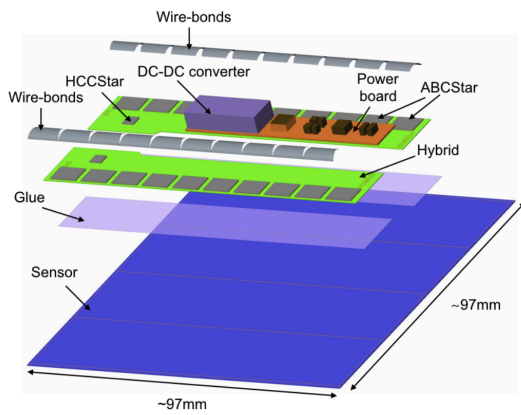
(a) An example barrel module diagram [5].

Figure 2: Diagram and picture of a module.

ATLAS ITk Strips modules are built from a silicon sensor as the active detection material, with a hybrid glued directly on top hosting ASICs for readout, alongside a powerboard to power module components. The ITk Strips endcaps will be built from 6 types of modules with different geometries in order to satisfy the radial geometry requirement, while the barrel will be composed of Short Strip (SS) and Long Strip (LS) modules, whose names correspond to the modules' relative strip sizes. A diagram portraying an example barrel module is shown in figure 2a. A photo of a Long Strip module, defined as a sensor with two "streams" of strips, a single powerboard and hybrid with 10 ASICs, is shown in figure 2b. Note that strips under (away from) the powerboard are defined as stream 0 (1).

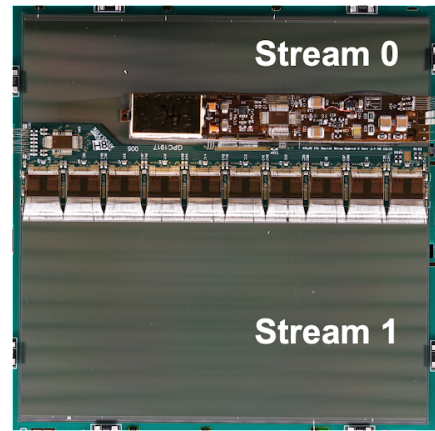
(b) A photo of a Long Strip module [6], with streams 0 and 1 labelled. Note that strips are aligned in the vertical direction.

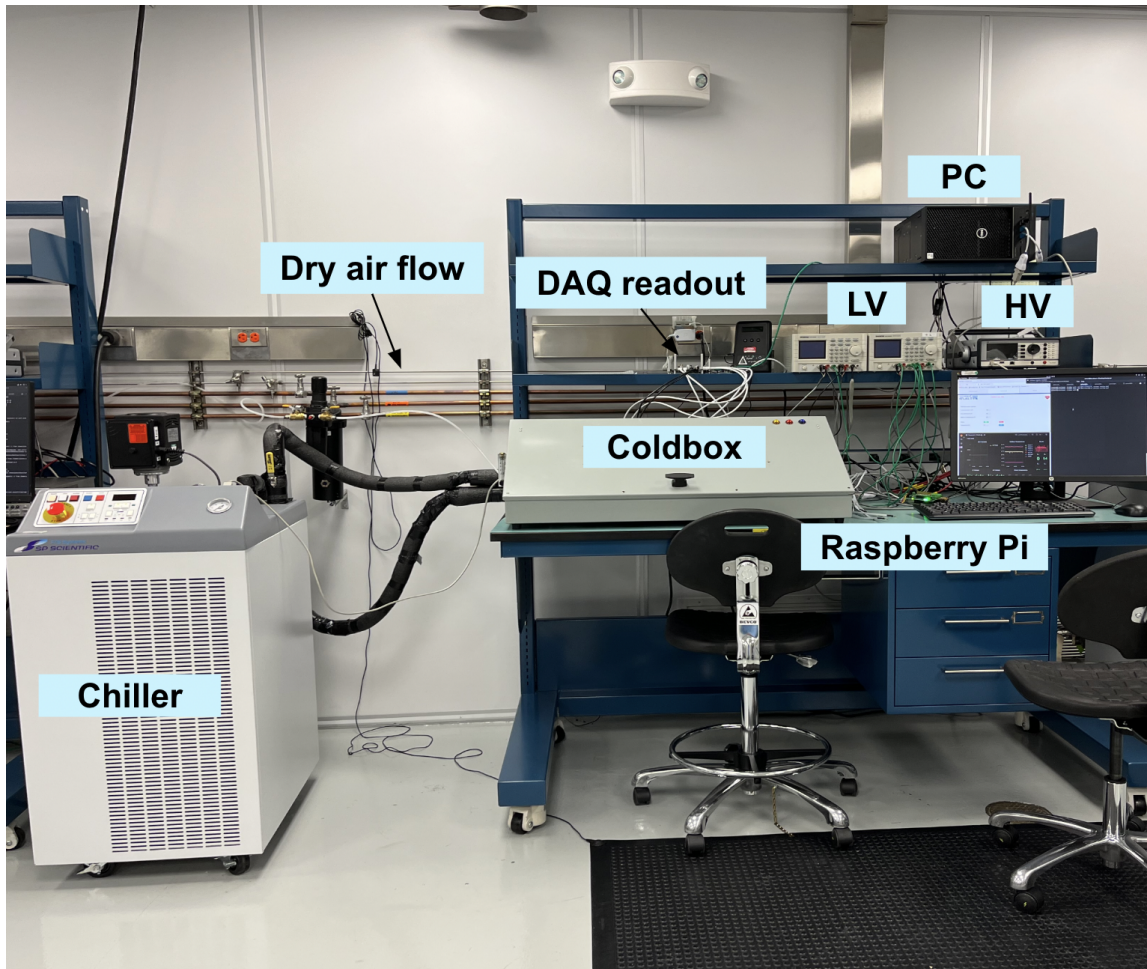
Figure 3: An example coldjig setup, comprised of a coldbox housing modules, and its associated hardware to control and monitor module environment and DAQ.

Thermally cycling modules requires an experimental setup which controls and monitors both environmental and data acquisition (DAQ) features. This is accomplished in the ITk Strips project with a coldjig, defined as a setup including a coldbox and associated hardware, an example of which is shown in figure 3. The following are pictured: A coldbox, containing up to four modules screwed into metal plates called "chucks". The temperatures of the chucks, and thereby the modules, is controlled with a set of cooling pipes between the chiller and the chucks. The coldbox is constantly flushed with dry air flowing from external pipes in order to minimize humidity, to prevent any ice or moisture from condensing on the modules during testing. A DAQ readout, consisting of a Nexys field programmable gate array [7] for fast processing of module data, and a custom interface board (FMC-0514-DP [8]) between the Nexys and modules, is used to perform various DAQ tests to measure module noise and gain at the strip level [4]. Low voltage (LV) power supplies are connected to the coldjig to provide 11V to module electronics. A High voltage (HV) power supply is connected to provide -350V bias voltage for sensor depletion during electrical tests and to take I-V measurements up to -550V. A PC is present to run DAQ software, and a Raspberry Pi [9] is

used for monitoring and control of the environmental elements of the setup including temperature, humidity, and dew point.

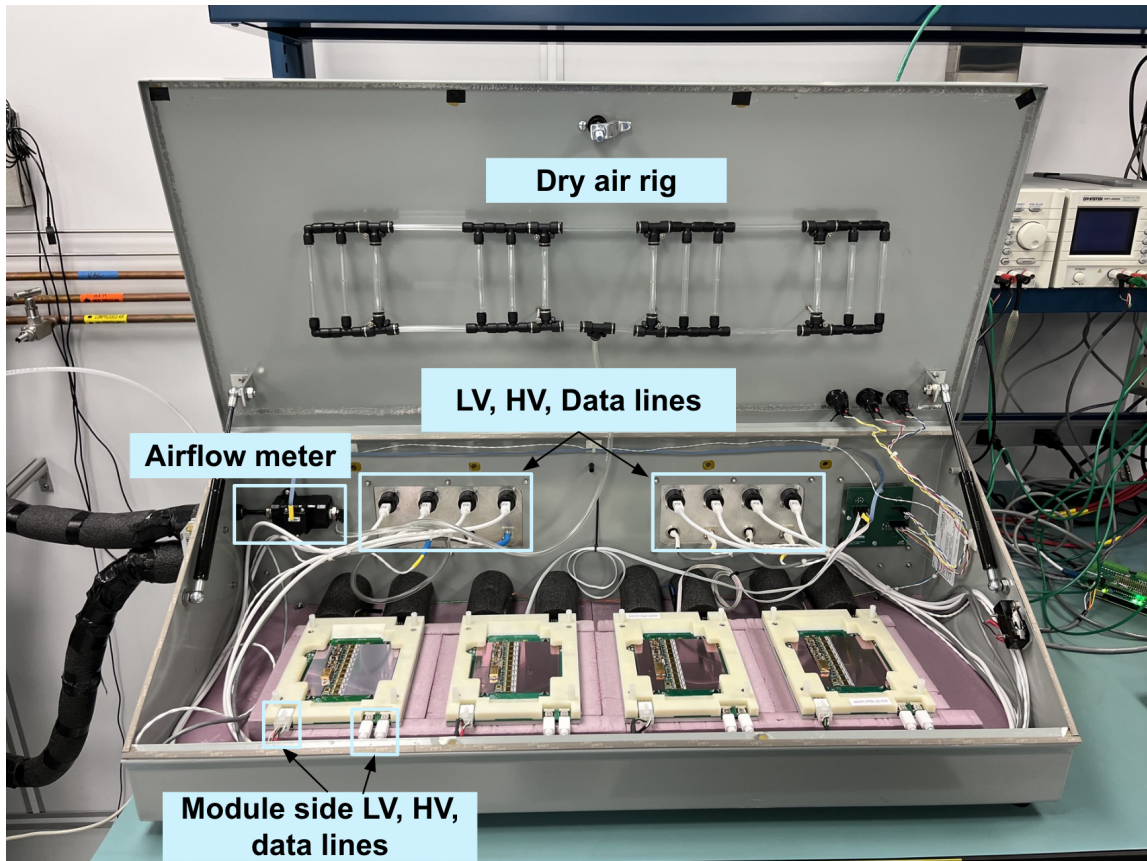
Figure 4: Opened coldjig with four Long Strip barrel modules attached.

A photo of the interior of a coldjig with four Long Strip barrel modules inside is shown in figure 4. The dry air rig directs dry air from the external pipes onto the modules. An airflow meter is installed in order to monitor the rate of airflow in Standard Cubic Feet per Minute (SCFM), which must be above 1.5 SCFM at all times. LV and HV are provided to the module via a Molex connection to a test frame. Through the same test frame, data from the module is read out through the back of the box, where it is connected to the FMC-0514-DP with DisplayPort cables.

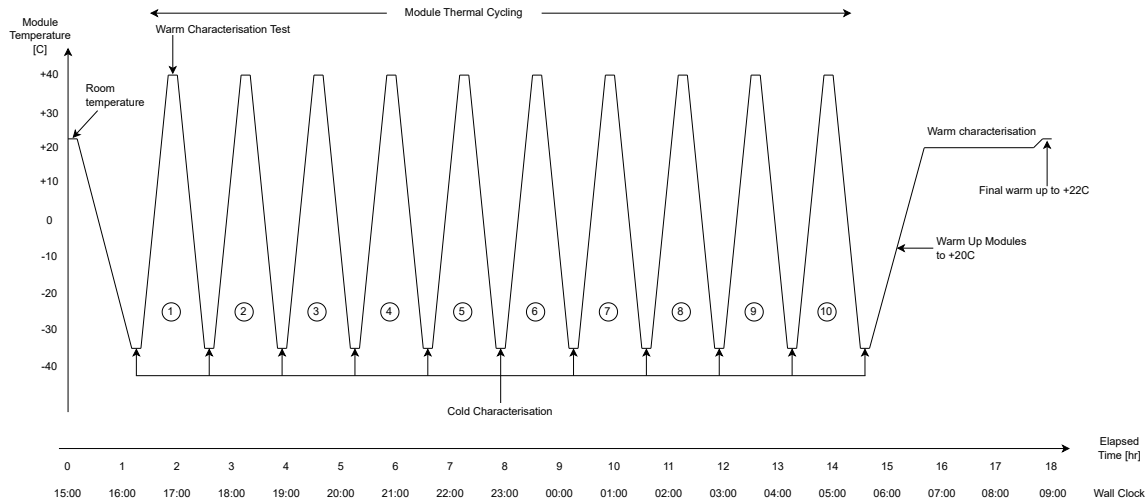
Figure 5: The thermal cycling QC procedure. The diagram shows an upper limit for the thermal cycle of $+40^{\circ}\text{C}$, as per the original QC plan.

changes on modules is emulated with thermal cycling: One thermal cycle is defined as the chiller starting at the required cold temperature, a cold electrical test, the chiller warming to the pre-defined warm temperature, a warm electrical test, and the chiller returning to the required cold temperature to begin another thermal cycle. This is achieved using setups identical or similar to that described in section 2. This procedure is shown in figure 3, where the original QC procedure included an upper limit for the thermal cycle of $+40^{\circ}\text{C}$. However, while developing this procedure during pre-production, the upper limit was reduced to $+20^{\circ}\text{C}$ after it was found that powered modules at $+40^{\circ}\text{C}$ approached the glass transition temperature of the glue securing electronics to the sensor. Additionally, a nominal thermal gradient of 2.5°C per minute is defined as part of the standard procedure. This is the final step of the module QC program: all modules must pass a post-cycling electrical test, and an I-V before being placed on a local support structure.

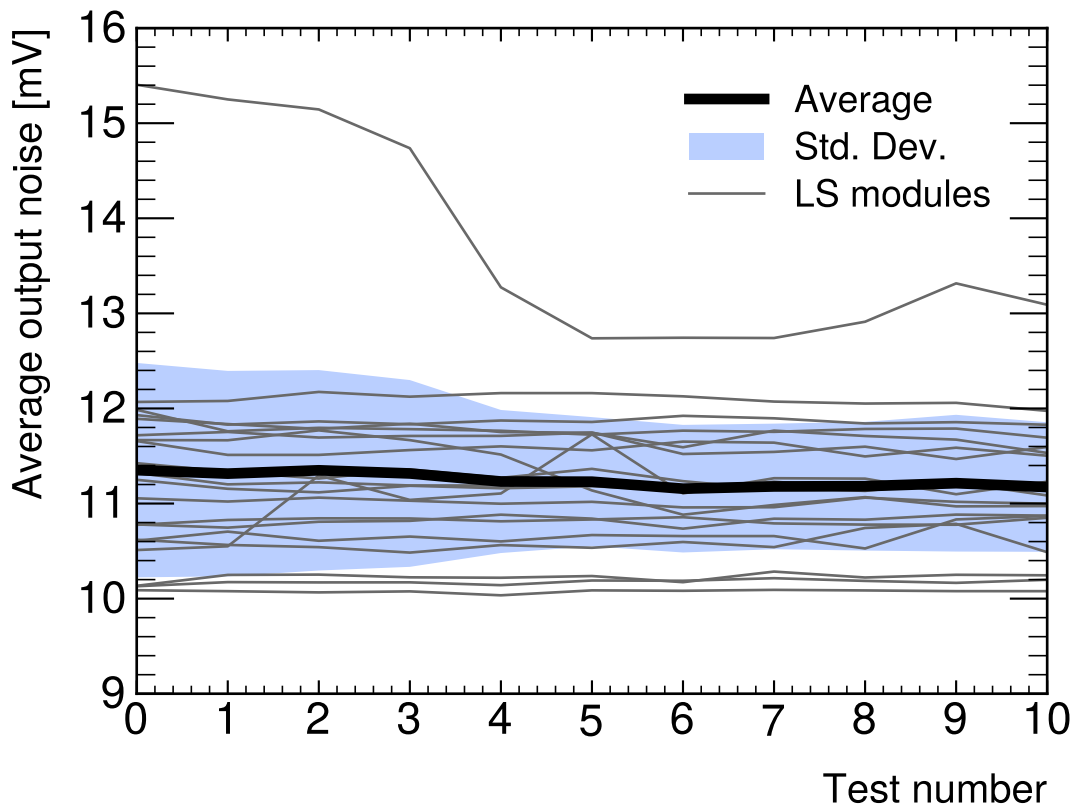
Figure 6: The average output noise of all strips in LS modules, during the 11 cold tests of thermal cycling (Test number 0 corresponds to the cold test before the first thermal cycle, see figure 3). The thin grey lines show trends of 20 individual pre-production LS modules, along with the average and standard deviation between all modules shown by the black line and blue area respectively.

Results from these thermal cycling tests as a function of test number indicate whether there is any clear degradation in electrical performance as a consequence of the thermal stress. Figure 6 shows the development of output noise in 20 pre-production LS modules, at each of the 11 cold tests. Most individual modules demonstrate a stable noise that is almost unchanged in each of the cold tests, and the average results of all modules is consistent with there being no gradual noise

increase. One module shows above average noise during cold tests, which improves as more cold tests are taken. In contrast, the noise from this module’s warm tests are stable. It is not understood why this particular behavior is observed for this module.

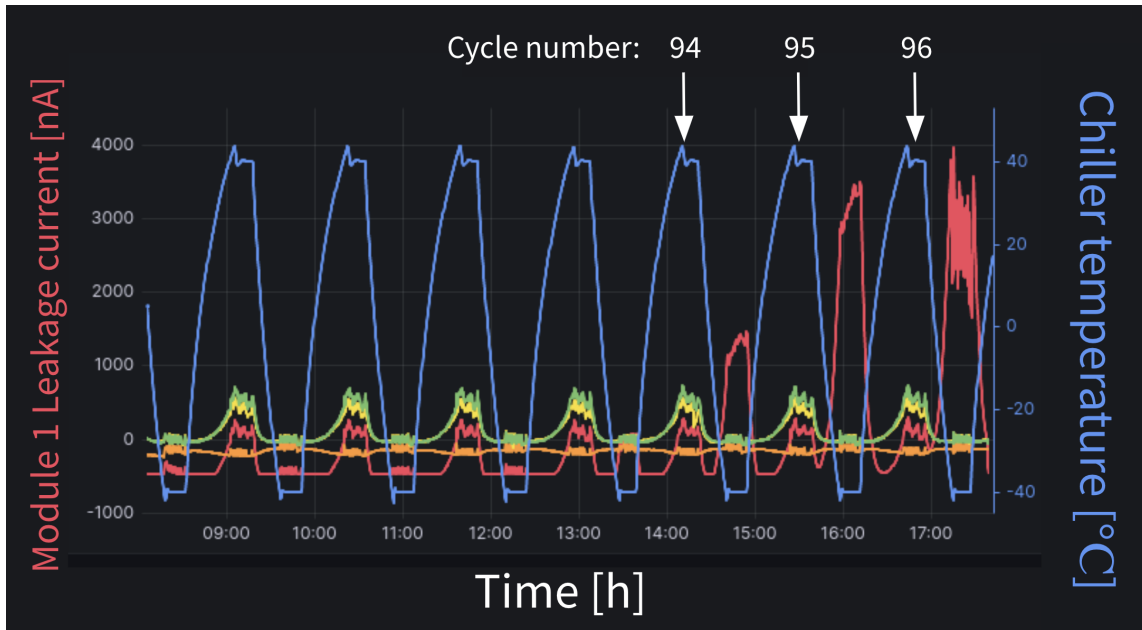
Figure 7: Module 1 leakage current (in red) during thermal cycles 90 to 96. The leakage current from Module 2, Module 3, and Module 4 are shown in yellow, green, and orange respectively.

Module 1 was thermally cycled 101 times in the coldjig described in section 2. During its first 62 thermal cycles, no change in behavior or performance was seen. During its 63rd thermal cycle the module's leakage current increased from its baseline value of about 200-500 nA to about $1.5\ \mu\text{A}$, and then during its 64th thermal cycle to about $2.5\ \mu\text{A}$. The cold DAQ test from the 64th cycle indicates a few very noisy strips on the sensor's edge.

During its next day of thermal cycling three days later, the first two thermal cycles did not show changes in behavior, but increased leakage current was again observed from cycles 66-70, this time up to about $4\ \mu\text{A}$. The next time the module was cycled four days later, the module showed no changes in behaviour during cycles 71-80. On its second to last day of cycling, an instance of increasing leakage current while cooling down was observed during cycles 94-96 as shown in figure 7, and relatively high leakage currents of about $4\ \mu\text{A}$ are seen during the final 5 cycles. In all of these instances, the current values are under the specification limit of $10\ \mu\text{A}$. It should be noted that during HL-LHC operations, sensor current will increase by several orders of magnitude, and irradiation will often remove any breakdown. It is also noted that increasing sensor current during temperature changes while sensors are biased, similar to what was observed for Module 1, has been observed in other modules during pre-production.

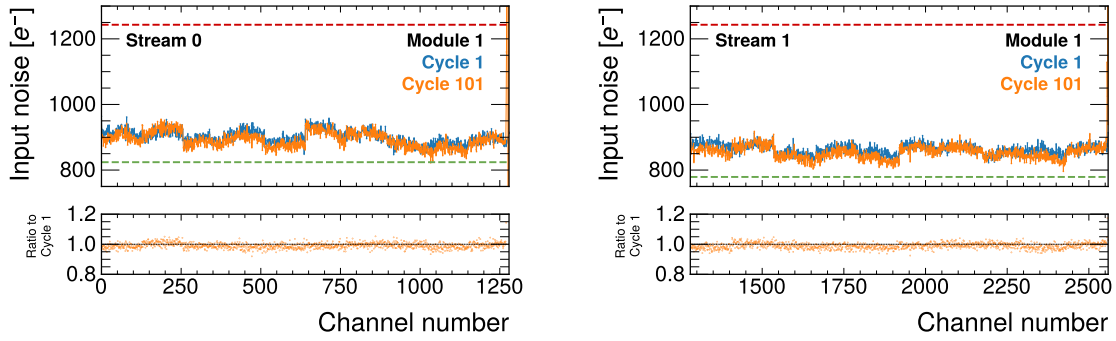
(a) Stream 0: corresponds to strips under the hybrid. (b) Stream 1: corresponds to strips away from the hybrid.

Figure 8: Comparison of Module 1 noise measured during first and final cold tests for streams 0 and 1.

A comparison of Module 1's noise during its first, and 101st cold tests is shown in figure 8 for both streams of strips. While there are a few noisy strips on the edges of each stream (near

channel numbers 1280 and 2550), the vast majority of strips have the same measured noise within 5% before and after cycling. Additionally, the measured noise is well below the maximum allowed noise of 1243 ENC. One would expect a higher noise measurement if taken at room temperature, but would not expect the noise to increase by the ≈ 300 ENC necessary to reach the threshold as noise increases of this magnitude are not typically seen in Long Strip modules between cold and room temperature tests. The measured noise exceeds the target room temperature noise in green, 824 (779) ENC for stream 0 (1), even when measured cold, indicating this module is noisier than expected. Upon inspection after testing, this module was found to have glue on the guard ring, which is known to increase sensor current measurement.

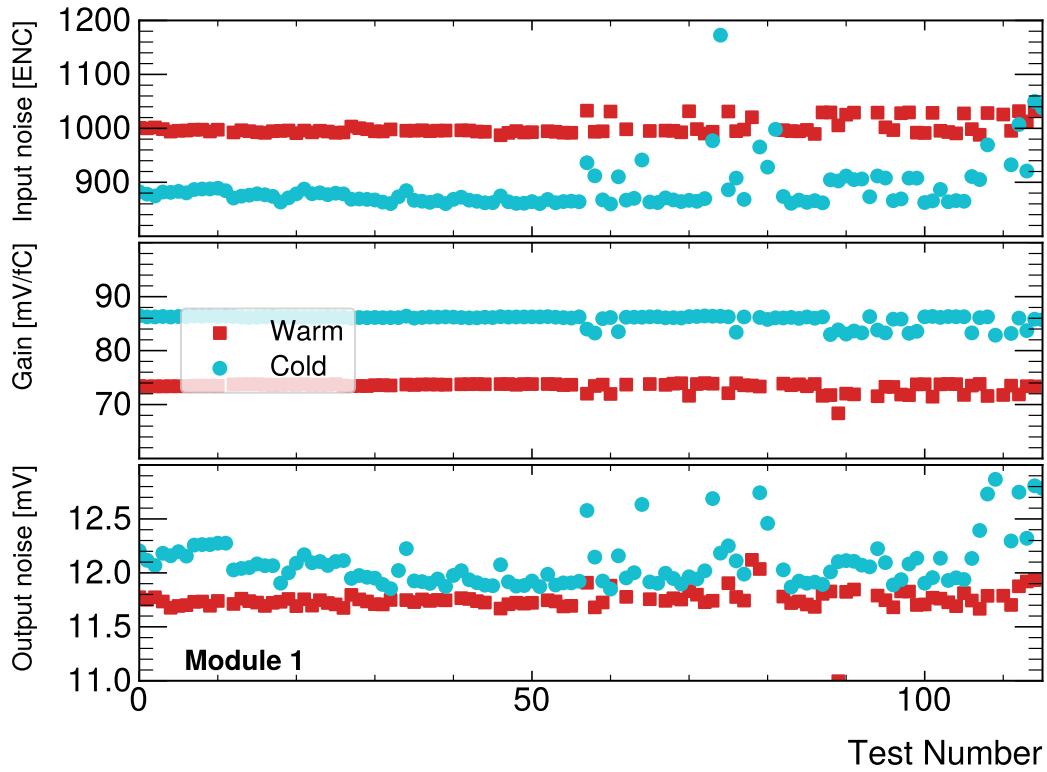
Figure 9: Module 1 input noise, gain, and output noise as a function of test number, separated by warm (Chiller at +40°C) and cold (Chiller at -40°C) tests. Note that there were more tests taken than number of thermal cycles, as sometimes a day of cycling would end on a warm test without completing a cycle, or one day would end with a cold test and the next day would start with a cold test.

Trends of Module 1's input noise, gain, and output noise during warm and cold tests as a function of test number are shown in figure 9. These trends show a roughly steady increase in average input and output noise vs. test number, indicating that the module is relatively stable.

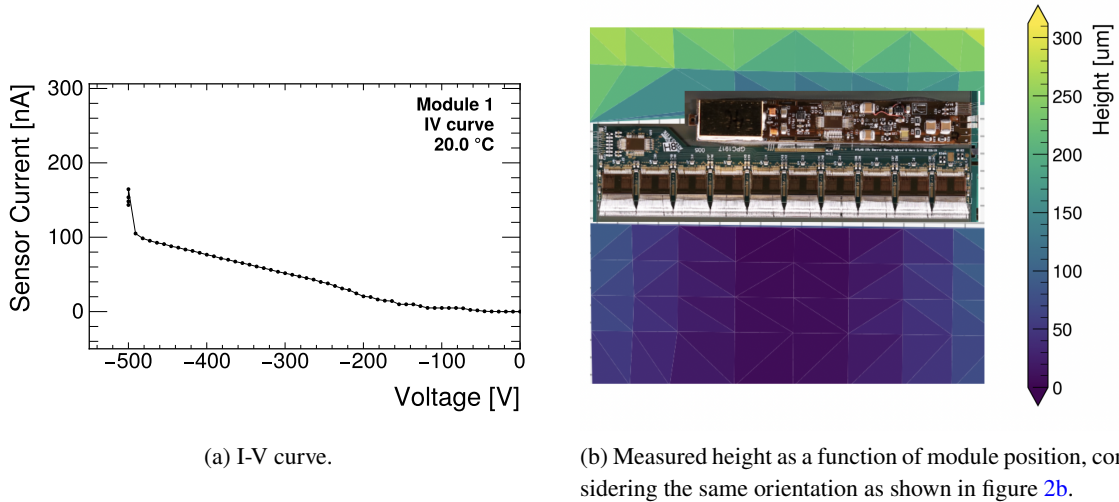
Figure 10: Post-cycling measurements of Module 1.

To further evaluate electrical performance, an I-V curve was taken at room temperature after thermal cycling, and is shown in figure 10a. Around -500V, the module begins to exhibit breakdown-like behavior, indicating it may have failed the nominal module QC which requires no breakdown before reaching -500V. However, this I-V shows signs of "training", as the current around -500V goes down with time as seen during its final three measurements, indicating the observed signs of breakdown may not be permanent. Furthermore, this module exhibits a large operational voltage range before reaching -500V. During operation, a module is expected to experience a convolution of effects from thermal cycling, radiation, and the ATLAS magnetic field. However, if behavior like this is seen during operation, the magnitude of the operating voltage can be decreased to move away from the breakdown region. After testing, this module was discovered to have pinholes. This can potentially explain the irregular step-like shape of the I-V curve.

A post-cycling metrology measurement was also taken, and is shown in figure 10b. Deformations are seen in the module in both the horizontal and vertical planes, and a maximum height of about 300 microns was measured. This exceeds the acceptable metrology specifications, as the corners can be no greater than 150 microns above the center of the module, and no less than 50 microns below the center of the module. This measurement, along with comparisons to shape measurements of modules thermally cycled to warm temperatures of +40°C and +20°C led to the decision to change the thermal cycling warm temperature in the QC procedure to +20°C, where a much less severe shape distortion was observed.

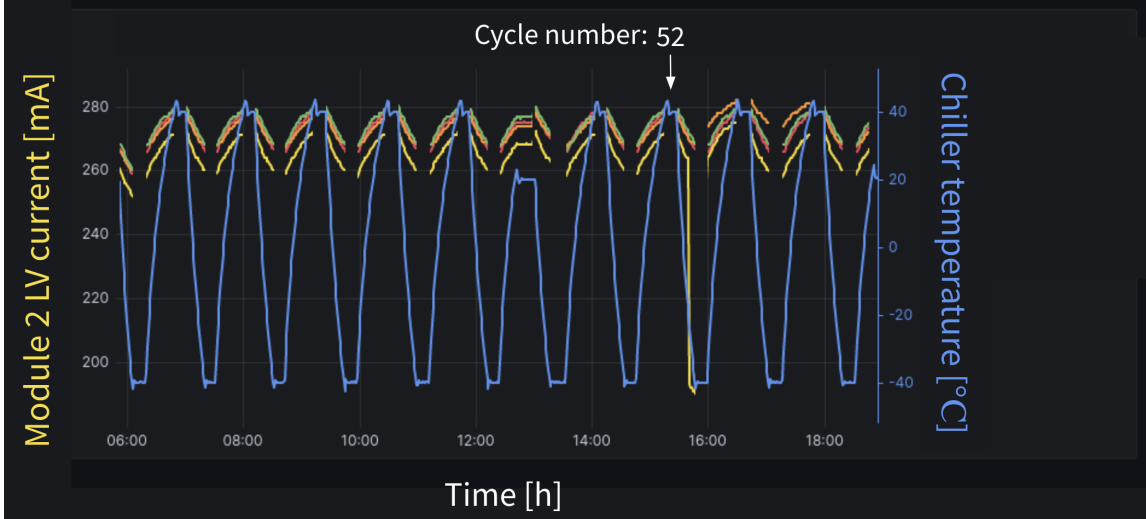
Figure 11: Module 2 LV current from cycles 45 to 54 (in yellow). The LV current for Module 1, Module 3, and Module 4 are shown in red, green, and orange, and stay around the expected value of 280 mA, with changes of about 10 mA due to cooling and warming.

Module 2 was thermally cycled 101 times³ in the coldjig described in section 2. For the first 51 cycles of this module, no significant deviations in sensor noise or current were observed. Starting with the 52nd cycle, intermittent instability was observed in input noise and LV current draw. An example of this is shown in figure 11. This suggests that either the pedestal trim was not properly applied during these tests, or the ASICs were not properly powered.

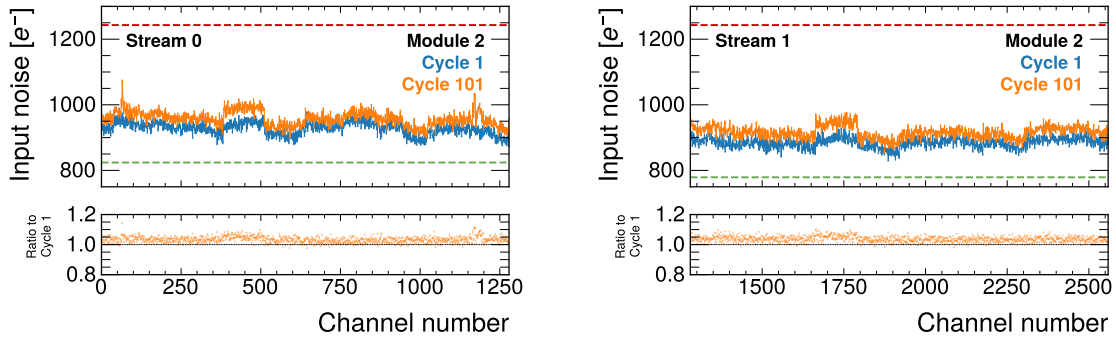
(a) Stream 0: corresponds to strips under the hybrid.

(b) Stream 1: corresponds to strips away from the hybrid.

Figure 12: Comparison of Module 2 noise measured during first and final cold tests for streams 0 and 1.

A comparison of input noise between its first and final cold test is shown in figure 12. While there are a few relatively noisy strips around channels 60 and 1175 (also seen in the output noise results), and there is a roughly constant increase in noise among all strips of this module after thermal cycling, the majority of strips are less than 5% noisier after cycling. As with Module 1, the measured noise is well below the maximum allowed room temperature noise of 1243 ENC. Also similar to Module 1, the measured noise exceeds the target room temperature noise in green, 824 (779) ENC for stream 0 (1), even when measured cold, indicating this module is noisier than expected.

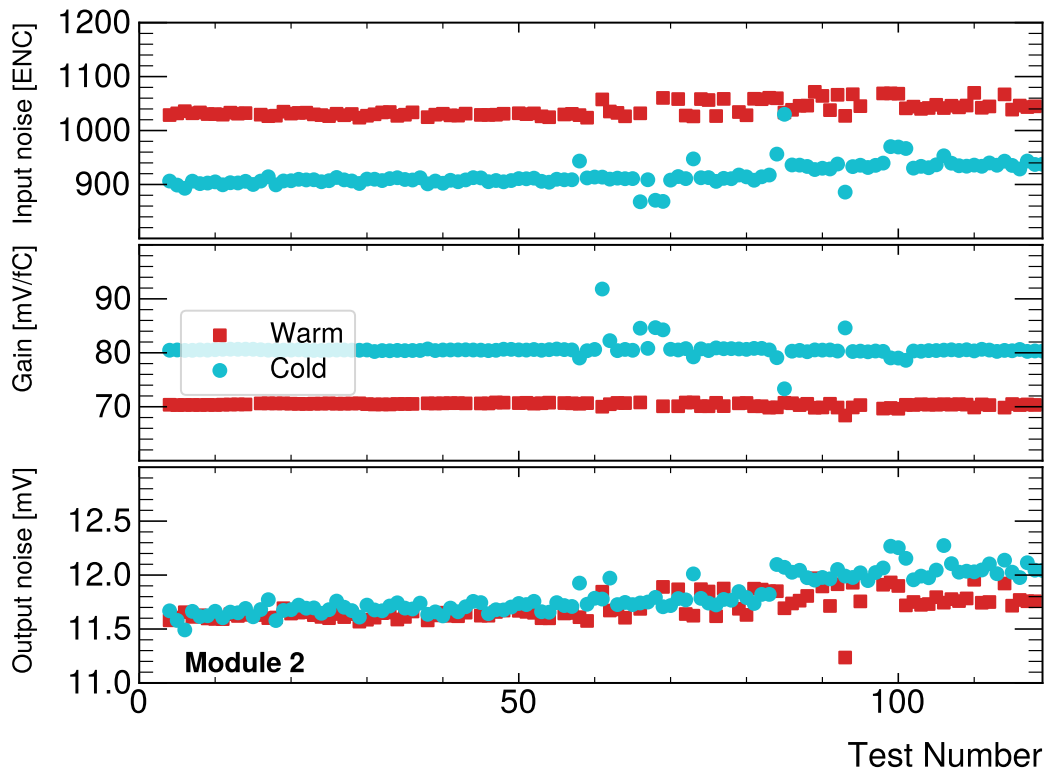
Figure 13: Module 2 input noise, gain, and output noise as a function of test number, separated by warm (Chiller at +40°C) and cold (Chiller at -40°C) tests. Note that there were more tests taken than number of thermal cycles, as sometimes a day of cycling would end on a warm test without completing a cycle, or one day would end with a cold test and the next day would start with a cold test.

Trends of Module 2's input noise, gain, and output noise during warm and cold tests as a function of test number are shown in figure 13. These trends show a slow rise in average input

and output noise vs. test number. While this is non-desirable behavior, noise is still well within specification and 100 cycles is far beyond the expected detector induced stress. Finally, an I-V curve was taken after cycling, and is shown in figure 14a.

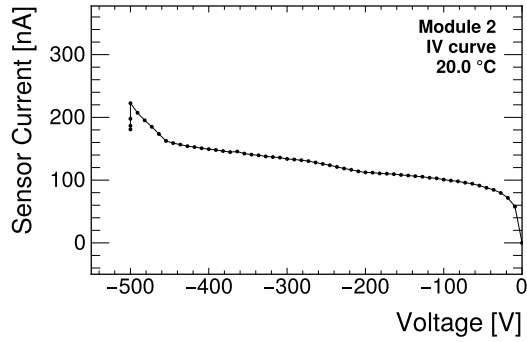
(a) I-V curve.

Figure 14: Post-cycling measurements of Module 2.

Similar to Module 1, this module begins to show increased leakage current as it approaches -500V. It is possible that this module would have failed the nominal QC, as it exhibits breakdown-like behavior before -500V. However, as was the case with Module 1, this I-V shows signs of training indicating its observed signs of breakdown may not be permanent. Also similar to Module 1, it may still be possible to operate this module depending on how the rest of the in-situ effects alter the module's electrical performance.

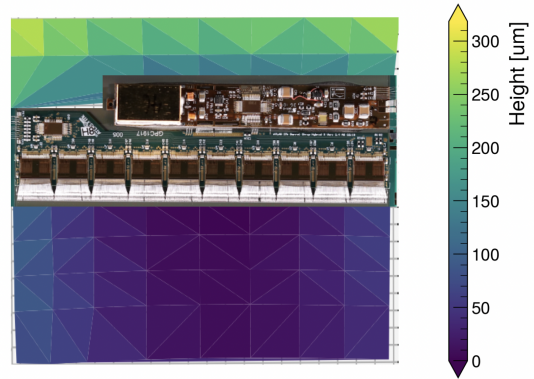
(b) Measured height as a function of module position, considering the same orientation as shown in figure 2b.

A post-cycling metrology measurement was also taken, and is shown in figure 14b. A similar

shape measurement to that of Module 1 is seen.

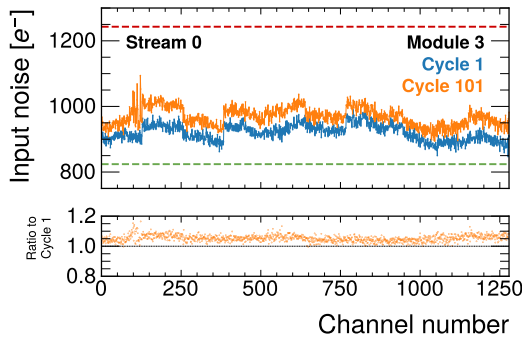
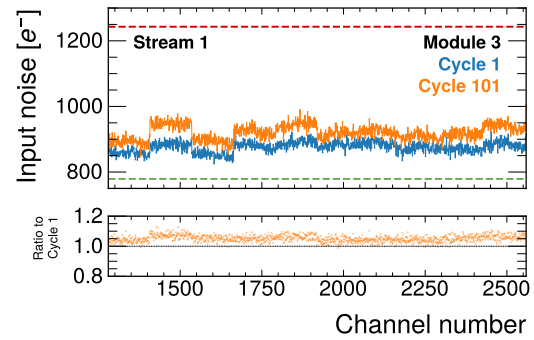
(a) Stream 0: corresponds to strips under the hybrid.

(b) Stream 1: corresponds to strips away from the hybrid.

Figure 15: Comparison of Module 3 noise measured during first and final cold tests for streams 0 and 1.

A comparison of input noise between its first and final cold test is shown in figure 15. Similar behavior is seen to that of Module 2: there are a few relatively noisy areas around channels 100 and 1175, and a roughly constant increase of about 5% in noise among strips after thermal cycling. As with Module 1 and Module 2, the measured noise is well below the maximum allowed room temperature noise of 1243 ENC. Additionally, the measured noise exceeds the target room temperature noise in green, 824 (779) ENC for stream 0 (1), even when measured cold, indicating this module was noisier than expected before any thermal cycling.

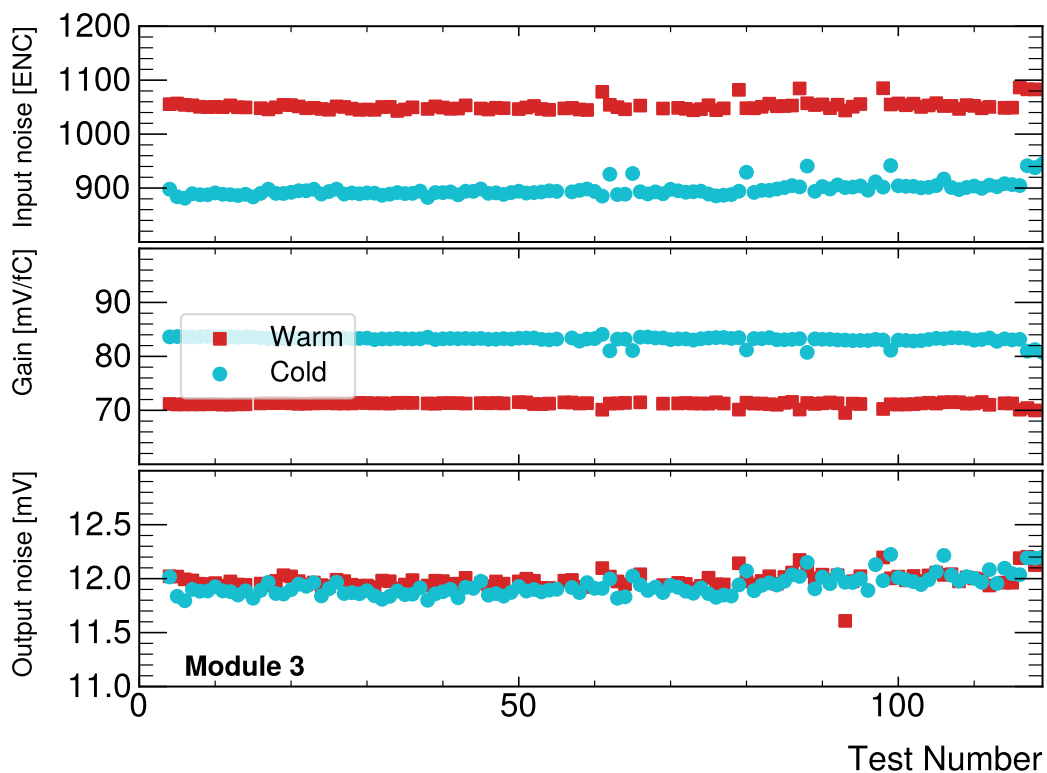
Figure 16: Module 3 input noise, gain, and output noise as a function of test number, separated by warm (Chiller at +40°C) and cold (Chiller at -40°C) tests. Note that there were more tests taken than number of thermal cycles, as sometimes a day of cycling would end on a warm test without completing a cycle, or one day would end with a cold test and the next day would start with a cold test.

Trends of this module's input noise, gain, and output noise during warm and cold tests as a function of test number are in figure 16. Noise is consistently higher on average for warm tests, as expected. Additionally, these trends show a roughly steady increase in average input noise vs. test number, indicating that the module is relatively stable, similar to Module 2.

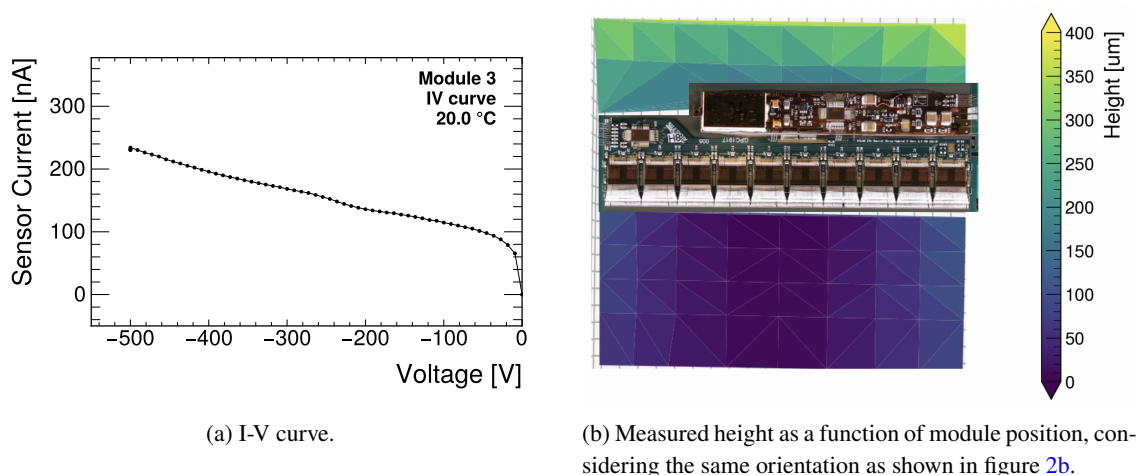
Figure 17: Post-cycling measurements of Module 3.

Finally, an I-V curve was taken after cycling, and is shown in figure 17a. This module does not show any indications of breakdown, and would have passed the I-V step of the nominal module QC.

A post-cycling metrology measurement was also taken, and is shown in figure 14b. A similar shape measurement to that of Module 1 and Module 2 is seen.
