Studies of aging and HV breakdown problems during development and operation of MSGC and GEM detectors for the Inner Tracking System of HERA-B[?]

Abstract

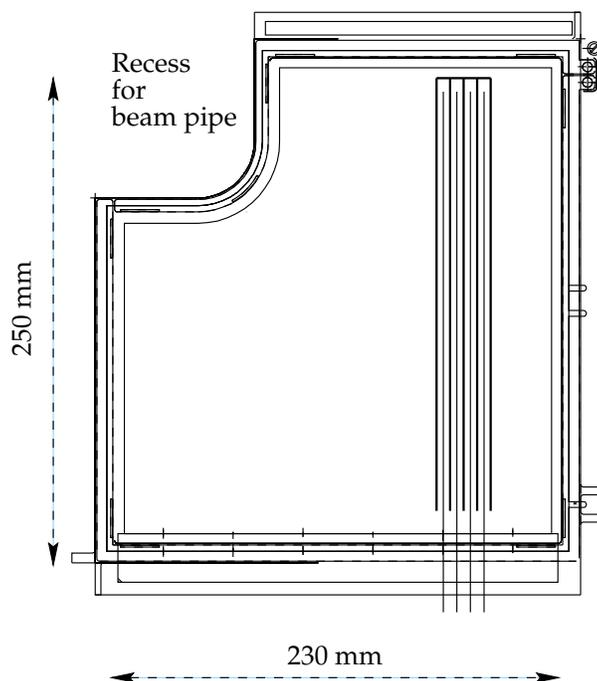
Fig. 1. Sketch of a MSGC chamber indicating size and shape of the wafer.

The interaction rate at the target varied between 3 MHz and 40 MHz. Most of the data were taken at 5 MHz. A typical distribution of the hit density in a detector is shown in Figure 16 for 5 MHz interaction rate. The hit density is about 0.006 per anode and event. The shape of the distribution is determined by the beam recess of the MSGC wafer (see Fig. 1) and the radial decrease of particle density.

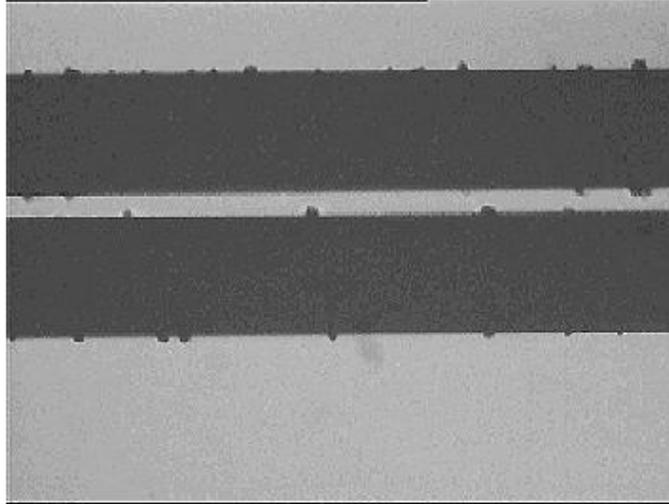
Fig. 2. Photograph of MSGC electrodes after operation of the chamber in a pion beam. Characteristic defects are observed at the electrode borders.

Already the very first day of operation we observed a severe problem which was not encountered in the laboratory. The cathode current showed large spikes, at the same time anodes got lost and sometimes pre-amplifier channels were destroyed. Inspection of the electrode structure in the laboratory under the microscope showed characteristic defects. In the area of the beam spot marks are found on the gold electrodes where the gold is evaporated both from the anode and from the cathode just opposite to each other. A typical photograph is shown in Figure 2. Obviously gas discharges had occurred which sometimes were so intense that they cut an anode strip completely. The lifetime of the chambers in the HERA-B environment with the foreseen technology would have been only months.

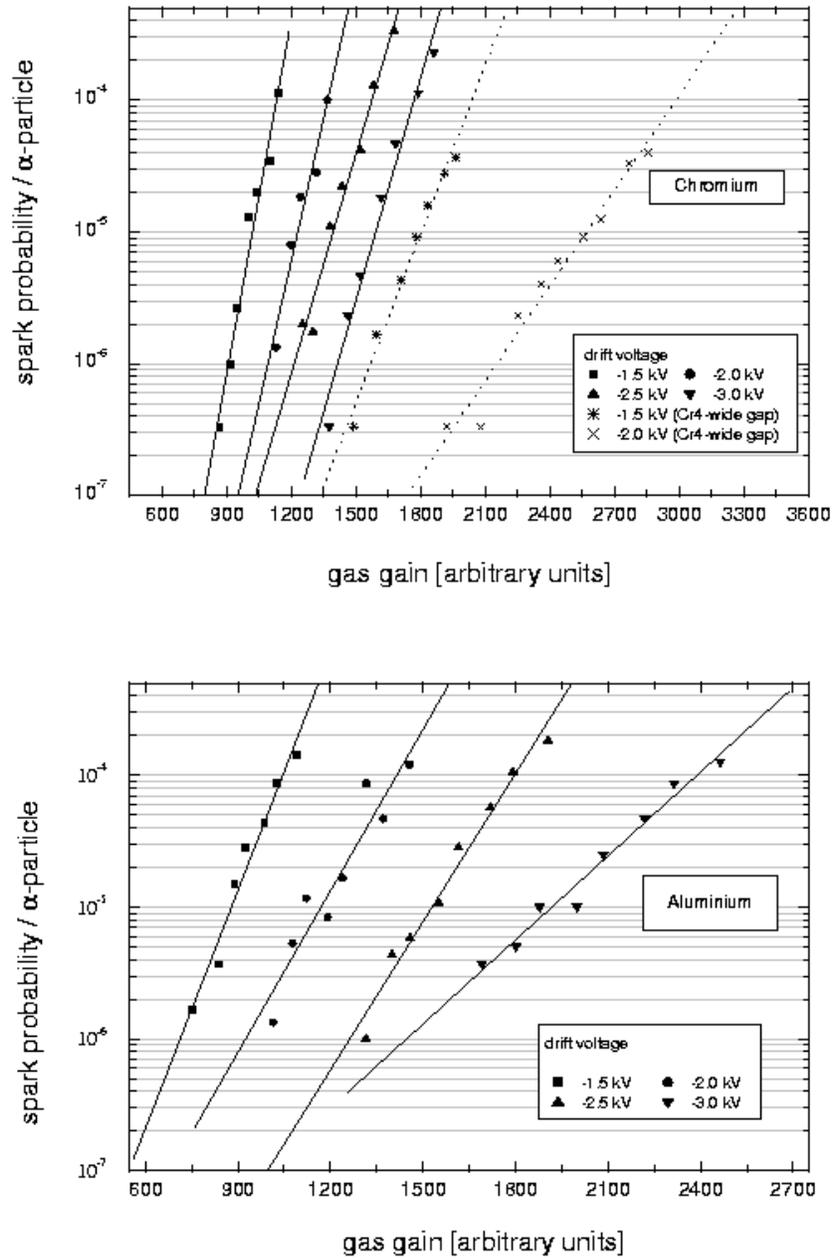
Fig. 3. Spark probability per α particle as a function of the cathode and drift voltages measured with a 0.15 μm chromium and a 1 μm aluminium structure.

A characteristic result from the second method is presented in Figure 3 which shows the spark rate as a function of the cathode and drift voltages measured with a 0.15 μm thick chromium structure and with 1 μm thick aluminum electrodes. We observe a strong exponential rise of the spark rate with the cathode voltage which is responsible for the

field near the surface and a much weaker dependence on the drift voltage. At fixed gas gain, high drift fields are favorable.

The effect of the width of the anode-cathode gap was studied by increasing it by a factor two to 120 μm . At fixed gain the spark rate is smaller (see Figure 3), but this positive effect is more than compensated by the more severe damage per spark observed with the wide gap, where the energy stored in the anode-cathode capacitance is much larger.

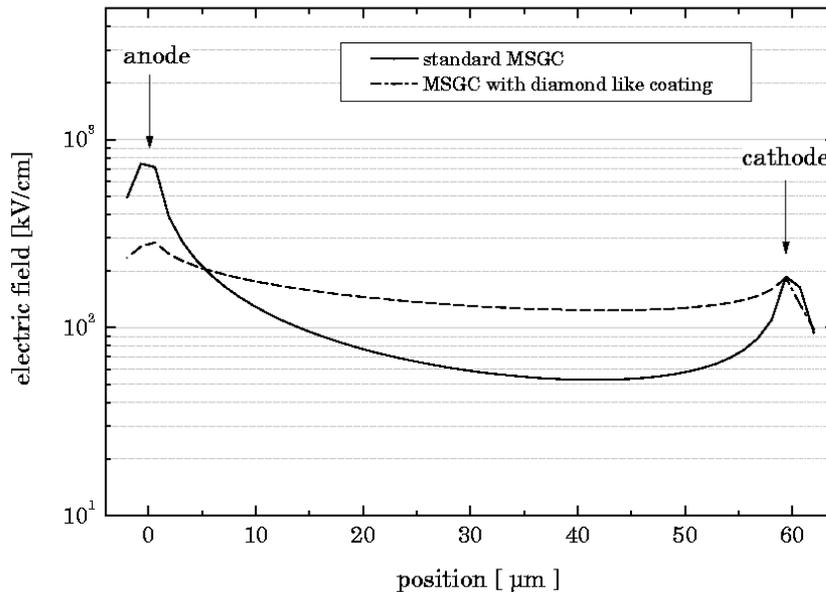
Fig. 4. Simulation of electric eld for coated and uncoated M S G C .

eld component parallel to the surface near the surface, whereas bare glass produces a strongly decreasing eld near the anode, which suppresses streamer discharges [11,12]. The electric elds between the electrodes computed for a coated and an uncoated substrate are shown in Figure 4. Even though dynamical eects from the space charge created by the avalanche are neglected, the simulation illustrates the qualitative di erence between the two con gurations.

The explanation for the reduced sparking threshold for coated wafers was con rmed by experimental evidence that sparks were predom inantly induced by ionization near the surface and is supported by the favorable eect of high drift elds at xed gas gain.

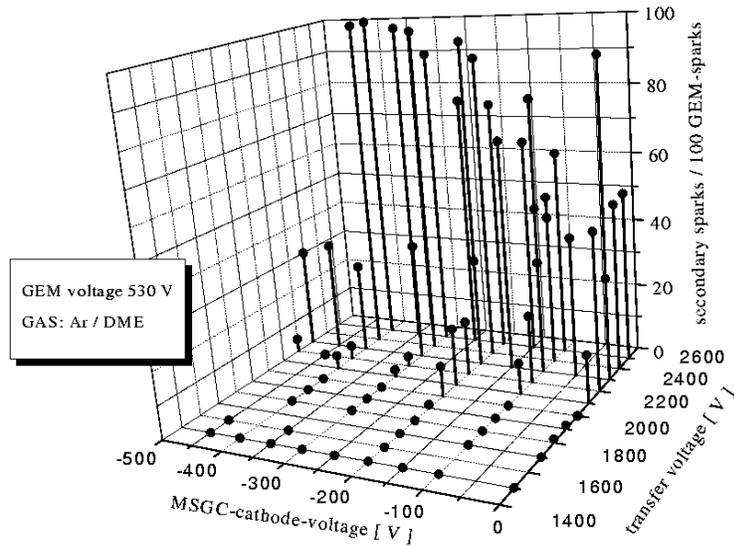
Fig. 8. Spark rate as a function of the cathode voltage and the voltage between GEM and the anodes. A transfer field of 2.5 kV/cm corresponds to

with additional gas amplification there, are likely to produce secondary sparks. Thus the rate of those strongly depends on the strength of the transfer field. This was confirmed by laboratory measurements presented in Figure 8 and it explained also the different behavior of the chambers at the two PSI tests which were performed at slightly different HV settings.

A significant dependence of the secondary spark rate on the cathode voltage has not been observed (see Figure 8).

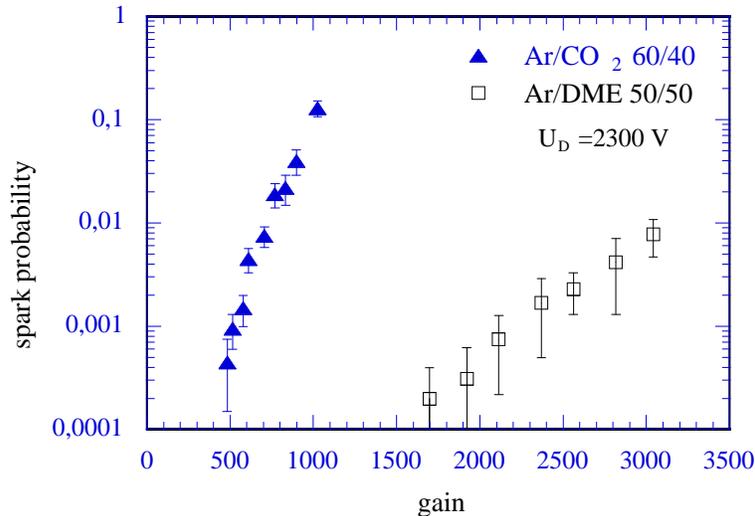
Fig. 9. Discharge rate induced by α -particles in a MSGC versus gas gain (arbitrary units) for two gas mixtures Ar/DME and Ar-CO₂.

Two gas mixtures were systematically studied, Ar+DME 50/50 and Ar+CO₂ 70/30. The DME mixture has better quenching properties hence less problems with gas discharges. It had also been extensively tested with respect to aging properties by several groups, which consistently reported no aging problems up to large charge depositions on the strips corresponding to many years of LHC or HERA-B operation [17]. Compared to Ar+CO₂ 70/30 it also has larger primary ionization, 24 primary electrons in average for a minimum ionizing particle in the 3 mm gas gap for Ar+DME compared to 18 for Ar+CO₂ which has also significantly larger transverse diffusion. However, there are also disadvantages of Ar+DME: The Ar+DME mixture is inflammable and constitutes therefore a safety risk. DME is not commercially available with guaranteed purity. Thus every bottle would have to be checked carefully in aging tests to ensure that the detectors are not polluted. In addition,

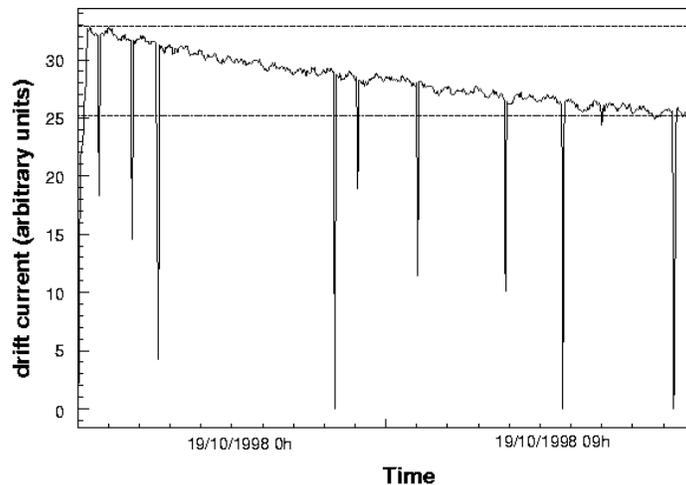
Fig. 10. Drift current (arbitrary units) as measured in the MSGC/GEM detector versus operation time during intense proton irradiation at PSI. The beam current was kept stable during the exposure. The gaps correspond to beam losses.

In autumn 1998 a beam test was carried out at PSI with two full size MSGC/GEM detectors using Ar-DME 50/50 as counting gas. The goal was twofold: during daytime the pion beam was used to study efficiencies, resolution and the performance of our trigger chain. During night time the detectors were exposed to an intense proton beam to accumulate a higher charge dose. The beam spot had a Gaussian profile with a typical full width at half maximum of 5 cm. Within few days a total accumulated charge of 2 mC/cm was reached in the center region. We observed a rather fast reduction of the drift current during proton irradiation for constant beam current. This was even seen online as shown in Figure 10 for a 12 hour period of proton running at maximal intensity (about 20 times HERA-B charge deposition rate). The detectors were subsequently investigated in the laboratory. Within the illuminated area the detectors still showed acceptable gas gain but outside the illuminated area they did not count at all. Optical inspection showed severe deposits on those anodes which were connected to ground and therefore experienced the nominal electrical field. Disconnected anodes showed no deposits. Deposits were found both in the irradiated area and over the rest of the detector. Parts of an irradiated wafer were sent to the Fraunhofer Institut für Schicht- und Oberflächentechnik which carried out a surface analysis shown in Figure 11. The anodes in the irradiated area were covered by a layer of 80 nm pure carbon. A picture of these deposits as seen with an electron microscope is shown in Figure 12. The areas outside, which were not irradiated were covered by an insulating layer of about 35 nm composed of hydrogen and carbon.

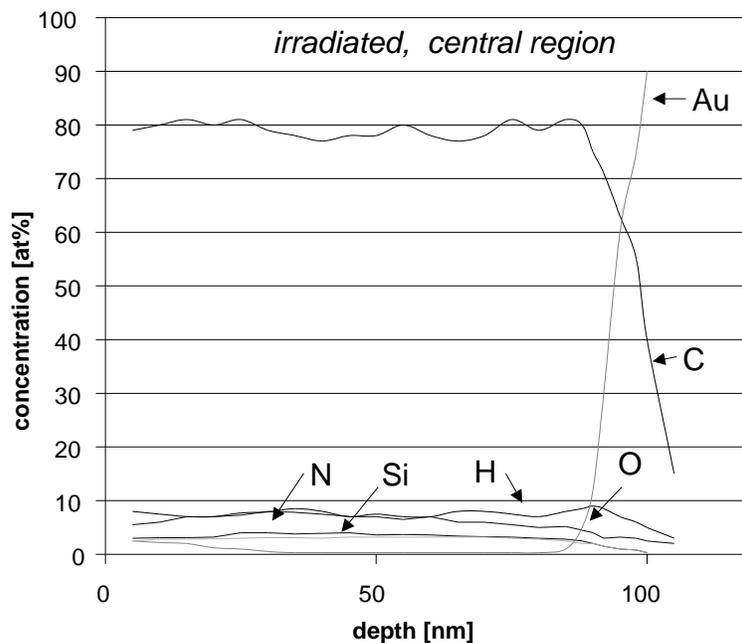
Fig. 11. Concentration of elements as a function of depth for the anode area in the irradiated region. A layer of carbon of 80 nm thickness is covering the gold surface.

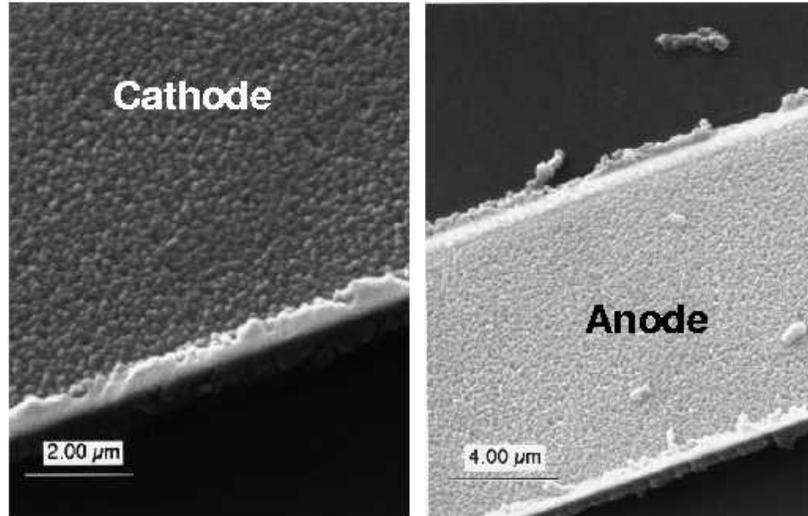
Fig. 12. Photograph (electron microscope) of anodes in the irradiated area of the MSGC after beam test at PSI.

Apparently, irradiation of a large area with Ar-DMG as a counting gas leads to fast aging and visible deposits on the anodes. These deposits are not limited to the irradiated area.

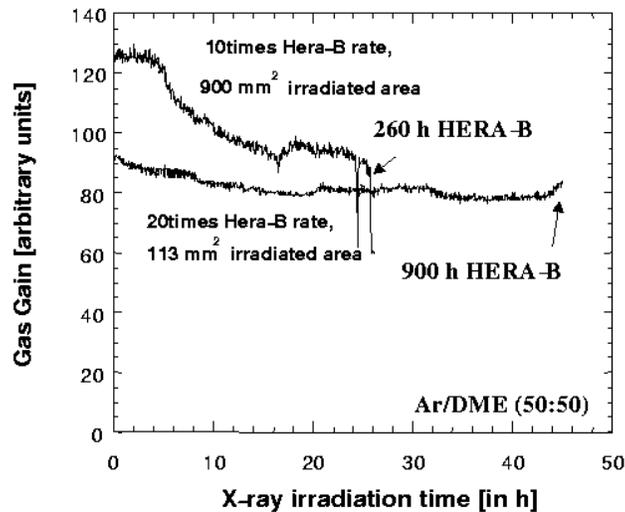
Fig. 13. Gas gain versus irradiation time for a MSGC/GEM detector using Ar-DME 50/50 and two different sizes of the irradiated area. The detector was irradiated with X-rays using a charge deposition rate corresponding to 10 respectively 20 times the maximal rate expected at HERA-B.

This unexpected result prompted a series of new laboratory aging tests. The final outcome is very surprising. The Ar-DMG gas mixture shows gas aging under X-ray irradiation if the area which is irradiated is large enough. This fact is illustrated in Figure 13 which shows the gas gain versus irradiation time for a collimator with an area of 113 m^2 as used before compared to one with an area of 900 m^2 . The large area was irradiated at half the local intensity of the smaller one. Identical chambers operated with Ar-CO₂ show no aging independent of the size of the irradiation area.

We therefore have to draw the conclusion that gas aging effects depend strongly on the size of the irradiated area. All evidence supports the assumption that the origin of these deposits is the DME itself. We have no explanation for this experimental fact but it invalidates all aging tests done before.

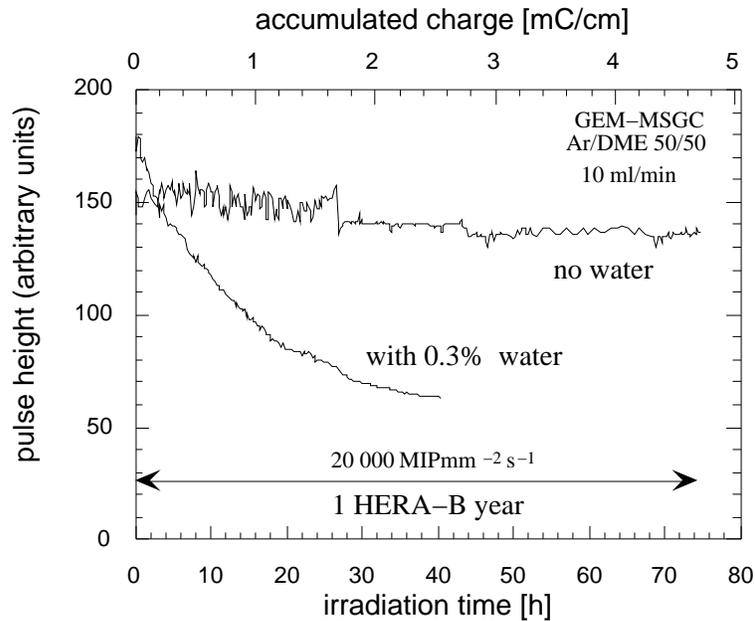
Fig. 14. Development of the pulse height for a gas mixture of Ar-DME with 0.3% of water and without water as function of the irradiation time.

The operation characteristics of a MSGC can be significantly improved by adding small amounts of water, typically 0.3%, to the counting gas. This avoids discharges near insulators e.g. near the detector frames and anode ends and improves the overall protection against sparking, probably by reducing the surface resistivity of plastic materials which tend to absorb water. Addition of water to the counting gas shows however very severe and fast gas aging for both, Ar-DME and Ar-CO₂. This is shown in Figure 14 which compares the pulse height as a function of accumulated charge for Ar-DME with and without an admixture of water. For the gas with water admixture the pulse height drops by a factor three for an accumulated charge of less than 3 mC/cm. Moreover the anodes show deposits in the irradiated area.

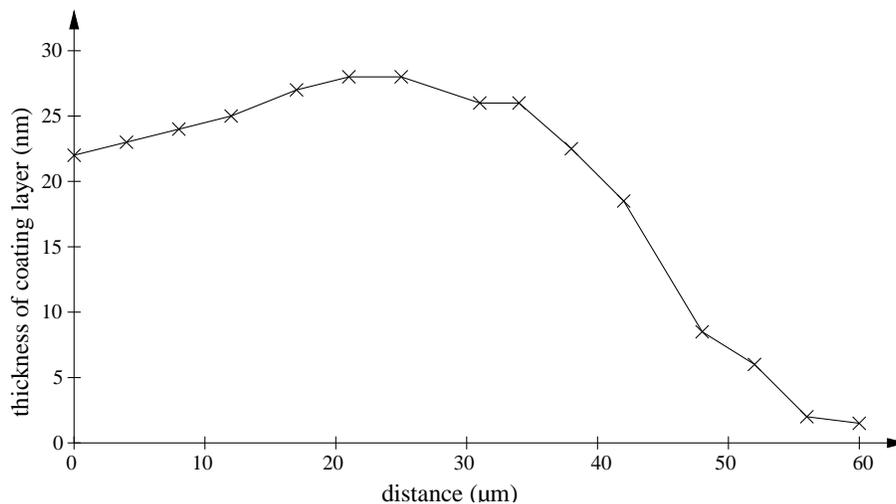
Fig. 15. Thickness of the coating layer across the cathode anode gap after strong irradiation. The anode starts at 60 μm.

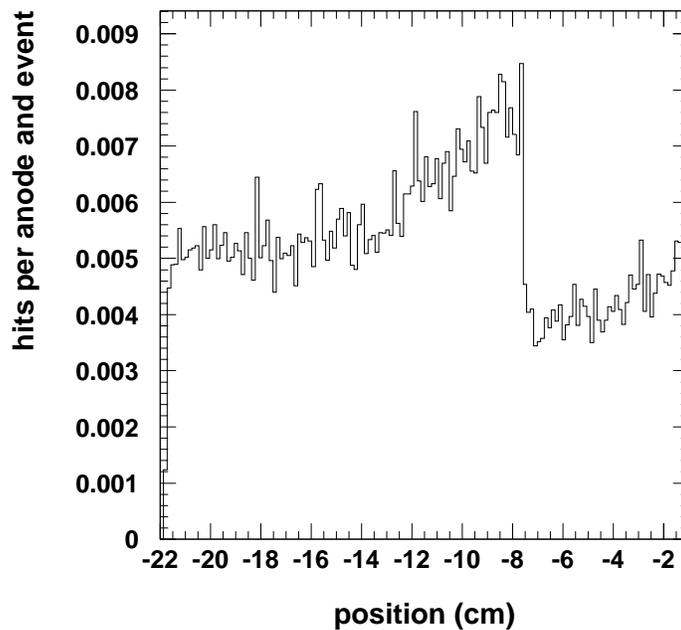
Fig. 16. Hit density as a function of the horizontal distance to the beam axis.

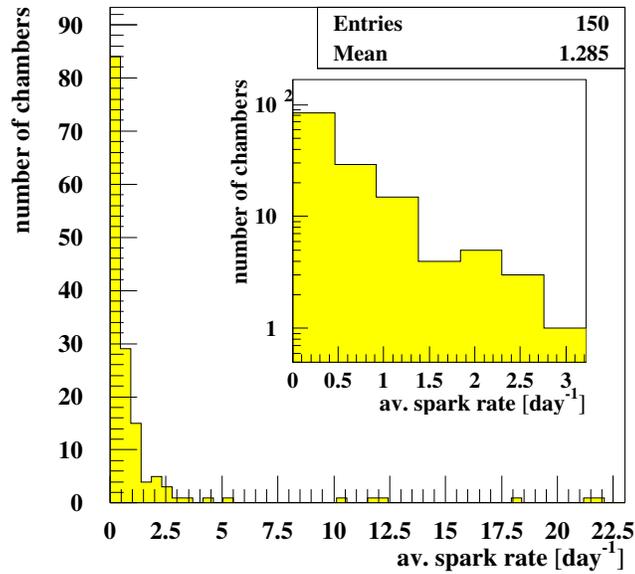
Fig. 17. Number of chambers as a function of their average spark rate. Most chambers show rates below two sparks per day at an average target rate of 5 MHz.

Sparking in GEMs cannot be avoided completely, but under normal conditions the rate is quite low, of the order of a single spark per day (see Figure 17), a rate which is tolerable. Only six chambers showed sparking at rates above ten per day.

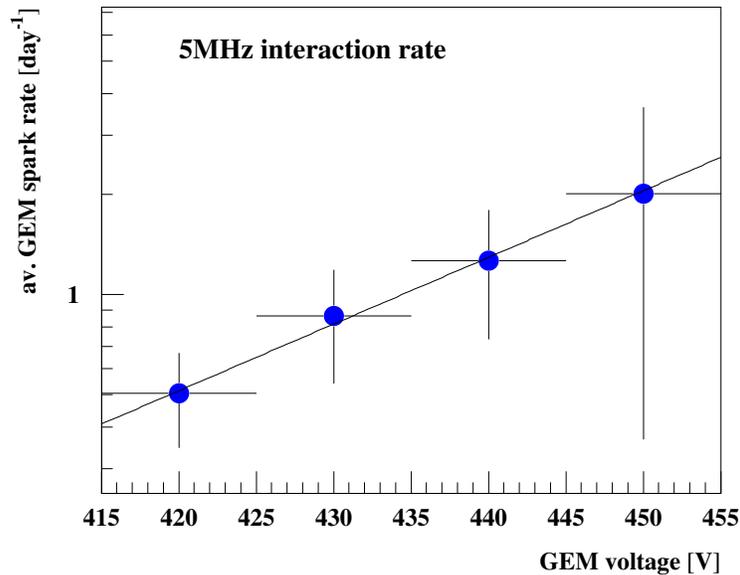
Fig. 18. Spark rate versus GEM voltage averaged over all chambers with rates below six per day. The error bars include systematic uncertainties.

The spark rate increases exponentially with the GEM voltage rising from 1 to 5 sparks/day when the GEM voltage is increased from 400 V to 450 V. This is shown in Figure 18 for chambers behaving normally. Chambers with exceptional high rates are excluded in this Figure to avoid a biased picture. As expected, the sparking rates increased with the beam intensity. Similar results have been reported in Refs. [20,21] where a linear dependence of the sparking probability on the beam intensity and a strong dependence on the beam composition has been observed.

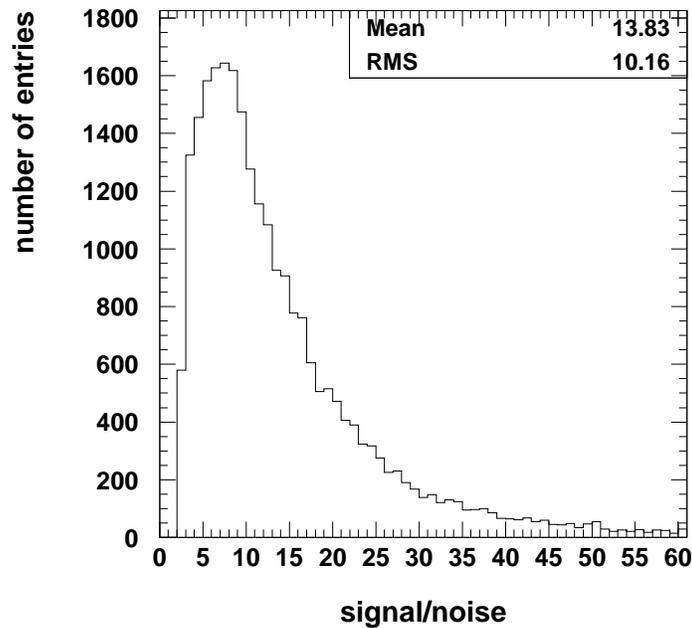
Fig. 19. Signal over noise distribution.

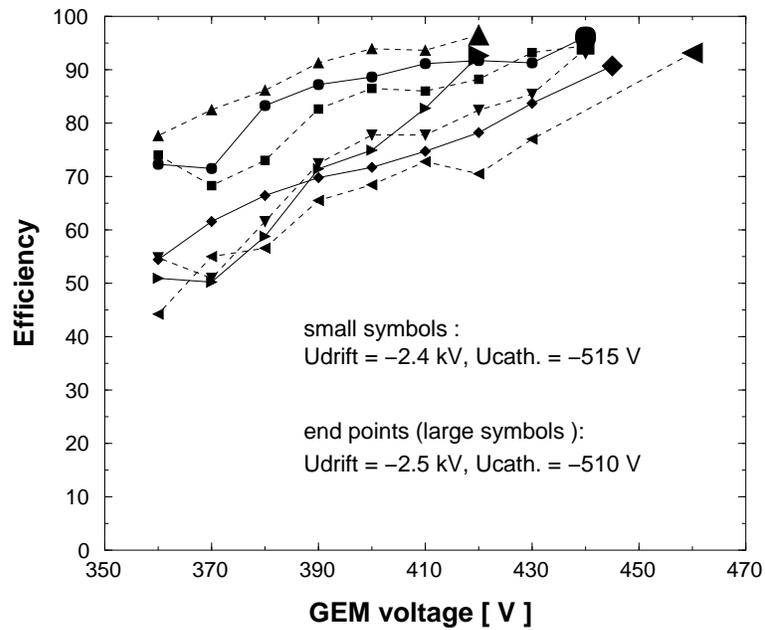
Fig. 20. Efficiency of seven detectors of station M S01 versus GEM voltage for fixed cathode and drift voltages. The large symbols show the efficiencies for the current voltage settings after individual gain adjustments.

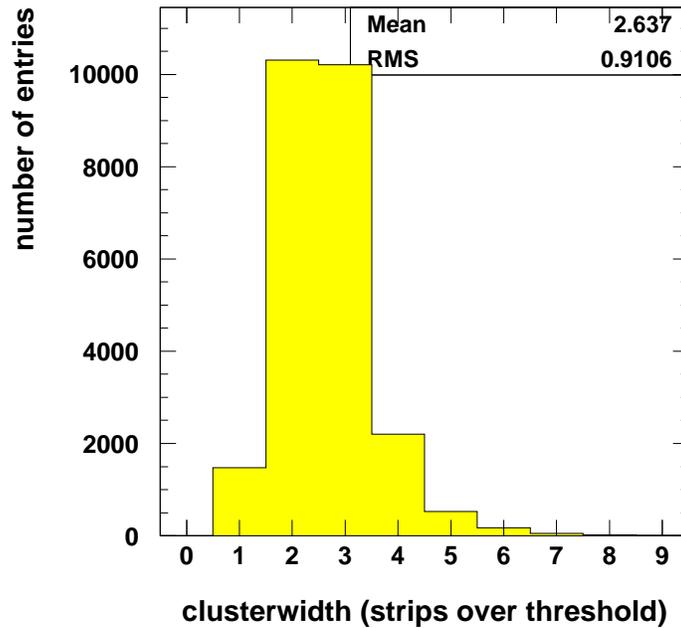
Fig. 21. Distribution of cluster width.

The strip multiplicity distribution shown in Figure 21 corresponds to a mean value of 2.6 for a threshold of 5000 electrons, which is twice the average noise level. This rather high value is compatible with the large transverse diffusion in Ar-CO₂ along the long drift path of the electrons.

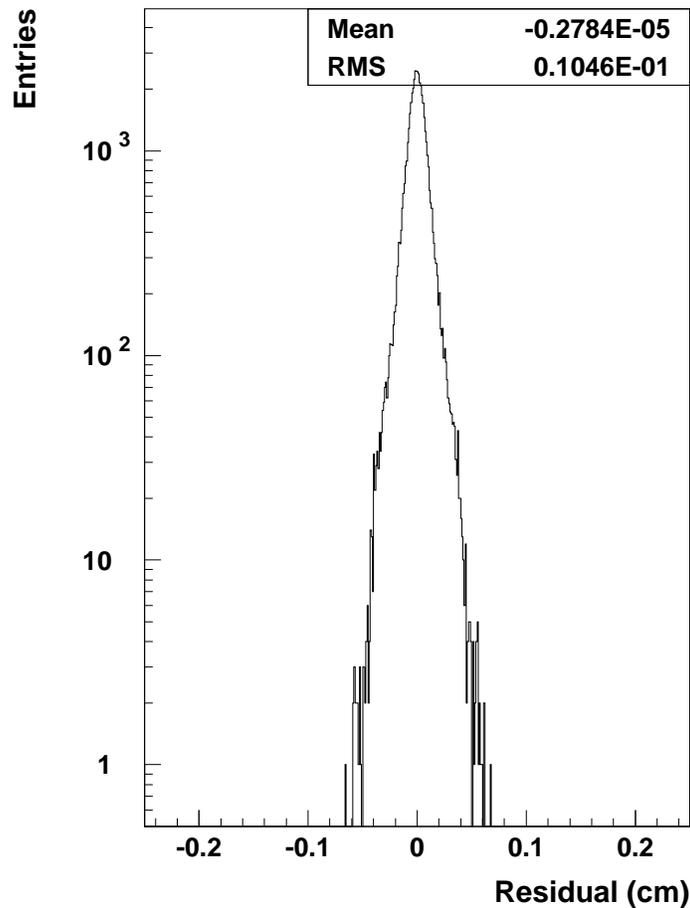
Fig. 22. Distribution of track residuals.

The ITR chambers have been geometrically aligned using an iterative fitting method. A residual distribution for fitted tracks of particles with momenta between 35 and 50

GeV/c is presented in Figure 22. In average 15 chambers contribute to one track. From a comparison of the observed root mean error of $105 \text{ } \mu\text{m}$ with a Monte Carlo simulation we conclude that the intrinsic spatial resolution of the detectors is better than $110 \text{ } \mu\text{m}$.
