# Tensile material properties of human rib cortical bone under quasi-static and dynamic failure loading and influence of the bone microstructure on failure characteristics

## Abstract

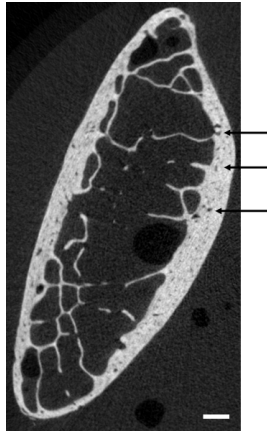
Figure 1: Cross-section of the left 6<sup>th</sup> from the antero-lateral aspect, from micro-computed tomography. The arrows indicate voids. The bar scale is 1 mm long.

The ribs were first cut into five 60-mm long pieces named A (most anterior piece) to E (most posterior piece). Isotropic images similar to figure 1 were obtained with a micro-computed tomograph (Scanco Medical Viva CT40, Brüttisellen, Switzerland) at a resolution of 30  $\mu\text{m}$ /pixel and used to determine where the bone coupons could be machined based on the curvature and the thickness of the cortical shell (Figure 2-a). Next, the periosteum was removed, and the sample was shortened with a small abrasive band saw equipped with a diamond blade (Diamond bone band saw, Mar-med

(figure 1): the cortical shell in the rib has pores, and the transition from the cortical to the trabecular bone can be somewhat blurred. Rather than using a two-part model for bone, a gradient approach may prove more accurate to predict the actual deformation modes and fracture locations under dynamic loading. Rib bone material properties need to be refined to include a more precise model for fracture prediction, such as stress concentration caused by the presence of pores or by the connection between the trabeculae and the cortical shell. Micromechanics approaches such as the cohesive zone models (Subit et al., 2009) would be worth evaluating as they can predict the onset of a crack based on the local microstructure.

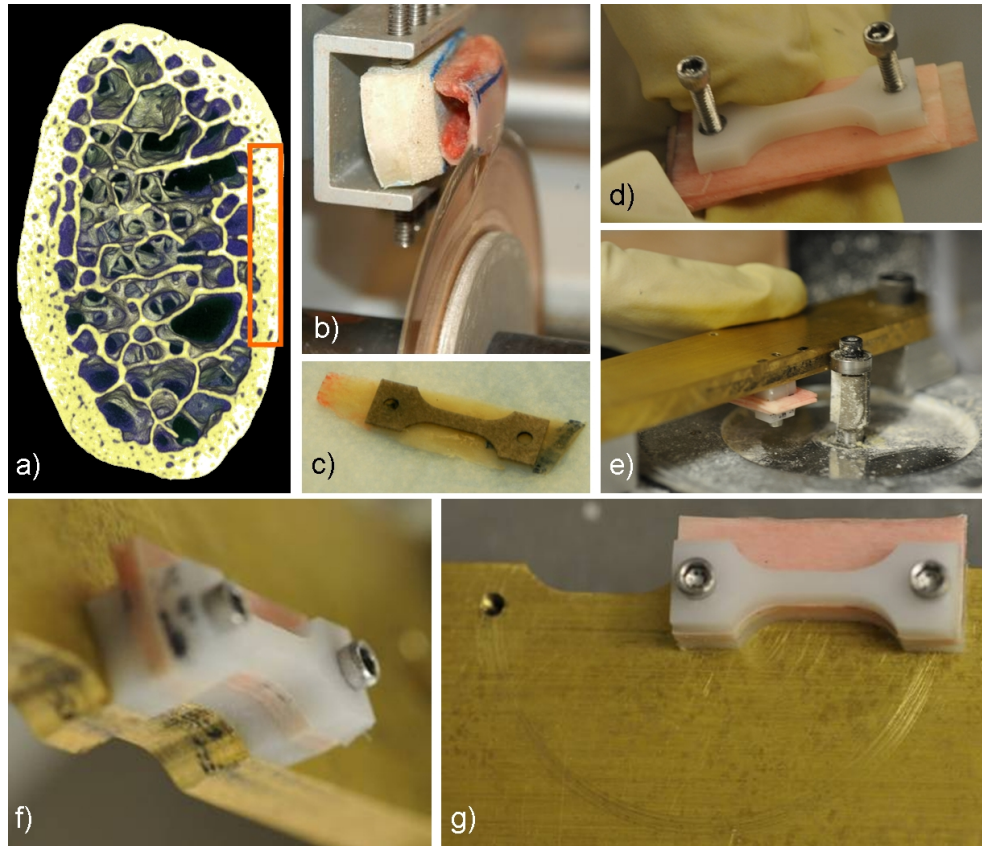
Figure 2: Machining of bone coupons.

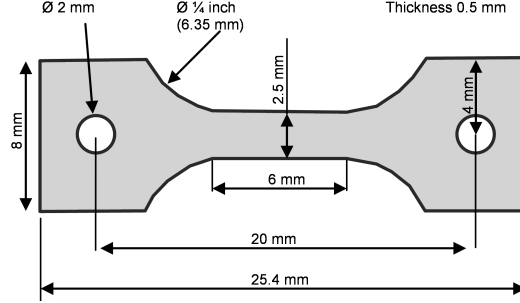
Figure 3: Dimensions of the bone coupons. The 2 holes are used only for references for machining and testing, and do not carry any load.

inc., Cleveland, OH, USA). The next cuts were performed with a low speed diamond saw (IsoMet low speed saw, Buehler Ltd, Lake Bluff, IL, USA, equipped with a 15HC Diamond blade) that can execute parallel cuts with micrometric accuracy. The sample was glued to a piece of hard foam that was then clamped in the sample holder in the desired orientation thanks to screws with spear tips (Figure 2-b). This step was critical in the machining process: the orientation of the bone slab had to be adjusted so that the cut performed with the low speed diamond saw would be entirely in the cortical shell. A first cut was made to generate the outermost flat surface. From there, an other cut was made parallel to the first one to create a flat piece of cortical bone (referred to as wafer) that was 0.5 mm thick (Figure 2-c). Next the two holes used to reference the position of the bone coupon (figure 3) were drilled in the wafer.

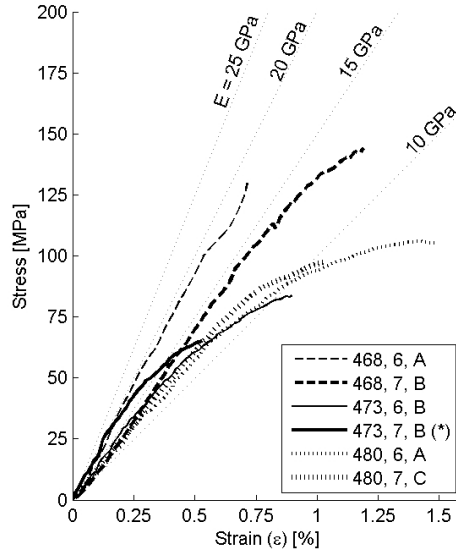
Figure 7: Strain-stress curves for the quasi-static tests. \*: sample fractured in the clamp.

Strain-stress curves were plotted for all the quasi-static tests (figure 7). The material properties were determined by assuming a linear elastic model between 0 and 0.5 % of tensile strain (table 3). Young's modulus ranged from 11.4 to 18.5 GPa, failure stress from 83.4 to 143.9 MPa, and failure strain from 0.71 to 1.49 % in quasi-static, and failure stress ranged from 94.7 to 155.9 MPa in dynamic.

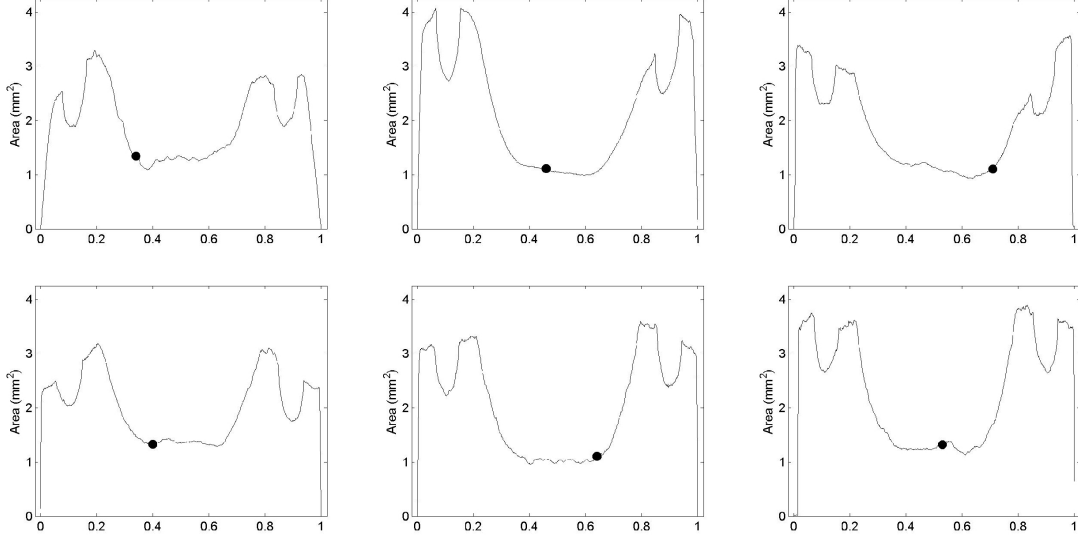
Figure 8: Variation of the cross-section (quasi-static tests). The fracture location is indicated by the dot. Zero is the anterior end of the coupon, and one is its posterior end.

The coupons machined in the human cortical bone are heterogeneous (Appendix A), and the actual cross-sections (determined by taking into account the presence of the voids) were smaller than the target of  $1.25 \text{ mm}^2$  (figures 8 and 9). When compared to the material parameters determined for the human femur (table 4), rib bone exhibits a lower Young's modulus, but the failure stress and failure strain are in the same range. Although the strains were not measured using the same methods for all these studies (extensometer or non contact optical measurements), it makes sense that the effective modulus appears smaller for the rib bones. The voids in the rib bone microstructure are not accounted for in the measurement of the cross-sectional area as the coupon cross-section is assumed to be rectangular and its area is approximated by measuring its thickness and width. With the femur cortical bone being denser than the rib cortical bone, coupons made of femur bone or rib bone with the same external dimensions would appear to have the same cross-sectional area, whereas the actual cross-section of the rib bone coupon will be smaller because of the voids.

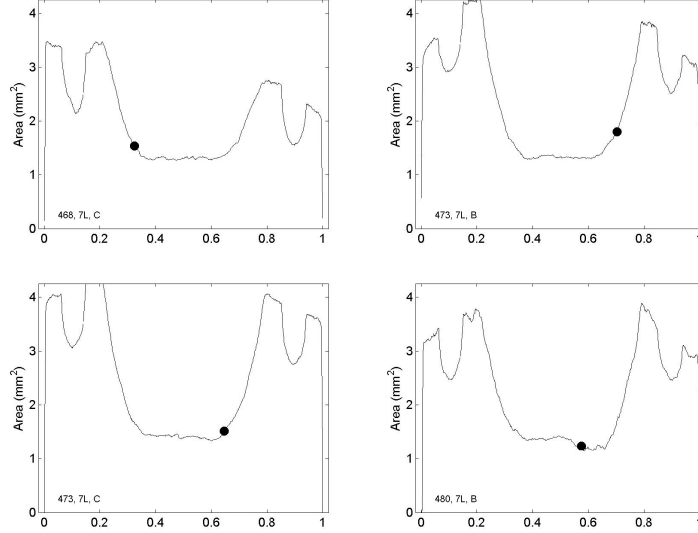
Figure 9: Variation of the cross-section (dynamic tests). The fracture location is indicated by the dot. Zero is the anterior end of the coupon, and 1 is its posterior end.

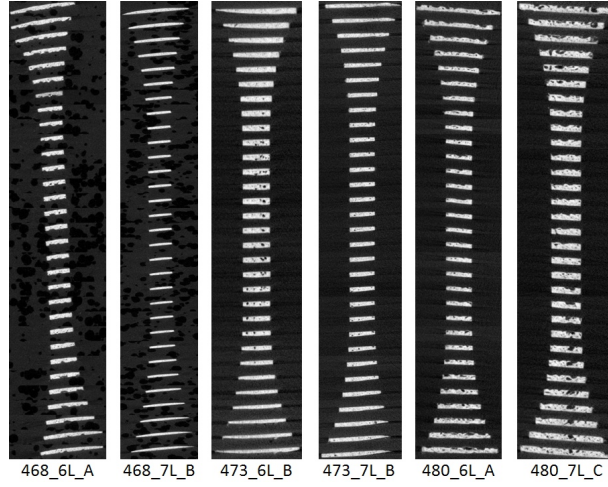
Figure A.10: Images of the cross-section obtained from micro-computed tomography (coupons tested under quasi-static loading). Only one every ten images is included.

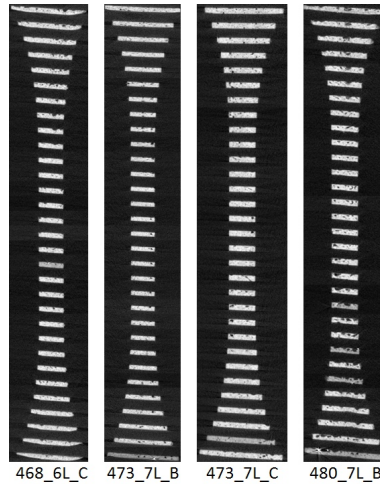
Figure A.11: Images of the cross-section obtained from micro-computed tomography (coupons tested under dynamic loading). Only one every ten images is included.
