Camera Gap Removal in SOLIS/VSM Images

Andrew R. Marble, Lorraine Callahan & Alexei A. Pevtsov

National Solar Observatory

October 14, 2013

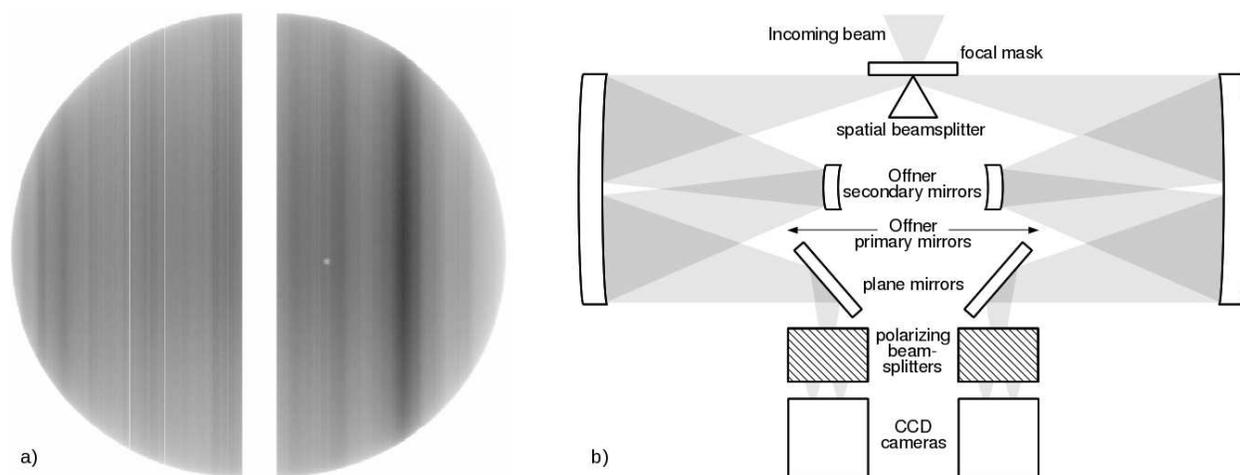
Figure 1 – (a) Level-1 6302L intensity image (without flat-field corrections) exhibiting the gap. (b) Schematic of the reimaging system within the VSM on SOLIS.

Initial images made with the Vector Spectromagnetograph (VSM) instrument on the Synoptic Optical Long-term Investigations of the Sun (SOLIS) telescope include a gap between the eastern and western hemispheres of the Sun (see Figure 1a). This gap corresponds to a physical separation in the focal plane of two halves of the solar disk image, where the width is determined by the positions of the cameras and optical train elements beyond the beamsplitter. As illustrated in Figure 1b, the (already dispersed) beam is spatially split into halves that are imaged onto two CCD cameras. To ensure no image loss, the cameras are illuminated such that there is a buffer on the order of tens of pixels between the spatially split edge of the beams and the corresponding end of the cameras. Thus, a gap devoid of illumination is present in the center of each row (Figure 2a) constructed by juxtaposing the camera images for each scan-line during Level 0-1 processing.

Cursory inspection of the gap profile seen in flats shows that the position and width of the gap are not constant, but rather change both from day-to-day and throughout the day (due to various effects that likely include flexure and thermal expansion in the optical train beyond the beamsplitter; see Figure 1b). As an example, these two properties of the gap were measured (using a fiducial definition of the gap as where the normalized intensity falls below 50%) and plotted in Figure 2 for a day with an unusually large number of flats. Not only is the position of the gap shown to shift by four pixels throughout that particular day, but the width varied by more than twice as much during the afternoon hours (approximately three pixels an hour).

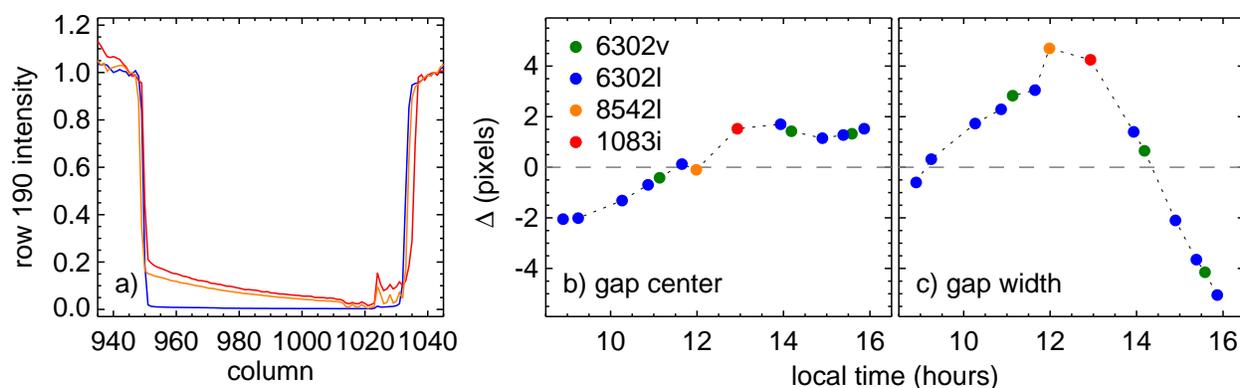
Figure 2 – Examples of the gap profile (a) from three flats taken on February 23, 2011 (separately normalized on both the left and right sides of the gap) and changes in the gap center (b) and width (c) from additional flats taken throughout the same day.

Using the *central* row of the intensity image to characterize the gap further mitigates the significant time elapsed between the start and end of an observation. Based on Figure 2, the gap center/width shouldn't change by more than a half/whole pixel during the 20 minute interval between observing the disk center and either pole for 8542L (the longest observation). There have been undocumented references to gaps with tilts somewhat larger than this; however, casual inspection of the gap profile can be misleading due to lack of reliable flat-fielding within the gap (where the cameras are not illuminated well or at all) and careful analysis is hindered by the fact that the Level 0-1 pipeline previously replaced pixels *thought* to be well within the gap with zeroes. In a few instances where this study uncovered gaps seemingly tilted on one side by as much as a pixel, it was found that the width was changing (rather than the gap center), due in turn to changes in the slope of the gap profile edges. Scattered light as a function of the Sun's orientation with respect to the slit may have been a contributing factor.

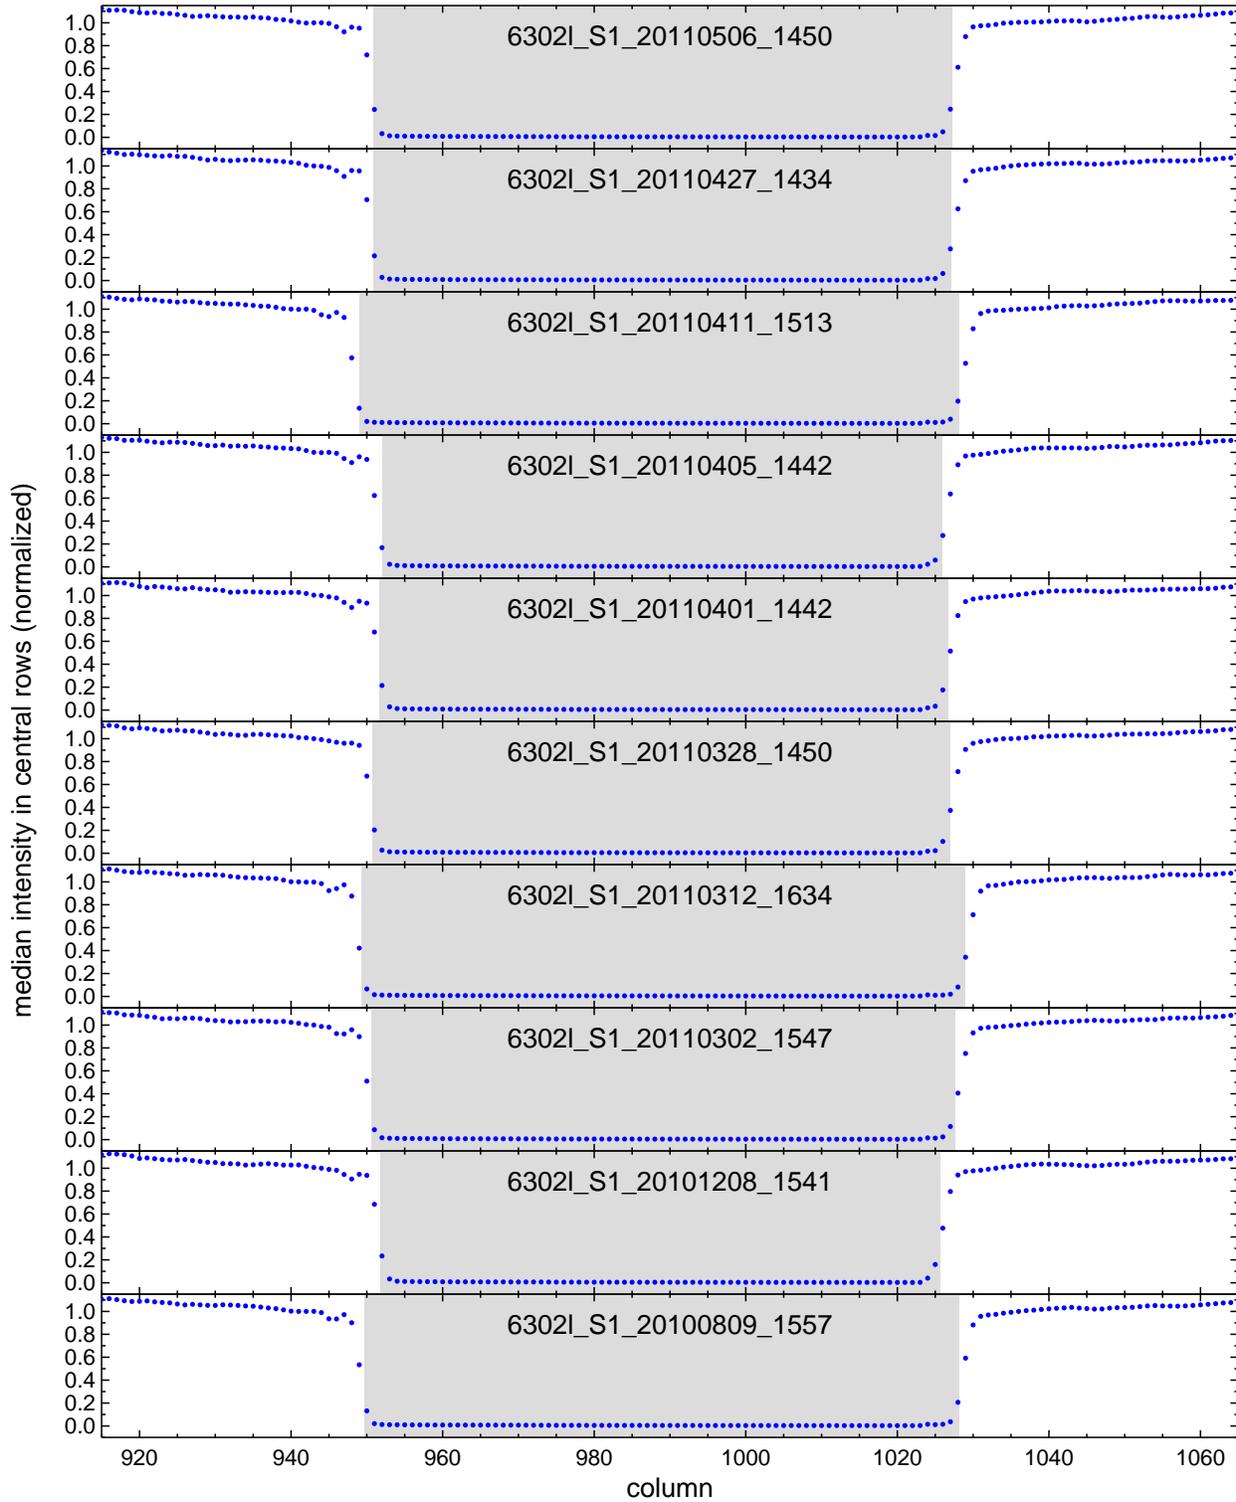
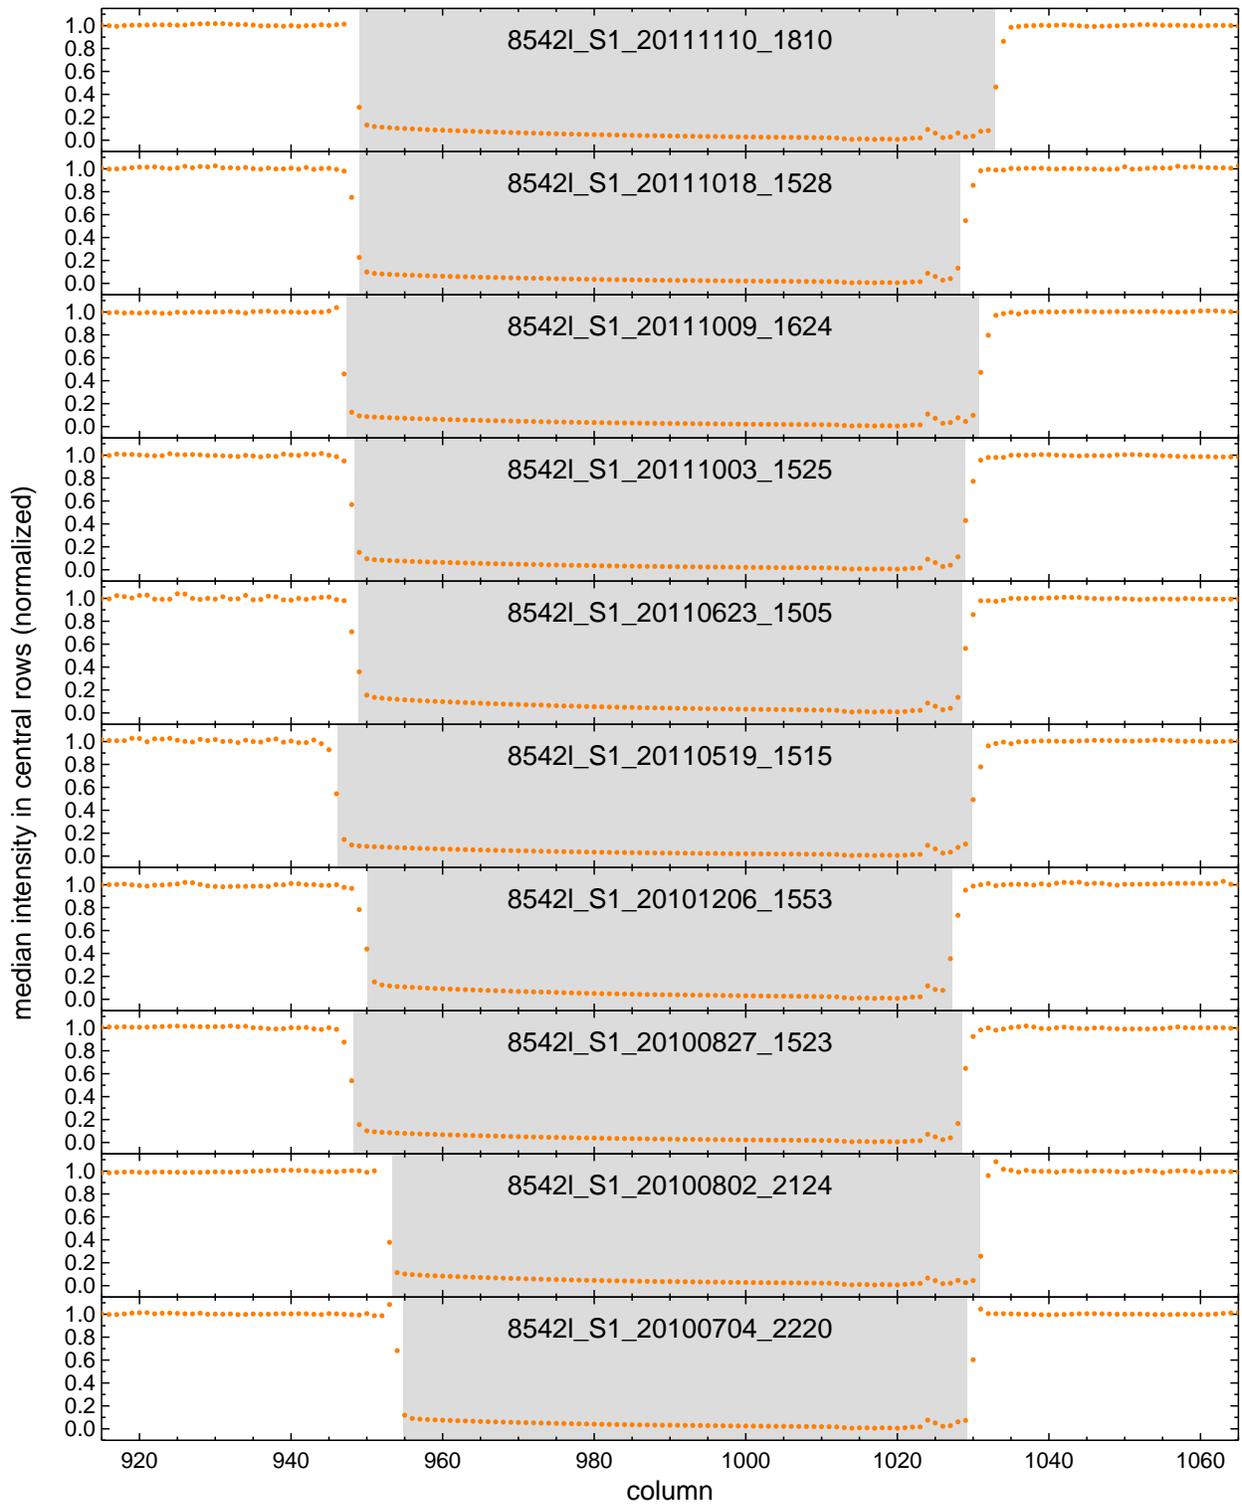
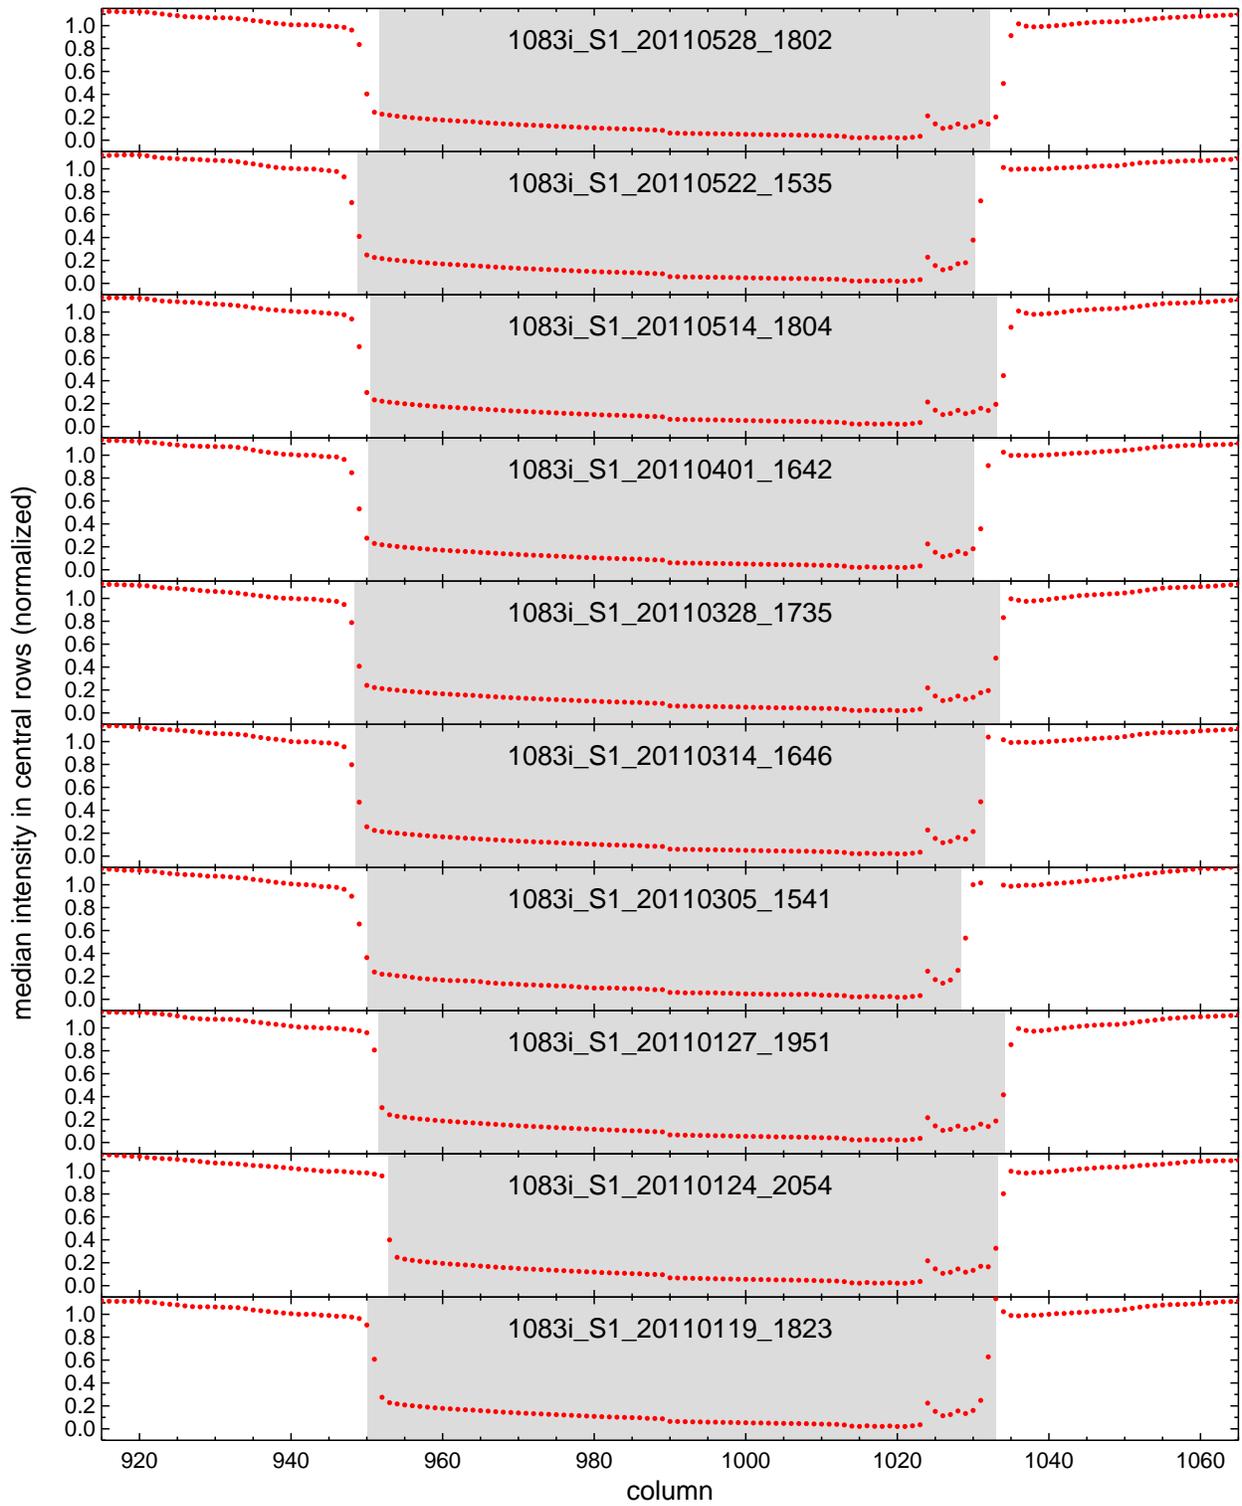
Figure 3 – Taken from the un-flat-fielded intensity images, these gap profiles are the median of the 20 most central rows normalized (separately to the left and right of column 990) by the median of the intensities within 3-13 pixels of the gap. The independently measured gap widths listed in Table 1 are indicated by the shaded regions that have been centered on each gap profile.

Figure 3 shows the central row gap profiles for the thirty observations with independently measured gap widths. These profiles come from un-flat-fielded intensity images produced specifically for this analysis. Flat-fielding is not valid inside the gap and results in computationally distorted profiles due to division of very small numbers by other very small numbers. Each undistorted gap profile is the median of the twenty most central rows, normalized separately to the left and the right of column 990 by the median of 10 columns just outside of the gap. The edges of the shaded regions corresponding to the gap width measurements in Table 1 similarly intersect the profiles near 50% of the fully-illuminated intensity (there is greater variance for the 1083I images due to less certain gap width measurements related to decreased contrast and worse seeing in both the infrared VSM observations and the corresponding ground-based reference images).

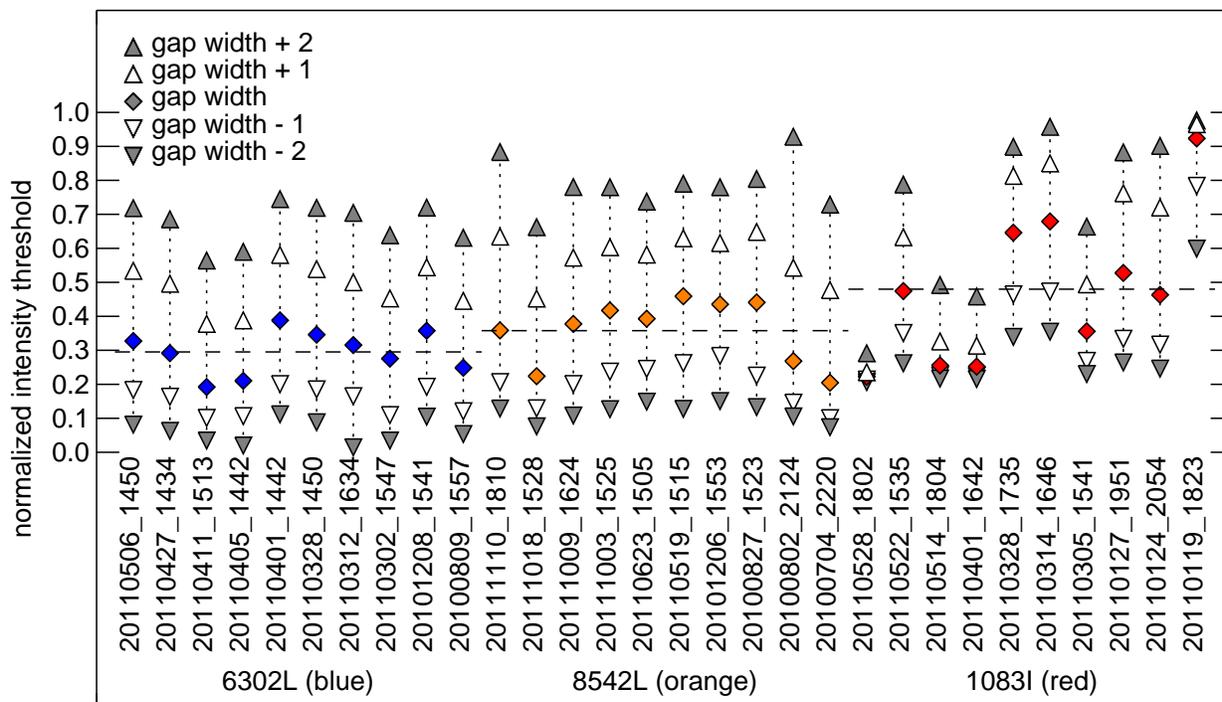
Figure 4 – Normalized intensity thresholds corresponding to the gap widths independently measured for ten 6302L (blue), 8542L (orange), and 1083I (red) observations.

The actual (interpolated) intensity thresholds corresponding to the measured gap widths are plotted as diamonds in Figure 4. Similarly, values yielding widths too large and too small by one or two columns are included (the latter become indistinguishable once the flat parts of the profile are reached). There is excellent agreement between the 6302L and 8542L observations, where the mean thresholds of 30% and 36% match the measured gap widths to the nearest integer in all cases. The poorer agreement between the 1083I observations is consistent with the comparatively less certain gap width measurements and is mitigated by once again adopting the mean threshold (48%). The correlation between threshold value and wavelength is expected due to relative contributions from scattered light.

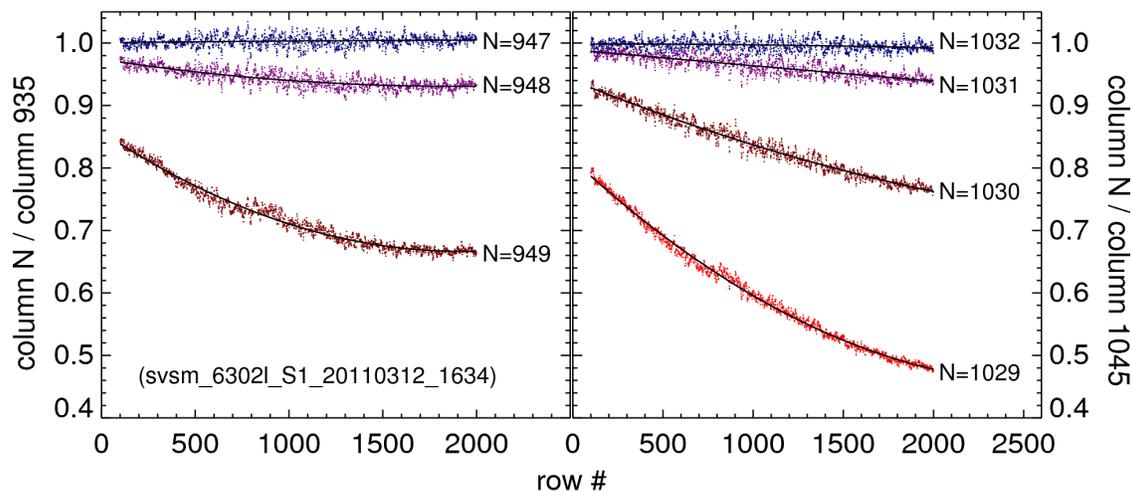
Figure 5 – Diminished relative intensity near the gap (the gap is columns 950 – 1028 in this case) is corrected for via division of the affected columns by the corresponding quadratic polynomial fits (black lines).

The Level-1 to Level-2 pipeline then simply removes the extraneous columns from all fits frames and records this fact in the header. Columns GAPCOL1-5 through GAPCOL1+4 (the five zero-indexed columns on either side of where the gap was) are re-scaled in order to account for diminished intensity near the gap. This diminution is not necessarily constant for all rows (see Figure 5) due to the changes in the gap profile wings discussed in § 2. Although scattered light (which should be subtracted rather than scaled) may be partially responsible for these changes, it is not necessarily the primary cause. Therefore, each column is simply divided by a quadratic polynomial fit to the intensity ratio of that column divided by an unaffected column (actually the median of several columns) further offset from the gap.
