Effects of neutron radiation on the optical and structural properties of blue and green emitting plastic scintillators

We report on the optical and structural properties of plastic scintillators irradiated with neutron beams produced by the IBR-2 reactor of the Frank Laboratory of Neutron Physics in JINR, Dubna. Blue UPS-923A and green plastic scintillators were irradiated with neutron fluence ranging from 10^{13} to 10^{17} n/cm². Discolouring in the plastic scintillators was observed after irradiation. The effects of radiation damage on the optical and structural properties of the samples were characterized by conducting light yield, light transmission, light fluorescence and Raman spectroscopy studies. The results showed that neutron radiation induced damage in the material. The disappearance of the Raman peak features in green scintillators at frequencies of 1165.8, 1574.7 and 1651.2 cm⁻¹ revealed significant structural alterations due to neutron bombardment. Losses in fluorescence intensity, light yield and light transmission in the plastic scintillators were observed.

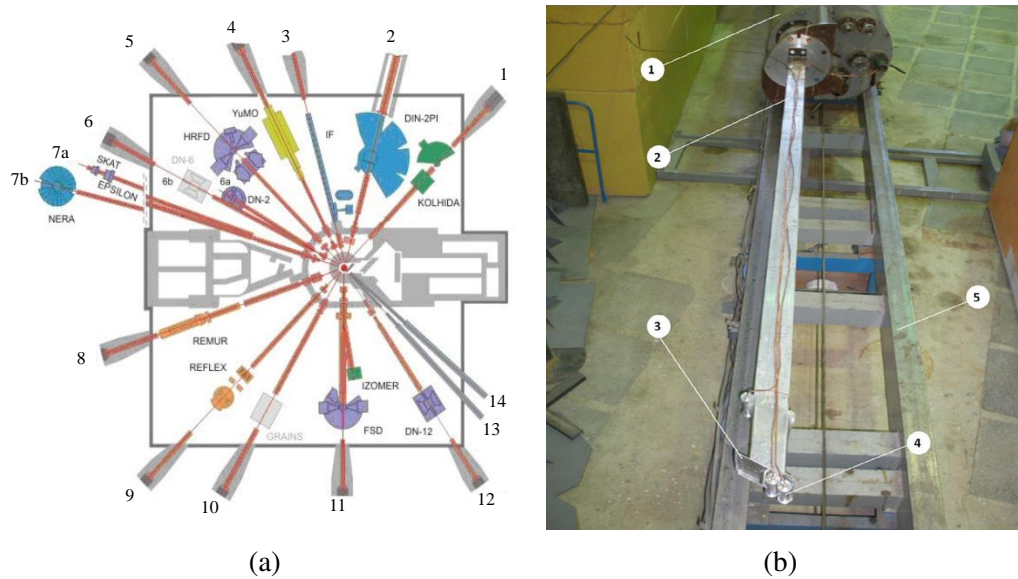
Figure 1: Layout of IBR-2 spectrometer complex (a), and the irradiation facility at the channel No. 3 of IBR-2 reactor experimental hall, the view from the external biological shield side: (1)-massive part of the irradiation facility, (2)-transport beam, (3)-metallic container for samples fastening, (4)-samples, (5)-rail way (b) [12].

Channel number 3 of the IBR-2 reactor, as schematically shown in Figure 1(b), located at the Frank Laboratory of Neutron Physics (FLNP) at the Joint Institute for Nuclear Physics (JINR) in Dubna, Russia was used to irradiate the samples [12, 13].

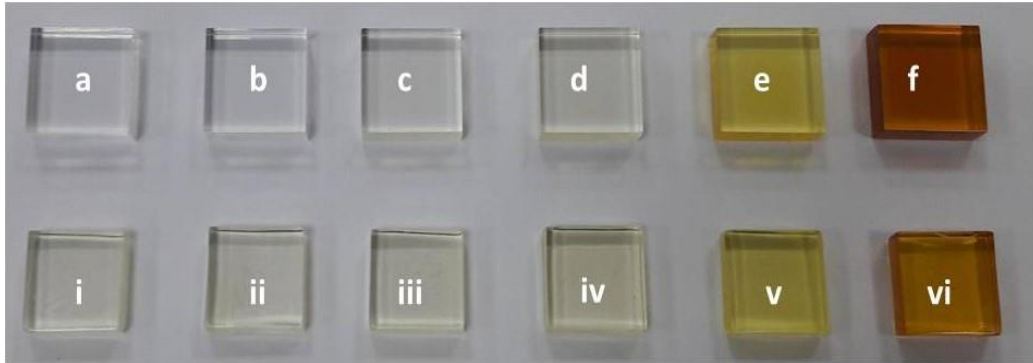
Figure 2: Neutron irradiated samples, Blue scintillators UPS-923A (a - f) and Green scintillators (i - vi). From the left column to right column: non-irradiated, 10^{13} , 10^{14} , 10^{15} , 10^{16} and 10^{17} n/cm².

The samples were subjected to a beam of neutrons for 432 hours, this was the duration of the reactor cycle during the October 2017 run (9 – 27 October 2017). The reactor operated at an average power of 1875 kW with the samples placed at various positions away from the reactor core to achieve various neutron fluences. The neutron fluence ranged approximately between $10^{13} - 10^{17}$ n/cm². However, during the irradiation only neutrons with energy $E > 1$ MeV were monitored. These neutrons account for about a quarter of the total flux. Hereafter we refer to number of fast neutrons with energy $E > 1$ MeV, although the actual amount of neutrons are a factor of four higher. As shown in Figure 2, the discolouration of the samples is evident after irradiation.

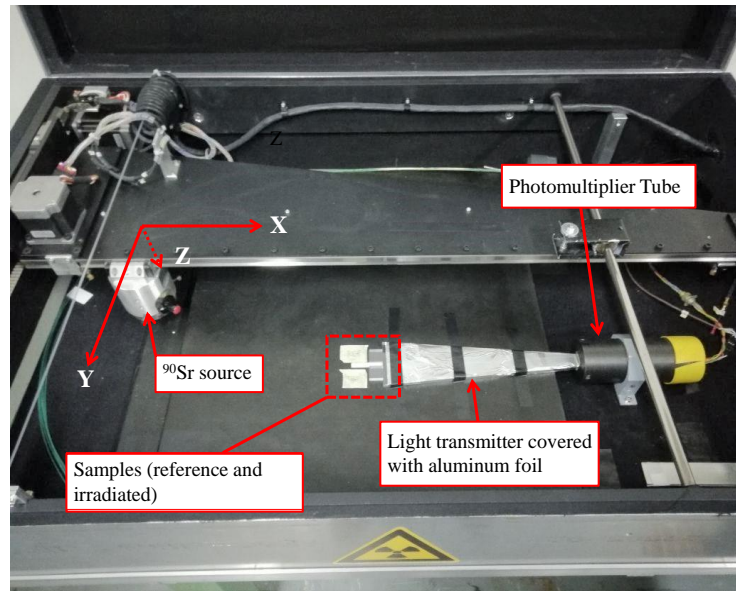
Figure 3: A photograph of light box set-up used to measure the light yield.

The light yield measurements were conducted at the European Organisation for Nuclear Research (ATLAS-experiment) using a light tight box set-up shown in Figure 3. The plastic scintillators were excited with β -electrons emitted by a ^{90}Sr source with average energies of 0.54 MeV and 2.28 MeV. The ^{90}Sr source

scanned over the sample in the X–Y direction whilst emitting radiation in the Z direction. The light emitted by plastic scintillators through fluorescence was detected by the photomultiplier tube (PMT). The signal generated by the PMT was further processed through electronics and digitized. To minimize background signals like those coming from the interaction of the β -electrons with the PMT, a light transmitter was used to transport the light produced by the scintillators to the cathode of the PMT. In addition, a light transmitter was covered with aluminum foil to impede β -electrons from the source.

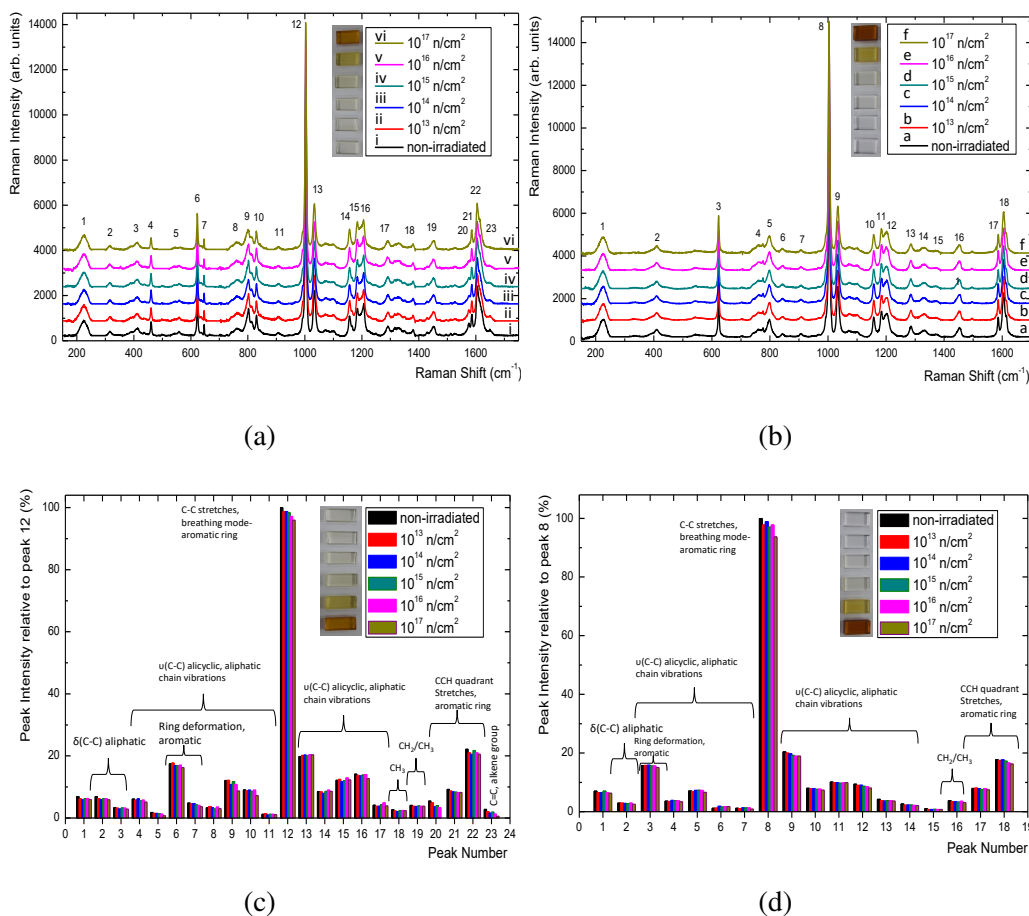
Figure 4: Background subtracted Raman spectra of irradiated and non-irradiated plastic scintillator samples for, (a) green plastic scintillators and (b) blue plastic scintillators UPS-923A. Plot of intensities of peaks relative to peak 12 (non-irradiated) for green (c) and peak 8 (non-irradiated) for blue scintillators (d). NB: The Raman spectra in (a) and (b) have been vertically offset for better visual presentation.

The only limitation of the 785 nm wavelength is that due to detector limitations on the instrument, Raman peaks can only be measured up to 2000 cm^{-1} . The -C-H and =C-H vibrational modes between 2800 and 3200 cm^{-1} could thus not be measured. Raman spectroscopy showed small changes in the structure, in comparison with non-irradiated and irradiated samples. Figure 4(a) and (b) reports the background subtracted Raman spectra of the green and blue emitting plastic scintillators.

Investigations were conducted in the quest of determining the radiation sensitive peaks. Intensities of the Raman peaks for both green and blue emitters were plotted relative to peak 12 and 8, respectively, in order to assess changes in the species present. Peak 12 and 8 typically represent aromatic ring structures, which influences the scintillation properties of the scintillator. The C-C bonds present in the structure give rise to a cloud of delocalized π -electrons that are prone to excitation by incident energetic particles. The results are shown in Figure 4(c) and (d). The ratio of most species found in the styrene backbone of samples to that found in the benzene ring shows a decrease after irradiation.

From the results shown in Figure 4(c) and (d), there is a significant decrease in the Raman intensities of aromatic breathing modes as well as alicyclic/aliphatic chain vibrations belonging to the aromatic benzene ring. These changes are more prominent in green emitting samples. It appears that the benzene ring structure undergoes a significant amount of damage. This could be a result of strong dehydrogenation due to the C-H bond breaking in the benzene ring and an emission of different C_xH_y groups with the absorbed neutron fluence as described by Torris, 2002 [16]. This causes a decline in the number of Raman active modes and hence could account for the observable effects. The Raman intensities of corresponding vibrational modes have been quantified and reported in Table 3 and 4 for green and blue emitting samples, respectively.

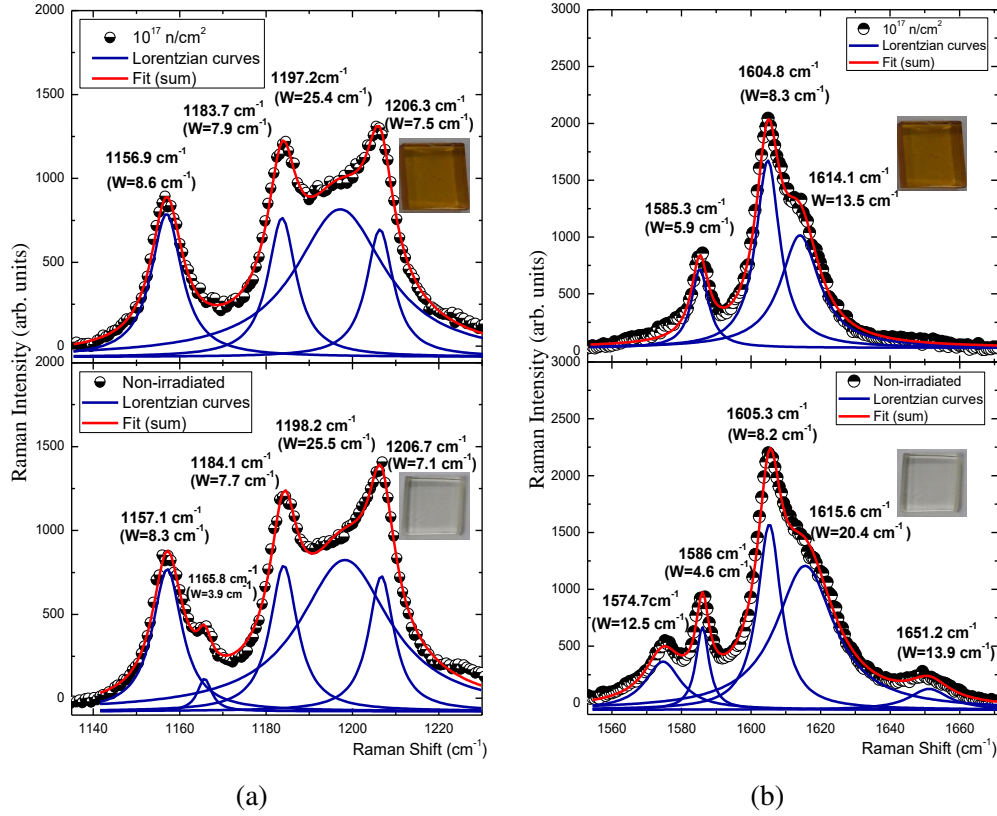
Figure 5: Lorentzian line-shape fitted function at regions 1140-1230 cm^{-1} (a) and 1560-1662 cm^{-1} (b), showing the disappearance of Raman modes at 1165.8, 1574.7 and 1651.2 cm^{-1} , which are present in the non-irradiated Raman spectrum of green scintillators.

It has been observed that, for green scintillators, Raman peak features at frequencies 1165.8, 1574.7 and 1651.2 cm^{-1} appear to be more sensitive to neutron radiation. These bands become less intense as the neutron fluence increases and finally disappear. They are most likely to be related to the fluor dopant 3HF (3-hydroxyflavone) [10, 11], although the primary peaks of 3HF do not match up that well with the peaks in the green scintillators spectrum [17]. It could be that the fluors are a “mix” of 3HF derivatives. Clearly the neutron irradiation does not have a major impact on the polystyrene since all the peaks are still present even for higher fluences. The corresponding Lorentzian fits of the non-irradiated and higher neutron fluence spectra are shown in Figure 5 and the peak intensity values are reported in Table 5.

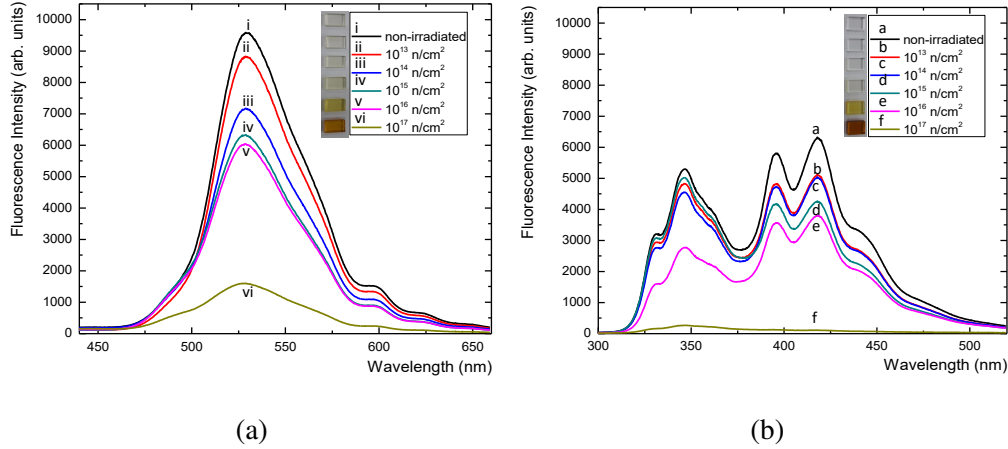
Figure 6: Fluorescence spectra for green scintillators (a) and blue UPS-923A scintillators (b).

Fluorescence spectra of plastic scintillator samples are shown in Figure 6. A two-peak feature in Figure 6(b) is observed for blue scintillators UPS-923A. Wavelength regions of 310-375 nm and 375-520 nm correlate with fluorescence of the polystyrene base and fluor dopants, respectively. The two-peak feature is observed since the fluorescence is predominantly from the benzene ring structures. However, the results for green emitting scintillators in Figure 6(a) reveal only a single fluorescence peak around 529 nm. For all samples, the decrease in fluorescence intensity is prominent as neutron fluence increases. There could be degradation of the aromatic benzene ring structures in the polymer base matrix and damage to the förster energy transfer mechanisms due to C-H bond breaking within the benzene ring. These damages are reported in literature by Torrisi, 2002 [16], to be the cause of luminescence yield reduction. The results of Raman spectroscopy reported in Table 3 and 4 affirm these changes, and are consistent with the fluorescence results. Damage to the benzene ring directly affects the scintillation process in the material.

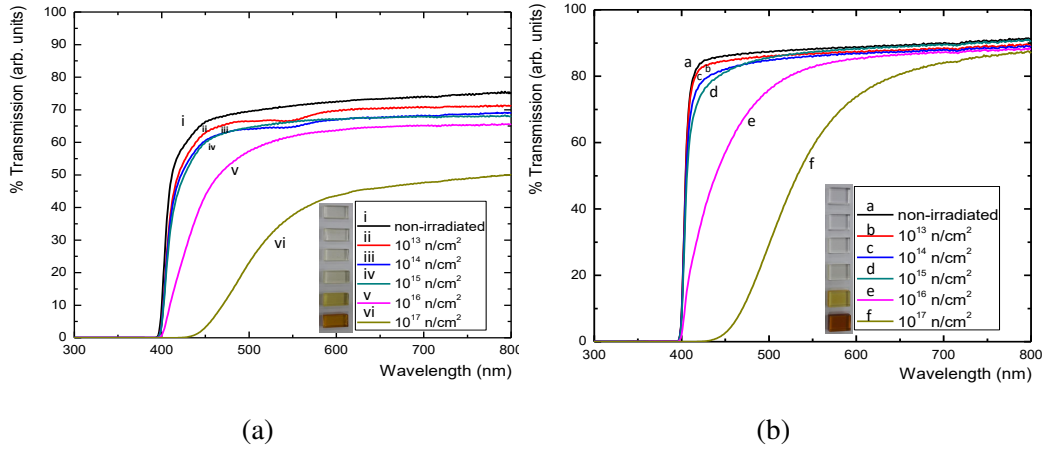
Figure 7: Light transmission spectra for green scintillators (a) and blue scintillators UPS-923A (b).

Transmission spectroscopy was conducted using the Varian Cary 500 spectrophotometer with the light transmission measured relative to transmission in air over a range of 300-800 nm. The results are shown in Figure 7. All the non-irradiated blue scintillators UPS-923A and green scintillators have an absorption

edge starting at 410 nm, which completely falls off at around 400 nm. The formation of an absorptive tint as neutron fluence increases is observed where the absorption edge drops and shifts to longer wavelengths. This effect is ascribed to the production of free radicals induced by radiation damage. These free radicals form absorption centers within the samples resulting in the light absorption competition and loss of transparency in scintillators.

From the light transmission plots, it is evident that blue scintillators UPS-923A possess the highest light transmission properties and appear to be most radiation tolerant as compared to green light emitters. The blue scintillator overall remains more transparent to all wavelengths, but becomes opaque to blue light after damage. Whereas, the green scintillators lose transmission in blue light region, but remain transparent in the 550+ nm region.

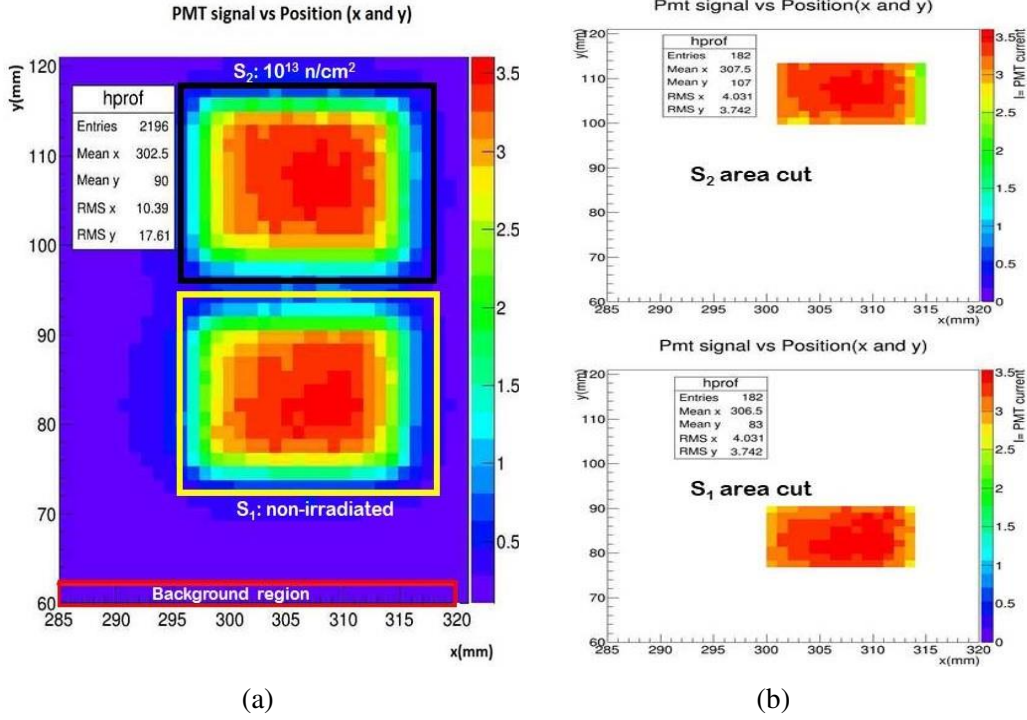
Figure 8: 2D mapping of the PMT signal with ⁹⁰Sr source position, indicating signal regions corresponding to regions on the experimental set-up (a) and plots of area cut with entries of high signal values (b) [color legend only available on electronic version].

The assessment of light yielded by irradiated plastic scintillator samples was performed by testing their response to a ^{90}Sr β -electron source. The signal generated by the PhotoMultiplier Tube was measured as a function of radiation source position. Figure 8(a) illustrates a 2D mapping of the signal measured in the X and Y direction over a pair of samples. The position of samples is approximated by the black and yellow boxes (color legend only available on electronic version), representing irradiated and non-irradiated samples, respectively.

Before analysis, the background was subtracted from the rest of the mappings. The background region marked with a red box on Figure 8(a) was selected on one of the 2D mapping surface with the signal not contaminated by the signal from the samples. A pair of irradiated (10^{13} n/cm²) blue test sample and the non-irradiated blue reference sample were used. The mean signal value of 0.1309 mean/entry over the selected area was used as a background value.

The area cuts plots shown in Figure 8(b) were selected from the 2D mappings with entries of high signal values. In order to analyse the light yield loss as a function of neutron fluence, the ratio of corrected signals from the reference and test samples were calculated and plotted against the neutron fluence as shown in Figure 9. The light yield loss in all irradiated samples is observed as neutron fluence increases. It is prominent at a fluence of 10^{17} n/cm². The light yield results are consistent with the fluorescence and light transmission results.

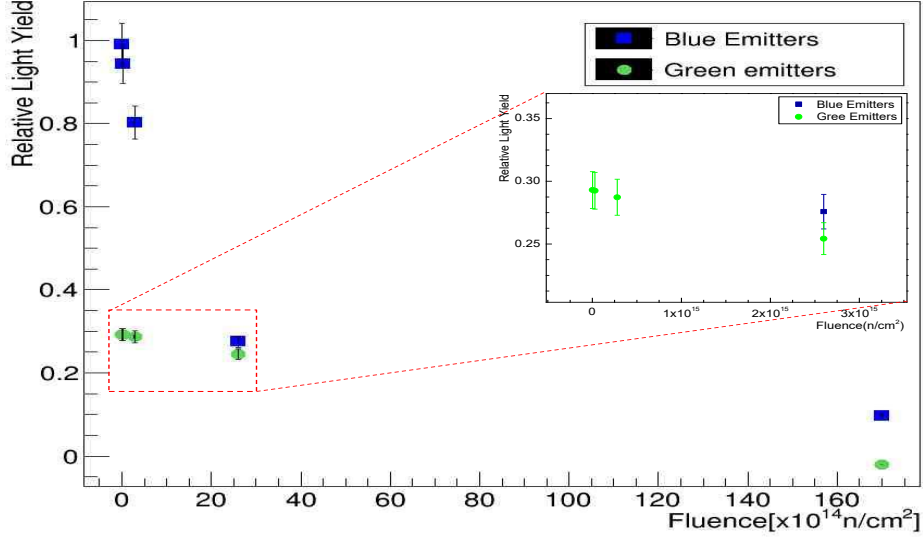
Figure 9: Light yield against neutron fluence for blue UPS-293A scintillator and green scintillator.
