Reverse Engineering the Raspberry Pi Camera V2: A study of Pixel Non-Uniformity using a Scanning Electron Microscope[☆]

Abstract

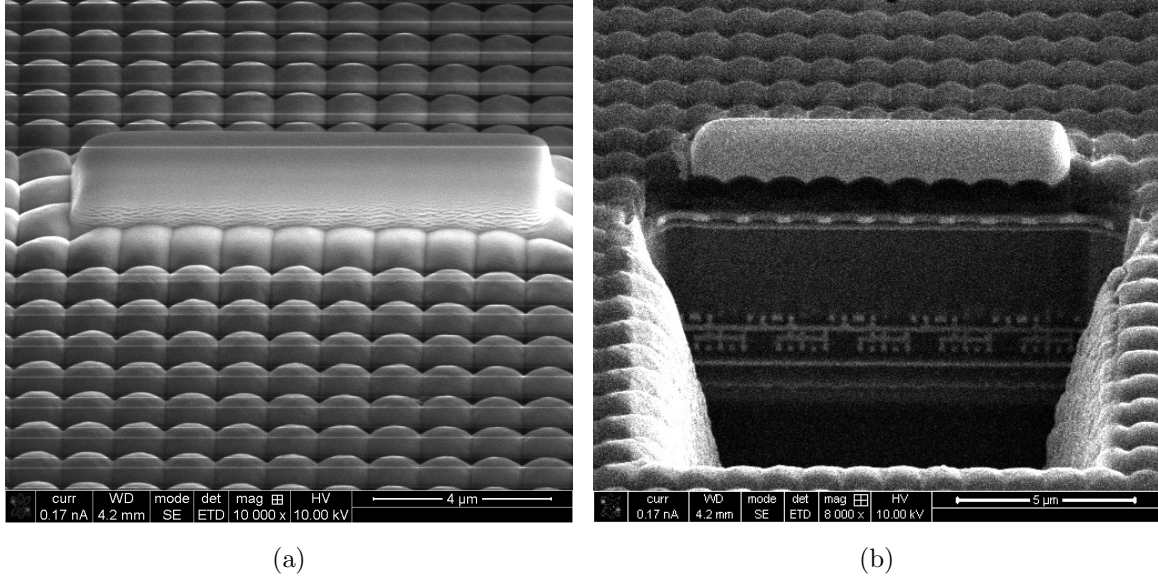
Figure 1: (a) Platinum (shown here as a growth on top of the micro-array) is deposited on the CIS to prevent micro-fractures forming during the excavation process. (b) The excavated region of the CIS is shown after the Gallium ion beam has been used to step out the material present in the region of interest. Several passes are used to obtain a smooth, polished cross-section.

Using a Sony IMX219PQ [11] image sensor as the test subject imaging was performed under a FEI Dual Beam Helios Nano Lab 600 scanning electron microscope [12]. The Helios allows imaging down to 1nm at 15kV. Minimal preparation of the sample is required before imaging since the image sensor is made primarily of silicon and hence, is conductive to the electron beam. The IMX219PQ comes as a package board from the Raspberry Pi Foundation. The sensor is de-constructed to obtain the silicon wafer in isolation to the peripheral circuit and attached to the FEI imaging platform by way of adhesive conductive dot. The platform is tilted to 52 to enable imaging and machining by the gallium focused ion beam. Under magnification, a layer of platinum was deposited above the area to be excavated to prevent fracturing (Figure 1a). After the platinum is deposited a process of staged cuts were made using a gallium ion beam to create an excavated area through the sensor that can be imaged (Figure 1b). The gallium ion beam is capable of machining down to 5nm allowing precise cuts to be made. This is a destructive process.

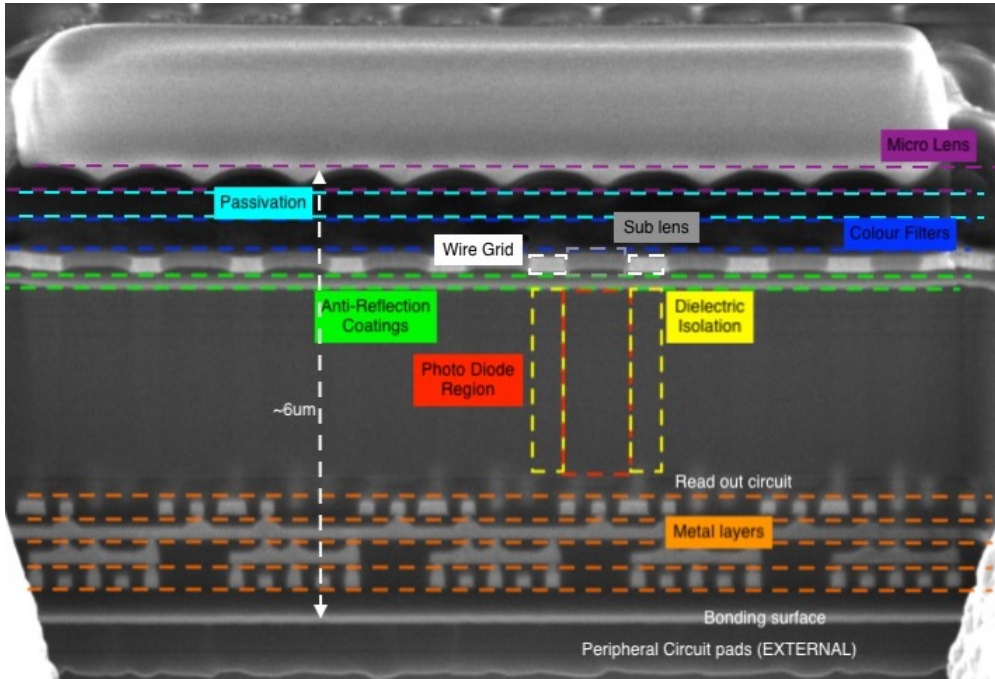
Figure 2: A horizontal cross-section of the IMX219PQ sensor. Each region of the sensor is clearly identified.

Using [3], Figure 2 and 3 presents the layers of the CIS with each region identified. The sensor is a back illuminated sensors (BIS) with a pinned photodiode (PPD). The P+ pinning layer can be seen in Figure 3. In Figure 2 the width of the sensor is measured as approximately 6um. This is consistent with the provided literature from Sony [13] which also indicates a dual wafer design. This is confirmed in these images with the bonding surface between the two wafers indicated in Figure 2 at the appropriate distance from the top of the micro LOS. In the micro LOS the structure can be seen as a main lens, passivation layer,

Bayer filter and then a minor sub lens nestled in between the nodes of the wire grid. The photodiode region is identified and isolated between two layers of P doped semiconductor used to prevent cross talk. The isolation regions are located directly beneath the wire grid used for optical isolation. This is seen clearer in Figure 3 where the microscope is focused onto the read out circuit layer of the image sensor.

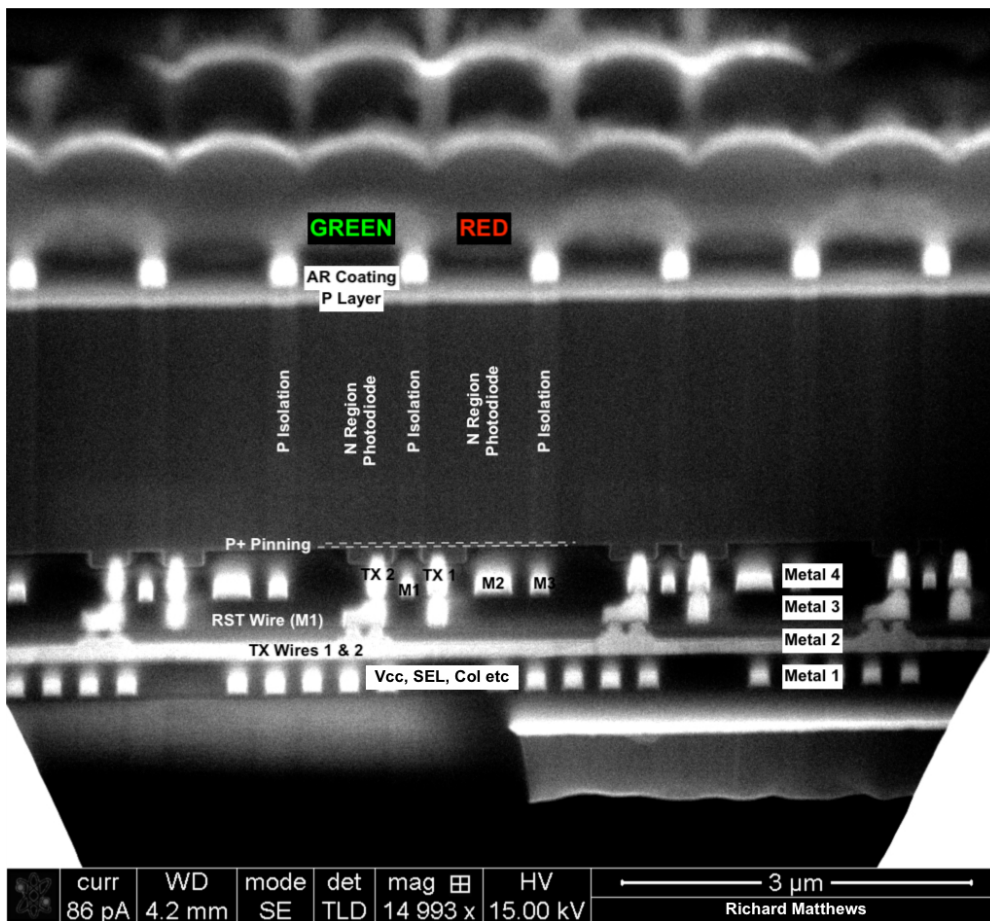
Figure 3: A secondary cross-section of the IMX219PQ sensor. The structure of the photodiode and circuit is identified within the image.

Using reference images from [3], the Bayer filter elements visible in Figure 3 are identified as green and red. This is made out as the red filter elements are thinner than green with the blue elements being thicker and filling almost the entire layer. The transfer nodes (TX) are visible within the image. From here it is possible to identify the individual transfer, M1 reset (RST), M2 source follower (SF) and M3 column select transistors within the Metal 4 layer. The wiring for each of these nodes is then routed to the underlying metal layers to provide read out access to the circuit, most likely on the peripheral or underlying silicon wafer. The TX wires are seen within the Metal 2 layer while it is assumed that the Vcc,

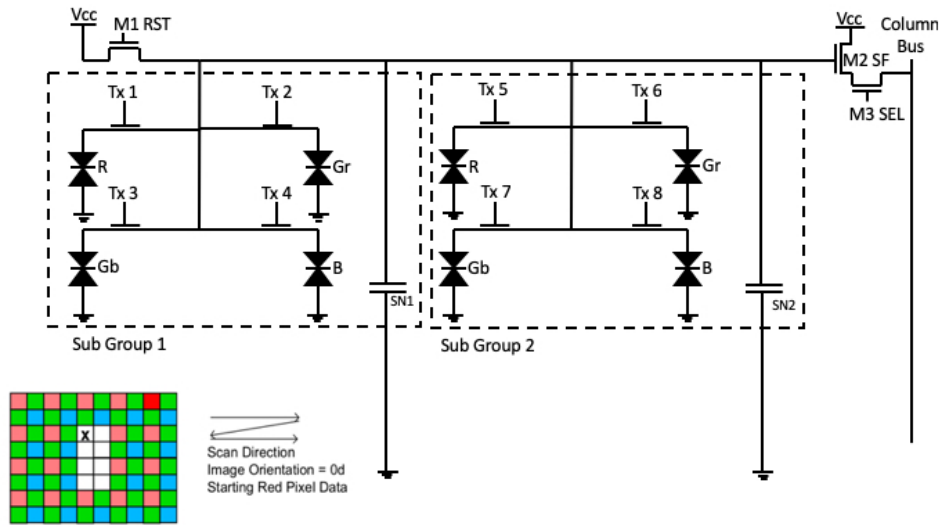
Figure 4: The equivalent circuit for the IMX219PQ pixel unit. Inset shows the scanning direction for read out of the IMX219PQ sensor when identifying a 2x4 pixel defect on the sensor taken from [14].

Using the information identified above in conjunction with [14] and [3] an equivalent circuit can be identified for the Sony IMX219PQ BIS pixel unit. From examining [14] we see that the sensor has the capability to store defective pixels in one of three modes: single pixels, single adjacent pixels by Bayer element and individual blocks of 2x4 adjacent pixels. Understanding how the sensor stores defects provides insight to the readout structure. It follows that the sensor has a pixel unit comprising of 2x4 photodiodes sharing a single readout circuit. Using [3] the pixel unit is comprised of a circuit of eleven transistors for every eight photodiodes. Using the familiar nomenclature of average number of transistors per pixel we see the IMX219PQ is a 1.375T (11 transistors per 8 pixels) design. This is indicated in Figure 4.

We suspect that the clover leaf pattern is utilised as per previous Sony iterations, in particular the sensor (Sony IMX145) in [3]. Unlike the equivalent circuit shown in [3, Fig. 9] we show only two sense node locations corresponding to the sense node in each of the two pixel subgroups noting the work of Fontaine in [3, Fig. 10] showing these two locations in

the centre of the clover leaf. We note that the charge for each photodiode when read out will be distributed on both of these nodes in parallel due to Kirchoff's Current Law. The readout circuitry is an important distinction to clarify as it forms a significant source of dark current. Sensors that demonstrate a different readout structure (3T, 4T, 2T, 1.75T) provide a possible source of difference for forensic identification. The dark current of such sensor configurations should be measured in future work. The clover leaf pattern should also be confirmed by imaging the bottom of the sensor.

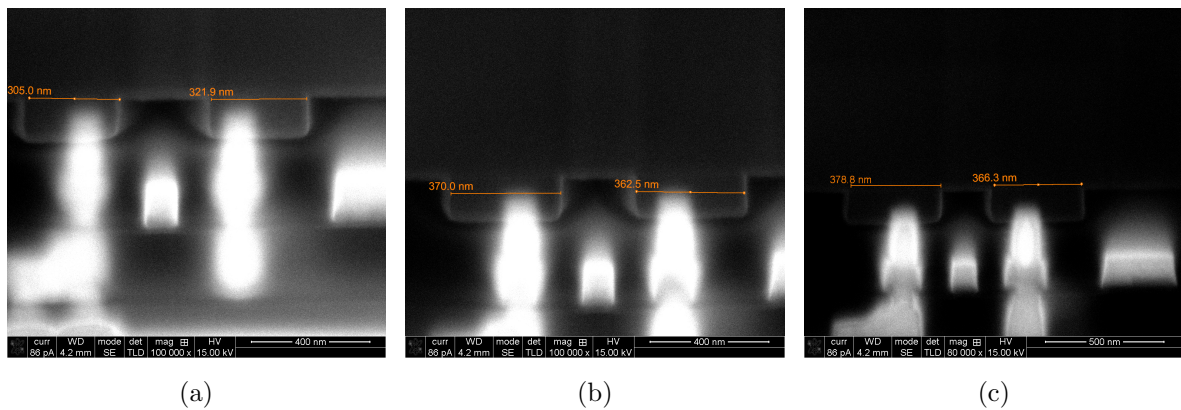
Figure 5: The length of six transfer gates are taken across three separate pixel units Odd gates are green, even gates are red. (a) Transfer gates 1 and 2. (b) Transfer gates 3 and 4. (c) Transfer gates 5 and 6.

Measurements were taken of the readout node of the photo diode using the SEM built in measurement tool. These were then verified manually by printing images to scale and measuring by hand. These results are shown in Table 1.

There is variation with all transfer nodes measured. The mean of all six transfer nodes is

Pixel	SEM Measure (nm)	Manual Measure (nm)	Average (nm)
1	305	308	307
2	322	329	326
3	370	370	370
4	363	364	364
5	379	380	380
6	366	378	372

353nm. Measuring the variance to the mean from each transfer node we obtain a double sided tolerance of +27nm and -46nm. Extrapolating, this leads to a feature size of 350nm with an engineering tolerance of +/-50nm. The polysilicon layer has an average thickness of 160nm with metal 4 being approximately 280nm in thickness. This is consistent with the 130nm lithography process design rules in [15] noting we have labelled our metal layers in reverse order. This measurement is not consistent throughout the layer with the layer increasing and decreasing in thickness throughout the images obtained. This thickness variation will cause minor geometric changes to the features of the circuit. These thickness variations will become more pronounced in top layers as the variations stack.

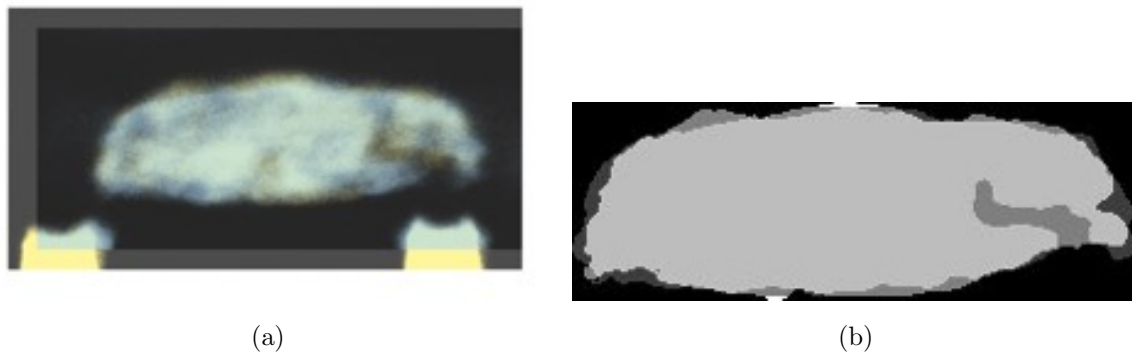
Figure 6: (a) Overlay of the two Green-Red Bayer filter elements. (b) The overlay of the two Green-Red Bayer filter elements as a binary image using FIJI [16].

Two Green-Red Bayer elements are overlaid in Figure 6. In 6a the microimagery is presented for the two immediate, same colour, neighbouring elements with noticeable variations in the structure of these two identical Bayer elements. The stained blue shows a large segment missing to the right where as the stained yellow is slightly thicker. The cropped images are run through a Canny edge detector in FIJI [16] to provide a binary gate to compare the two filter elements against. This result of the Canny edge detector is presented in 6b. White is where element 1, previously tinted yellow, is presented. Dark grey is element 2 previously tinted blue. Dark white is where both elements are, and light grey is where only element 1 is present. This shows the contrasting differences between the two CFA elements with a hole

in element 2 positioned above the optical block (metal grid). These minor variations are likely to create optical aberrations known as Seidel aberrations affecting where individual photons will strike the depletion region of the photodiode [17, 18].

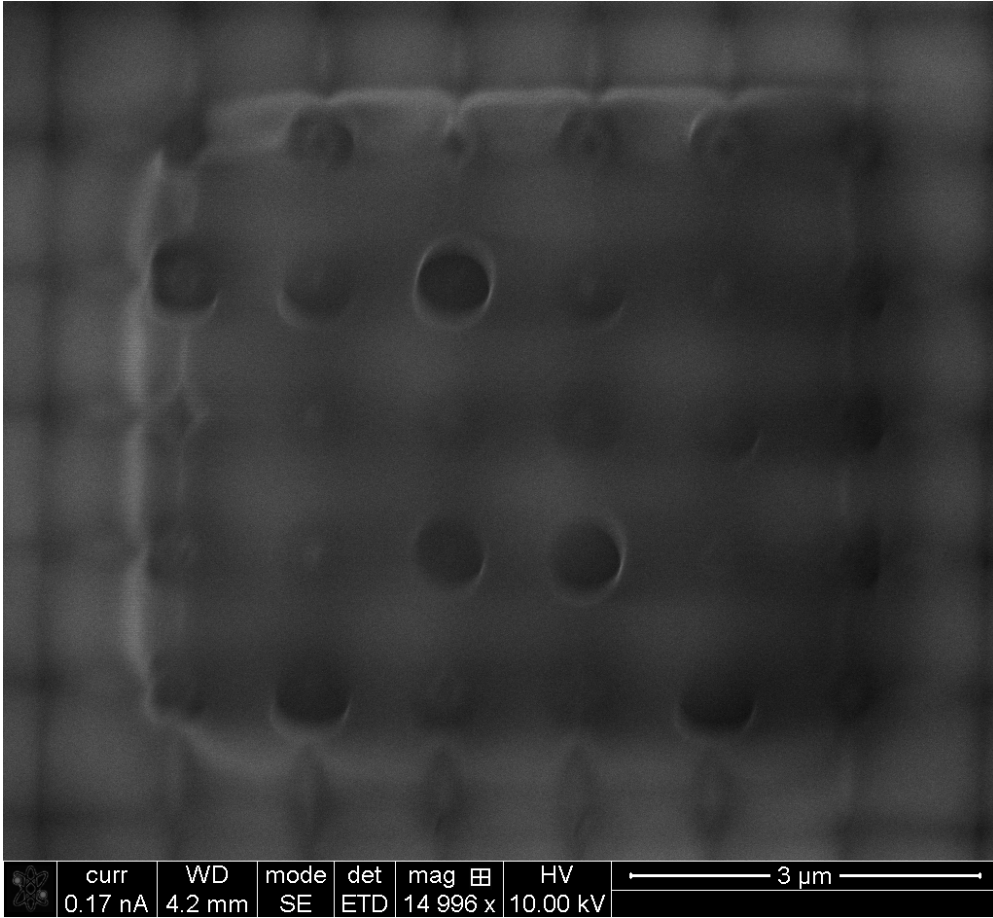
Figure 7: Sectioning the top lens layer of the IC reveals the passivate later above the Bayer elements below the micro lenses. Bubbles are evident above the wire grid in random locations on the surface of the chip.

The Bayer filter is not the only region that is observed to have irregularities which will cause optical aberrations. Sectioning off the top layer of the micro LOS provides access to the passivation layer in between the micro lens and the Bayer elements. Shown in Figure 7 holes in the passivation layer are visible directly above the wire grid elements. This is another defect within the structure of the sensor that is not uniformly distributed on every pixel. Once again, the formation of holes within the upper layers of the micro LOS are likely to cause aberrations [17, 18].

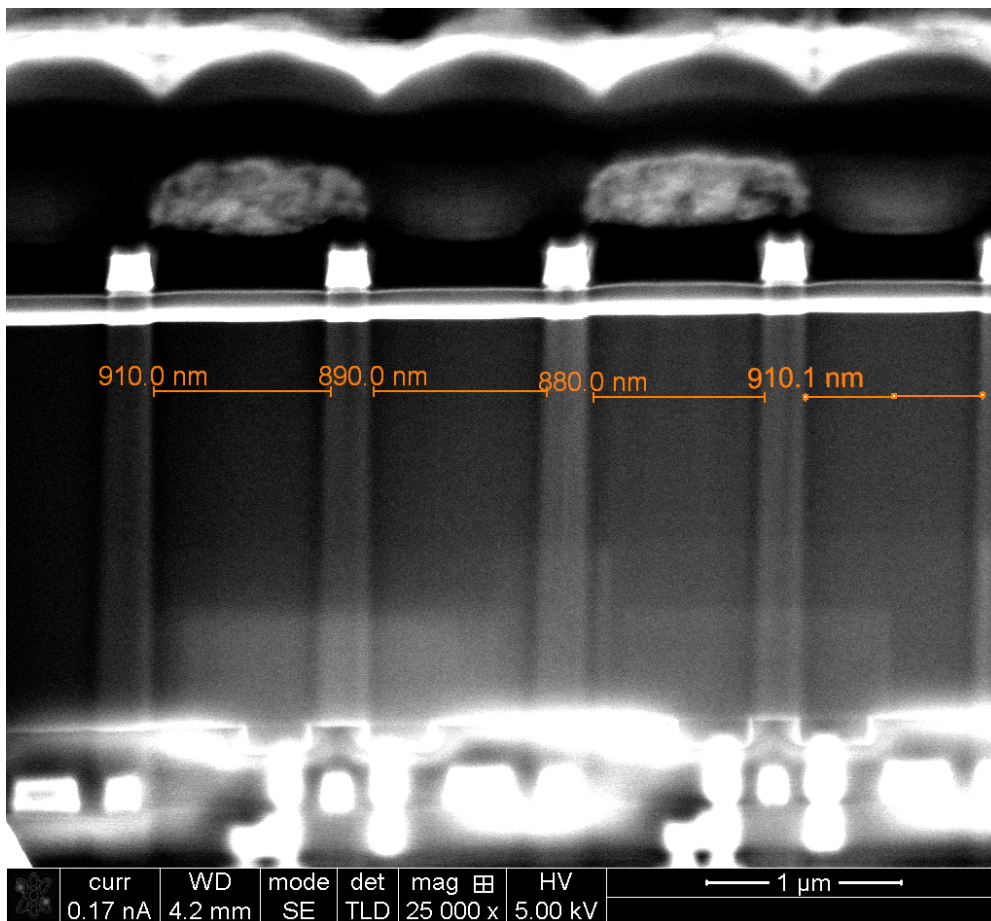
Figure 8: Four photodiodes from two separate pixel units compared for length.

Four photodiodes and their length are shown in Figure 8. We note the presence of a charging artefact due to the highly conductive metal layers causing a smearing effect into the photodiode region on the image. Measurements are taken well away from this artefact to avoid any contamination. Measurements are taken from the SEM and then confirmed via manual scaling as per section 4.2. These measurements are displayed in Table 2. All measurements show variation from photodiode to photodiode.

The mean photodiode length is measured as 894nm with a variance of +/-14nm. The nominal pixel length is stated as being 1120nm (1.12um) [14]. Measuring the length of the

Photodiode	SEM Measure (nm)	Manual Measure (nm)	Average (nm)
1 Gr	910	899	905
2 R	890	873	882
3 Gr	880	879	880
4 R	910	905	908

together obtains an average pixel length of 1134nm (1.13um). The four pixels in Figure 8 are manually measured to obtained a length of 451nm. This provides a mean measurement of 1127.5nm (1.13um). These measurements indicate that the pixel length is slightly larger than stated in the documentation due to manufacturing tolerance.
