Tribocorrosion under galvanic interaction of Ti6Al4V and NiCr implant alloys

Micromovements that occur in the joint between dental prostheses and implants can lead to wear-induced degradation. This process can be enhanced by corrosion in the oral environment influenced by the presence of solutions containing fluoride. Moreover, the eventual galvanic interactions between NiCr and Ti alloys can accelerate the wear-corrosion process. In this work, the tribocorrosion process of Ti6Al4V and NiCr alloys used in dental implant rehabilitations immersed in fluoride solutions at different pH values was investigated. The galvanic interaction effect between the alloys was also assessed. Tribocorrosion tests in corrosive media were performed with isolated Ti6Al4V and NiCr alloys, followed by testing with both alloys in contact. The media selected were based on fluoride concentrations and pH values that are possible to be found in oral environments. Analysis of the surfaces after the tribocorrosion tests was carried out using confocal laser microscopy. The wear profile and volume losses were determined by confocal measurements. It was concluded that the galvanic interaction between the alloys i

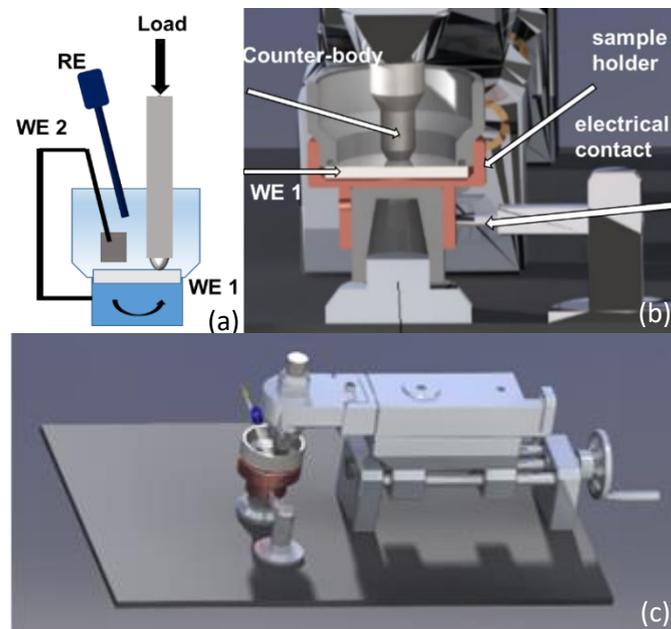
Figure 1: Setup of tribometer adapted for galvanic corrosion measurements. (a) electrochemical cell, (b) internal view of cell, (c) tribometer.

The tribocorrosion test was performed in an electrochemical cell containing 100 mL of the selected solution attached to a rotational ball-on-plate tribometer, with the specimen surface facing upward against the counter-body alumina sphere. Figure 1 presents the scheme of the experimental setup used. An electrochemical cell configuration for control and measurement was used, with a silver/silver chloride (Ag/AgCl) reference electrode, and a working electrode (WE1 in Figure 1). The choice for sliding ball-on-plate was based on previous studies of Borrás et al. [26], Dimah et al. [27], Lepicka et al [28], Licausi et al. [29] and Licausi et al. [30] for evaluation dental implants, being a proper method to mimetic dental implant-abutment contact compared to the use of real implants. The electrochemical cell was machined in polymer, and an O-ring was attached to the working electrode to prevent solution leakage. A constant rotational frequency was imposed through a motor shaft attached to the holder. The electrochemical cell was connected to the potentiostat, while the alumina ball was kept fixed and connected to the tribometer. The sample holder allowed electrical contact between the working electrode with the potentiostat for single evaluation, or coupled for galvanic interaction evaluation.

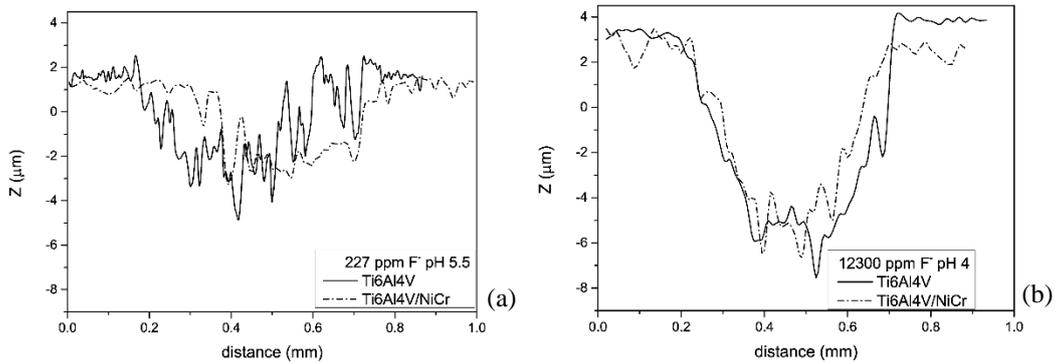
Figure 2: Wear track profiles obtained for Ti6Al4V single alloy and in couple combinations of Ti6Al4V/NiCr in 227 ppm at pH 5.5 (a) and 12300 ppm at pH 4.0 (b). Worn materials – Ti alloy.

Wear track profiles obtained with confocal laser analysis, measured perpendicularly to the sliding direction, are shown in Figure 2 for isolated Ti alloy and for coupled to NiCr, Figure 3 for isolated NiCr alloy and for coupled to Ti, in both solutions. The corresponding wear volume loss obtained from confocal analysis was converted to wear rate that is depicted in Figure 4. Clearly, the more aggressive solution, high fluoride content and low pH, favours the higher volume loss of Ti measured as the profile of worn track regardless the galvanic couple with NiCr.

Isolated and coupled Ti alloy wear profiles exhibited deeper and rougher tracks, indicating the more severe degradation of this material in comparison with single and coupled NiCr. The deepest valley values were used to estimate the statistical significance. Under the same test conditions, single Ti alloy wear profiles were deeper in 12300 ppm/pH 4.0 than in 227 ppm/pH 5.5 ($p < 0.05$). However, the values obtained for the couple Ti6Al4V/NiCr exhibited lower depth than single Ti6Al4V in both environments. The inverse couple, NiCr/Ti6Al4V exhibited higher penetration depth when compared to single NiCr in the more aggressive solution. This finding indicates a galvanic effect of Ti alloy in fluoride content. The wear volume loss obtained was converted to wear rate with Eq. (2), used by Lepicka et al. [28]:

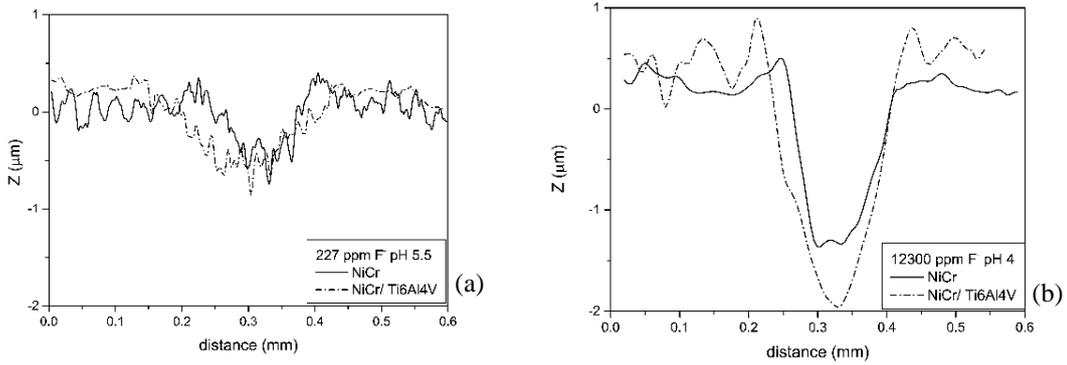
Figure 3: Wear track profiles obtained for NiCr single alloy and in coupled combinations of NiCr/ Ti6Al4V in 227 ppm and pH 5.5 (a) and 12300 and pH 4.0 (b). Worn materials – NiCr alloy.

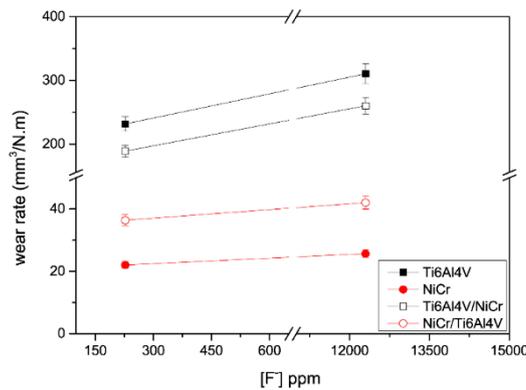
Figure 4: Specific wear rate obtained for Ti6Al4V, Ti6Al4V/NiCr, NiCr, and NiCr/Ti6Al4V in 227 ppm/pH 5.5 and 12300 ppm/pH 4.0.

The specific wear rate is depicted in Figure 4. Titanium alloy presented an increase in the wear rate with increasing fluoride concentration, as found by Sivakumar et al. [33]. Comparing the alloys tested under single and coupled configurations, significant differences in wear volume losses were observed in both solutions ($p < 0.05$). Titanium alloy, either singly or coupled with NiCr, exhibited a specific wear rate *circa* five times that of the NiCr alloy ($p < 0.05$). Furthermore, the NiCr wear rate was not strongly affected by the environment or galvanic interaction, with a slight increase in wear. However, Ti alloy exhibited significant variations between solutions ($p < 0.05$) and with and without the effect of galvanic interaction. This effect of galvanic interaction was beneficial for Ti because it decreases the volume loss.

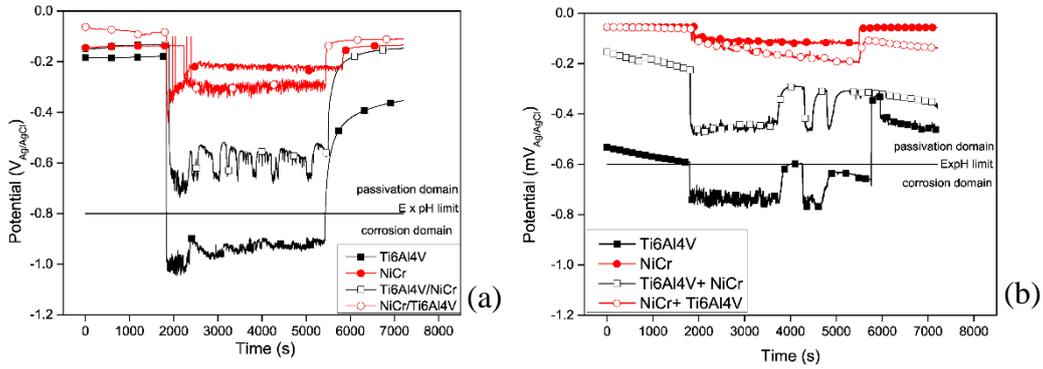
Figure 5: OCP measurements during tribocorrosion tests for single and coupled combinations of NiCr and Ti alloy in 227 ppm/pH 5.5 (a), and 12300 ppm/pH 4.0 (b).

The evolution of OCP before, during, and after sliding is shown in Figure 5, and the evolution of the coefficient of friction (μ) during sliding is given in Figure 6. NiCr has a higher potential than Ti alloy without friction. The friction provokes a potential decay, the corresponding parameters of which are shown in Tables 2 and 3.

Before sliding, the OCP of single NiCr and coupled NiCr/Ti6Al4V stabilised at similar values in both solutions, with $p > 0.05$. For single Ti6Al4V and coupled Ti6Al4V/NiCr in 227 ppm/pH 5.5, before sliding, OCP also stabilised at similar values ($p > 0.05$). However, for 12300 ppm/pH 4.0, the OCP of single Ti6Al4V and Ti6Al4V/NiCr were more unstable, with a difference in potential that could be associated with galvanic interaction ($p < 0.05$). The single Ti6Al4V in 12300 ppm/pH 4.0 presented a continuous decrease in potential, with a tendency to stabilise within the thermodynamic corrosion domain of Ti. When coupled to NiCr, the Ti alloy in this solution presented a shift to higher OCP values, although with a continuous decrease in the potential over time. It is important to point out that the OCP of couples tends to stabilise within the thermodynamic passivation domain, as shown in Figure 5.

At the start of sliding, in all tested conditions, an immediate decay of the potential to lower values was observed because of the severe mechanical removal of the films formed at the metallic surface [7,13]. For NiCr alloy in 227 ppm/pH 5.5, single and coupled, lower potential values were maintained throughout the sliding process, recovering the initial values when the sliding was interrupted ($p > 0.05$). This behaviour is associated with the fact that in the corrosive solution, the Ti alloy remains passive, as pointed out in Figure 5, without influencing the corrosion process of NiCr when associated therewith. In 12300 ppm/pH 4.0, single NiCr maintained lower values of potential during the sliding, while the coupled NiCr/Ti6Al4V presented a decreasing potential during sliding, but with no significant differences between the initial and final values until sliding stopped ($p > 0.05$). This behaviour can be associated with titanium, which in this solution presents a tendency to corrode, making the coupled potential lower during sliding. For all conditions, at the end of sliding, the potential presented values close to the initial value, indicating the repassivation ability of NiCr. However, after sliding in 12300 ppm/pH 4.0, the coupled NiCr/Ti6Al4V presented a tendency to decrease potential, as a consequence of the potential variation of the Ti alloy towards the corrosion domain in this solution.

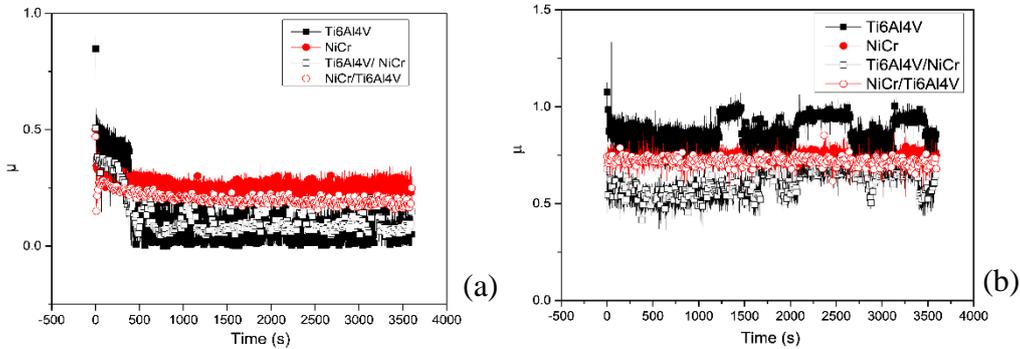
Figure 6: Coefficient of friction measurements during sliding from tribocorrosion tests of single and coupled combinations of NiCr and Ti alloy in 227 ppm/pH 5.5 (a) and 12300 ppm/pH 4.0 (b).

The evolution of the coefficient of friction is shown in Figures 5 and 6, with the respective averages given in Tables 2 and 3. The coefficient of friction calculated during the sliding steps exhibited a quick initial increase, corresponding to the destruction of the passive film, as mentioned in the literature [1], or to the removal of the first layer of material and initiation of the wear track. The subsequent evolution of the coefficient of friction suggests that after the initial step of film destruction, the alumina ball contacted the ground-sliding surface and the quasi-stationary process started. Results obtained with the NiCr alloy under sliding did not present significant variation for the coefficient of friction between the isolated and coupled conditions, for each solution ($p > 0.05$). However, the increase in fluoride concentration increased the coefficient of friction ($p < 0.05$), without affecting its amplitude ($p > 0.05$), for both alloys. Ti alloy sliding surfaces presented a decay in the coefficient of friction when under galvanic interaction with NiCr, for both solutions ($p < 0.05$), as well for the amplitude of the coefficient of friction ($p < 0.05$). Figure 9 presents the observed correlation that can be established during the sliding between OCP and the coefficient of friction for isolated and coupled Ti6Al4V. These variations can be associated with the incidence of plastic deformation, creation of new wear track lines, and debris acting as a third body on the wear tracks [7,11].

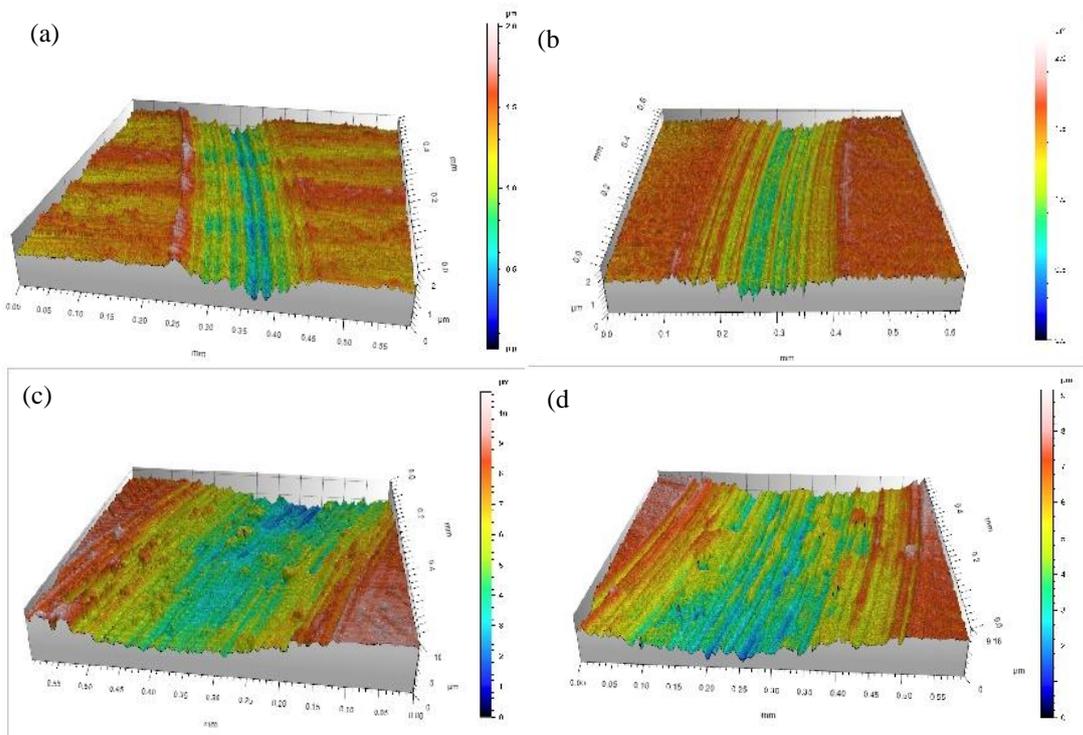
Figure 7: 3D image of a section of worn track for single NiCr (a), coupled NiCr/Ti6Al4V (b), single Ti6Al4V (c), and coupled Ti6Al4V/NiCr (d) after sliding tribocorrosion tests in 227 ppm fluoride and pH 5.5.

Figures 7 and 8 show the wear tracks of alloys after sliding in 227 ppm/pH 5.5 and 12300 ppm/pH 4.0, respectively. NiCr exhibited a track aligned with the sliding direction, with marks corresponding to the position where the alumina ball was in contact with the sliding surface. No differences in the wear track were observed for the isolated NiCr and coupled NiCr to Ti6Al4V in both solutions. For the Ti alloy, the wear

track showed areas associated with plastic deformation and detachment of the surface for isolated Ti6Al4V and coupled Ti6Al4V to NiCr in 227 ppm/pH 5.5, although it was less intense for the couple. In 12300 ppm/pH 4.0, isolated Ti6Al4V did not present persistent areas associated with plastic deformation because of the intense dissolution, while for the Ti6Al4V coupled to NiCr, it was possible to observe areas associated with plastic deformation and detachment of the material; however, these area were smaller than they were in 227 ppm F⁻ pH 5.5. The intense dissolution of isolated Ti6Al4V in 12300 ppm/pH4.0 was identified by Barros et al. [34]. The analysis carried out by the authors through SEM and ICP-MS techniques allowed to characterize the surface morphology and ions released and the maintenance on a passive state of coupled Ti6Al4V.

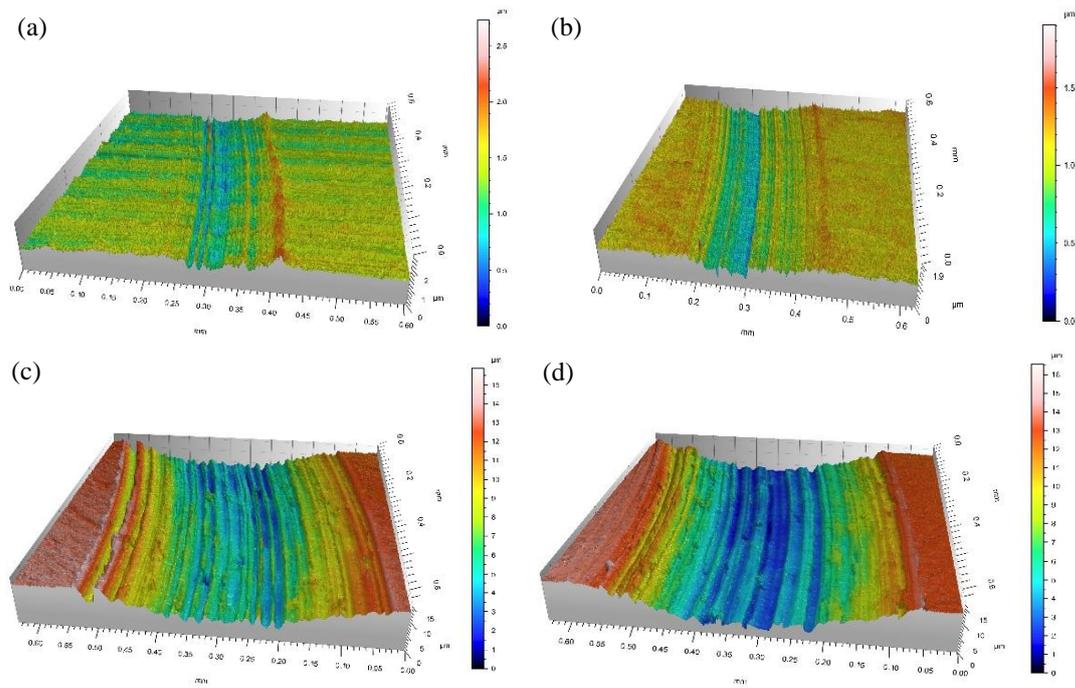
Figure 8: 3D image of a section of worn track for single NiCr (a), coupled NiCr/Ti6Al4V (b), single Ti6Al4V (c), and coupled Ti6Al4V/NiCr (d) after sliding tribocorrosion tests in 12300 ppm fluoride and pH 4.0.

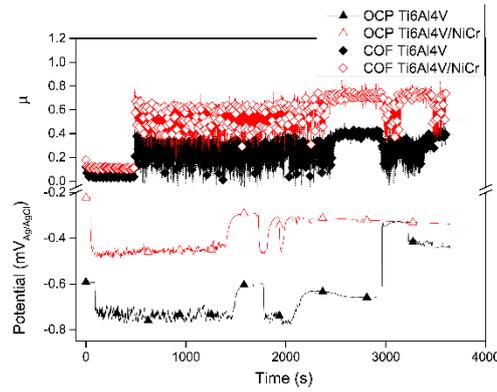
Figure 9: Correlation between coefficient of friction and OCP of Ti6Al4V during sliding tribocorrosion tests in 12300 ppm/pH 4.0 solution.
