# Degradation mechanism of 0.15 µm AlGaN/GaN HEMTs: effects of hot electrons

Z. Gao<sup>\*</sup>, F. Rampazzo, M. Meneghini, C. De Santi, F. Chiocchetta, D. Marcon, G. Meneghesso, E. Zanoni

Abstract – The degradation mechanisms of AlGaN/GaN HEMTs adopting Fe and C co-doping, with high and low carbon doping concentration were investigated by means of hot-electron step stress and 24 hours' stress tests. Firstly, DC and EL characterization at room temperature are summarized, then the parametric evolution during hot-electron step stress tests at the semi-on state was compared, the assumption for the degradation mechanism is that hot-electrons activated the pre-existing traps in the buffer, attenuate the electric field in the gate drain access region and damaging the gate contact, the parametric evolution during constant stresses is discussed.

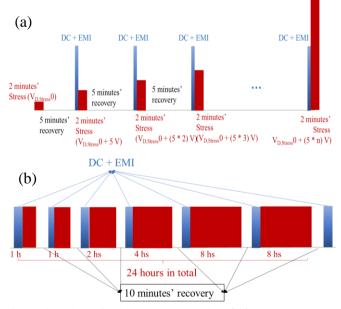
Fig. 1 Flow chart of (a) the step stress and (b) 24 hours' stress

HEMTs were submitted to on-wafer step-stress and constant voltage 24h stress tests. During step stress (in semi-on state, where the EL intensity is the strongest), drain voltage was increased from 0 V up to devices catastrophic breakdown in 5 V step, two minutes long each. During each stress step, drain and gate currents as well as EL intensity were monitored. After each stress step, the device was kept unbiased for 5 minutes, afterwards, a standard DC characterization and an EL image at the bias condition where there is the EL Bell peak ( $V_G = -1.5 V$ ,  $V_D = 5 V$ ) was taken, as shown in Fig. 1 (a).

gate currents were monitored, and a standard DC characterization were done after 1 hour, 2 hours, 4 hours and 8 hours, 16 hours and 24 hours' stress, after being kept unbiased for 10 minutes, as shown in Fig. 1(b). At least two devices were tested at each test condition.

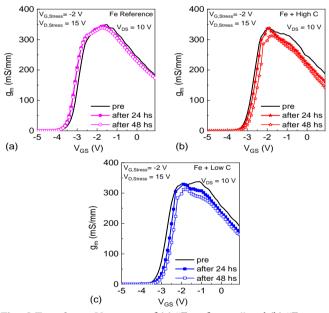
Fig. 8 Transfer  $g_m$ -V<sub>G</sub> curves of (a) "Fe reference" and (b) "Fe + High C" and (c) "Fe + Low C" wafers before and after 24 hours' stress at (-2 V, 15 V).

The transfer  $g_m$ -V<sub>G</sub> curves of the devices before and after 24 hours' stress are shown in Fig. 8. No significant  $g_{m,max}$  decrease was observed after the 24 hours' stress in all the wafers, however, there is about 5%, 8% and 9% drop in transconductance at high V<sub>GS</sub> for "Fe Reference", "Fe + Low C" and "Fe + High C" wafers, respectively. In order to observe the effects of hot-electron stress, the same device from each wafer was biased at the same point for another 24 hours, results showed that there is 2%, 6% and 7% degradation in  $g_{m,max}$  for the "Fe Reference", "Fe + Low C" and "Fe + High C" wafers, respectively; at the same time, the  $g_m$  degradation at high V<sub>GS</sub> turn into saturation.
