# Performance of chemically modified reduced graphene oxide (CMrGO) in Electrodynamic Dust Shield (EDS) applications

## Abstract

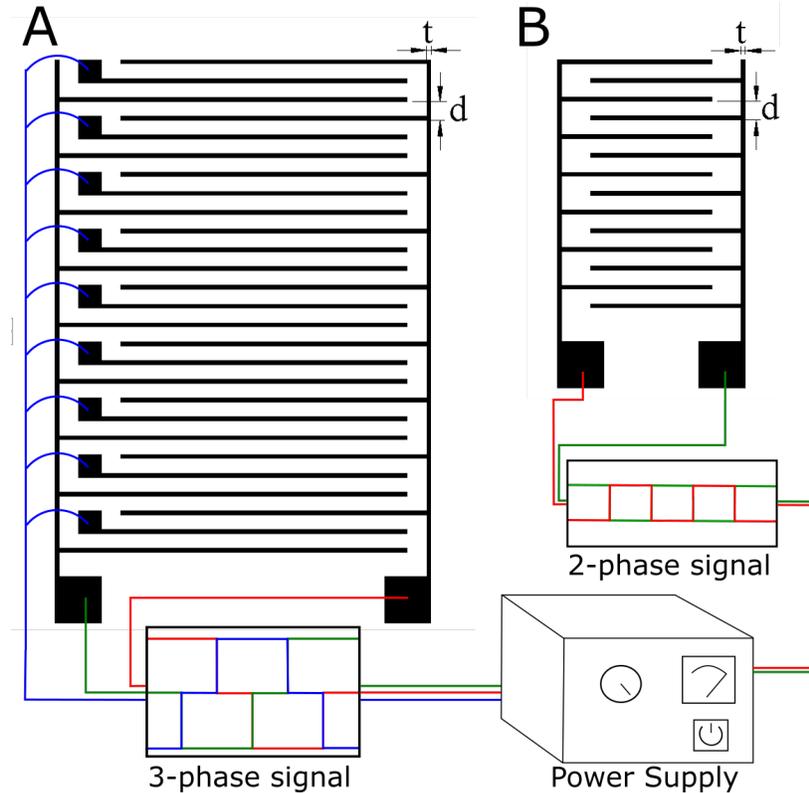
Figure 1. Illustration of the EDS patterns used in these experiments and associated dimensions. The three-phase device is shown in (A) and the two-phase device is shown in (B).

To initiate dust movement in EDS, a low-frequency, high-voltage AC signal is applied to the electrodes. Typical interdigitated device designs (shown in Figure 1) can be either 2-phase, consisting of two parallel electrodes, or 3-phase, consisting of three electrodes in either a rectangular or circular pattern.[19] The 2-phase devices can be run with one electrode grounded (1-phase operation) or with an AC signal applied to both electrodes (2-phase operation), while the 3-phase devices require a 3-phase signal. The applied fields set up a varying electric field above the device surface, where a standing wave potential is generated for 2-phase and a traveling wave for 3-phase devices. For the particles on the surface to be affected by the applied fields, they must themselves become electrically charged. In dielectrically capped devices, microdischarges produced at the edges of the electrodes create numerous charged species, and the mobile electrons can quickly diffuse to the positively charged electrode while the positive ions migrate through the dielectric and can accumulate on grain surfaces.[18] Coulombic and dielectrophoretic forces from the EDS

EDS devices were fabricated by patterning a surface-localized nanocomposite layer using melt infiltration to flow polymer substrate material into spray-cast nanoparticle traces (see Figure 2). Labeled diagrams of the devices are shown in Figure 1. The electrode trace thickness (' $t$ ') was 0.5 mm and the inter-electrode spacings (' $d$ ') were 2 mm for all devices used. The spray casting and infiltration approach produced a device composed of only CMrGO, modified with linear dodecyl substitutes,[20] (Figure 2A) and the chosen thermoplastic substrate, HDPE. Surface-localized nanocomposite traces were made by dispersing CMrGO in chloroform ( $\text{CHCl}_3$ ) at concentration of 10mg/ml and using a commercial airbrush (iwata Eclipse) and custom steel mask to pattern the CMrGO onto HDPE substrates (Figure 2B). After deposition, sprayed substrates were placed in a mold and static pressure and heat was applied to melt infiltrate the HDPE

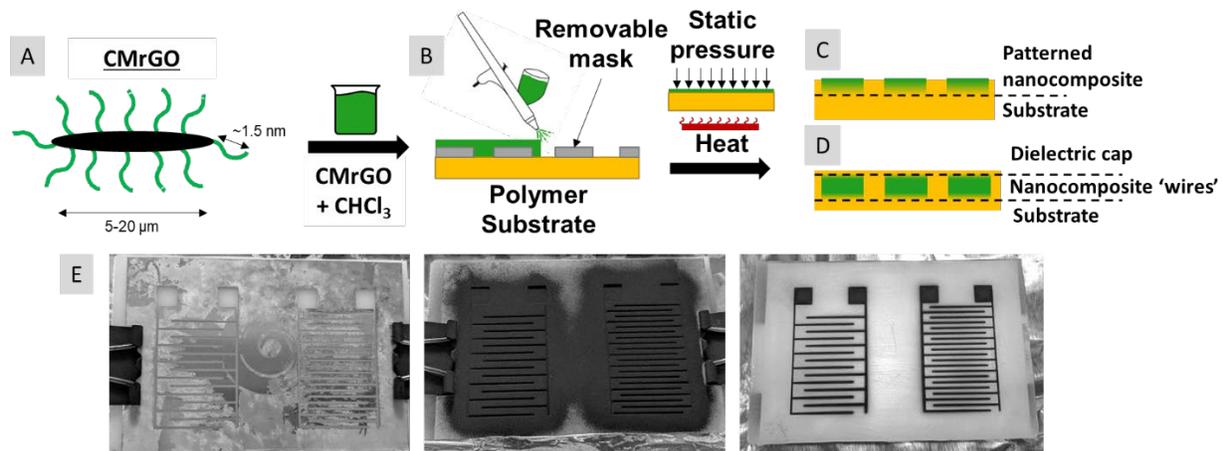
Figure 2. (A) Reduced graphene oxide chemically modified with dodecyl substituents (CMrGO) was dispersed in  $\text{CHCl}_3$  and (B) sprayed over a removable steel mask. (C,D) Sprayed substrates were then subject to heat and pressure to create an infiltrated surface-localized nanocomposite device. (E) Masked substrate before spraying (left), masked substrate sprayed with CMrGO (middle), patterned EDS devices on HDPE surface (right). White HDPE substrates are shown in these images to enhance visual contrast for photographs.

substrate into the CMrGO layer to create patterned nanocomposite regions fully integrated with the device surface (Figure 2C). Careful selection of the processing temperature, time, and pressure during infiltration allowed for direct control over the extent of infiltration and resulted in surface morphology which was varied from topographically rough and partially consolidated to smooth and fully consolidated, rough and smooth devices, respectively. After infiltration, devices were briefly sonicated in chloroform and wiped clean prior to use. This cleaning procedure removed any CMrGO particles that were not at least partially embedded in the HDPE matrix. Average sheet resistance measured using a 4-point line probe at five separate locations can be found in Table S1.

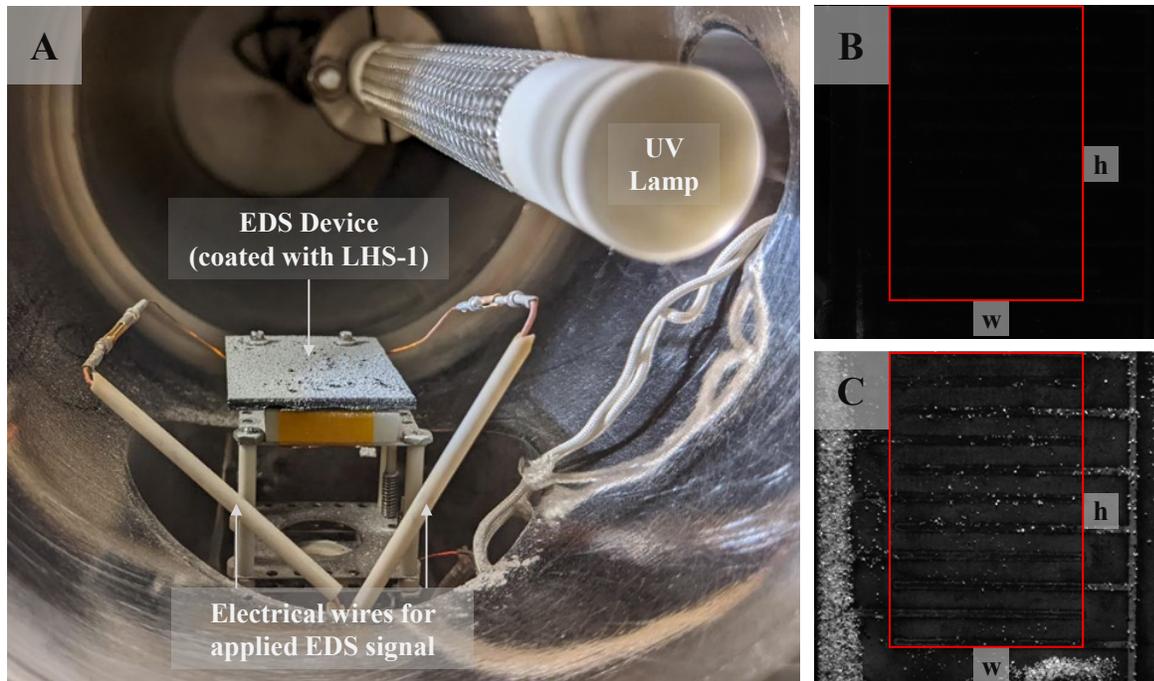
Figure 3. (A) Experimental system with 2-phase sample installed and coated with a layer of dust. The UV excimer lamp is ~5 cm above the device surface. (B) Camera images of the device surface prior to coating with dust and (C) after running the EDS for ~5 min. The area of analysis, indicated by the red box, had a width of about 13mm and a height of about 21mm.

To determine the dust removal efficiency, time-lapse images were captured at 1 sec intervals while the EDS was active. The devices were illuminated with a collimated, 455 nm LED light source (Thor Labs, M455L4) mounted outside the experimental chamber to provide uniform lighting across the entire surface. The intensity of the LED did not cause any observable heating, and the brightness was sufficient such that no change in illumination conditions could be detected during UV lamp pulsing. Photos of the bare and cleaned devices (see Figure 3B,C, respectively) were taken from directly above using a monochromatic camera (Manta, 146B GigE) with a 25 mm focal length lens (Navitar). The surface cleanliness was determined using the ImageJ software to determine the percentage of the surface covered by dust using a brightness thresholding technique.[22] The area of analysis of the 2-phase devices was restricted to only the area where the electrodes overlapped (see Figure 3C), while for the larger 3-phase devices the entire

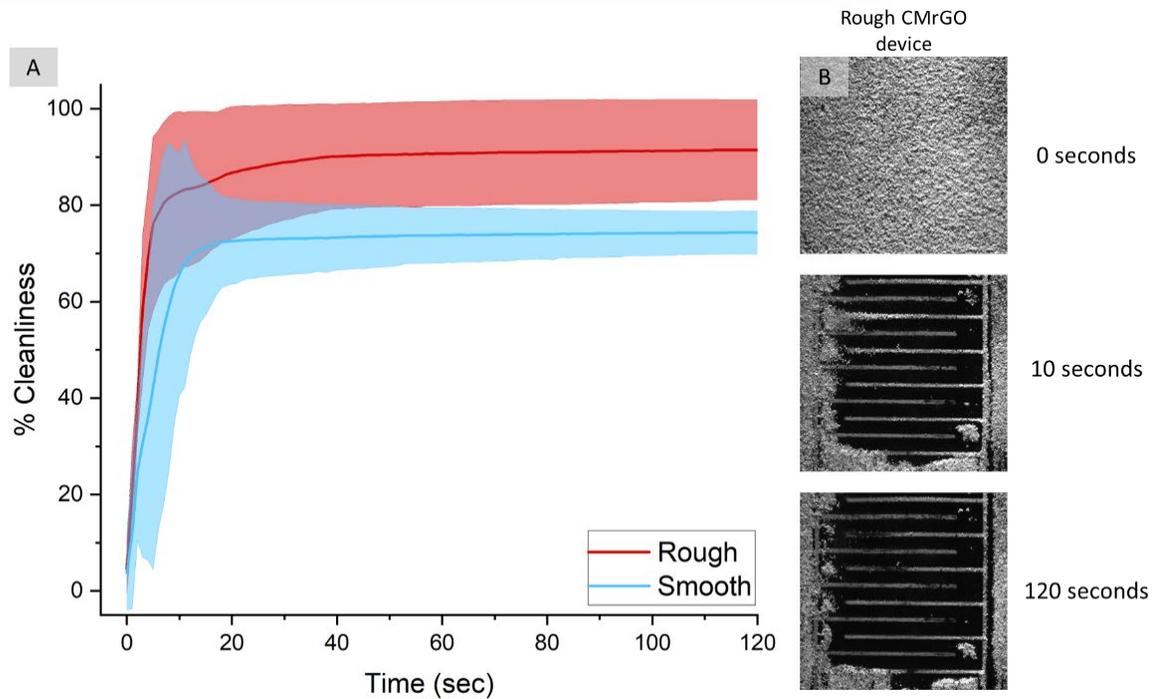
Figure 4. (A) Surface cleanliness achieved for the CM-rGO EDS devices as a function of time using 1000V peak-to-peak applied to the rough (red) and 2000V peak-to-peak applied to the smooth (blue). The mean cleanliness with 95% confidence intervals were determined from 3 experiments for each condition. (B) Images of the rough sample during one of the experiments. The top image was the initial condition, the middle image was ten (10) seconds into the experiment, and the bottom image was the was one-hundred-and-twenty (120) seconds into the experiment after a steady state had been reached.

The rough devices cleared the dust at significantly lower voltages than the smooth devices, 1000 V vs 2000 V, respectively, and were routinely able to achieve a higher percent cleanliness as shown in Figure 4A. For both device configurations, most of the dust was cleared within a few seconds of initiating the EDS, and a steady state cleanliness was typically reached in 10-20 seconds. The EDS cleaning behavior was repeatable for similarly prepared devices, and the cleanliness could be obtained for at least three sequential re-dusting and activation tests. However, there was an eventual decrease in the grain removal efficiency with additional testing for both rough and smooth devices. This led to a more gradual clearing of the dust grains from the surface and a reduction in the maximum % cleanliness achieved for the same EDS testing parameters. The differences in the initial cleaning efficiencies immediately after the EDS is turned on is indicted by the large initial confidence interval for the smooth device (Figure 4A); no smooth device ever reached greater than 85% cleanliness, and the larger uncertainties in the 95% confidence intervals for the first 20 sec are due to different rates of cleaning. For the rough devices, significant degradation in the performance was typically evident by the fifth test. This effect was even more pronounced in the UV tests described further in §3.2. A visual demonstration of the progression in surface cleanliness is shown in Figure 4B, where the lower panel indicate that residual dust tended to accumulate on the conductive traces.

approach their maximum cleanliness within 10-20 seconds (see Figure 4A), while the 3-phase devices typically required >50 seconds to reach the maximum dust removal, even in the very first device test after production (Figure 5A). The vacuum chamber pressure was also observed to have a notable effect on the efficiency of the smooth 3-phase devices, which was not the case for the 2-phase devices. Experiments run after pumping the chamber for several hours showed significantly worse performance than the devices that were pumped overnight (see Figure 5A). The degradation of performance in the smooth 3-phase device due to sequential activation and re-dusting was lower than the smooth 2-phase device, despite higher operating voltages. Figure 5B shows a series of cleanliness images for the smooth three-phase device at  $10^{-7}$  Torr operating conditions. Similar to the 2-phase devices, the dust segregated to the conductive trace regions.

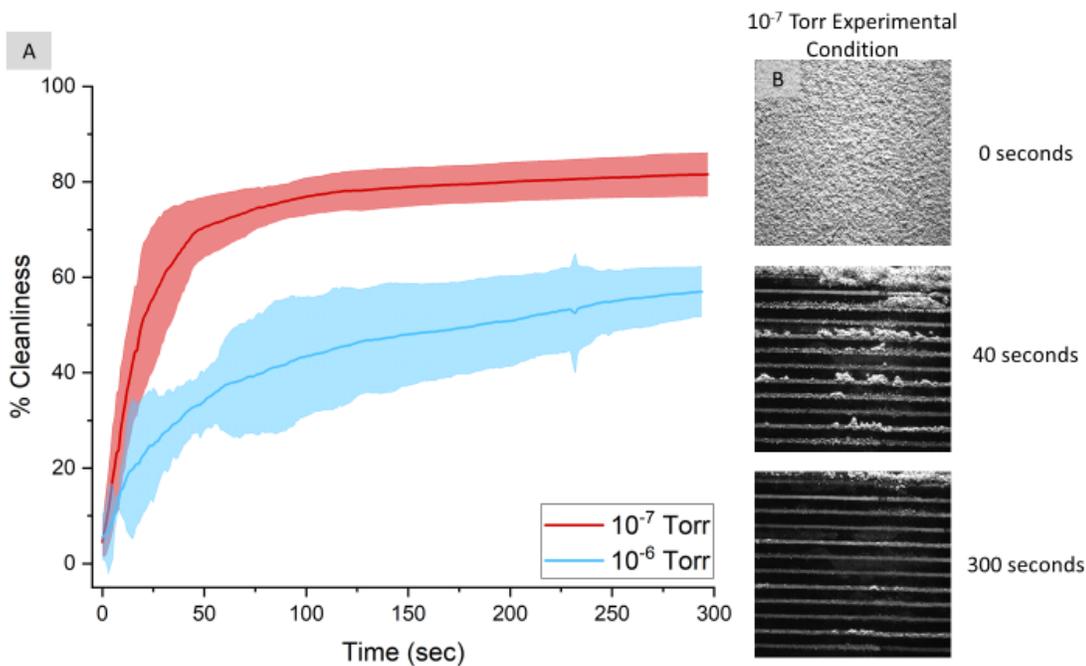
Figure 5. (A) Surface cleanliness versus time achieved using the 3-phase smooth CM-rGO EDS devices after pumping the vacuum chamber for about four (4) and twenty-four (24) hours (blue “ $10^{-6}$  Torr” and red “ $10^{-7}$  Torr”, respectively). (B) Images of the  $10^{-7}$  Torr sample during one of the experiments. The top image was the initial condition, the middle image was forty (40) seconds into the experiment, and the bottom image was the was three-hundred (300) seconds into the experiment when the experiment had ceased.

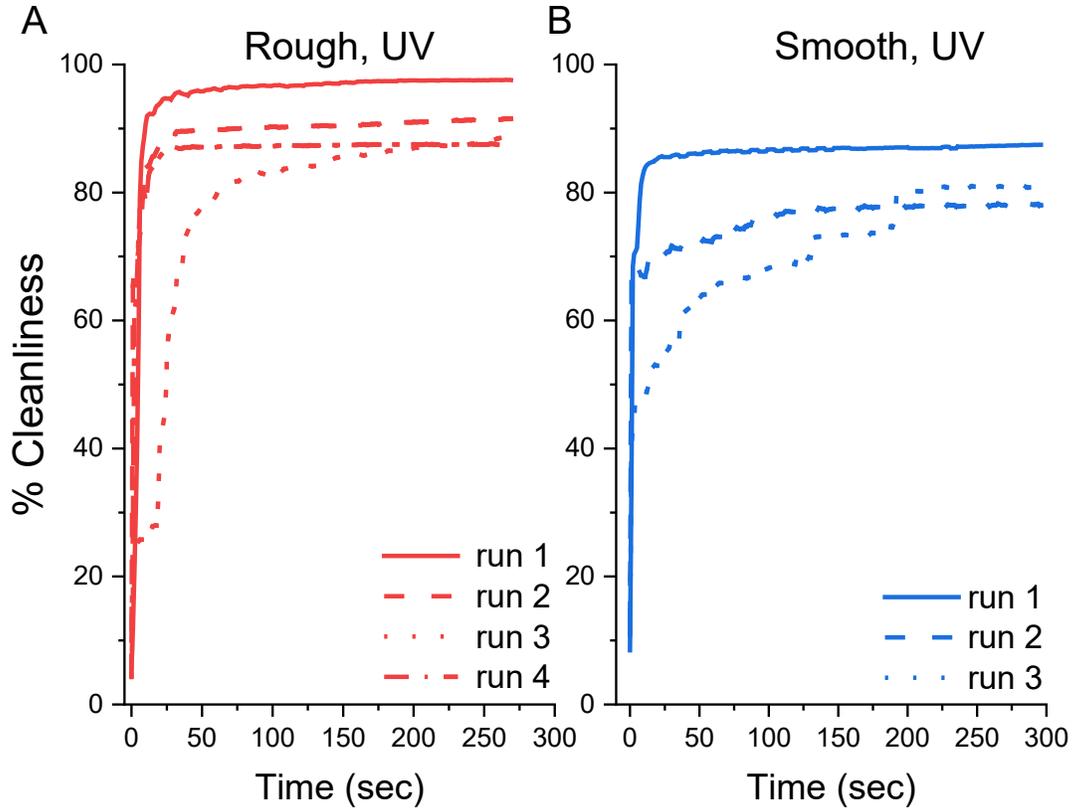
Figure 6. Line plots depicting the % cleanliness achieved using (A) 800V peak-to-peak applied to the rough configuration and (B) 1000V peak-to-peak applied to the smooth configuration while illuminating the dust surface with UV light.

It was observed that, while the UV was on, there was an increase in the frequency and abundance of discharges for similar operation voltages as in the non-UV experiments. Further, subsequent activation and re-dusting tests showed that UV illumination caused the devices to degrade more rapidly, but in the same manner as the non-UV tested devices, as shown by the erosion of the device surfaces in Figure S1C,F and S3C,F. The series of runs shown in Figure 6 for both the rough and the smooth samples show a clear deterioration in performance after the first test. This trend was not observed for the non-UV tests presented above in which variable cleanliness results had no clear trend associated with activation and re-dusting. In the UV tests for the rough sample, test 1 showed rapid and near complete (>95%) removal of the dust from the device surface at only 800 V, but by the fourth test the rate of cleaning was noticeably delayed, as shown in Figure 6A, and the maximum cleanliness reached during the experiment was only about 85%. Subsequent testing on these devices with UV continued to degrade the performance. A similar trend was noted in the

smooth devices tested with UV, where initially similar cleanliness levels to the non-UV tests were achieved, but subsequent tests slower cleaning and reduced ultimate cleanliness (Figure 6B).

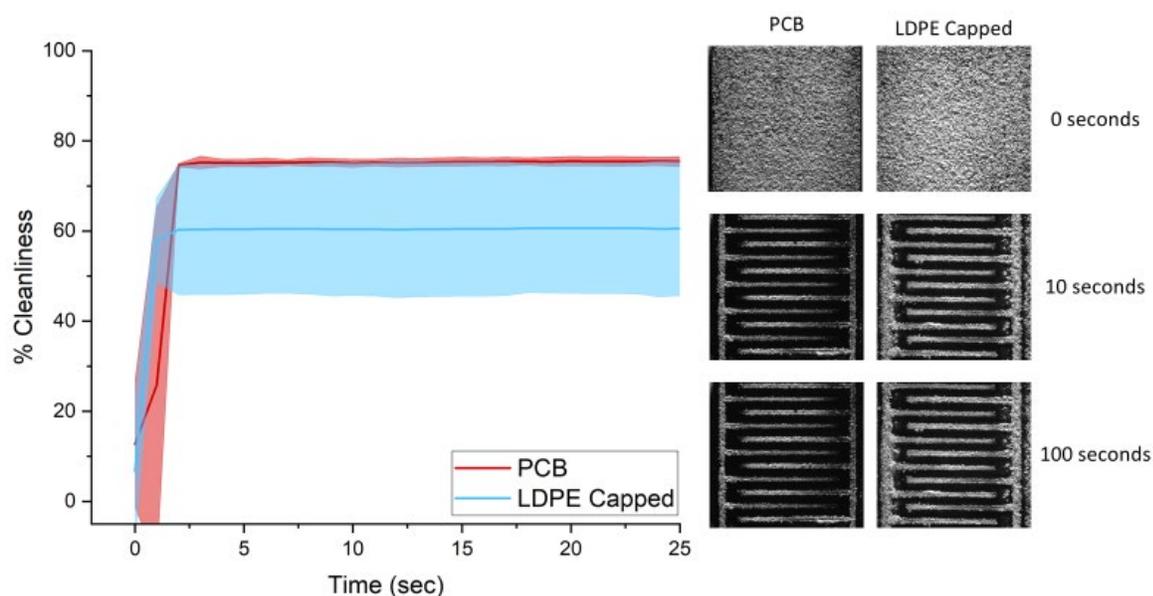
Figure 7. Surface cleanliness versus time achieved using the PCB EDS chip (red) and the LDPE capped CM-rGO EDS chip (blue) with UV photoelectric charging. The mean cleanliness with 95% confidence intervals were determined from 3 experiments for each condition.

The percent removal for the low-density polyethylene (LDPE) and PCB capped devices is shown in Figure 7. The LDPE capped device showed more variable cleaning performance than the PCB device, but there was no trend in the cleanliness indicating degradation of the device as seen in the uncapped conditions exposed to UV. Variability of the cleaning performance of the LDPE capped device manifested as different final cleanliness values with no significant change in the rate of cleaning during subsequent tests. The PCB device attained consistent cleanliness values; however, they did not perform as well as the uncapped CMrGO devices, despite the larger applied EDS potentials.
