# High-Resolution Short-Circuit Fault Localization in a Multi-Layer Integrated Circuit using a Quantum Diamond Microscope

As integrated circuit (IC) geometry and packaging become more sophisticated with ongoing fabrication and design innovations, the electrical engineering community needs increasingly-powerful failure analysis (FA) methods to meet the growing troubleshooting challenges of multi-layer (with multiple metal layers) and multi-chip components. In this work, we investigate a new electronics FA method using a quantum diamond microscope (QDM) to image the magnetic fields from short-circuit faults. After quantifying the performance by detecting short-circuit faults in a multi-layer silicon die, we assess how a QDM would detect faults in a heterogeneously integrated (HI) die stack. This work establishes QDM-based magnetic imaging as a competitive technique for electronics FA, offering high spatial resolution, high sensitivity, and robust instrumentation. We anticipate these advantages to be especially useful for finding faults deep within chip-stack ICs with many metal layers, optically-opaque layers, or optically-scattering layers.

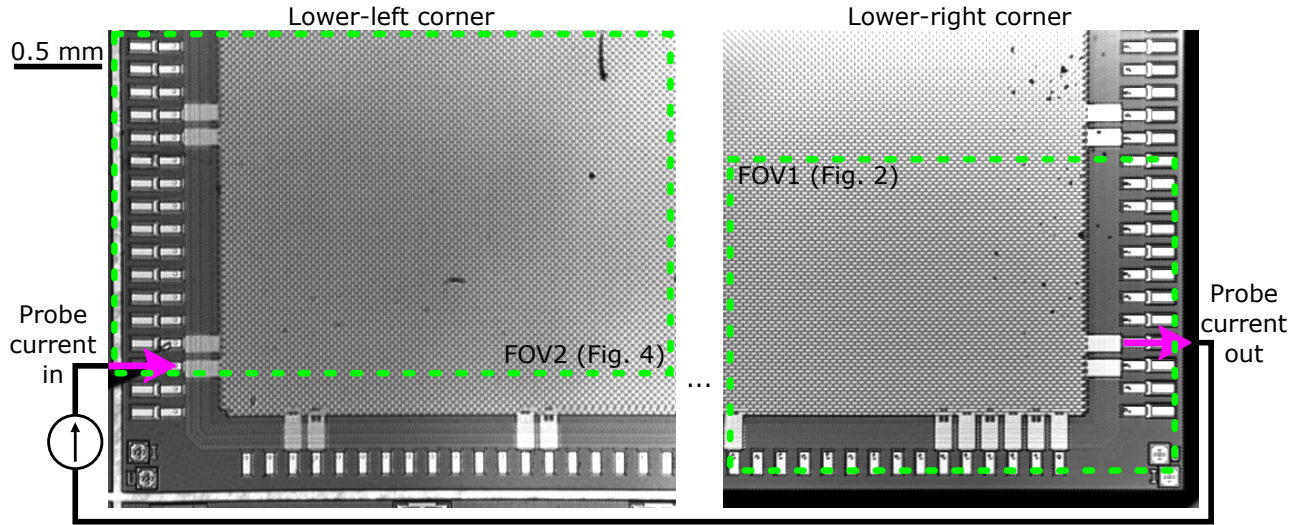
FIG. 1. Photos of the lower-left and lower-right corners of the DUT, which we investigate in this work. We apply a probe current to a pad near the lower-left corner, after which it flows through the DUT and is collected from a pad near the lower-right corner. The green boxes indicate the fields of view (FOV) shown in later figures.

Figure 1 shows optical images of the lower-left and lower-right corners of the DUT, where we searched for short-circuit faults. We present the results of two such dice. The fields of view being imaged are indicated as FOV1 and FOV2 for Die 1 and Die 2, respectively. We applied a test current between two pads using probe tips, then used NV magnetic imaging and TIVA imaging to search for short-circuit faults.

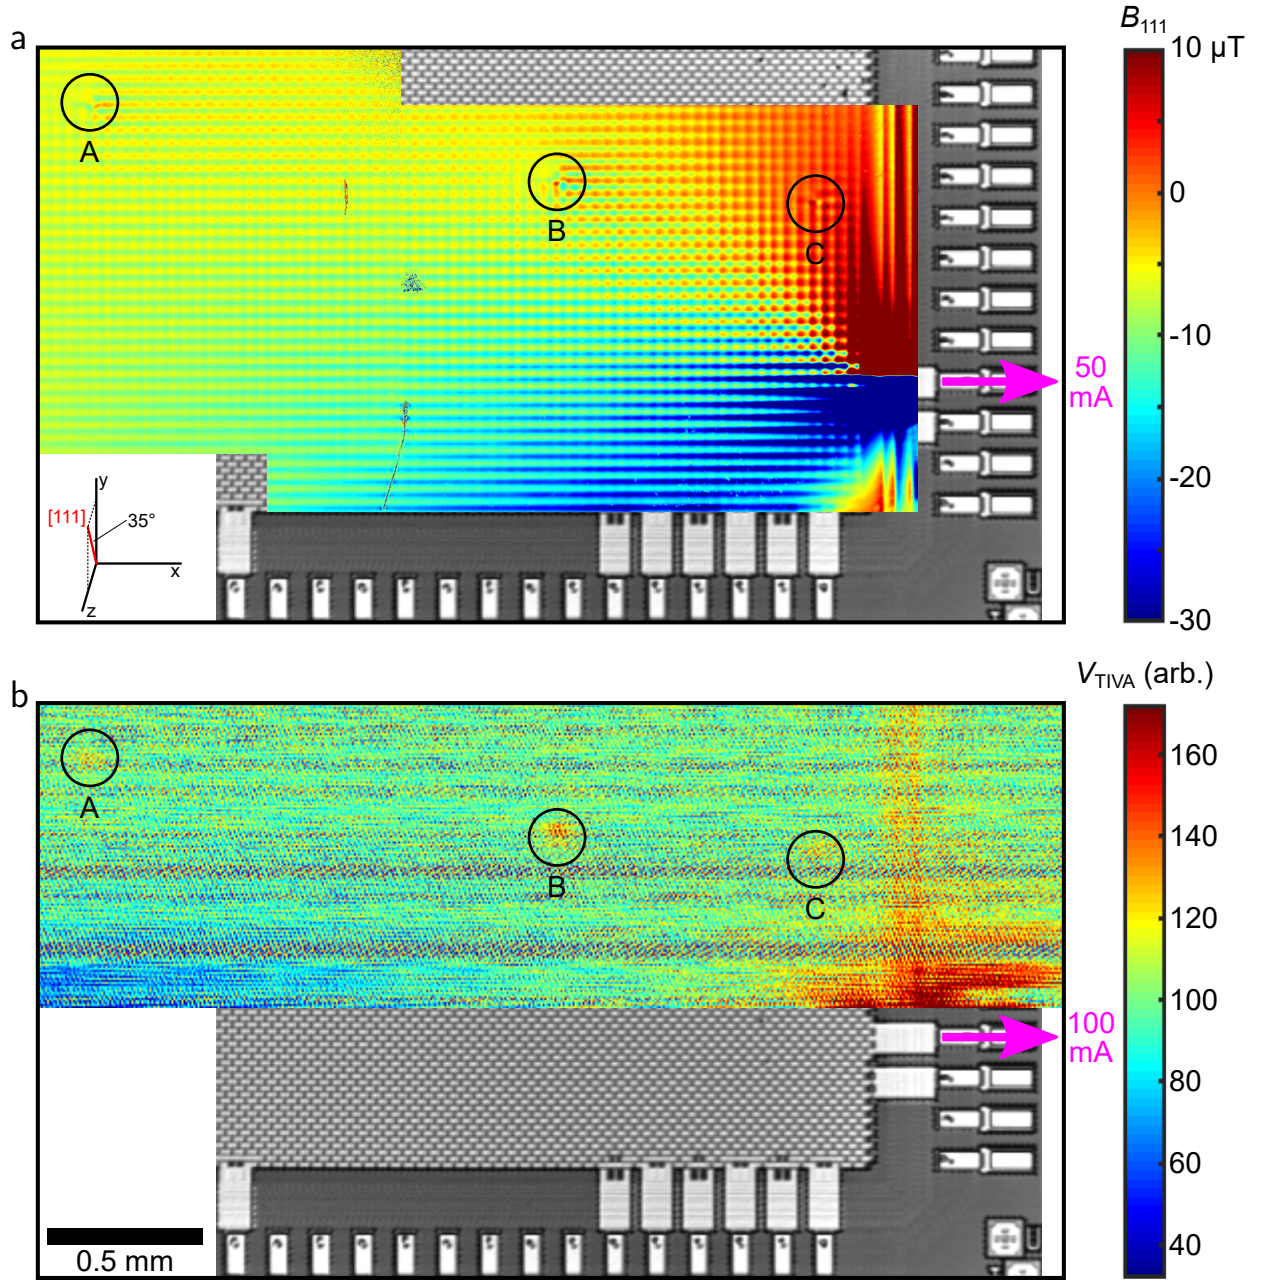
FIG. 2. (a) NV magnetic image with a 50 mA test current, with Faults A-C circled. The extra scratch marks are due to defects in the diamond surface. (b) TIVA image with a 100 mA test current, showing Faults A-C in the same locations.

Figure 2 shows two overlaid NV magnetic images and a TIVA image near the lower-right corner of a die (FOV1). We applied a 50 mA test current for the NV magnetic imaging experiments and a 100 mA test current for the TIVA imaging experiment. As the applied current disperses from the input pad and converges towards the output pad, it creates a grid pattern in the magnetic images similar to the grid pattern of Layers 4 and 5. The grid pattern contains defects caused by

current traveling between Layers 4 and 5 along the  $z$ -axis, indicating short-circuit faults (labeled Faults A, B, and C). For comparison, the faults in the TIVA images appear as circular features (where laser heating at the fault location modifies the resistance) on top of a nominally-uniform background.

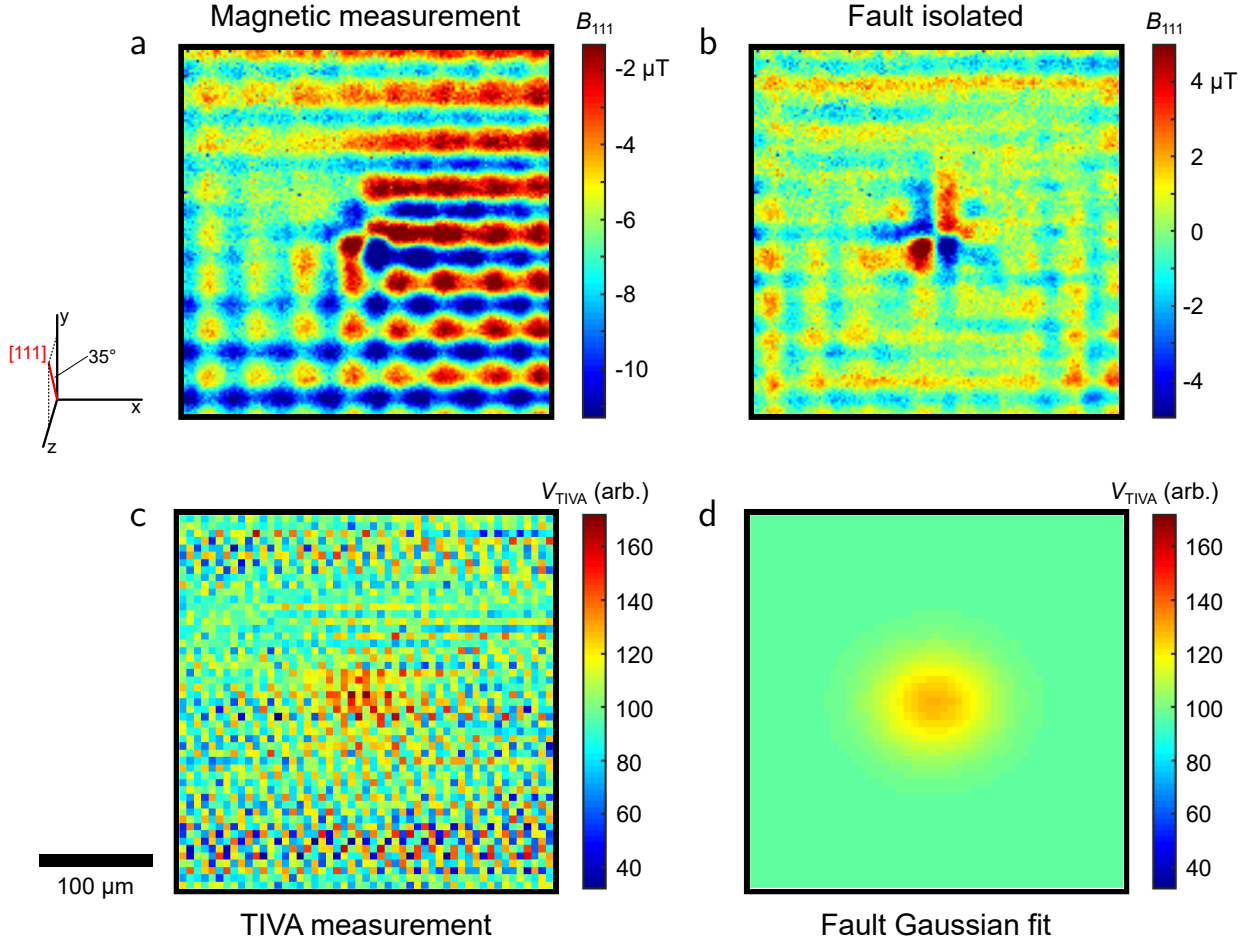
FIG. 3. (a) QDM magnetic image for Fault B. (b) Magnetic image after suppressing the background magnetic fields, removing the grid pattern in the Fourier transform and removing a quadratic background field. From this image, we extract a  $B_{\text{fault}} \approx 7.7 \mu\text{T}$  fault amplitude when applying a 50 mA test current. (c) TIVA image for Fault B. (d) 2D Gaussian fit for the TIVA image, from which we extract  $V_{\text{fault}} = 32$  and  $\delta V = 19$  for the fault amplitude and noise floor when applying a 100 mA test current. Note that both methods had a 20 minute experiment duration, but the TIVA imaging experiment had  $2\times$  larger test current,  $\sim 3\times 3$  larger pixels, and almost  $4\times$  larger area.

In Fig. 3a-b, we evaluate  $B_{\text{fault}}$  for Fault B. This is nontrivial to evaluate because we have to separate the  $B_{\text{fault}}$  amplitude from the grid pattern superimposed on the fault, and both have a comparable amplitude. To separate them, we took the Fourier transform of Fig. 3a and set the amplitudes of the frequency compo-

nents from the grid pattern to zero. After calculating the inverse Fourier transform (with a suppressed grid pattern), we removed a quadratic background magnetic field. These fault isolation steps yield the magnetic field map of the isolated fault in Fig. 3b. Fault B has a 7.7  $\mu\text{T}$  amplitude when using a 50 mA test current, which leads to  $\text{SNR}_{\text{QDM}} = 5.1$  for a 1 A test current, 1 s measurement duration, and  $1 \times 1 \mu\text{m}^2$  pixel size.

In Fig. 3c-d, we evaluate  $V_{\text{fault}}$  and  $\delta V$  for Fault B. We fit the fault image with a 2D Gaussian function to find  $V_{\text{fault}} = 32$  and  $\delta V = 19$  in arbitrary units. Applying the relevant normalization factors, we get  $\text{SNR}_{\text{TIVA}} = 0.15$  for 1 A test current, 1 s measurement duration,  $1 \times 1 \mu\text{m}^2$  pixel size, and  $2.74 \text{ mm}^2$  image area.

For NV magnetic imaging, Fault B has a location uncertainty of a few microns, indicated by the width of the cross shape in Fig. 3b. Note that the  $\{x, y\}$  location of a fault within the  $8 \mu\text{m} \times 8 \mu\text{m}$  overlap between the traces in Layers 4 and 5 cause very different magnetic images. Simulating this phenomenon and comparing to the experimental magnetic images can yield a fault position uncertainty significantly smaller than the  $16 \mu\text{m}$  periodicity for these conducting layers. For the TIVA image, the 2D Gaussian in Fig. 3d has a standard deviation of  $34 \mu\text{m}$ . This standard deviation provides an estimate for the spatial resolution, though the centroid uncertainty can be made arbitrarily small with sufficiently-good SNR. Overall, we conclude that our QDM spatial resolution is  $\sim 10\times$  better than the TIVA imaging spatial resolution, though both could be enhanced with additional hardware improvements and post-processing efforts.

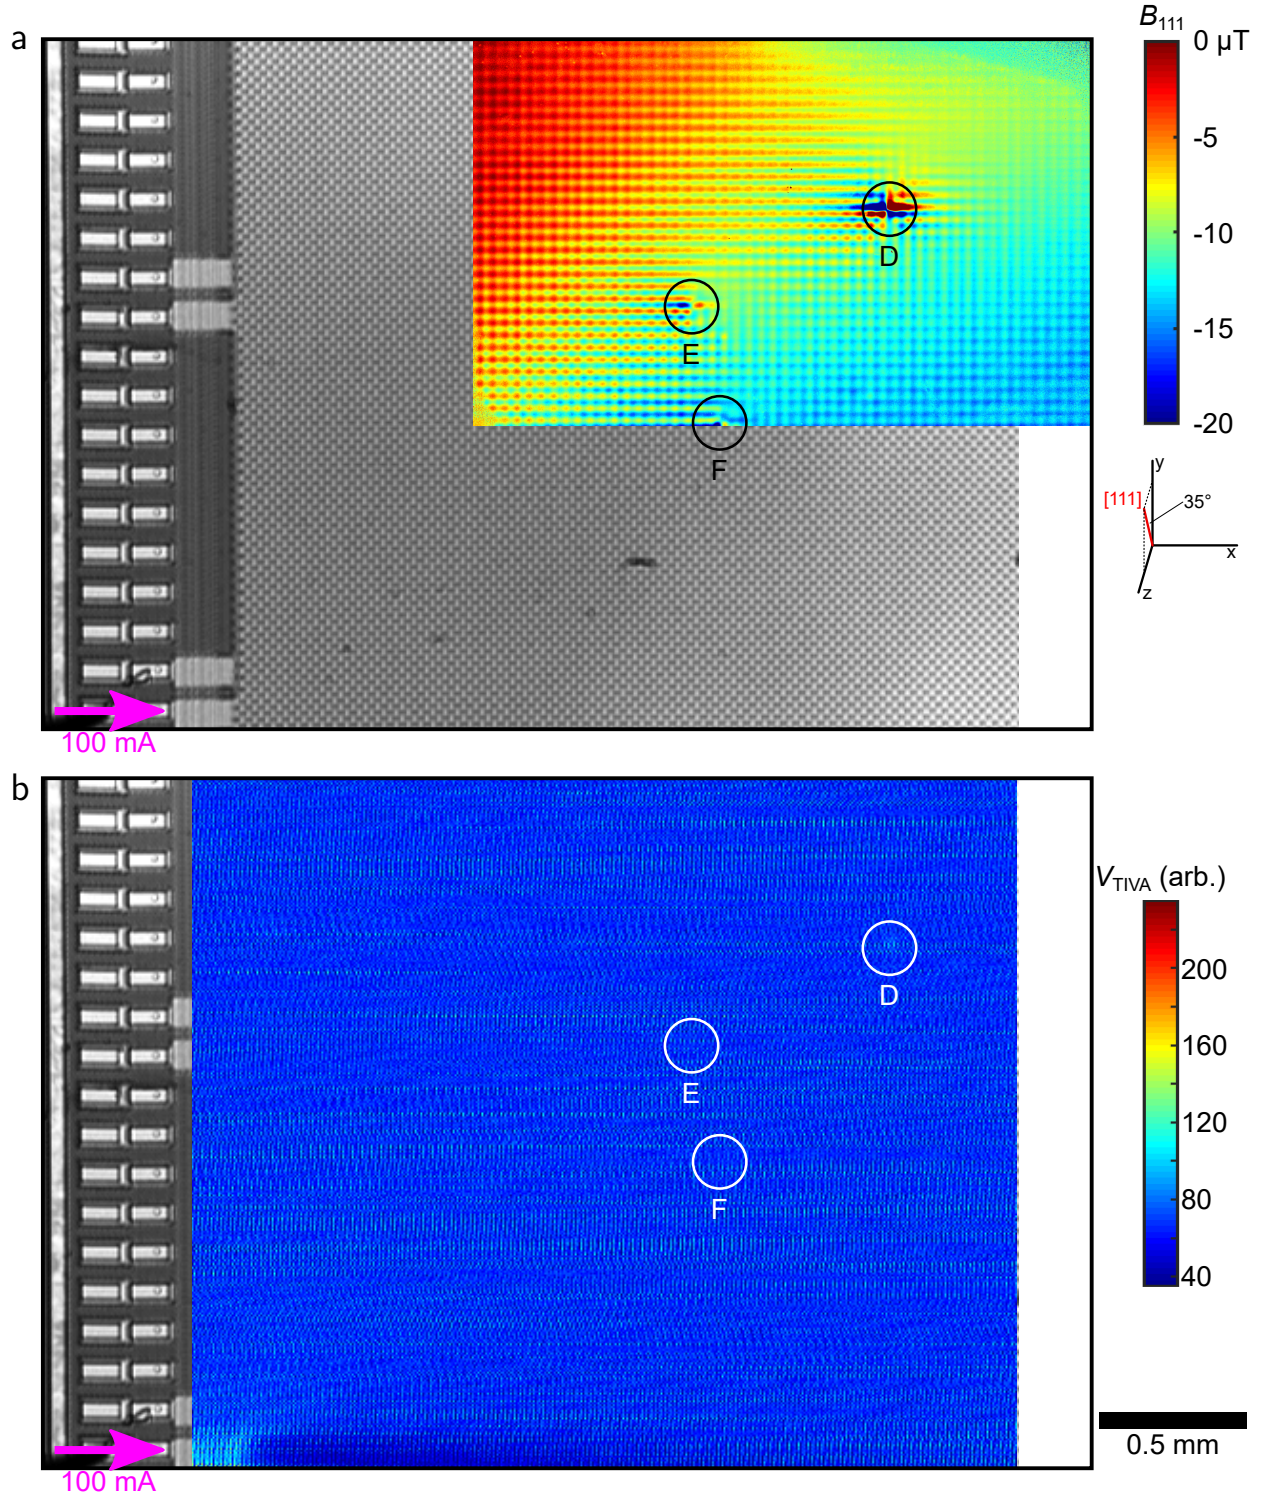
FIG. 4. (a) QDM magnetic image for FOV2, showing Faults D-F. (b) TIVA image for FOV2, showing the same three fault locations. Fault D is visible, but Faults E and F are too weak to see.

Figure 4 shows magnetic and TIVA images for a second die, in an area closer to the middle of the die where the currents are weaker. We applied a 100 mA test current for both the NV magnetic imaging and the TIVA imaging experiments, and we see three additional short-circuit faults, labeled Faults D, E, and F. Both techniques see a strong short-circuit fault (Fault D), though it is barely visible in the TIVA image. Furthermore, the NV magnetic image sees two additional faults (Faults E and F), which have magnetic field amplitudes that are

$\sim 20\text{-}40\times$  weaker than that of Fault D. Faults E and F are too weak to see in the TIVA image, confirming our earlier finding that  $\text{SNR}_{\text{QDM}}$  is better than  $\text{SNR}_{\text{TIVA}}$ . Given knowledge of their locations from the magnetic image, we were later able to locate them after several

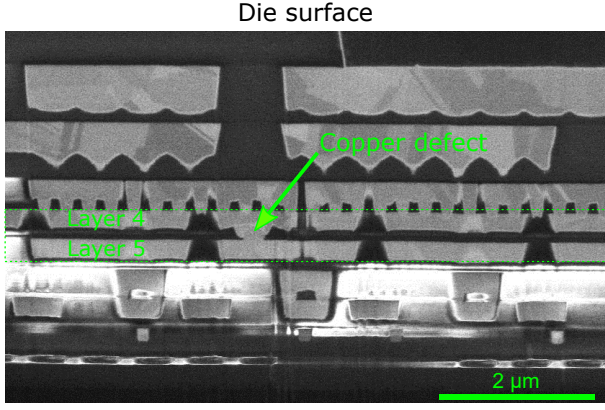
FIG. 5. A scanning optical microscope (SEM) image of a die cross-section showing Fault F, which is caused by a copper defect between Layers 4 and 5.

sections. Figure 5 includes a cross-section for Fault F, showing the copper defect causing a short between the conducting layers.

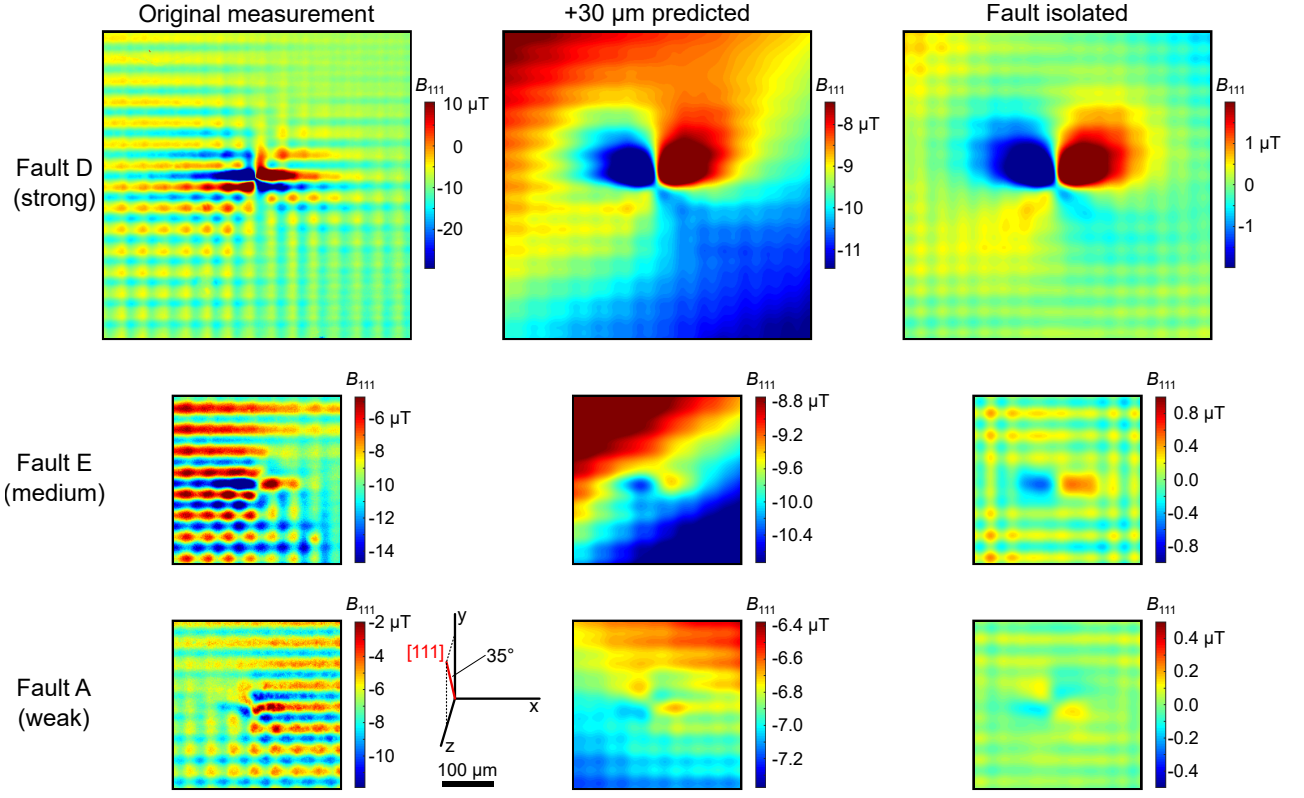
FIG. 6. Magnetic images for Faults D, E, and A, representing strong, medium, and weak-amplitude faults. Using the measured magnetic images (left column), we simulate the magnetic images if the die was part of an HI device, with an additional 30  $\mu\text{m}$  die on top (middle column). We applied the same fault isolation post-processing to remove the background ripples and gradients as in Fig. 3 (right column).

The DUTs imaged in Fig. 2 and Fig. 4 are intended to be part of an HI device, with an additional 30  $\mu\text{m}$  die to be mounted on top. To simulate the magnetic images for short-circuit faults if they were measured in an HI device, we calculated the expected magnetic field images with 30  $\mu\text{m}$  of additional standoff distance [6], shown in Fig. 6. We evaluated the anticipated performance for three typical fault magnetic amplitudes: strong (Fault D), medium (Fault E), and weak (Fault A). As expected, the grid patterns and fault features become weaker and coarser, but fortunately the fault features are still visible with the added standoff distance, especially after using the fault isolation steps described above. This suggests that NV magnetic microscopy could also work well for HI devices, despite the increased standoff distance. However, since weak magnetic features become more difficult to isolate from the background magnetic field with increasing standoff distance, minimizing the measurement standoff distance is always preferable. Despite these limitations, Fault D (which has a large  $B_{\text{fault}} \approx 120 \mu\text{T}$  amplitude and a small background gradient) should be visible as far as

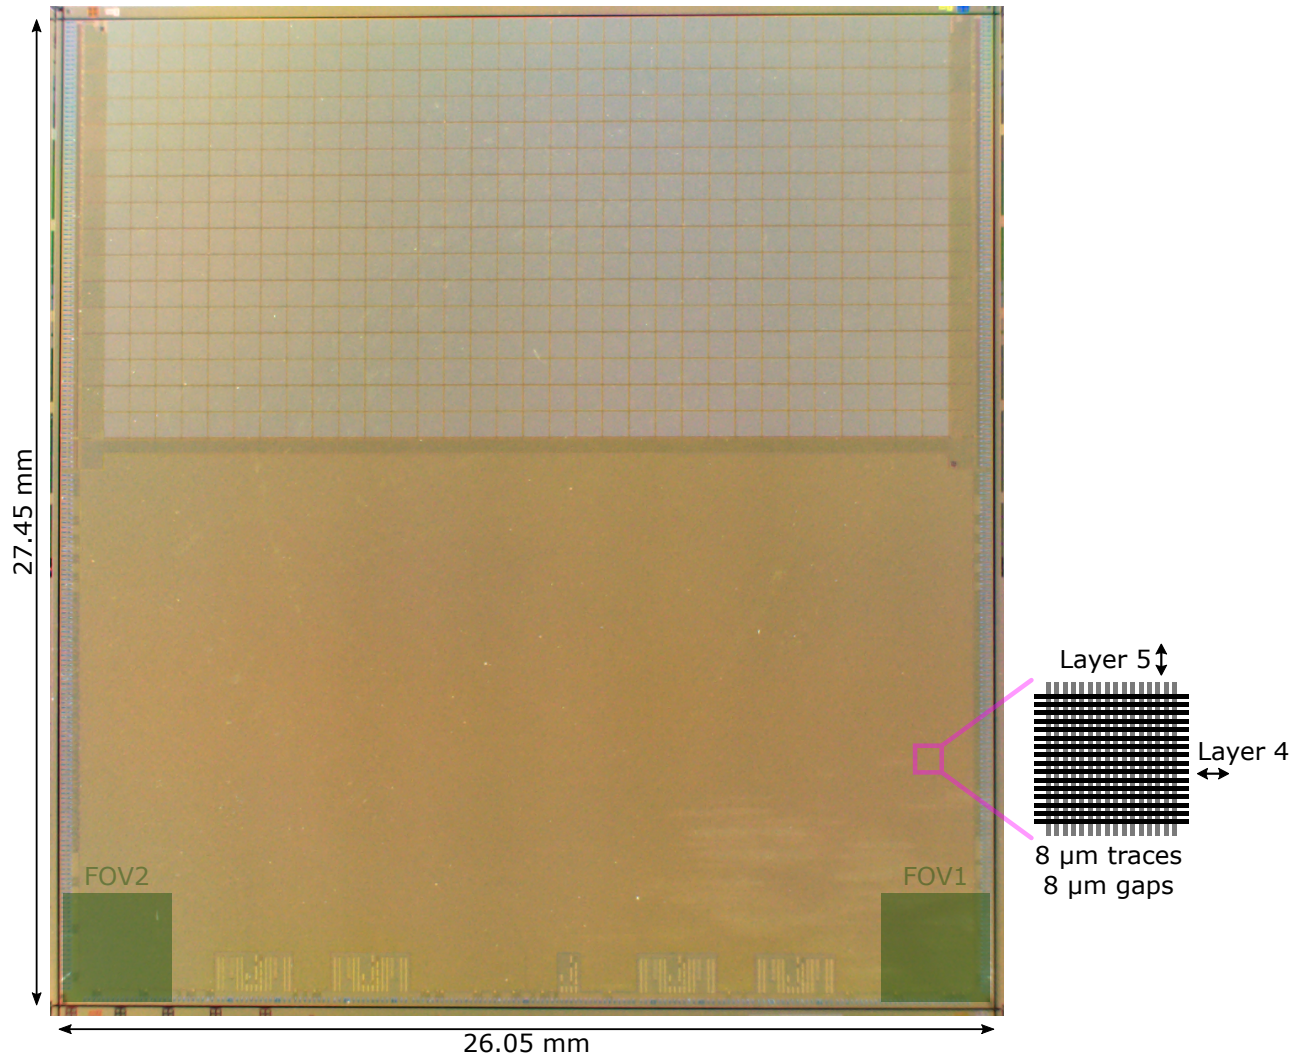
**Supplementary Figure S1.** Image of the device under test (DUT) used in this work, an ASIC with multiple conducting layers. The fields of view examined in this work (FOV1 and FOV2) are highlighted in green, and the inset shows the grid layout for the relevant conducting layers (Layers 4 and 5).

Figure S1 shows a photo of an example die studied in this work. Die 1 and Die 2 were made on a silicon wafer, and we performed the experiments on the DUTs before wafer dicing. Internally, the DUT has multiple metal layers, and our work involved searching for short-circuit faults between the power planes in Layers 4 and 5. These layers contain orthogonal rows and columns arranged in a grid pattern, as shown in the Fig. S1 inset. We applied test currents through probe tips placed on the relevant pads.

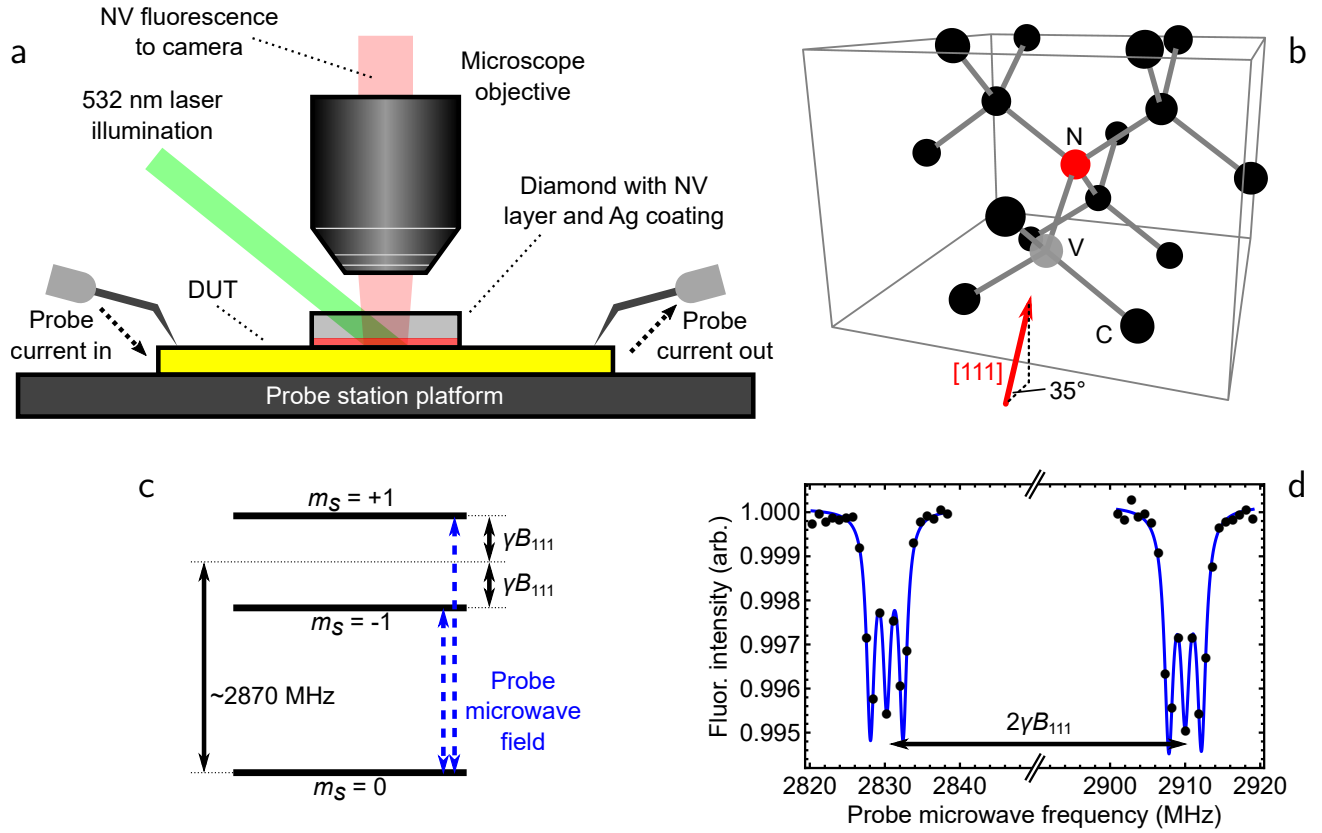
**Supplementary Figure S2.** (a) Schematic of the combined QDM/probe station setup for measuring a DUT, in this case an ASIC die. A diamond sample with a surface NV layer (red stripe) is placed on top of the DUT, illuminated with 532 nm laser light, and the NV fluorescence is imaged by the microscope. The microwave wire and bias  $B_{111}$  magnetic field are not shown. (b) NV center in the diamond carbon lattice, with an arrow showing the [111] crystallographic direction. (c) Energy level diagram of the NV ground-state magnetic sublevels, indicating the  $\pm\gamma B_{111}$  Zeeman effect and the zero-field splitting ( $\sim 2870$  MHz). (d) Example single-pixel ODMR spectrum; each lineshape is split into three peaks due to the  $^{14}\text{N}$  hyperfine interaction [S6].

Our QDM setup combines an optical fluorescence microscope (used for magnetic imaging) and a probe station (used to apply test currents to the DUT), as shown in Fig. S2a. In the QDM setup, we place a  $4 \times 4 \times 0.5$  mm<sup>3</sup> diamond sample (Sample A in Ref. [S1]) with a 4  $\mu$ m sheet of magnetically-sensitive NV centers on top of the DUT (Fig. S2b). The NV electronic ground-state magnetic sublevels are sensitive to the magnetic field  $B_{111}$  along the N-V axis (the [111] crystallographic direction), leading to the  $m_s = 0$  to  $m_s = \pm 1$  transition frequencies being shifted by  $\pm \gamma B_{111}$ , where  $\gamma \approx 28$  GHz/T is the NV gyromagnetic ratio. We illuminate the NV layer using 532 nm laser light from the side of the microscope objective, which pumps the NVs into the  $m_s = 0$  sublevel. Applying a resonant microwave field drives NVs from the  $m_s = 0$  to the  $m_s = \pm 1$  sublevels, reducing the NV fluorescence emission. Sweeping the microwave frequency and imaging the NV fluorescence with the microscope, we obtain an optically-detected magnetic resonance (ODMR) spectrum for each pixel in the microscope field of view. By fitting the ODMR spectra for each pixel to extract the center frequencies, we obtain a  $B_{111}$  map detected by the NV layer [S2].

In this setup, we used a static 1.5 mT bias field along the N-V axis, and subtracted the magnetic field maps acquired using equal and opposite test currents applied to the device to remove any contributions to the magnetic images other than the test current (such as the bias magnetic field). We used 200 mW of laser power, and imaged a  $1.31 \times 2.09$  mm<sup>2</sup> area with a 1.09  $\mu$ m pixel size and a 20 minute typical experiment duration. Finally, to prevent the laser light and NV fluorescence from generating photocarriers in the DUT, we applied a protective coating (5 nm Ti, 150 nm Ag, and 150 nm Al<sub>2</sub>O<sub>3</sub>) to avoid altering the internal currents in the DUT with stray light [S3].

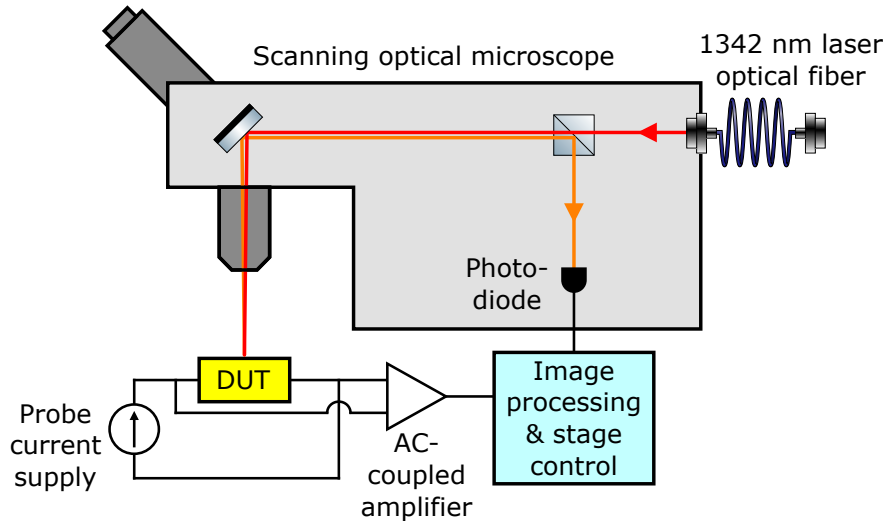
**Supplementary Figure S3.** Schematic of our TIVA setup. We illuminate the DUT with 1342 nm laser light (red beam), and we measure the reflected light (orange beam) with a photodiode. While applying a constant current to the DUT, the voltage across the DUT is also recorded. The scanning optical microscope apparatus moves across the DUT surface, imaging the reflected light intensity and TIVA voltage at each pixel.

Thermally-induced voltage alteration (TIVA) is a technique for localizing defects in semiconductor ICs (Fig. S3) [S4, S5]. Illuminating the DUT with a Nd:YVO<sub>4</sub> continuous-wave monochromatic laser (1342 nm, 0.924 eV) with a photon energy below the silicon band gap (1.14 eV) causes localized heating, generating voltage gradients from thermal gradients (Seebeck effect) without creating electron-hole pairs or photocurrents. For TIVA imaging, localized heating from the focused laser beam alters the resistance of a short-circuit fault, producing a change in the IC power demand. Increased sensitivity is achieved when the DUT is under constant-current biasing. As we scan the laser beam across the DUT surface, we record the changes to the applied voltage and power demand, which indicates the heating (and fault) locations.

We used a laser-scanning microscope (Checkpoint InfraScan 400TDM) to map the thermally-induced voltage changes and the corresponding reflected laser intensities, allowing us to spatially localize the defect sites. For our measurements, we typically used 140 mW of 1342 nm laser light, a  $3.21 \times 3.21$  mm<sup>2</sup> scan area with a 6.27  $\mu$ m pixel size (512 $\times$ 512 pixels), and a 20 minute measurement duration. After finishing the scan, the instrument provides

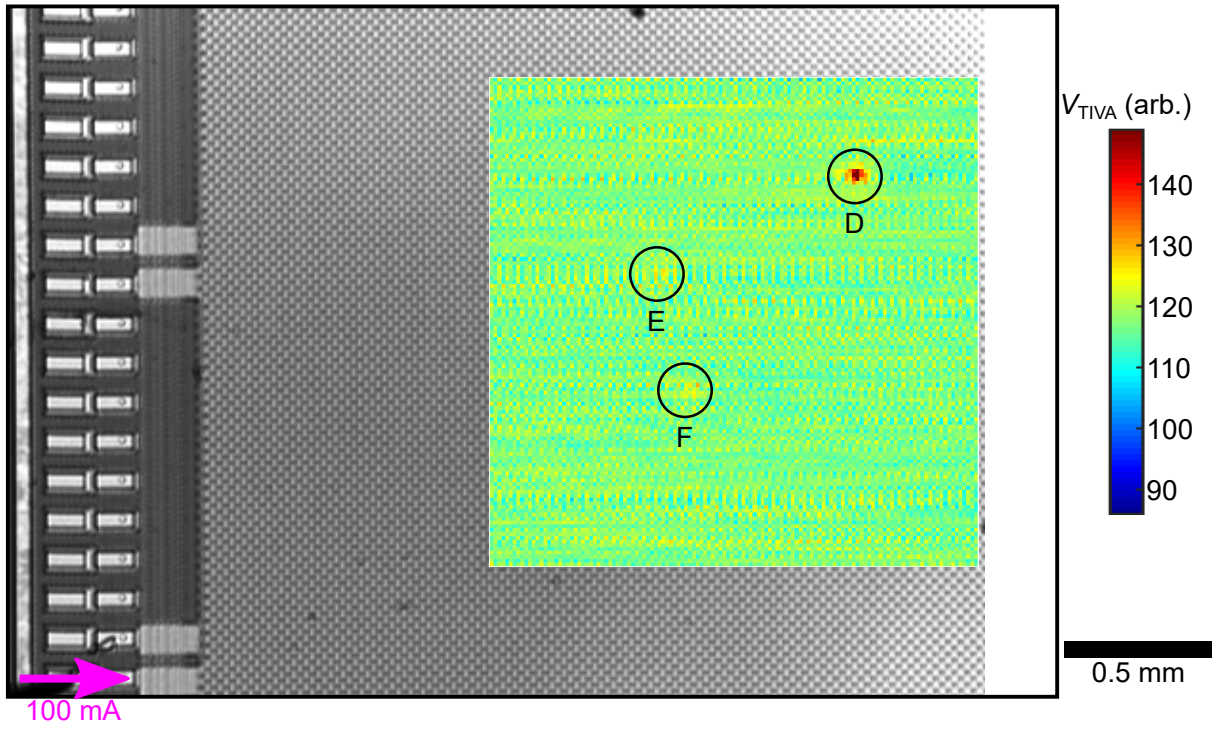
**Supplementary Figure S4.** TIVA image of FOV2 with an improved noise floor ( $4\times$  smaller scan area,  $3\times$  longer averaging time,  $4 \times 4$  pixel binning). Faults E and F (which are clearly visible in the NV magnetic image) are barely visible despite these improvements, showing that NV magnetic imaging is able to find weaker faults in less time than TIVA imaging.

To check whether Faults E and F in FOV2 could feasibly be detected in a TIVA imaging experiment, we modified the TIVA imaging experiment to improve the noise floor. We used a  $4\times$  smaller scan area,  $3\times$  longer averaging time, and  $4\times 4$  pixel binning, totalling a  $\sim 14\times$  SNR enhancement. Figure S4 shows the resulting TIVA image. Despite these enhancements, Faults E and F are barely visible in this TIVA image. However, this confirms the fault positions are consistent with the NV magnetic image (Fig. 4a in the main text).
