# Characterization of Nanostructural Imperfections in Superconducting Quantum Circuits

Decoherence in superconducting quantum circuits, caused by loss mechanisms like material imperfections and two-level system (TLS) defects, remains a major obstacle to improving the performance of quantum devices. In this work, we present atomic-level characterization of cross-sections of a Josephson junction and a spiral resonator to assess the quality of critical interfaces. Employing scanning transmission electron microscopy (STEM) combined with energy-dispersive X-ray spectroscopy (EDS) and electron-energy loss spectroscopy (EELS), we identify structural imperfections associated with oxide layer formation and carbon-based contamination, and correlate these imperfections to the patterning and etching steps in the fabrication process and environmental exposure. These results suggest that TLS imperfections at critical interfaces significantly contribute to limiting device performance, emphasizing the need for an improved fabrication process.

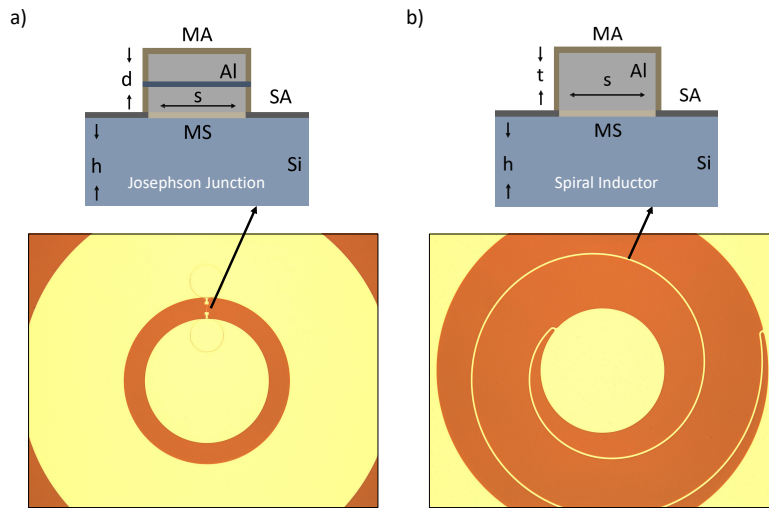
**Figure 1.** (a) Optical image of the qubit indicating the location where the lamella was extracted for scanning transmission electron microscopy (STEM) analysis. (b) Optical image of the resonator showing the lamella extraction site.

The superconducting quantum device studied in this work consists of transmon qubits arranged in a  $4 \times 4$  lattice within a 3D-integrated coaxial circuit quantum electrodynamics (cQED) architecture<sup>40–42</sup>. The qubits and resonators are fabricated on opposite sides of the silicon substrate and capacitively coupled through the bulk substrate. The coupling strength is primarily determined by the substrate thickness and the geometry of the capacitive pads of both the qubit (in Fig. 1(a)) and the resonator (in Fig. 1(b))<sup>40</sup>. The detailed steps of the fabrication process are described<sup>43,44</sup>, with relevant design parameters given in Table 1. Spin-coating a protective photoresist layer on the backside is critical in double-sided fabrication process to protect the wafer and prevent additional contamination. The resonators side is patterned first while the qubit side is covered with photoresist, followed by cleaning the photoresist and spin-coating another protective photoresist layer on the resonators side and patterning the qubits side.

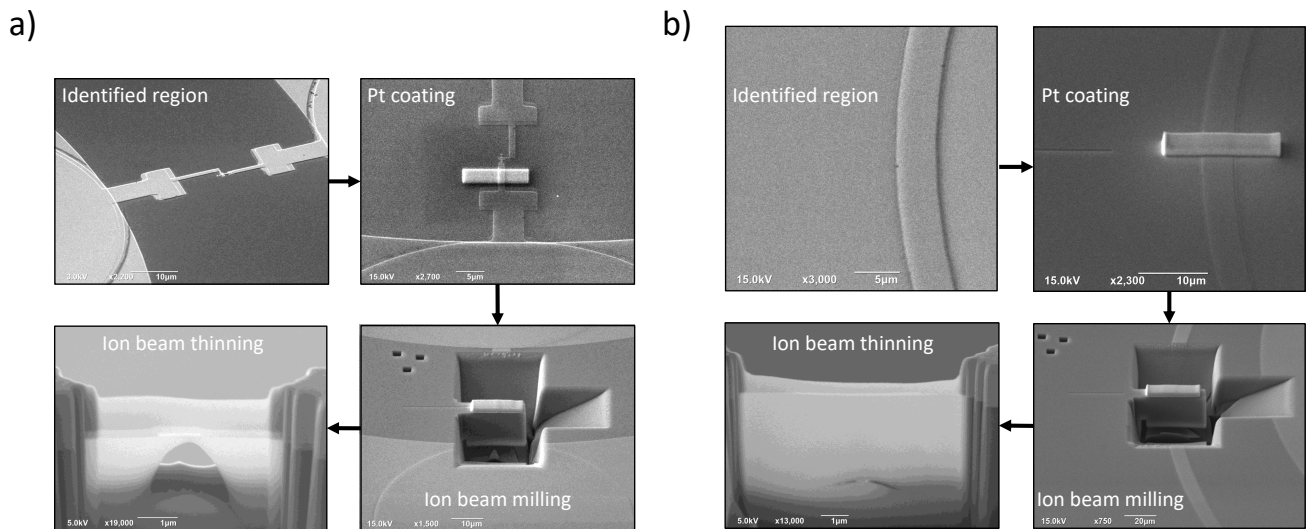
**Figure 2.** Detailed Scanning Electron Microscope (SEM) images during the Focused Ion Beam (FIB) process, illustrating ion beam milling and thinning of the lamella on both (a) the Josephson junction and (b) the spiral inductor. The final fine-thinned lamella for each circuit element is then prepared for high-resolution STEM characterization via controlled vacuum transfer.

To investigate the structural characteristics of the fabricated devices, cross-sectional samples were prepared using a dual-beam Focused Ion Beam Scanning Electron Microscope (FIB-SEM, JEOL 4700F). The samples were initially mounted onto holders and transferred into the FIB-SEM system. The regions of interest were identified using SEM imaging, and a protective layer of platinum was deposited first by an electron beam and subsequently by ion beam to protect the surface during milling. This protective layer prevents damage to the sample surface from the ion beam during milling. Details of the FIB process is shown for both the Josephson junction (qubit side in Fig. 2(a)) and the spiral inductor (resonator side in Fig. 2(b)).

In this section, we present a detailed analysis on two critical components on both sides of the fabricated device: the Josephson junction (qubit side in Fig. 2(a)) and the spiral inductor (resonator side in Fig. 2(b)). The analysis on oxide thickness, elemental distribution, and surface roughness discussed here represent qualitative trends observed across a limited number of cross-sectional lamellae. Given the inherent non-uniformity of surface oxidation, carbon contamination, and roughness across the device, combined with the localized nature of the TEM-based analysis, a detailed quantitative analysis would not be robust and reproducible. For this reasons, we focus this discussion on spatial trends and the relative differences between interfaces, while including limited quantitative analysis through linescans across the interfaces, rather than stressing on absolute quantitative measures.

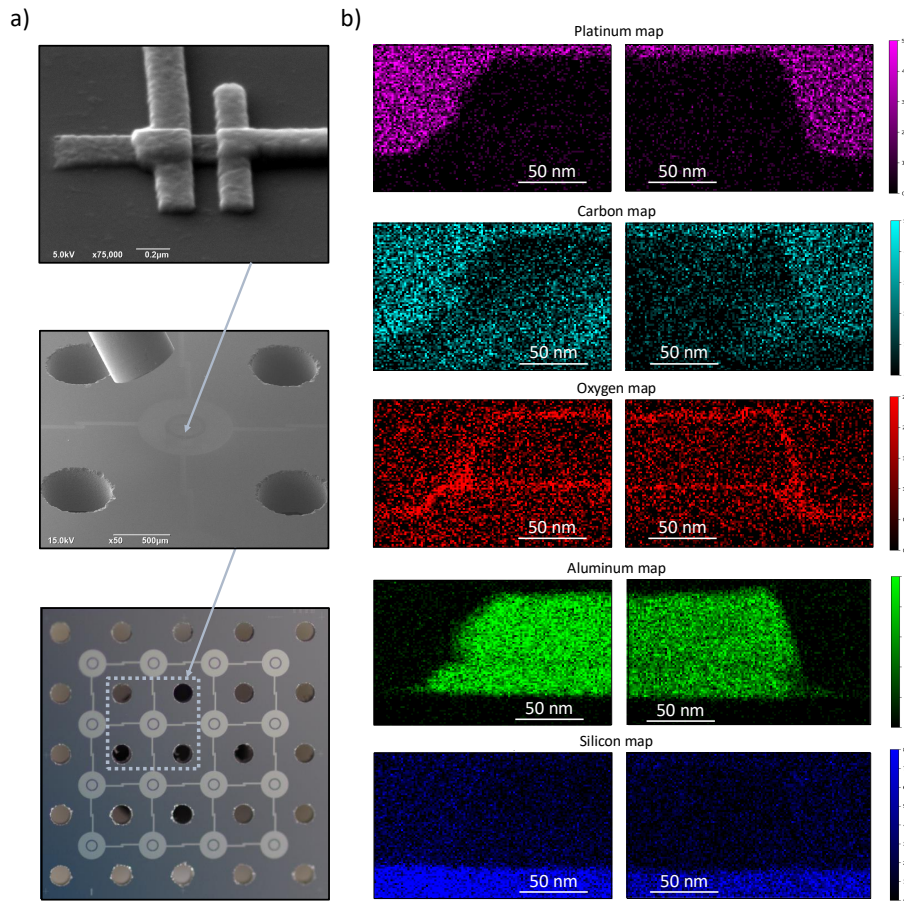
**Figure 3.** (a) Scanning electron microscopy (SEM) images showing the location from which the lamella was extracted from the qubit side for cross-sectional analysis of the Josephson junction. (b) Cross-sectional STEM combined with dispersive X-ray spectroscopy (EDS) elemental maps of both sides of the lamella from the Josephson junction area, highlighting the elemental compositions of oxygen (red), aluminum (green), silicon (blue), carbon (teal), and platinum (purple). The observed carbon signal within the platinum capping layer originates from the gas injection system (GIS) used during deposition since the precursor is not pure platinum, but Methylcyclopentadienyl trimethyl platinum.

Starting with the Josephson junction sample, Fig. 3(a) presents SEM images of the device where the lamella was extracted for cross-sectional analysis, and Fig. 3(b) showing the elemental distribution in the lamella. From Fig. 3(b), the MS interface is notably clean across the whole sample, exhibiting minimal oxygen content, which suggests a lack of significant oxidation at this interface. This is clear when comparing the MS interface with the pronounced presence of oxygen at MA and SA interfaces as well as at the tunnel barrier between the two evaporated aluminum thin films, corresponding to the intentionally formed  $\text{AlO}_x$  layer during the junction oxidation process.

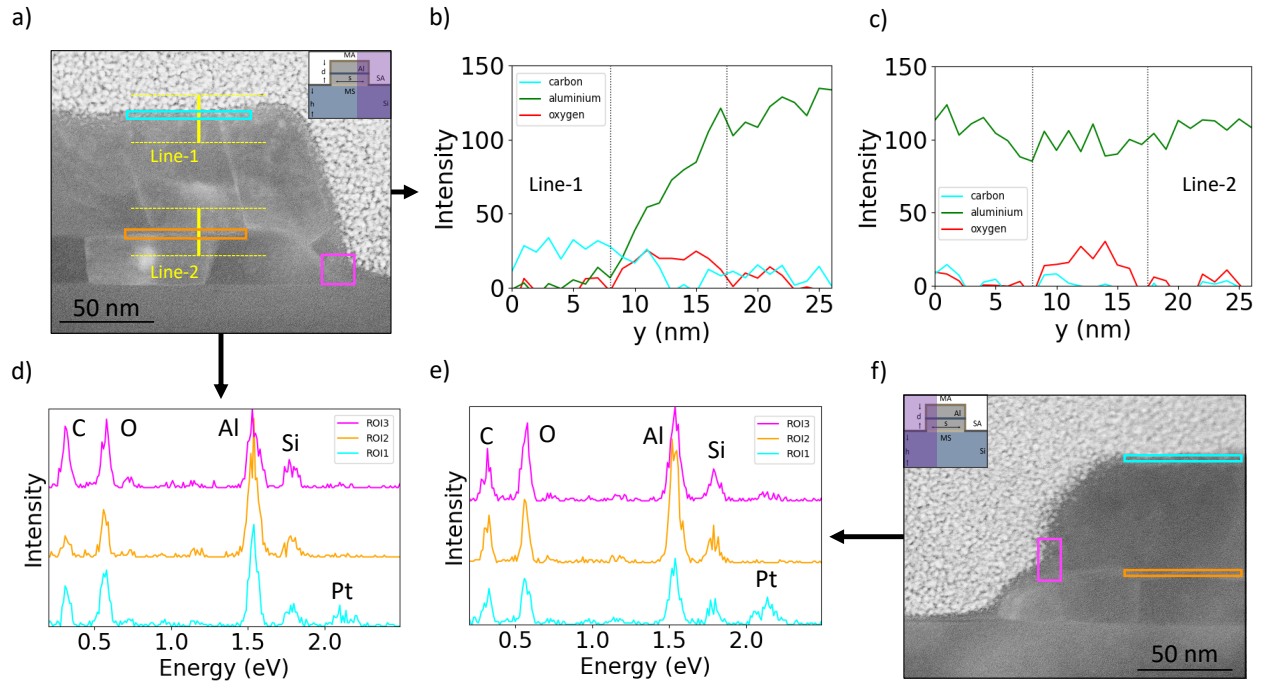
**Figure 4.** Low-Angle Annular Dark Field (LAADF) images in (a) and (f) reveal the grains in the polycrystalline aluminum films due to diffraction contrast. Regions of interest (ROIs) in (d) and (e) are marked: ROI-1 corresponds to the top surface oxide, ROI-2 to the aluminum oxide ( $\text{AlO}_x$ ) at the tunnel barrier of the junction, and ROI-3 to the oxide at the side of the junction. Elemental concentrations across these ROIs contain aluminum, oxygen, carbon and platinum. The presence of background silicon is noted throughout the images. Linescans reconstructed from EDX maps in (a) are shown in (b) and (c). (b) Shows elemental profile along Line-1 revealing a surface oxide layer approximately 10 nm thick with increasing aluminum content with depth and carbon pickup at the top of the oxide layer and in the platinum capping layer. (c) Elemental profiles along Line-2 showing a thinner oxide layer about 7 nm thick with lower carbon contamination.

The Low-Angle Annular Dark Field (LAADF) images in Fig. 4(a) and (f) show pronounced diffraction contrast, revealing the grain structure in the polycrystalline aluminum films. Three regions of interest (ROIs) are identified and it is noted that these ROIs include both oxide and some aluminum, making it challenging to isolate the oxide exclusively in these particular maps. Additionally, a background signal from silicon is also present throughout the images. In the right part of the lamella (see Fig. 4(a) and (d)), we observe that the  $\text{AlO}_x$  layer within the junction (ROI-2) appears to have the lowest amount of carbon contamination compared to the oxygen-rich layers at the top and side surfaces, suggesting a higher purity in the tunnel barrier. However, in the left section of the lamella (see Fig. 4(e) and (f)), we see a similar amount of carbon in all ROIs. Carbon maps show that the platinum coating contains more carbon, but there are patches of carbon in the bulk aluminum area as well.

The low carbon contamination in the  $\text{AlO}_x$  tunnel barrier (ROI-2) suggests that the controlled oxidation process effectively produces a high purity insulating layer essential for the junction. However, the pronounced oxygen presence at the MA and SA interfaces indicates that surface oxidation is occurring post-fabrication, likely due to the subsequent fabrication process and exposure to ambient conditions. The carbon levels across different ROIs in the left section of the lamella imply that carbon contamination could be widespread, possibly introduced during sample preparation or from residual processing materials. This pervasive carbon and oxygen at air interfaces could contribute to dielectric loss, building a decoherence channel for the qubit.

In addition, linescans reconstructed from EDX maps across the surface oxide layers of the Josephson junction area are shown in Fig. 4(b) and (c). Line-1 and Line-2 were analyzed to assess the thickness and composition of the oxide layers in different regions. In Line-1, the surface oxide layer is approximately 10 nm thick. The aluminum content appears to increase with depth into the surface; however, here the layers are not completely flat which may cause some smearing of the features. Additionally, there is a noticeable presence of carbon at the very top of the oxide layer within the platinum capping layer, but less within the underlying device. In contrast, Line-2 reveals an oxide layer of about 7 nm thick exhibiting low levels of carbon contamination.

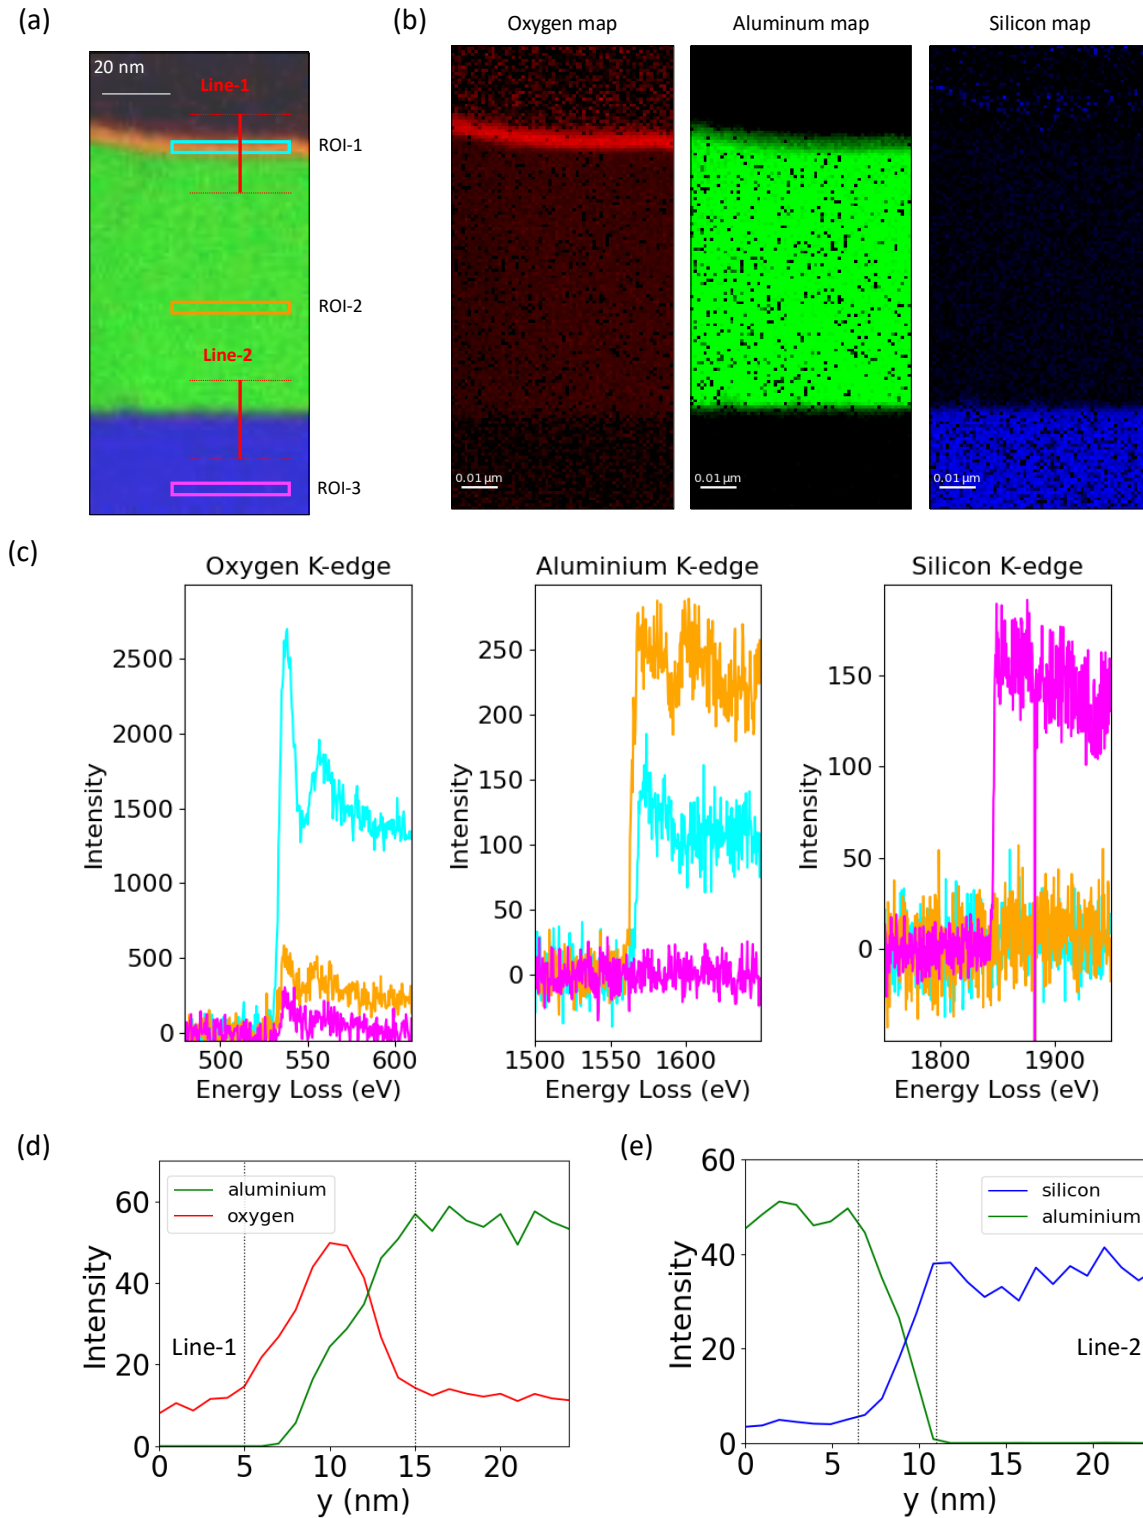
**Figure 5.** (a) Scanning transmission electron microscopy (STEM) combined with electron-energy loss spectroscopy (EELS) maps of the middle section of the lamella extracted from the spiral inductor, with regions of interest across the interface indicated by boxes. The elemental compositions of oxygen (red), aluminum (green) and silicon (blue) are shown in a combined EELS map. Individual colored images of (b) oxygen, aluminum, and silicon illustrate high contrast of each elemental distribution. (c) Oxygen K-edge, aluminum K-edge, and silicon K-edge EELS spectra from the three ROIs, showing more oxygen in ROI-1, more aluminum in ROI-2, and more silicon in ROI-3. Linescans along different regions in (a) are shown in (d) for Line-1 and (e) Line-2. The elemental profiles along (d) Line-1 reveal a surface oxide layer approximately 10 nm thick, while (e) Line-2 indicates a much cleaner interface with no relative oxygen signal.

Next, we discuss materials analysis on the spiral inductor in Fig. 2(b), where the results in Fig. 5 presents a detailed analysis of the middle section of the lamella, a key component in the resonator circuit. In Fig. 5(a), the cross-sectional STEM-EELS maps highlight regions of interest (ROIs) across the interface, marked by boxes. The individual images for (b) oxygen, aluminum, and silicon illustrate the distribution of these elements in the examined region. Note: the observed silicon signal in the platinum capping layer in (b) is likely an artefact from lamella projection. The corresponding EELS maps in Figure 5(c) clearly show three distinct regions:  $\text{AlO}_x$  surface (ROI-1), Al film (ROI-2), and Si substrate (ROI-3). In addition, linescans reconstructed from EDX maps along different regions are presented in Figures 5(d) and 5(e), corresponding to Line-1, Line-2, and Line-3, respectively. The elemental profiles along Line-1 reveal the presence of a surface oxide layer approximately 10 nm thick, characterized by significant concentrations of aluminum and oxygen. In contrast, the profiles along Line-2 show a much cleaner interface with no relative oxygen signal as also seen in Fig. 5(b), suggesting minimal oxidation at this boundary with sharper aluminum and silicon profiles. This observation of a relatively clean MS interface with minimal oxygen content is consistent with the Josephson junction results shown in Fig. 3(b), where the MS interface was also found to be notably clean across the sample. These findings highlight the variability in interface quality as the differentiation between oxidized and cleaner regions indicate the importance of precise fabrication techniques to control the oxidation process and maintain the integrity of the interface.

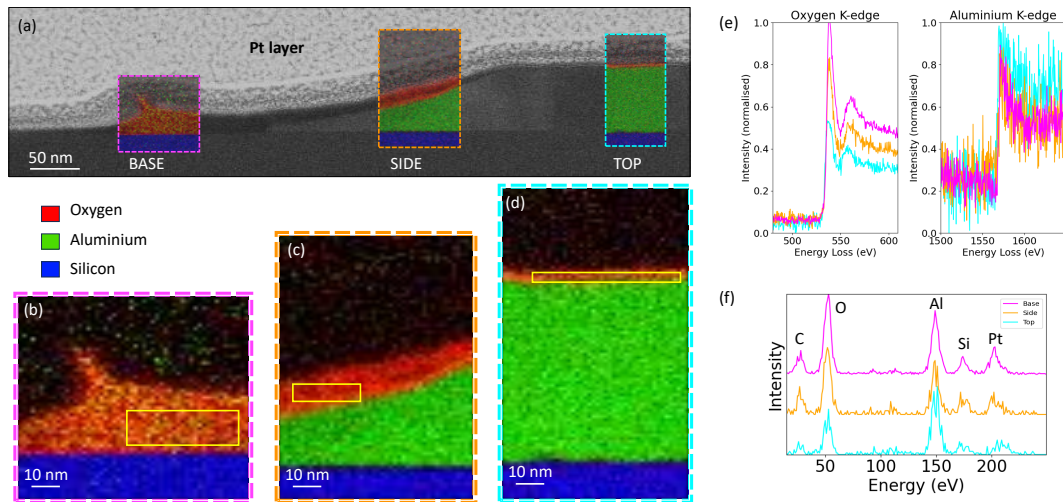
**Figure 6.** (a) Cross-sectional scanning transmission electron microscopy (STEM) image of the left side of the lamella extracted from the resonator side showing locations of electron-energy loss spectroscopy (EELS) maps, highlighting the elemental compositions of oxygen (red), aluminum (green) and silicon (blue). EELS maps from (b) the base, (c) the side and (d) the top of the aluminum thin-film, with the region of interest for the  $\text{AlO}_x$  spectra indicated as yellow boxes. (e) Oxygen K-edge and aluminum K-edge EELS from the  $\text{AlO}_x$  regions. (f) EDX spectra from the same regions of interest.

Figure 6 shows the cross-sectional STEM image of the left side of the cross-section. EELS maps were acquired from three regions of the aluminum thin film: the base, sidewall, and top surface. Analysis of both EELS and EDX data reveals that the oxide layer exhibits increasing oxygen content from the top to the side to the base regions. The aluminum content remains relatively constant throughout these areas. Moreover, EDX results show that the carbon content is higher at the base and sides, suggesting that the thicker oxygen-rich layers observed in these regions may contain a noticeable amounts of organic impurities. In contrast, the oxide layer on the top surface has less carbon, suggesting a cleaner oxide layer.

These observations indicate that the sidewalls and base of the aluminum thin-film are more prone to oxidation and contamination compared to the top surface. The increased oxygen content from top to side to base suggests that these regions accumulate thicker oxide layers. The higher carbon content at the base and sides, as revealed by EDX, implies the presence of organic impurities. This suggests that photolithography and wet-etching steps which selectively target these regions may leave behind contaminants that preferentially adhere to the sidewalls and base. While the aluminum intensity appears similar across all three regions (see Fig. 6(a)), the oxygen signal increases progressively from the top to the base. This suggests that the  $\text{AlO}_x$  in these areas originates from the same oxidation mechanism during fabrication and ambient exposure, but varies in oxygen level and thickness likely due to spatially non-uniform etching dynamics, particularly at the base. The cleaner oxide layer on the top surface indicates that this area is less exposed to contaminants or that any impurities are more effectively removed or prevented from adhering during processing. These differences in impurity levels are critical because the thicker, impurity-rich oxide layers at the side and base could introduce additional dielectric loss. Further optimizing the photolithography and etching processes to reduce these imperfections, especially at the sidewalls and base, is essential for enhancing the quality of the processed aluminum thin-film device.

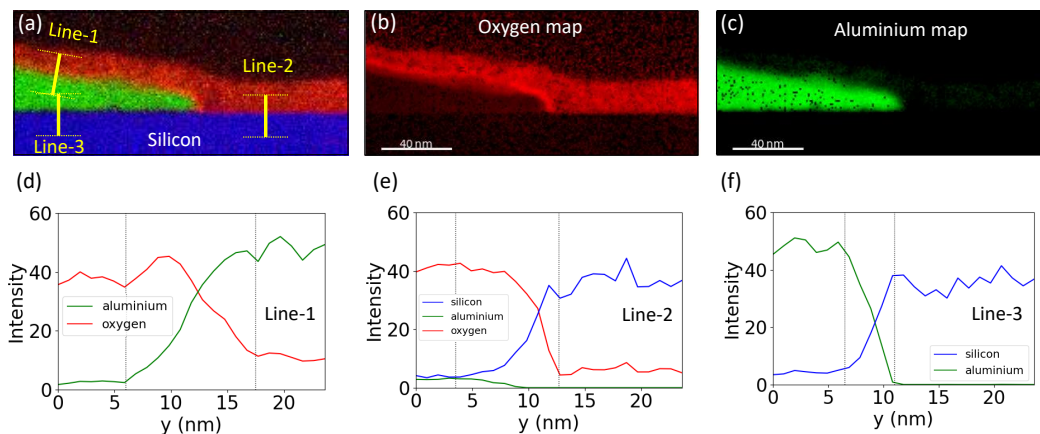
**Figure 7.** (a) Cross-sectional scanning transmission electron microscopy (STEM) images of the right side of the lamella from the resonator side, highlighting the elemental compositions of oxygen (red), aluminum (green), and silicon (blue). (b) Individual colored images of oxygen, and (c) of aluminum, illustrating the presence of aluminum oxide ( $\text{AlO}_x$ ). Linescans reconstructed along different regions in (a) are shown in (d) for Line-1, (e) for Line-2, and (f) for Line-3. The elemental profiles along Line-1 show concentrations of aluminum and oxygen, revealing a surface oxide layer and Line-2 show concentrations of silicon and oxygen, while Line-3 indicate a much cleaner interface with no relative oxygen signal.

Furthermore, Fig. 7 provides a detailed compositional analysis of the right side of the cross-section. In Fig. 7(a), the EELS maps highlights the distribution materials composition and the EELS maps in Fig. 7(b) and 7(c) display the localized presence of oxygen and aluminum, respectively, confirming the formation of aluminum oxide ( $\text{AlO}_x$ ) layers. Linescans reconstructed from EELS maps along three different regions are presented in Fig. 7(d), 7(e), and 7(f), corresponding to Line-1, Line-2, and Line-3, respectively. The elemental profiles along Line-1 reveal a surface oxide layer, with increasing aluminum content as depth increases, suggesting a gradient in the thickness of the oxide layer from the surface inward. The profiles along Line-2 indicate thicker oxide layer with an increase in silicon content at depth. This may indicate interdiffusion or oxidation extending into both the metal and substrate. In contrast, the profiles along Line-3 show a much cleaner interface, with no relative oxygen signal and sharp transitions in aluminum and silicon content across the interface, suggesting minimal oxidation and a well-defined boundary between the aluminum thin film and the silicon substrate.

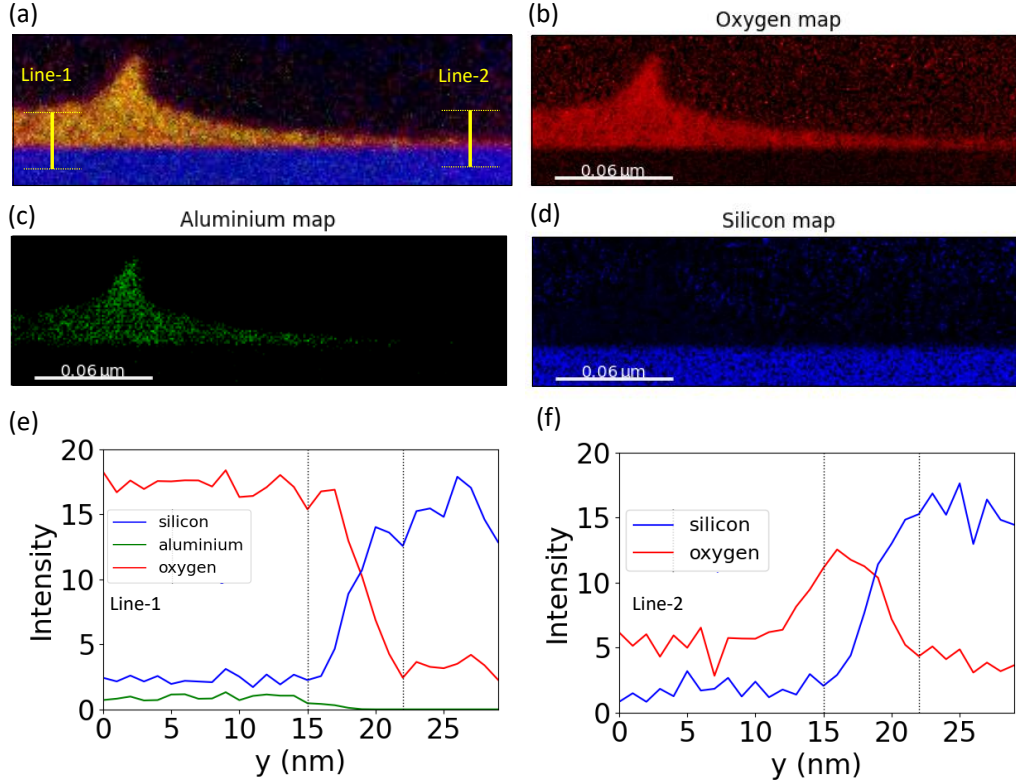
**Figure 8.** (a) Cross-sectional scanning transmission electron microscopy (STEM) colored images at right of the lamella at the location of a structural imperfection from the resonator side, highlighting the elemental compositions of oxygen (red), aluminum (green), and silicon (blue). Individual colored images of the same area for (b) oxygen, (c) aluminum, and (d) silicon, show that this imperfection observed here consists predominantly of aluminum oxide ( $\text{AlO}_x$ ). Linescans reconstructed along different regions indicated in (a) are shown in (e) for Line-1 and (f) for Line-2. The elemental profiles along Line-1 display concentrations oxygen, revealing a surface oxide layer approximately 20 nm thick while Line-2, which is further to the right, show non-uniform but thinner oxide layer.

Additionally, in Fig. 8(a), the cross-sectional STEM images highlight the distribution of materials composition at further right of the lamella. The individual elemental maps of the same area confirm that this bulk of the residual layer observed on both sides of the spiral inductor is predominantly composed of oxygen with only a thin presence of aluminum, indicating that it is primarily aluminum oxide ( $\text{AlO}_x$ ) rather than silicon oxide ( $\text{SiO}_x$ ). This indicates that oxidation is occurring mainly within this much thinner aluminum film rather than at the aluminum-silicon interface. From the linescans reconstructed along two different regions in Fig 8(a) we can see the elemental profiles in which Line-1 (see Fig 8(e)) shows concentrations of oxygen, revealing a surface oxide layer approximately 20 nm thick with increasing silicon content as depth increases. This suggests a substantial oxidation layer on the surface in the aluminum thin film. In contrast, the profile along Line-2, which is further to the right, shows non-uniform but thinner oxide layers with increasing silicon content with depth. This may indicate some degree of interfacial oxidation or diffusion of oxygen into the silicon substrate in this region.
