# Disorder, defects and bandgaps in ultra thin (001) MgO tunnel barrier layers

P. G. Mather, J. C. Read, R. A. Buhrman
Cornell University, Ithaca, NY 14853-2501
PACS: 73.40.Gk, 73.61.Ng, 68.37.Ef, 85.75.Dd, 85.75.Ss

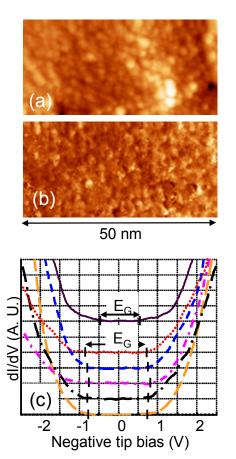
Figure 1, Mather *et al.*

Fig. 1: (Color online) STM topograph (a) and simultaneously acquired DOS map (b) for a 15 Å sputtered, annealed MgO film on Fe, acquired at a tip bias of 2V, 100 pA. There is little overall correlation between electronic structure and topography. DOS measurements (dI/dV) across surface (c - dotted lines) show uniform band gap values ( $\sim$ 1.5 V); structure in DOS map is due to variation in strength of band tails. Curves are offset for clarity. Solid curve is from an identical, but unannealed sample. The band gap is ( $\sim$ 0.5 V) smaller.

Figure 1 shows topographic (a) and DOS ( $dI_t/dV_t$ ) (b) images from a thin, sputtered MgO layer (5 Å Mg / 10 Å MgO) imaged with a tip bias  $V_t = 2$  V and tunnel current  $I_t = 100$  pA after annealing at 375 C. The 2 V DOS map indicates that there are substantial variations in the electronic structure across the surface of the MgO layer, but with no clear correlation with the MgO topography. DOS measurements ( $dI_t/dV_t$  vs.  $V_t$ ), as shown for example in Fig. 1 (c), reveal that this MgO layer exhibits a band-gap that is rather symmetric about the Fermi level ( $V_t = 0$ ) and that only varies marginally in amplitude from spot-to-spot from its average value of  $E_G \sim 1.5$  eV. Such measurements indicate that the variations in the DOS map (Fig.1a) result from local differences in the bias dependence of the band tails once the band-gap is exceeded. This is consistent with variations arising from where the Fermi level of the disordered MgO is pinned due to local fluctuations in defect character and density. Very similar DOS results (solid curve, Fig. 1c) are obtained from 5 Å Mg / 10 Å MgO layers examined prior to annealing, but in this

case the symmetrical band-gap is only ~ 1.0 eV, *i.e.* in the case of the sputtered MgO layer, thermal annealing is found to increase  $E_G$  by ~ 0.5 eV.

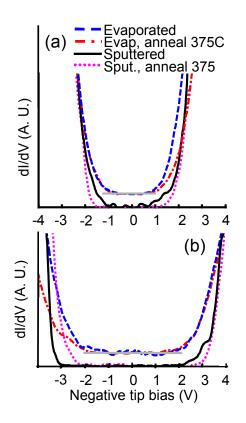
Figure 2, Mather *et al*.

Fig, 2: (Color online) DOS measurements for several 20 Å film preparation methods (a).
Sputtering produces a band gap of ~1.5 eV, which annealing further increases to ~2.5 eV.
Annealing sputtered films broadens the band gap and reduces vacancy-defect sites. Egun
evaporation results in band gaps that are not improved upon annealing. Measurements for 30 Å
(b) films show that as the surface moves away from the strained, disordered Fe/MgO interface
the vacancy-defect density drops and the band gap increases.

We find a substantial change in the DOS of the sputtered MgO layers when the thickness is increased by as little as 5 Å. In Fig. 2a, we show representative DOS measurements taken before and after annealing, which again reveal relatively symmetric band tails, but  $E_G$  has increased with MgO thickness to ~ 1.5 eV before annealing and to ~ 2.5 eV afterwards. For still thicker MgO layers, 15 Å Mg / 15 Å MgO, the increase in  $E_G$  continues, with Fig 2b showing representative DOS plots that yield  $E_G \sim 6$  eV before annealing, and nominally the same after annealing, although in some cases it is as high as ~ 7.5 eV (Fig. 3c), which is the value reported from STS measurements on well-ordered and annealed MgO layers epitaxially grown on Ag single crystal [7].

The behavior of the e-beam evaporated MgO layers is similar, but somewhat different in detail. For a 15 Å e-beam layer, DOS measurements again show  $E_G$  is relatively uniform, ~ 1.0 eV, across the surface in the as-grown state. Thermal annealing has essentially no effect on  $E_G$  on the e-beam evaporated samples. For 20 Å and 30 Å layers, the average  $E_G$  progressively increases, up to ~ 4.0 eV in the latter case, but again annealing has no significant effect. We attribute this different behavior under thermal annealing to the presence of an additional type of atomic defect in the sputtered as opposed to the e-beam evaporated layers. X-ray photoemission spectroscopy (XPS) data on similarly grown layers [8] show a significant, ~ 0.5 eV, shift to lower binding energy (BE) of the Mg and O signals from the oxide for the sputtered MgO in comparison to e-beam deposited layers. Such a shift is consistent with a significant density of negatively charged Mg vacancies in the sputtered oxide. We present STS data below that further support this conclusion, but we note here that the presence of both Mg and O vacancies in the

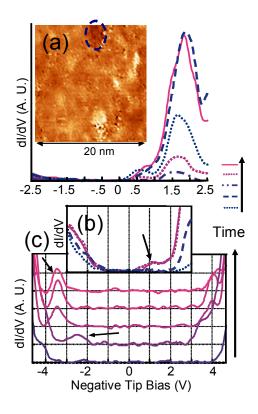
Figure 3, Mather *et al*.

Fig. 3: (Color Online) DOS measurements (a) for a 20 Å annealed, sputter deposited MgO film, taken at the lowest points in the DOS map (inset, circled) show peaks characteristic of oxygen vacancy sites 1.75 V and 0.5 V above the Fermi level. Image parameters were -2.5 V tip bias and 100 pA. (b) shows a peak from a similar DOS spot in an unannealed 20 Å film. The discrete levels become smeared out into a band tail in the more disordered unannealed sample.
(c) DOS measurements on a defective site from a 30 Å sputtered, annealed MgO film. Curves are offset for clarity. Initial curve exhibits very close to the full 7.8 eV MgO bulk band gap, while a

defect state (see arrows) due to a Mg vacancy appears in subsequent measurements as the STM tip drifts. This state is ~1V above the valence band maxima (VBM)

inability of the oxide to withstand the significant tunnel currents required for the measurement without local electronic degradation. However, occasionally in the 20 Å layers, particularly after annealing, it is possible to perform DOS measurements in the vicinity of individual defects. We accomplish this by taking a DOS map at a high bias voltage, and identifying regions, typically  $\sim$ 3 nm in extent, of noticeably lower signal amplitude. By placing the STM tip in this region and taking DOS measurements as the tip slowly drifts about in this region, due to the limitations of this room temperature measurement, signals indicative of somewhat isolated defects could sometimes be obtained. An example is given in Fig. 3a, where we show successive DOS sweeps taken while the STM tips drifts about within the circled region of the low spot of the DOS map shown in the inset. There are two distinct, albeit broad, peaks in the DOS, a small peak centered at  $V_t \sim -0.5$ V and a larger peak centered at  $V_t \sim -1.75$ V, about 1 eV below the apparent, local conduction-band minimum (CBM) of the oxide layer, with the amplitudes of these peaks varying as the tip drifts closer or further away from the defect center. A total-energy functional (TEF) calculation [10] indicates that the neutral oxygen vacancy or F center in MgO should have its filled electron energy levels  $\sim$  1.2 eV below the MgO conduction band. Yet such a vacancy defect, when located within electron tunneling distance of an underlying electrode, can be expected to be in the  $F^{2+}$  state at equilibrium if the F state energy is indeed near the CBM. The two peaks then would correspond to the initiation of electron tunneling to the lowest unoccupied level of the defects, resulting in final states  $F^+$  and F respectively. The TEF calculation treats the oxide in isolation and the F<sup>+</sup> defect with a change in the bound charge density of the six adjacent Mg atoms, producing a level only 0.13 eV below that of the neutral defect. However, metallic screening from the underlying electrode can be expected play a significant role in our experiment which may explain the > 1 eV difference in the positions of the two peaks that we observe. In

We have also observed defect states when they are not so dilute as to be discrete. In Fig. 3b we show a series of DOS sweeps taken with the STM tip over a region of an unannealed 10 Å Mg/10 Å MgO layer where the high-bias DOS map indicated a more bulk-like behavior than average. There we see a broad plateau of band-tail states extending from ~ 0.5 to 2.0 + eV, depending on tip location. It is straightforward to attribute this behavior to the presence of a higher density of defects than in the annealed sample of Fig. 3a; a density sufficient to broaden the peak structure into a distinct defect band below the main conduction band onset, but not sufficient to have the defect states dominant the overall behavior – the case over much of the area of such samples (see Fig. 2a). Note also the substantial band tailing in the valence band in Fig. 3b, due to the defect induced disorder, in contrast to the much lower VBM in the less defective region of the annealed sample shown in Fig. 3a. The role of these defect states in producing broad band-tails and narrowing  $E_G$  in the thinnest MgO layers now appears clear.

Previously we had mentioned that XPS measures considerable negative charging in sputtered MgO layers, which we have attributed to the presence of a substantial density of Mg vacancies, V centers. If the electron levels of V centers are close to the VBM [10] they should be occupied due to tunneling from the underlying electrode and will be negatively charged, V<sup>2-</sup>. We have found STS evidence for such defect states in a 30 Å, sputtered and annealed MgO layer. DOS sweeps taken, again while the tip drifts across the surface, show (Fig. 3c) clear evidence of a local peak in the DOS at about 1 eV above the VBM, with data taken at different

places over the surface showing peaks at different tip bias points but always in essentially the same position relative to the local VBM.
